# Samanalawewa Dam Willowstick Survey

## Willowstick rapidly located leak at dam troubled for decades

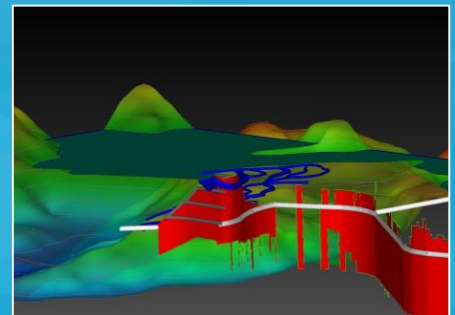
In three weeks the survey pinpointed the two main areas where the cut-off was comprised. A subsequent borehole confirmed the location of the main leakage path at a depth of 100m to within 100mm.

3D visualization of flow paths

Following the Willowstick survey it was possible to undertake cost effective remedial works ensuring the safety of the dam and allowing it to store water again.
