USING WILLOWSTICK INVESTIGATIONS TO TARGET REMEDIATION AND EVALUATE ITS EFFECTIVENESS

LOCATION
Austria

DATE
2015 & 2017

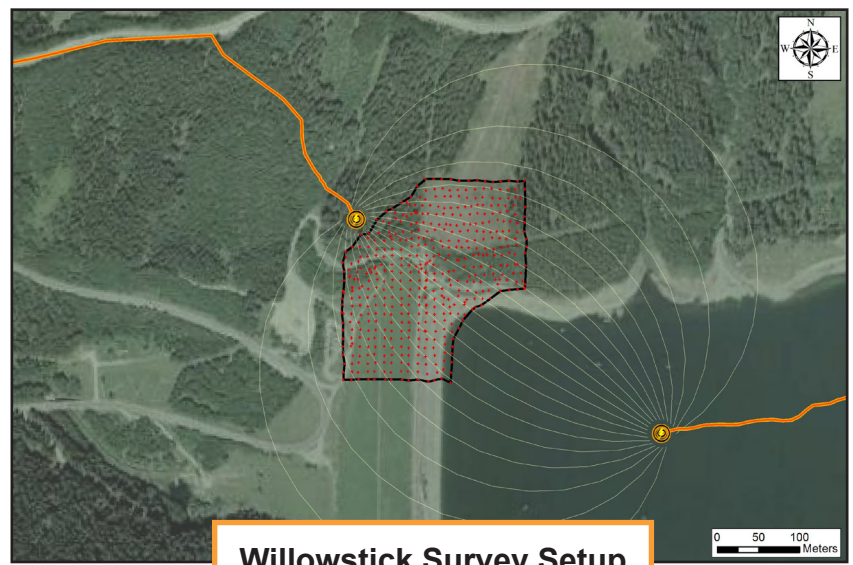
In 2015, Willowstick completed an investigation at the dam, with several surveys covering the entire dam, and identified an unexpected preferential seepage flow path through the north (right) abutment. The rest of the dam was working as designed.

Using the information from the 2015 investigation, the dam owner improved the existing grout curtain in the north abutment. The first part of the improved grout curtain was installed in 2017, but it didn't eliminate the seepage.

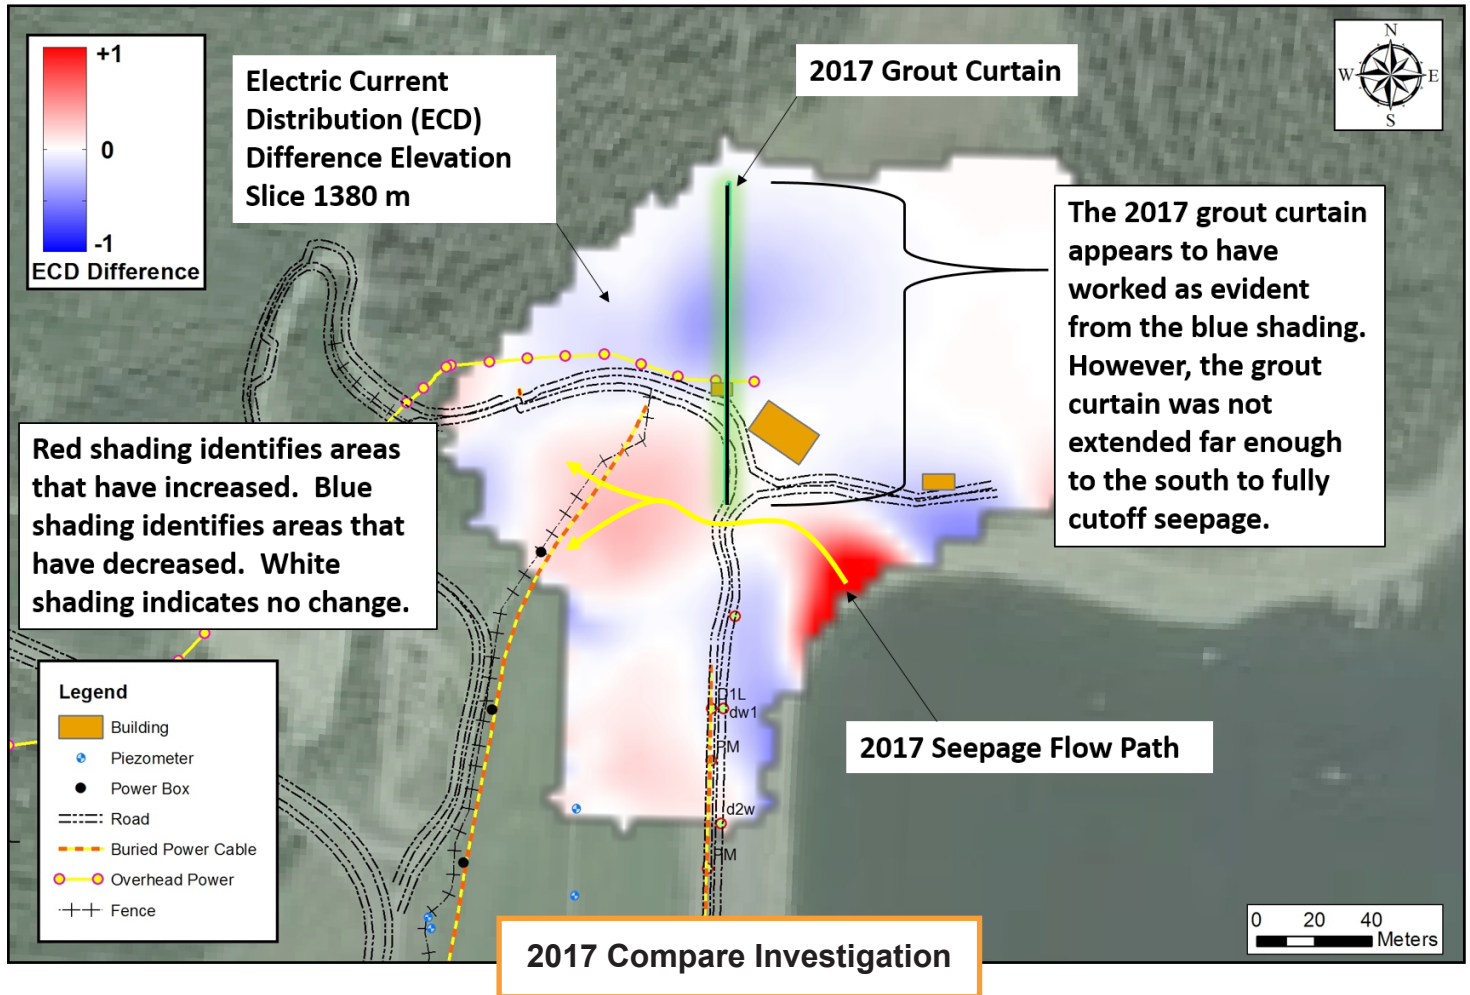
After the completion of the Compare survey in 2017, the results were compared to the readings from the 2015 investigation. The difference between these models showed increased electrical current along a pathway just south of the 2017 improved grout curtain. The preferential seepage flow path had shifted to pass around the southern end of the grout curtain.
