Kauffman Stadium Assessment

JCSCA + Burns & McDonnell

This document contains information pertaining to the condition of Kauffman Stadium as documented by the Jackson County Sports Complex Authority (JCSCA), including descriptions, conditions, and exhibits which have been reviewed by Burns & McDonnell and documented in this report.

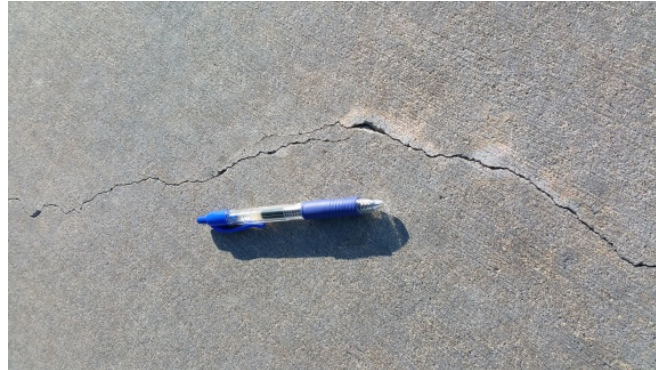
Figure C-1: Minor Cracking at Concrete Walkways

A portion of distresses observed consisted of cracking, and most cracking observed was low severity. Minor, vertical hairline cracking along with minor web cracking was observed in some retaining walls. Minor cracking was also observed at several locations in concrete walkways around the stadium, as shown in Figure C-1. Several slightly more severe distresses in the concrete were also observed. Faulting was observed at a joint within the range of pedestrian traffic, as shown in Figures C-2 and C-3. This faulting is considered moderate severity and any joints faulting within the natural flow of foot traffic pose a tripping hazard.

The majority of the concrete flatwork elements were observed to be in satisfactory condition. Continue to perform routine maintenance to seal and repair minor cracking observed along walkways and concourses. Replace any missing, damaged, or otherwise unsatisfactory joint sealant and/or backer rod required for concrete joints.

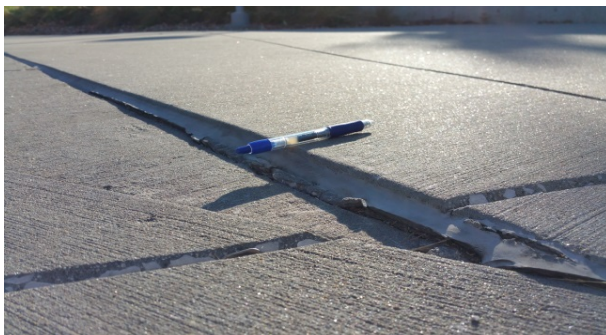
Figure C-2: Joint Fault at Pedestrian Traffic Way

Joint distress is another common deficiency in concrete pavement that was observed in the pavement at Kauffman. At several locations, joint failure was observed both at the face of structures and within walkway pavement. At some of these joints missing sealant or differential settlement was observed, as shown in Figures 4 and 5. In locations where the paved surface or stairs settle at a different rate the adjacent structure, sealant has pulled away from the joint rendering it ineffective.

- Monitor any minor faulting slabs in walkways for progression of the faulting. If faulting becomes more severe, repair or replacement of concrete may be necessary. To protect pedestrian safety and provide a full ADA compliant route, repair and/or replace any faulting panels or pavers to maintain a consistent surface where faulting has resulted in a drastic elevation change.
- Replace or secure any trench drain or drainage structure as necessary to prevent it from being accidentally or intentionally dislodged and maintain design inflow capacities. Loose trench drain covers could be a tripping hazard for pedestrians.

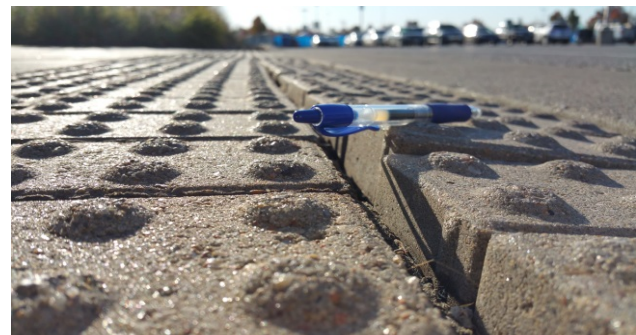
Figure C-3: Uneven Paver Settlement at Pedestrian Traffic Way

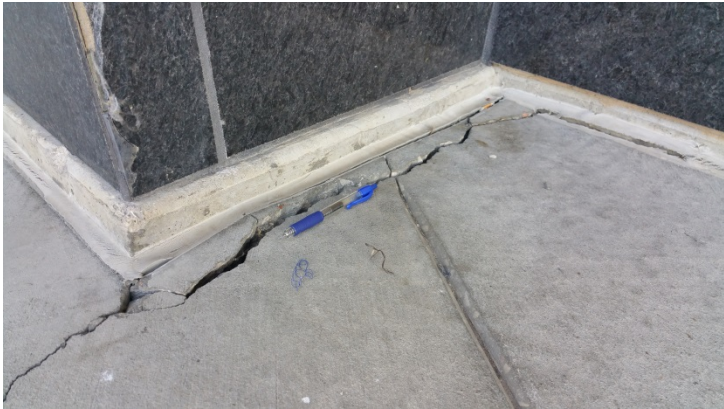
At several locations, both at the face of structures and within walkway pavement, some higher severity spalling was observed. In many cases, this spalling was coupled with missing or damaged sealant. These two deficiencies combined can amplify the negative effects of one another and increase the rate of degradation of the pavement, as shown in Figure C-5.

Figure C-5: Joint Spalling Along North Building Facade

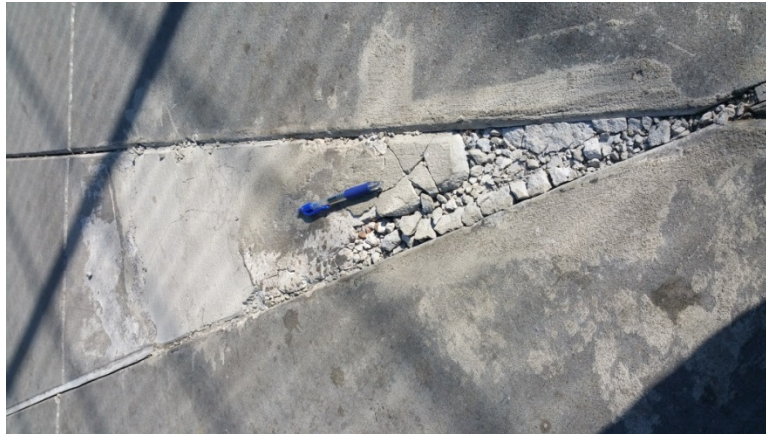
Spalling was observed in a few other locations as well. In some locations spalling could be found in what appeared to be recently patched concrete, as shown in Figure C-6.

Figure C-6: Damaged Pavement Patch Outside of Gate D

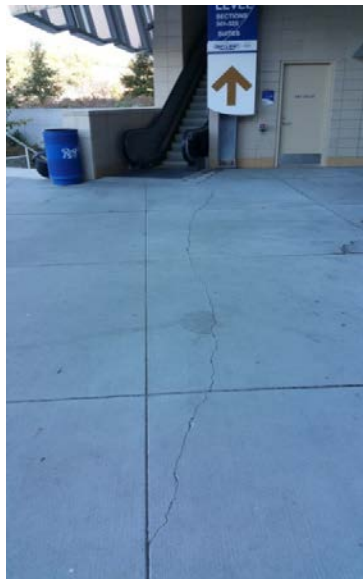
Figure C-7: Crack Near Spiral Ramp Behind Gate 3

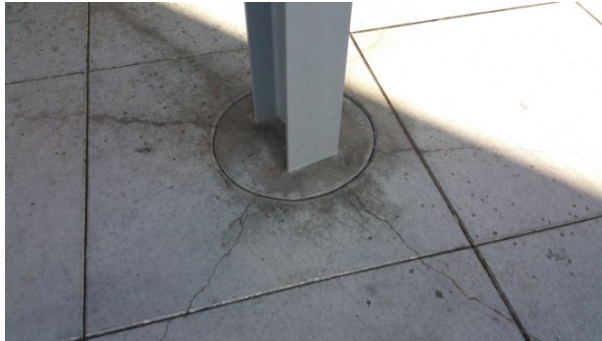
Figure C-8: Cracking Radiating Out From Column Foundation

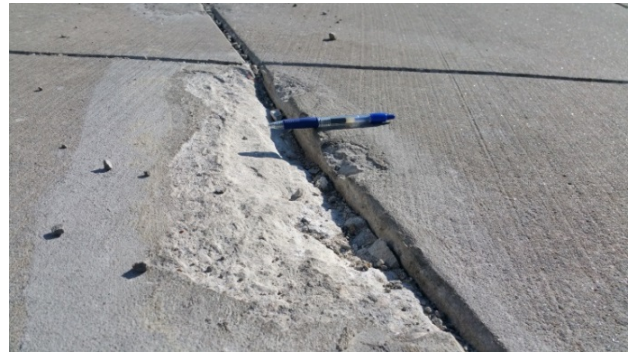
Figure C-9: Edge Spalling Immediately Inside Gate D

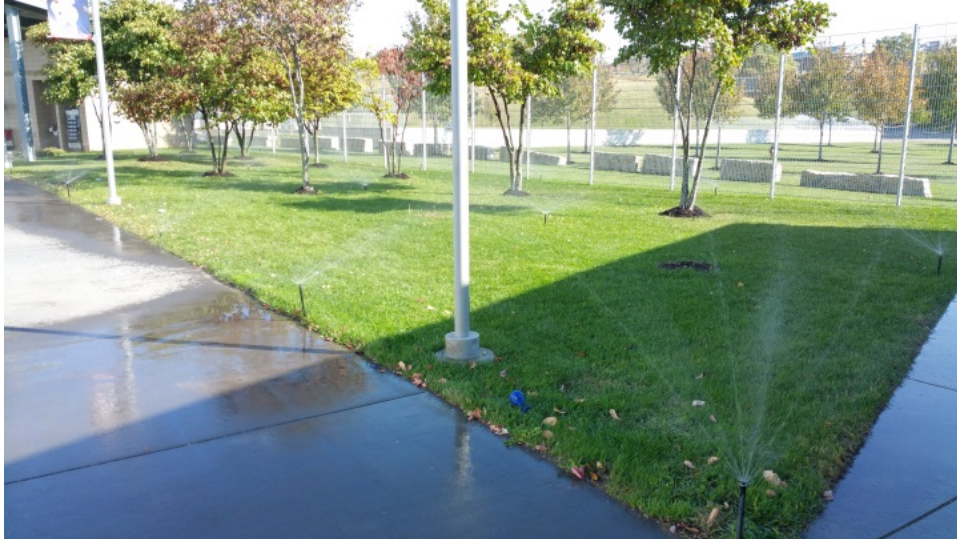
Domestic grasses were observed in satisfactory condition and irrigation systems were observed as operational. In several locations, the irrigation system was distributing water beyond the grass and into concrete walkway areas, as shown in Figure L-2.

Figure L-2: Irrigation System in Operation

- To optimize the efficiency of the irrigation system, adjust the operating range to prevent excess water from spraying the concrete sidewalks. Refer to Figure L-2.
- Consider maintaining weeds and re-grading the narrow grass area next to the electrical equipment pad northeast of the stadium to provide positive drainage away from both the adjacent structure and the concrete equipment pad.
- Repair and reset the damaged storm water inlet structure. This would not only improve the aesthetic appeal of the area, but would also help prevent ponding that may be occurring from a currently restricted inlet. Refer to Figure L-4.

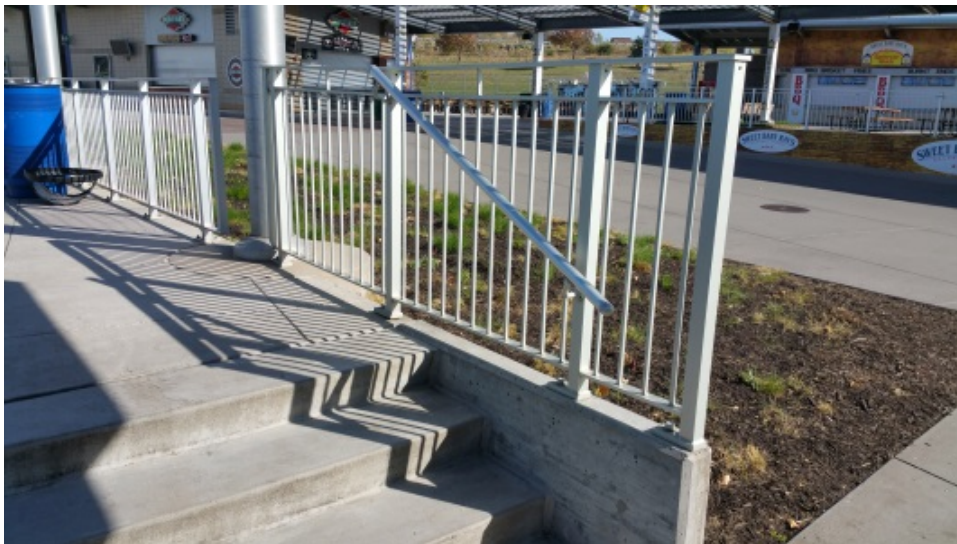
A weak guardrail was observed at a location north of the Budweiser deck. This railing was loose at the connection to the retaining wall and presents a potential safety and accessibility concern, as shown in Figure L-3.

Figure L-3: Unsecure Hand Rail at Stairs

- Secure loose hand rail and fence to avoid safety and accessibility concerns. This may simply require tightening a few connections, or could involve installing a new hand rail. Refer to Figure L-3.

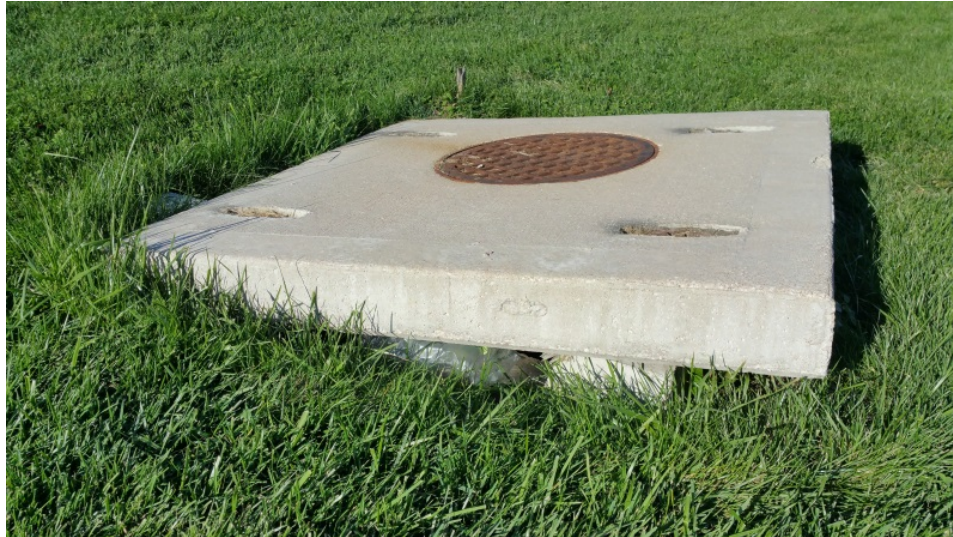
A storm water inlet structure to the east of the stadium is damaged and dislodged from its intended position. This structure may not be providing sufficient flow, as shown in Figure L-4.

Figure L-4: Dislodged Storm Structure

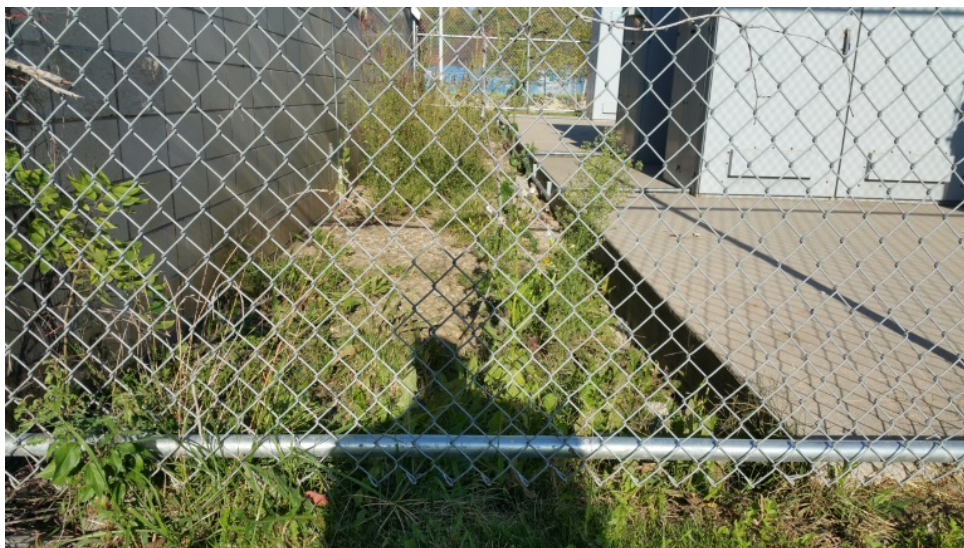
A somewhat isolated area just northeast of the stadium appears to be lacking maintenance. Based on observations, this area could also be ponding water during rainfall events, as shown in Figure L-5.

Figure L-5: Vegetation and Sedimentation indicate potential Water Ponding in this Area

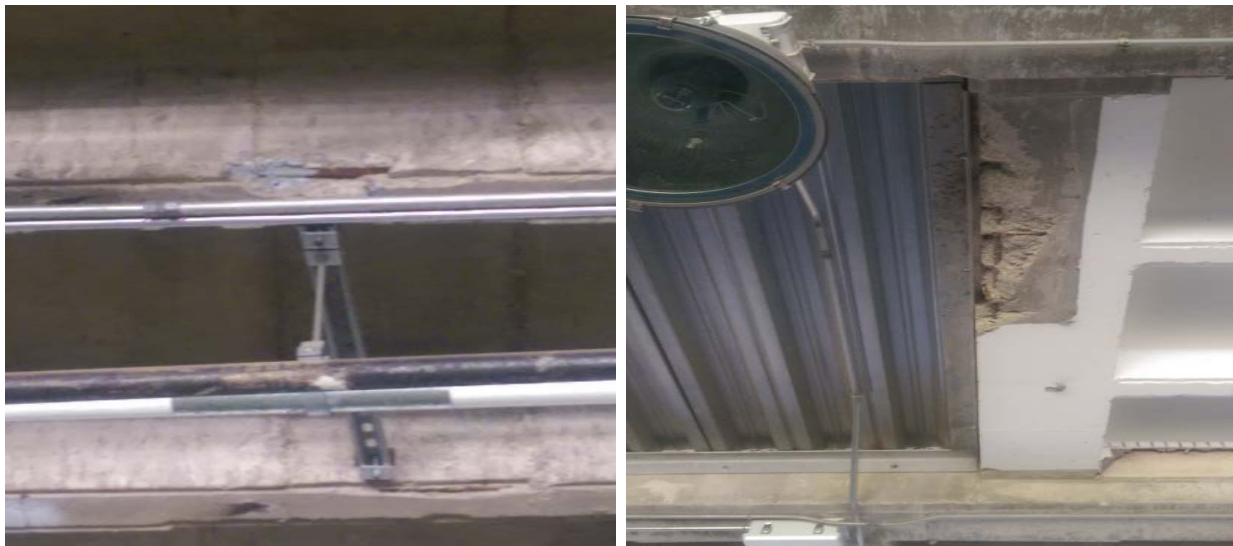
The original reinforced concrete pan joist slab systems are currently in satisfactory condition. No major cracks or spalling was observed. However, minor cracking and spalling exist exposing the reinforcement as shown in Figure S-2 (left image). This image was taken standing in the concourse at the top of section 220. Minor cracking and spalling was also observed while standing in the concourse at the top of section 312, as shown in Figure S-2 (right image). These areas should be closely monitored and patched within the next 1 to 2 years.

Figure S-2: Concrete Spalling, Exposing Reinforcement

The majority of all superstructure elements were observed to be in satisfactory condition. Minor cracking and spalling were observed for the original concrete pan joist system. This has led to the exposure of reinforcement. Closely monitoring these areas is recommended. Concrete patchwork is recommended within the next 1 to 2 years.

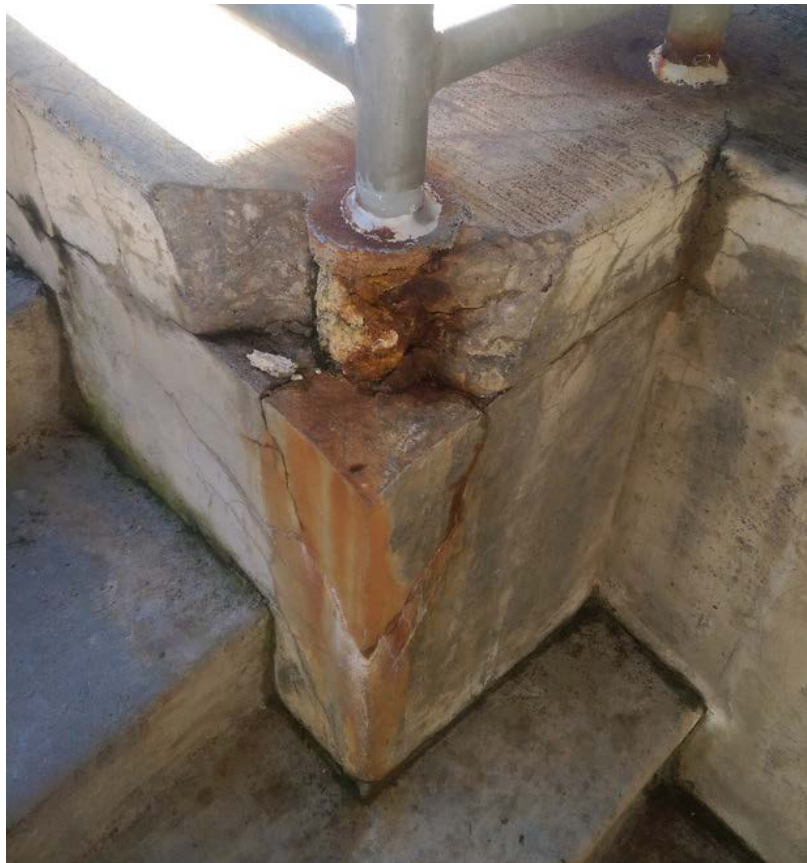
Guard rails are primarily in satisfactory condition. However, corrosion and concrete spalling were observed in some locations, as shown in Figure S-5. This image was captured in Dugout Suite B.

Figure S-5: Corrosion and Concrete Spalling of Guardrail

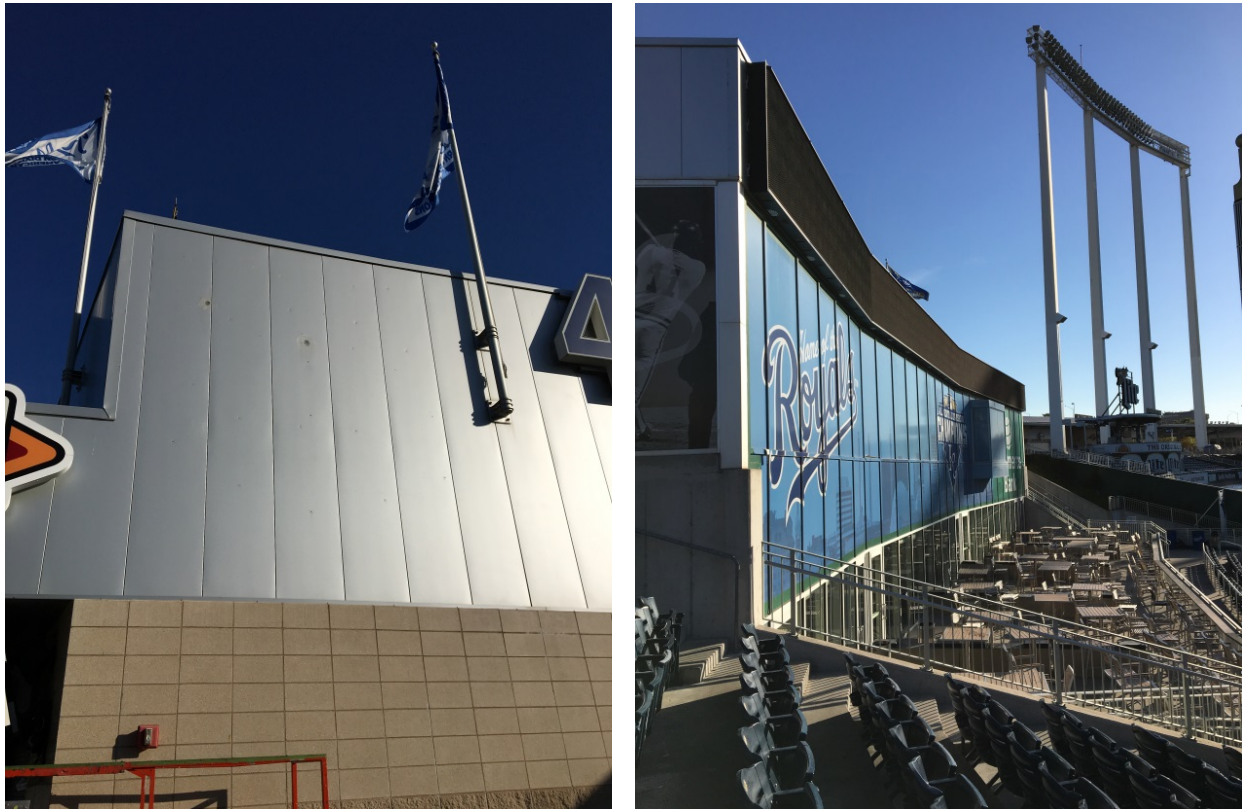
Insulated metal panels at the Hall of Fame structure, in general, are in satisfactory condition. However, baseball depressions in the metal panel were observed, as shown in Figure AF-5 (left image). This image was taken from the South side of the Hall of Fame structure, looking North.

Figure AF-5: Metal Panel and Storefront System at Hall of Fame Structure

Insulated metal panels around the facility appear to be in satisfactory condition, generally. However, depressions in the insulated metal panels, most likely caused by home run baseballs, were observed at South side of the Hall of Fame structure. Refer to Figure AF-5 (left image) for specific locations.

- Consider replacing metal panels or sealing the depressions to avoid potential moisture problems that may be caused by a breach in the envelope. Over time, it is possible that the finish of the metal panels may be affected resulting in surface rust and streaking near the damaged area.

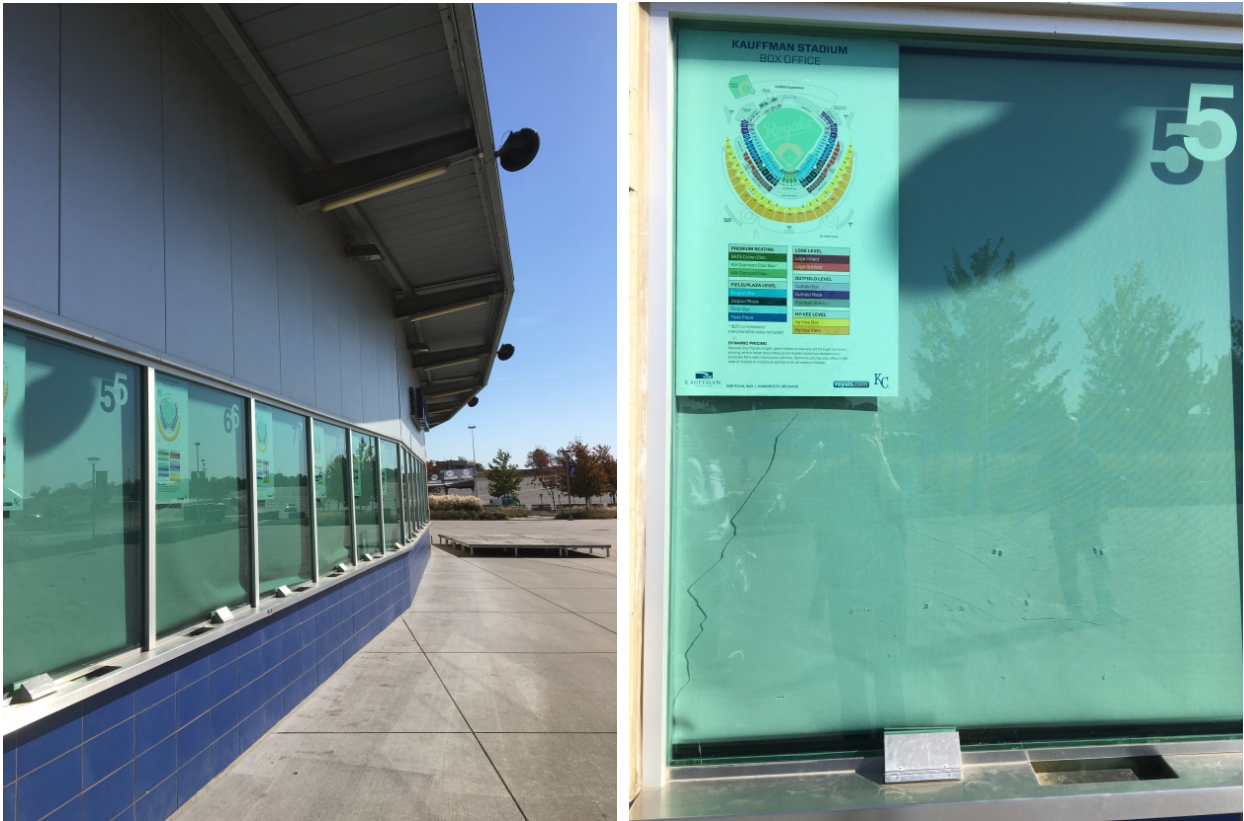
Insulated metal panels and glass storefront systems at the ticketing structure, in general, are in satisfactory condition. However, glass at a few of the ticketing windows was observed to be cracking, as shown in Figure AF-6 (right image). This image was taken at the ticketing structure on the Southwest side of the stadium.

Figure AF-6: Storefront System at Southwest Ticketing Counter

Glass storefronts, in general, appear to be in satisfactory condition. However, glass panels at a few of the ticketing windows on the Southwest Ticketing structure were observed to be cracking as shown in Figure AF-6 (right image).

- Consider repairing or replacing the damaged glass to maintain a quality appearance at the entry to the facility and to prevent further damage to the glass or aluminum frames.

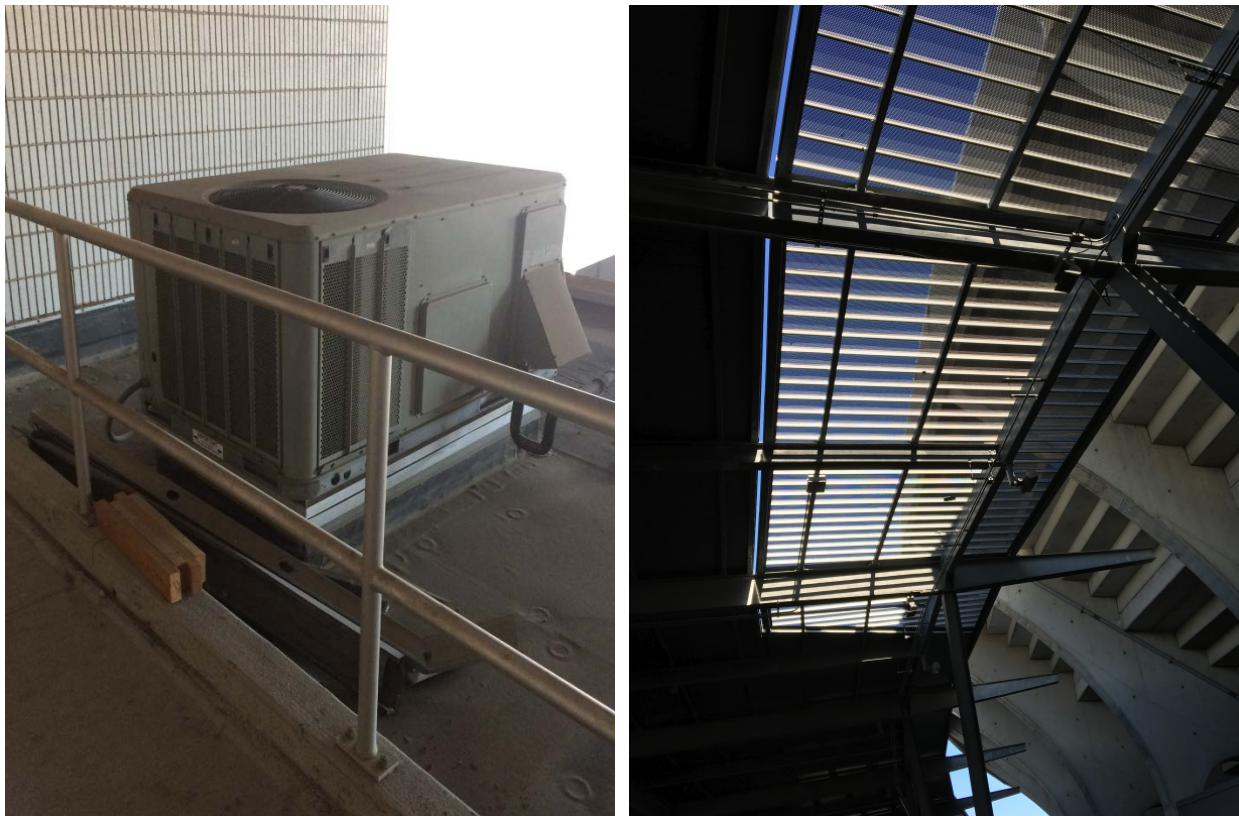
Roofing membranes appear to be in satisfactory condition. Roofing membranes observed were free of rips, tears, or defects. However, construction debris was observed at the catwalk area between roofs at the Writing Press level, as shown in Figure AR-1 (left image).

Figure AR-1: Roofing Membrane (left) and Standing Seam/Perforated Metal Panel (right)

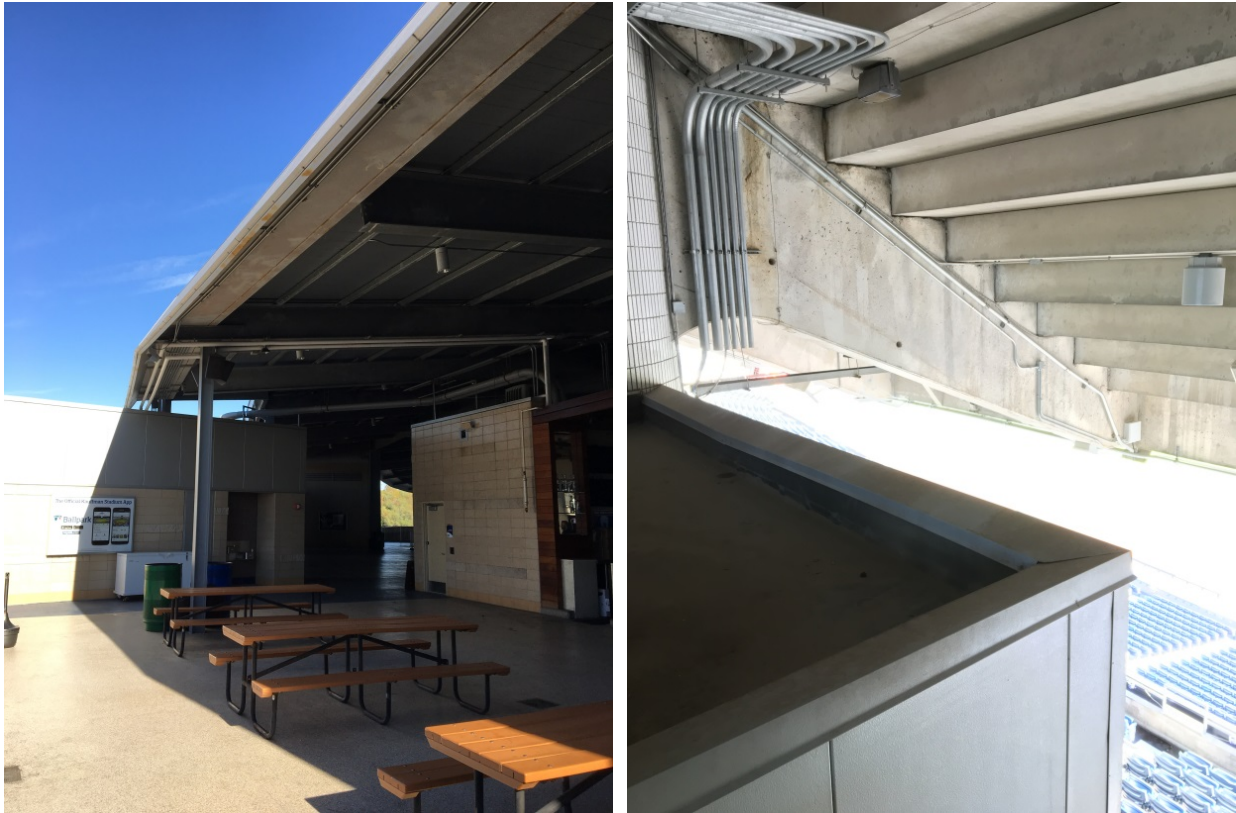
Coping and fascia panels at roof eaves and parapets were observed to be in satisfactory condition, typically. However, rust is beginning to stain the underside of the fascia panel at the View Level bar areas, as shown in Figure AR-2 (left image).

Figure AR-2: Roof Coping and Fascia Panels at Roof Eaves and Parapets

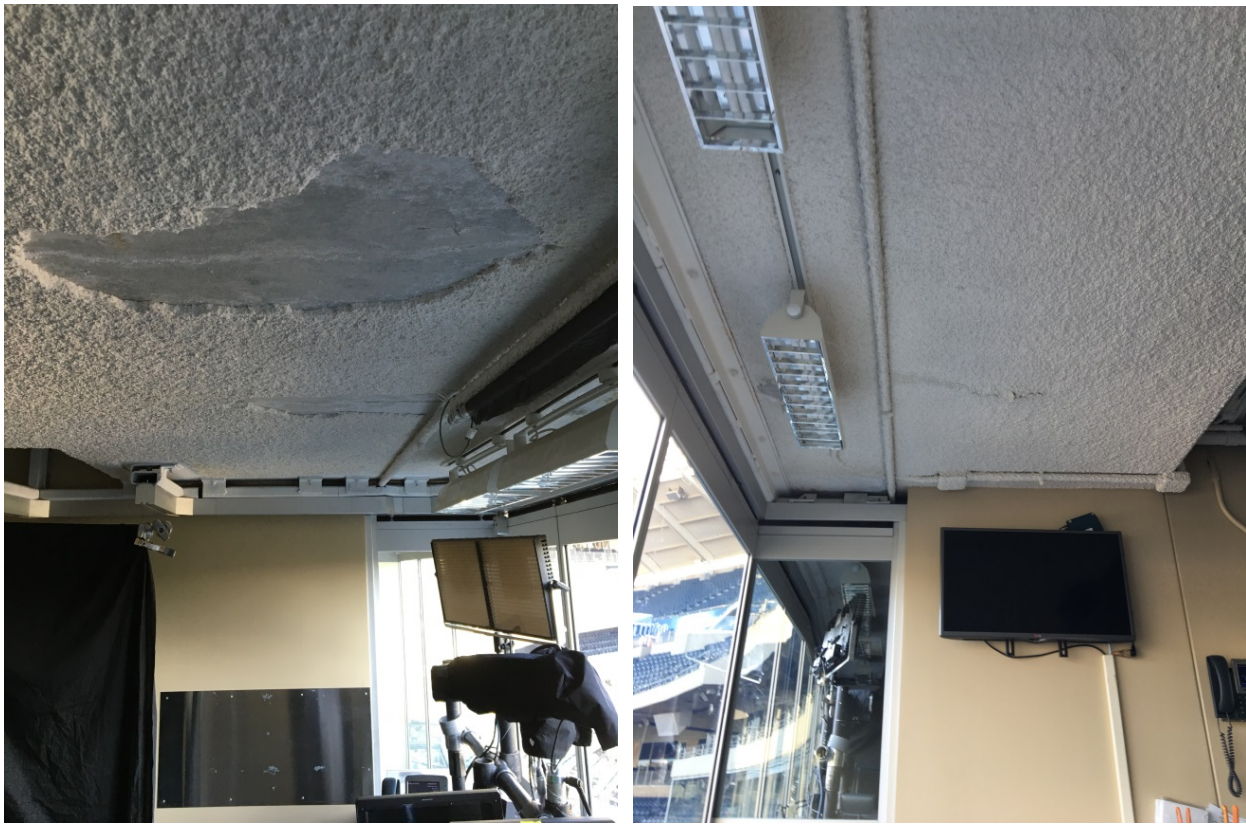
Exposed ceilings appear to be in satisfactory condition, typically. However, at various locations on the Press Level sprayed on fire proofing was observed to be peeling and chipping away from the structure, as shown in Figure AI-5.

Figure AI-5: Sprayed on Fire Proofing at Exposed Concrete Structure

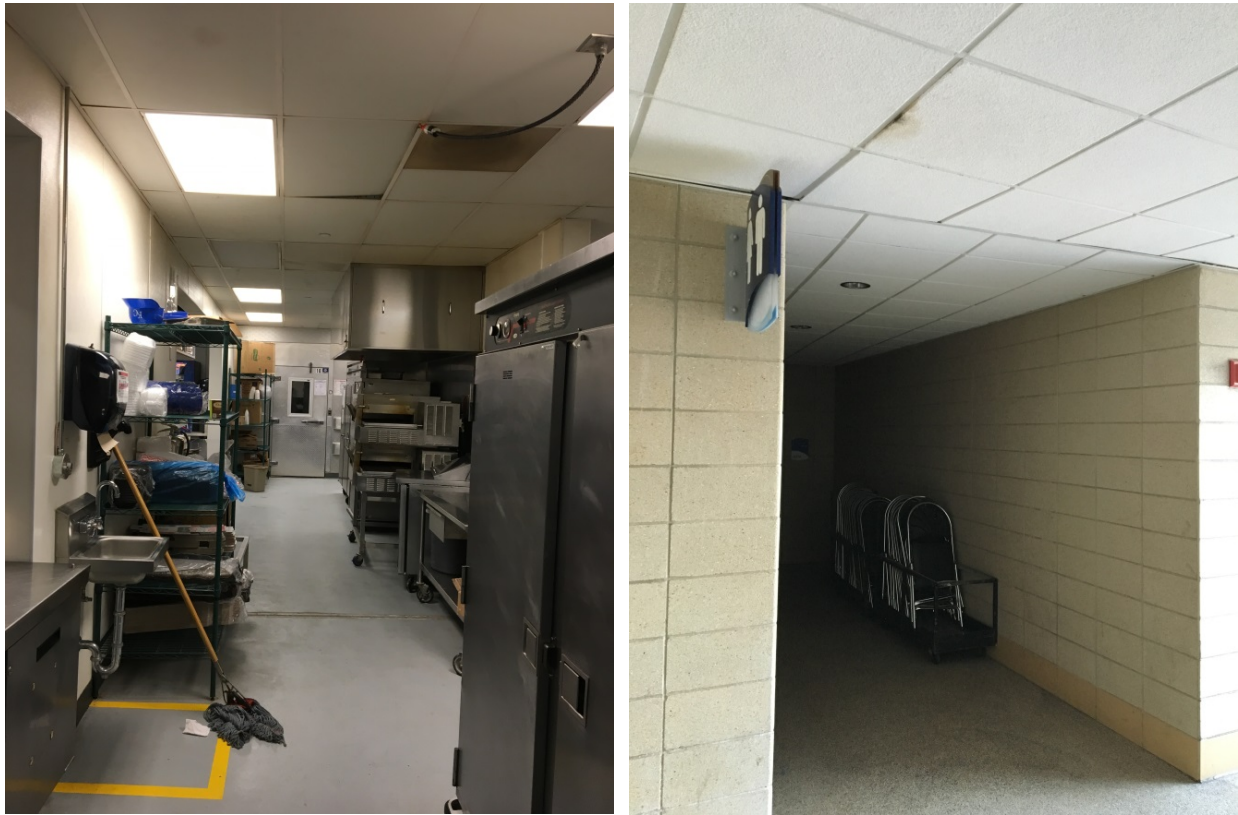
Acoustical ceiling tiles appear to be in satisfactory condition, generally. Several back of house areas, including kitchens and pantry areas, contained warped, drooping, or stained ceiling tiles as shown in Figure AI-7 (left image). Exterior ceiling tiles leading out of the central elevator lobby area at the Service Level were observed to be stained, as shown in Figure AI-7 (right image).

Figure AI-7: Interior and Exterior Acoustical Ceiling Tiles

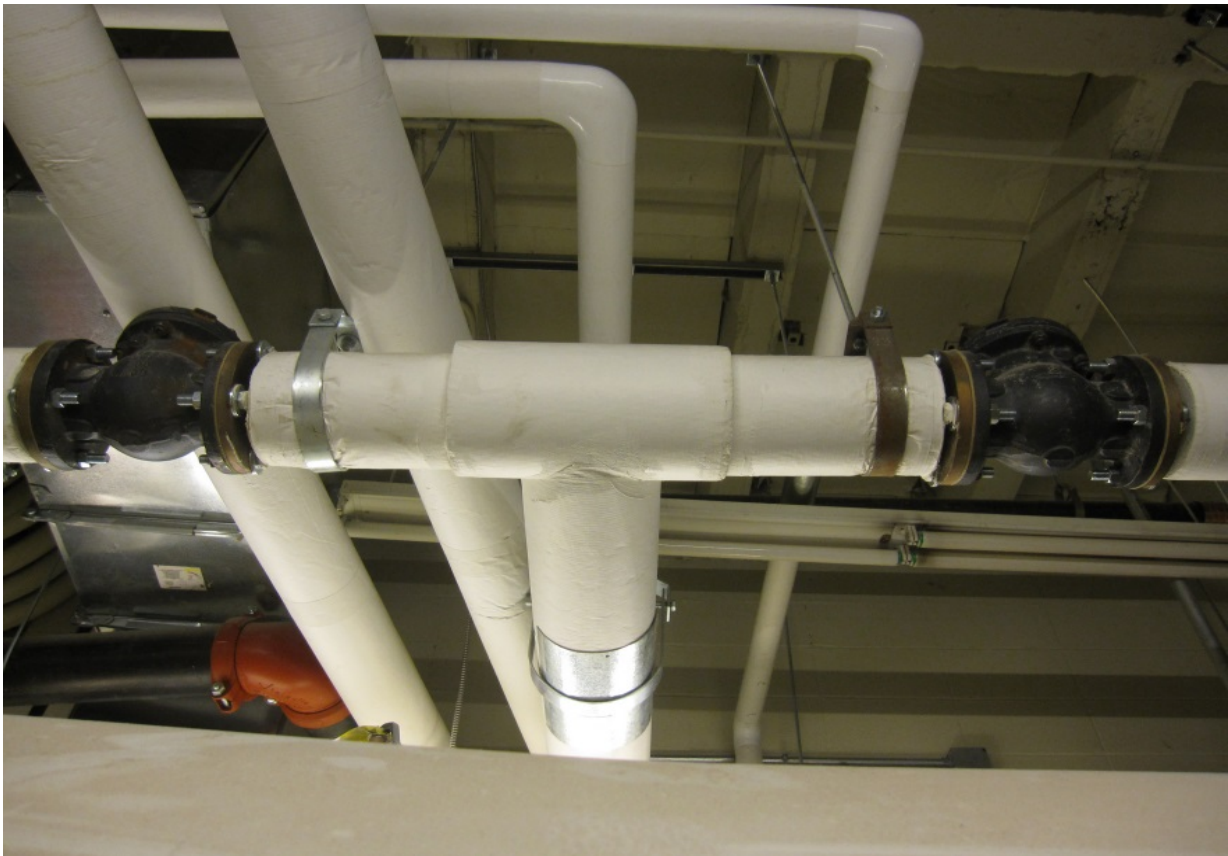
As seen in Figure M-1, several piping insulation shields were not present. Overtime, the weight of the piping will “crush” the piping insulation – thus degrading the effectiveness of the insulation. Evidence of this “crushing effect” has already begun to occur. To prevent this, piping shields should be placed between the pipe hanger and the insulation.

Figure M-1: Piping Hangers Missing Insulation Shields

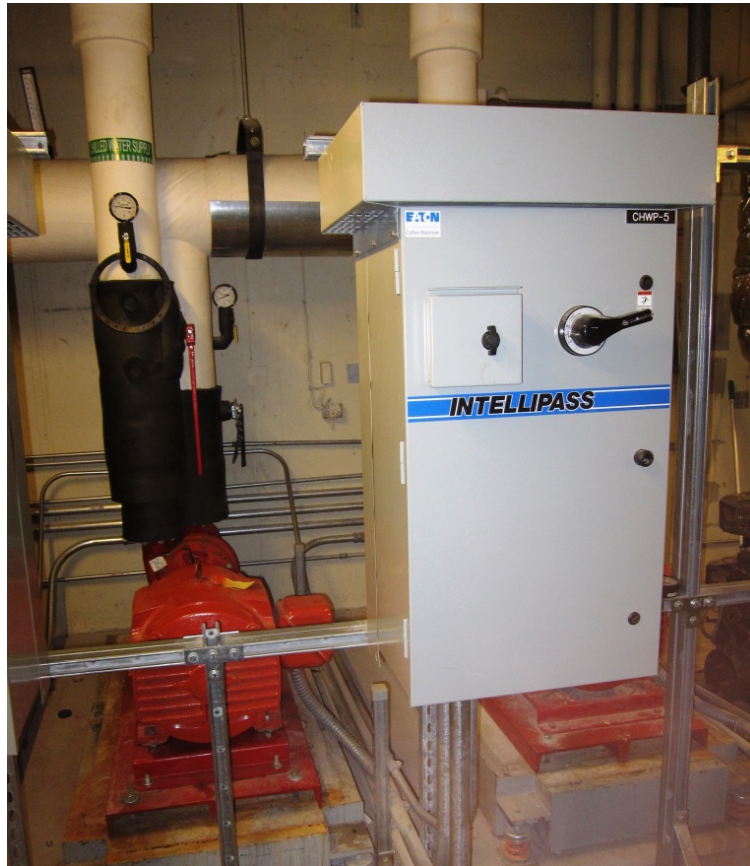
Chilled water pump, CHWP-5 as shown in Figure M-2, had a noticeable vibration sound while running. This excessive vibration could be a result of a misaligned shaft or worn bearing. Attention should be given to this particular pump to investigate the origin of the vibration sound.

Figure M-2: Chilled Water Pump, CHWP-5

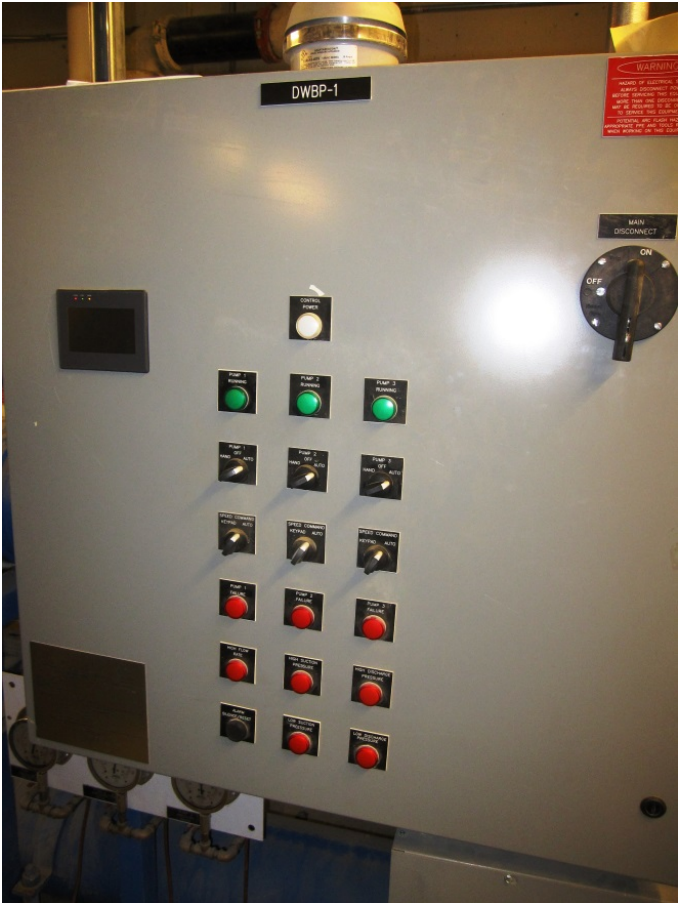
The domestic water booster pump package is also located within this boiler room. The control panel for the pumps had some indication lights that were burned out, specifically for pump #1 as shown in Figure M-3. Control panel lights should be checked to verify if they are working properly.

Figure M-3: Domestic Water Control Panel

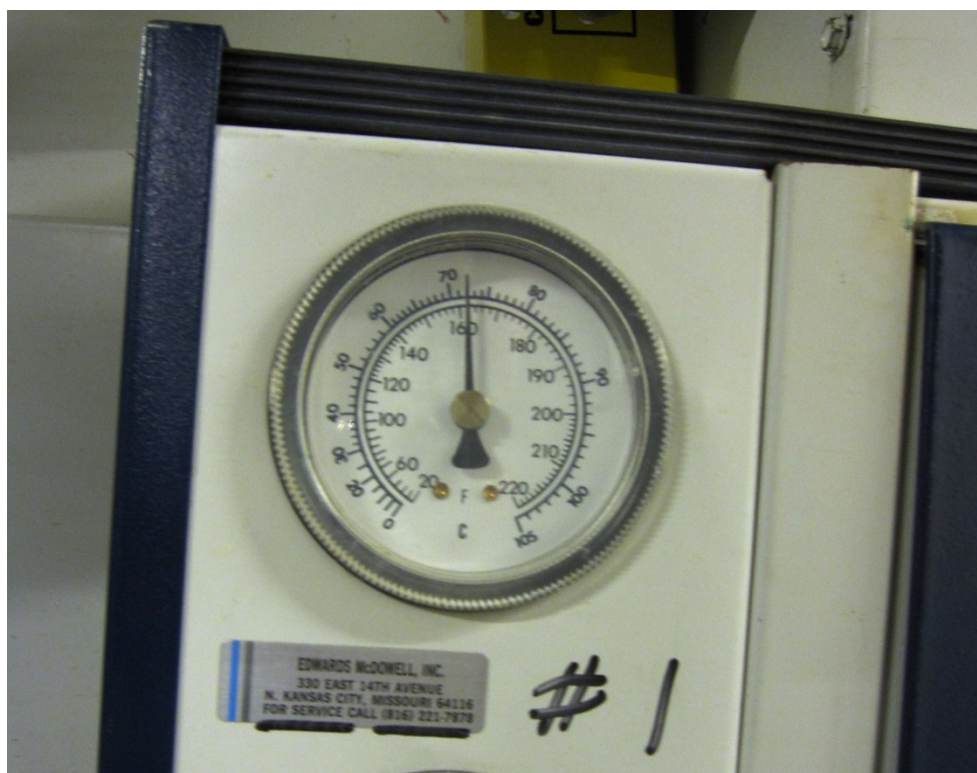
It was observed that the domestic hot water boilers were set to deliver 160°F water throughout the facility, shown in Figure M-4. This temperature has a higher potential of general population scalding. Standard hot water temperatures are typically limited to 140°F within public facilities. Readjusting the hot water temperature output to 140°F is recommended. This would not only decrease the potential scalding issue, but it would also provide utility energy savings.

Figure M-4: Hot Water Boiler Temperature Gauge

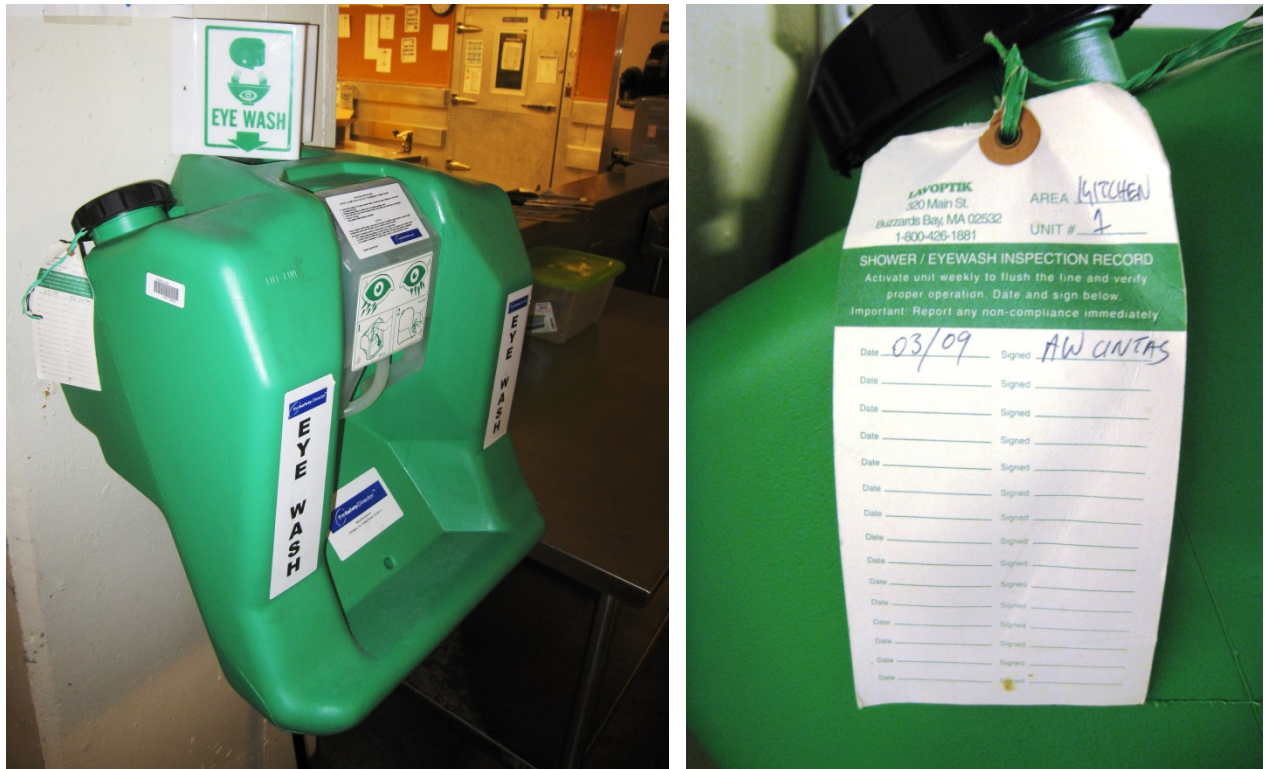
The main kitchen mechanical systems appeared to be in satisfactory condition. The wall-mounted eyewash station, shown in Figure M-5 (left image), currently has a low water level within the body of the eyewash. It also does not have an up-to-date verification tag, as shown in Figure M-5 (right image). This eyewash will need to be completely emptied and refilled to the recommended water level. After this has been completed, an updated tag date can be added.

Figure M-5: Wall-Mounted Eyewash Station and Verification Tag

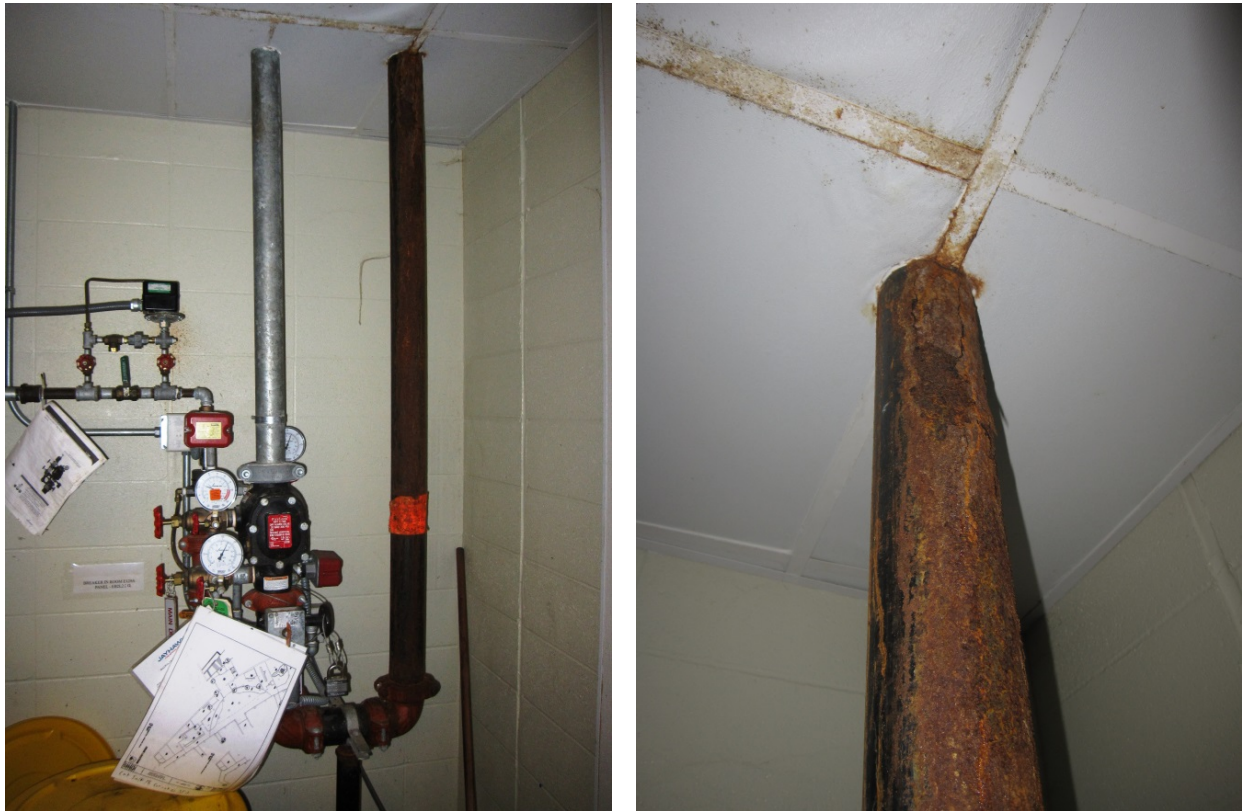
The main kitchen also houses a dry-pipe sprinkler valve, shown in Figure M-7 (left image). The valve itself appears to be in satisfactory condition. The steel piping associated with this dry-pipe system has severe corrosion/deterioration. Figure M-7 (right image) shows the level of severity of this pipe. This side of the sprinkler valve is under high pressure – thus, if a rupture were to happen through the side of this pipe, the extent of the property damage could be a large value number. It is HIGHLY recommended that this particular section of piping is repaired or replaced.

Figure M-6: Dry-Pipe Sprinkler Valve System and Corrosion of Steel Piping

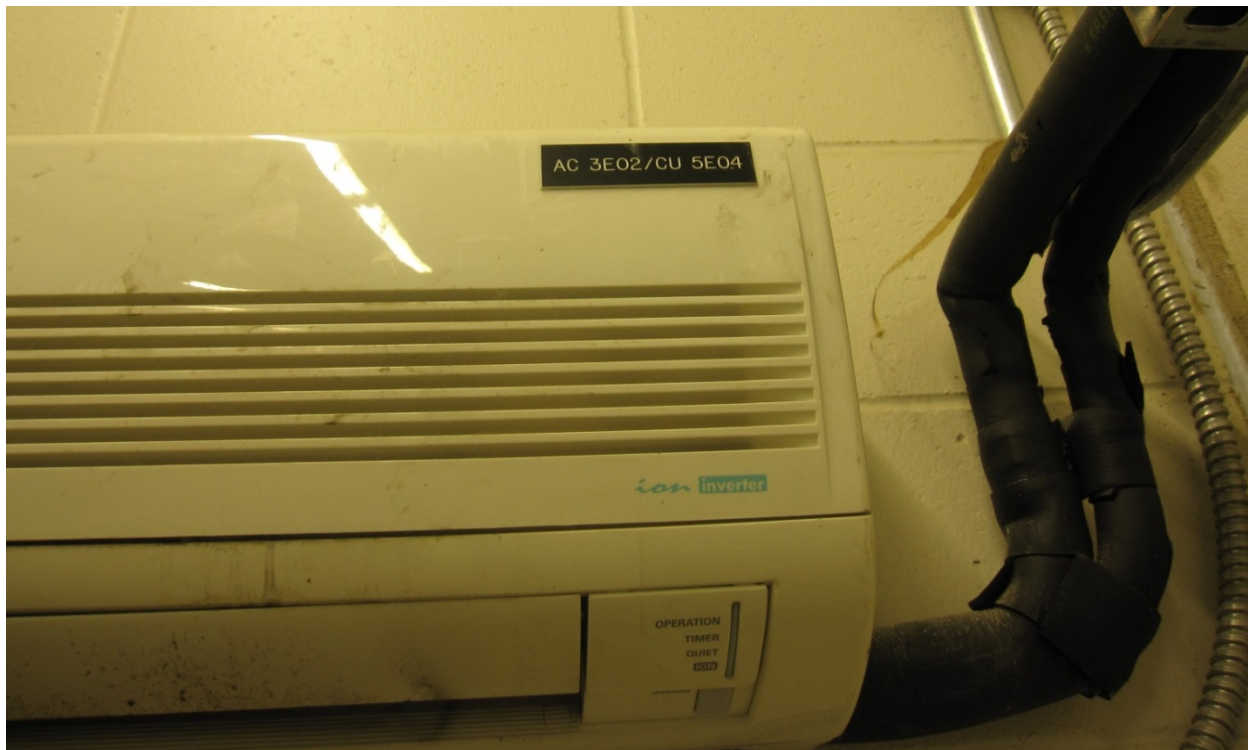
Direct expansion wall units are used to maintain temperature within the various electrical rooms throughout the facility. The majority of these units were observed to be in satisfactory condition. Figure M-9 shows the wall unit located inside Electrical Room E234. This unit, labeled AC 3E02, had excessive fan noise. This is typically a result of low fan oil or foreign debris within the unit. It is recommended that this particular unit is maintained properly.

Figure M-7: Wall Unit AC 3E02

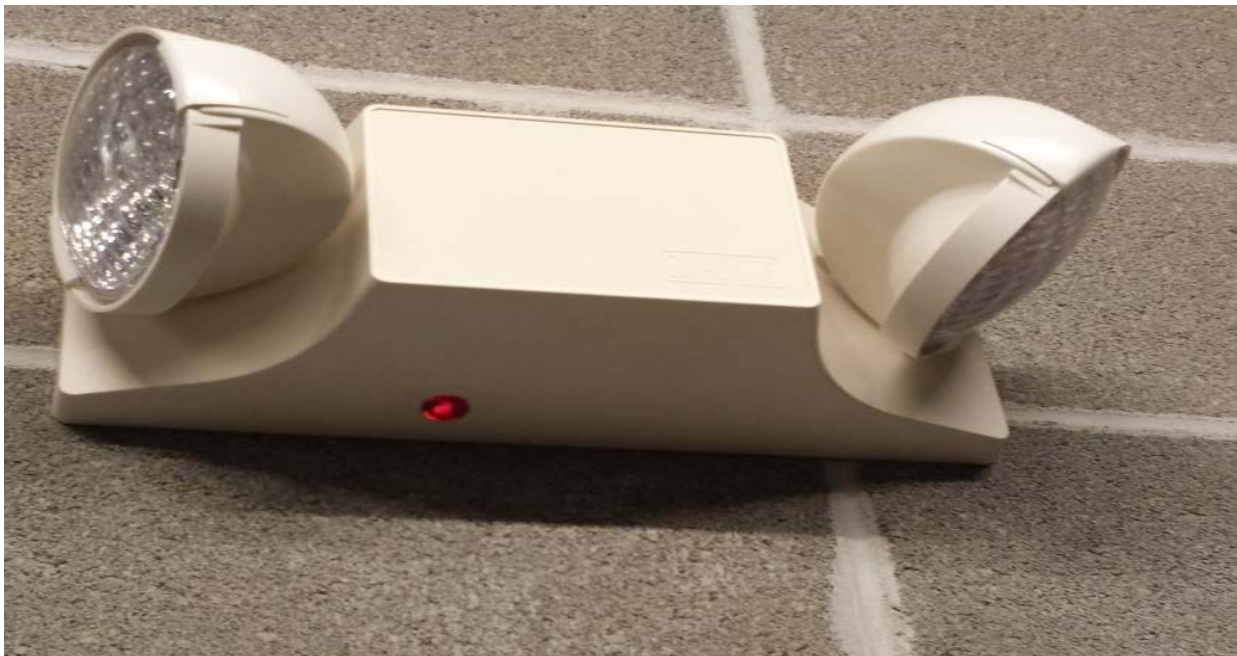
The operation of the emergency bug-eyed battery units were in unsatisfactory condition as the emergency bug-eye battery units were not operational throughout the field and dugout levels. See Figure E-1, as shown below.

Figure E-1: Emergency Bug-Eyed Light Fixture

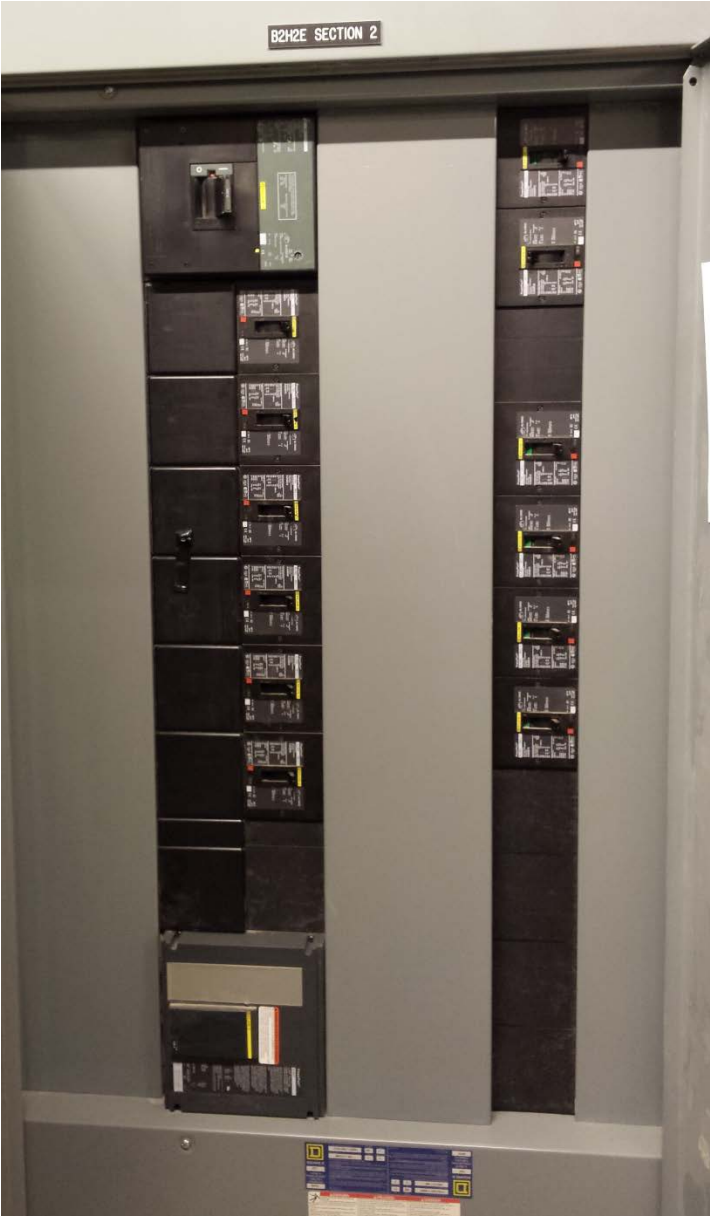
See Figure E-5 for unlabeled breakers in panelboard B2H2E section 2.

Figure E-5: Distribution Board B2H2E Section 2 with Unlabeled Breakers
