Kauffman Stadium Assessment

JCSCA + Burns & McDonnell

This document contains information pertaining to the condition of Kauffman Stadium as documented by the Jackson County Sports Complex Authority (JCSCA), including descriptions, conditions, and exhibits which have been reviewed by Burns & McDonnell and documented in this report.

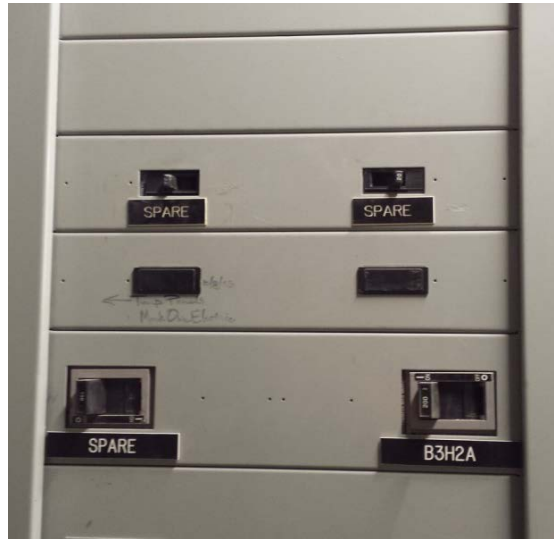
It has been observed that space, spares and panelboard labeling was satisfactory with the exception of switchboard B3M in which does not have all spares and spaces labeled, an existing panelboard not labeled, and branch circuit breakers in distribution board B1C3A are not labeled. . See Figures E-7, E-8 and E-9, as shown below.

Figure E-7: Switchboard B3M with Blank Covers Not Identified as Specs

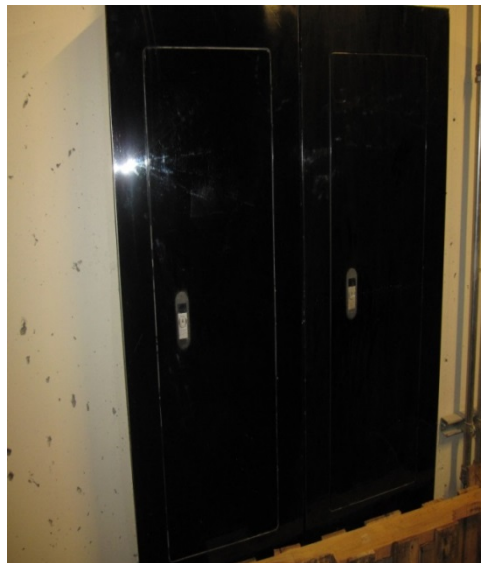
Figure E-8: Existing Unlabeled Panelboard

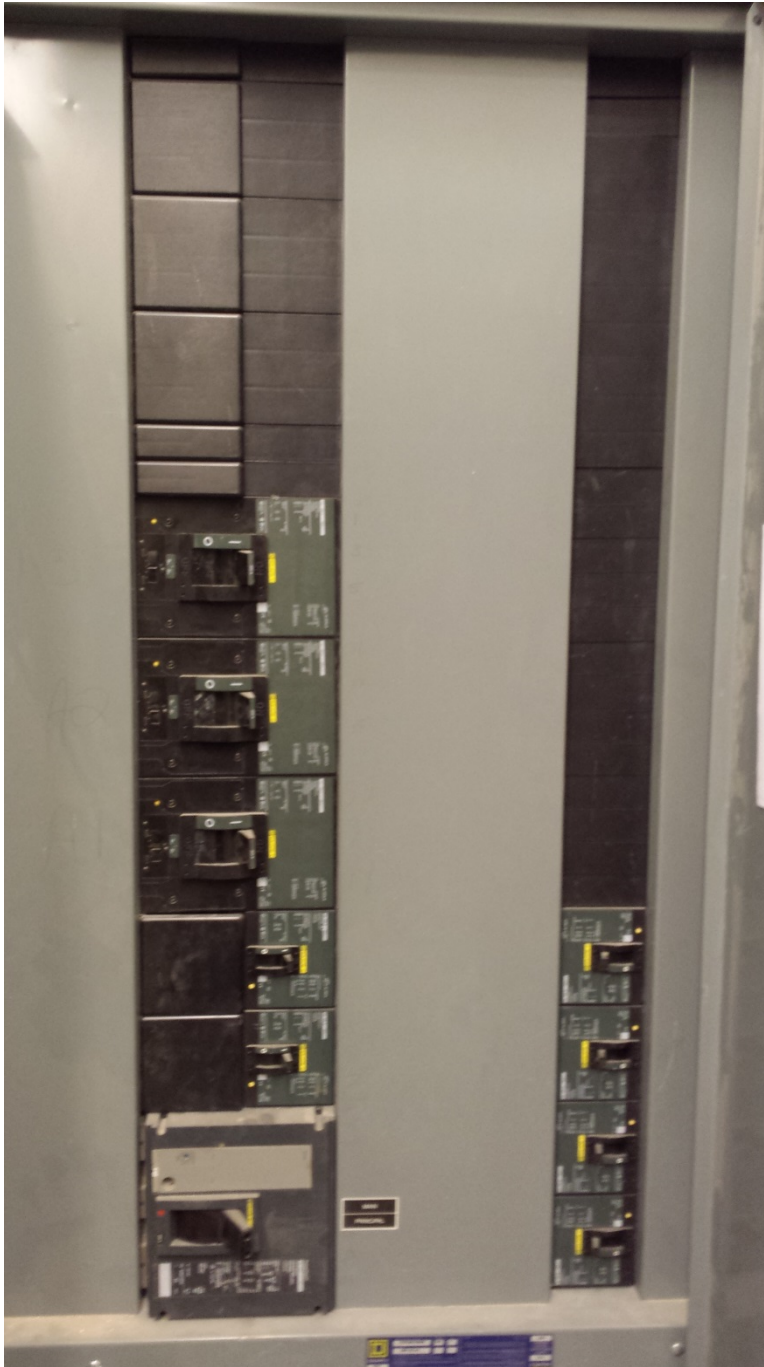
Figure E-9: Unlabeled Breakers in Distribution Board B1C3A
