PROPERTY INSPECTION REPORT

Concerning: Client Prospective Address **Insp.#:**
(Address or Other Identification of Inspected Property)

By: Danny Pitts, TREC License # 4717 11/24/14
(Name and License Number of Inspector) (Date)

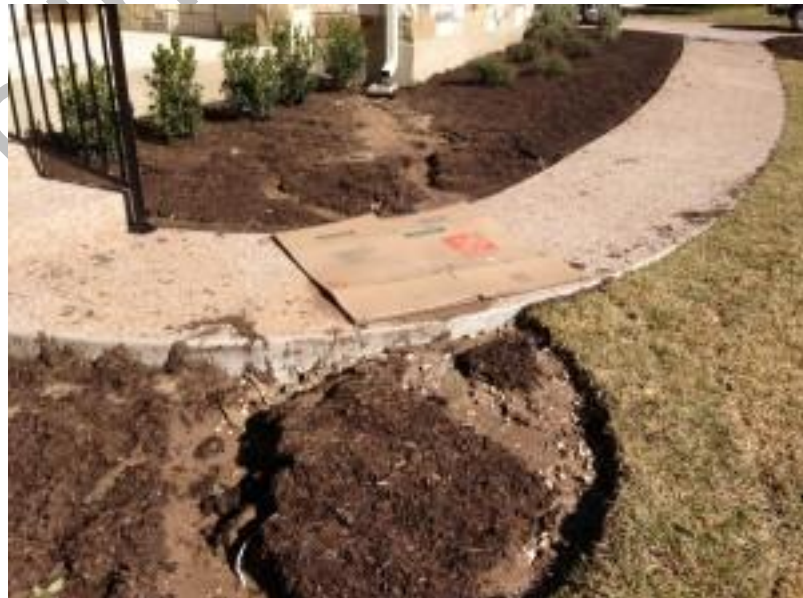
- REGRADE THE SOIL – Regrade the soil down & away from the foundation (the code requires 5% slope extending 10 ft. out from the house) to divert the water around & away from the house. In other words, this means that the soil should fall 6 in. within 10 ft. of the house on all 4 sides of the house.
- THERE IS EROSION TAKING PLACE – At the front & the left rear.

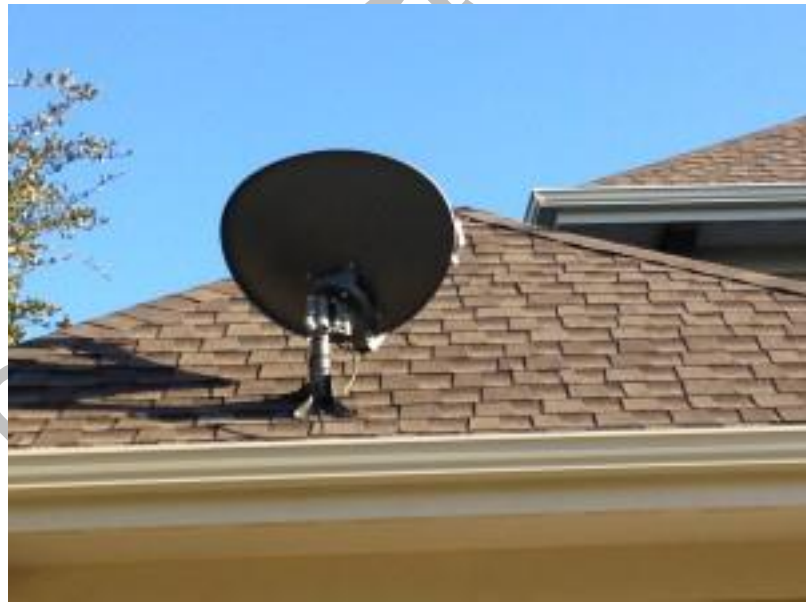
- MISSING STEP FLASHINGS – Step flashings are required at the roof / wall connections by code. NOTE: Turnback flashings / J flashings are present rather than step flashings. The use of turnback flashings is a common construction practice in the Central Texas region.
- MISSING FACTORY BUILT KICKOUT FLASHINGS – At the roof / wall connections at various locations where a wall extends below the roof termination (to prevent water penetration behind / into the siding). Site built kickout flashings (which may not be water tight) are present.
- THE INSTALLATION OF THE SATELLITE DISH MOUNTING BRACKET – May not be water tight / has exposed screws.

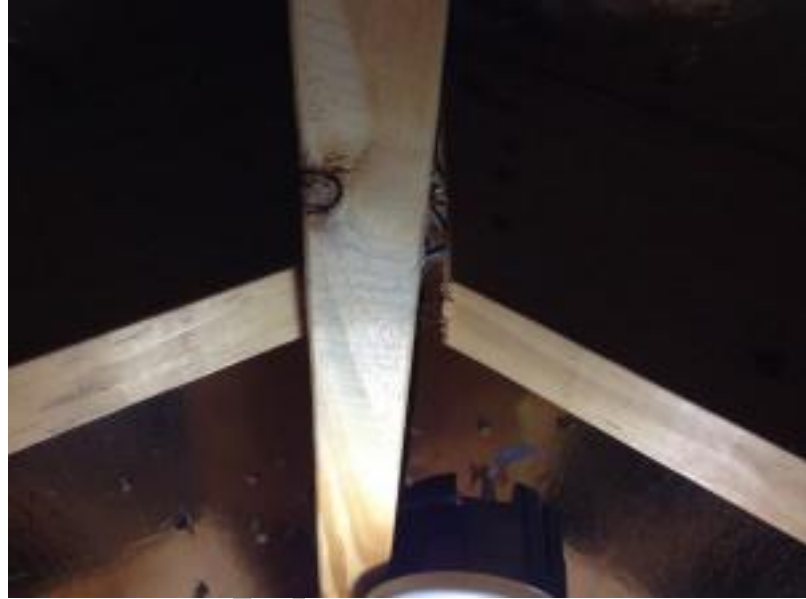
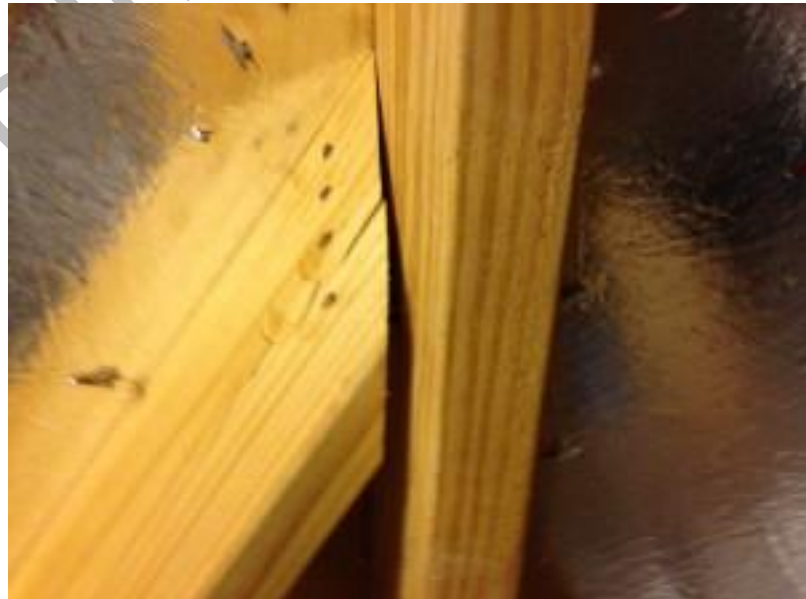
- THE ATTIC FRAMING:
 - Loose / poor fitting joints at the hip, valley, & ridge rafters at various locations. Add mechanical connectors to stabilize the loose / poor fitting joints.

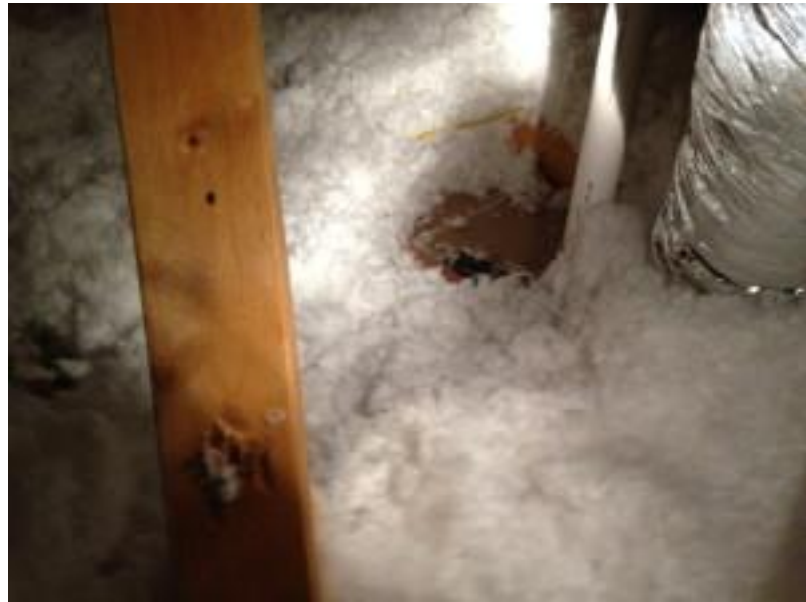
- THE INSULATION - Is missing at an area above the left rear bedroom / bath. I would suggest that a minimum of R-38 be added to the ceilings.

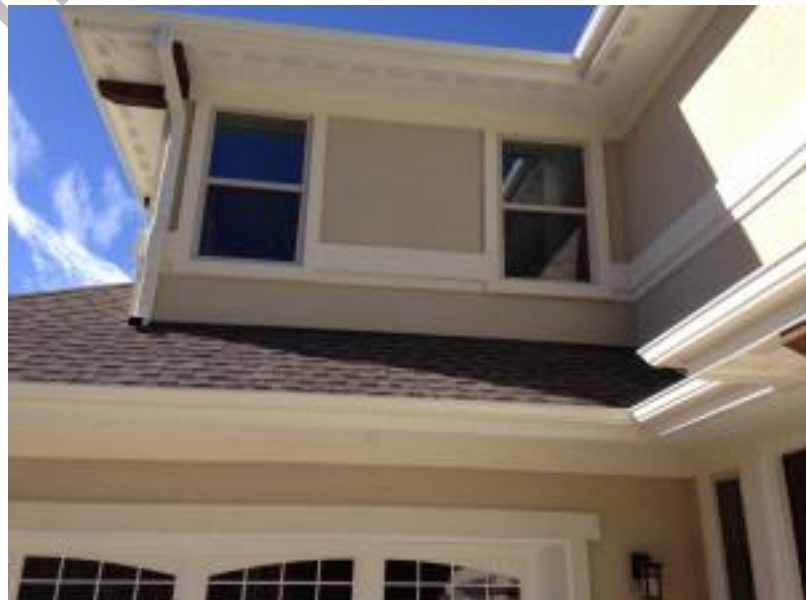
- STUCCO CONTROL JOINTS / EXPANSION JOINTS – Are missing. Are not present for every 144 square feet of wall area (a rough industry standard) & at the corners of the door & window openings.

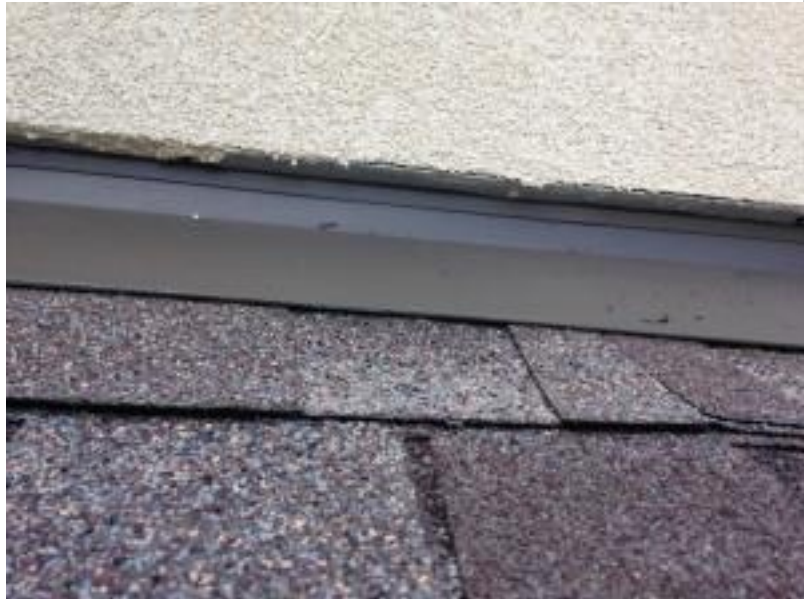
- STUCCO SIDING IS PRESENT – This report does not attempt to identify the type of stucco system installed or the installation methods used to install this stucco system. I am not an expert in the evaluation of stucco siding. If concerned, have a certified stucco specialist advise you.
- THE HOLES IN THE WEEP SCREED FLASHINGS WHICH PROVIDE A DRAINAGE PLANE FOR THE STUCCO – Are clogged at various locations at the bottom of the stucco walls.

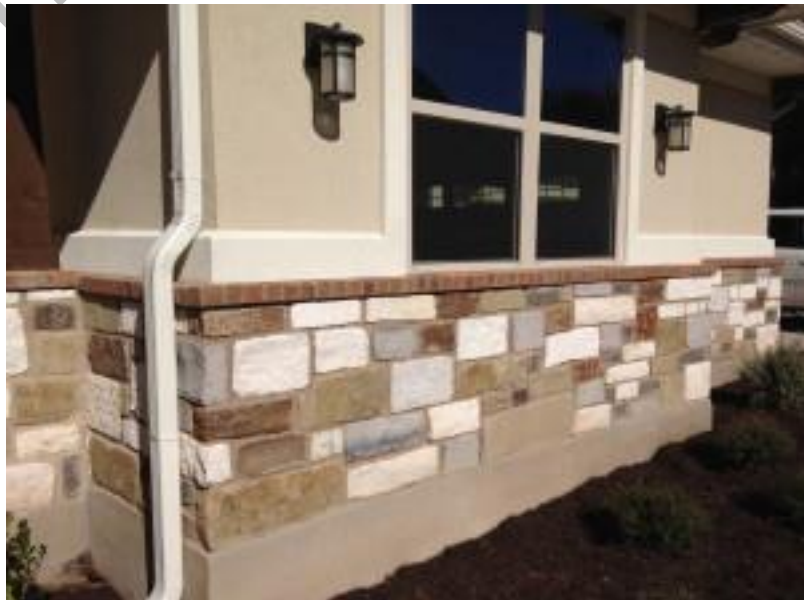
- FLASHINGS ARE MISSING AT THE CONNECTIONS OF THE BRICK / ROCK TO THE STUCCO SIDING – At various locations. The flashings should be installed behind the siding and extend over and down the face of the rock to prevent water penetration.

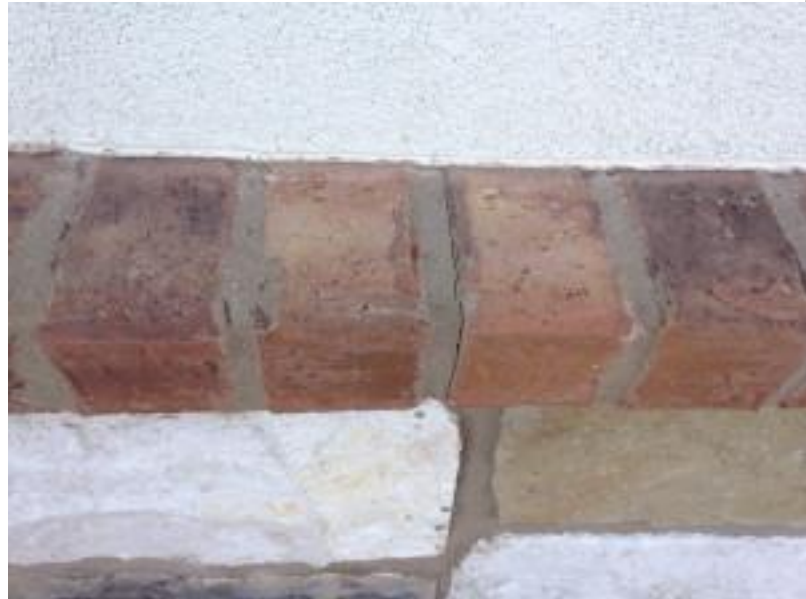
- WEEP HOLES EVERY 32 IN. – Are missing at the first layer of the rock. Weep holes are present at the first layer of the rock but are not spaced every 32 in. apart as required at various locations.
- CRACKS / HOLES IN THE BRICK / ROCK MORTAR - At various locations. Seal the cracks & holes to prevent water penetration.

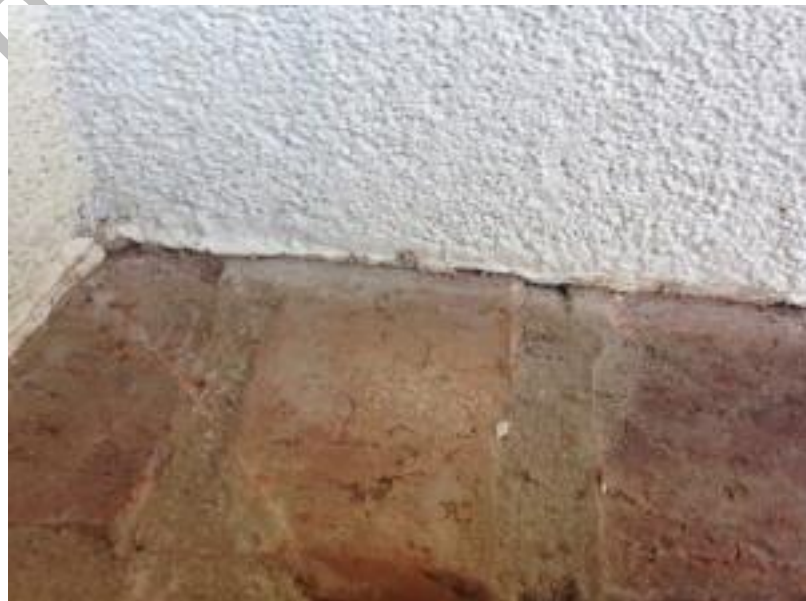
- RECAULK – At the brick / rock moldings, the windows, the trim & the brick / stucco siding connections at various locations (to prevent water penetration). Seal all the wall penetrations. The maintenance of the caulk will be an ongoing process.

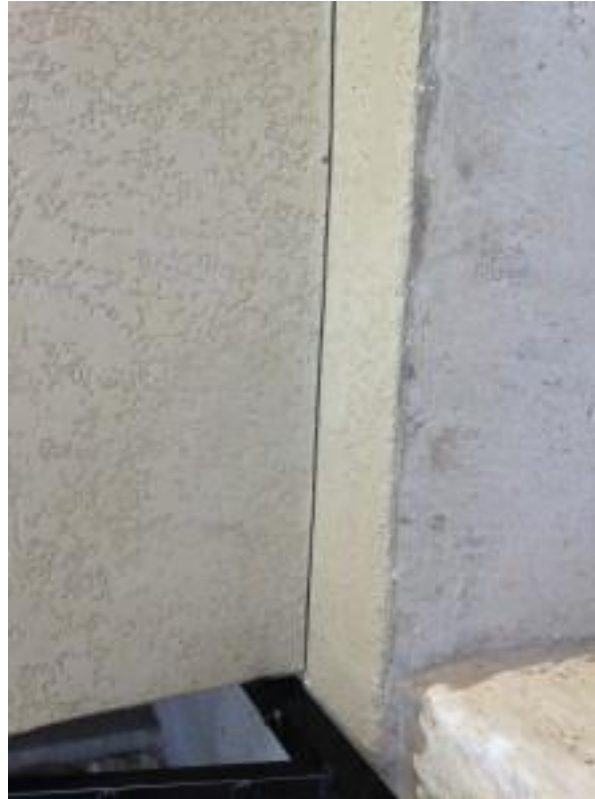
- THE REAR STAIRS & POOL DECK – Are a cold joint (a cold joint is created when an addition slab is poured against an existing slab). It is unknown if the 2 slabs are properly tied together.

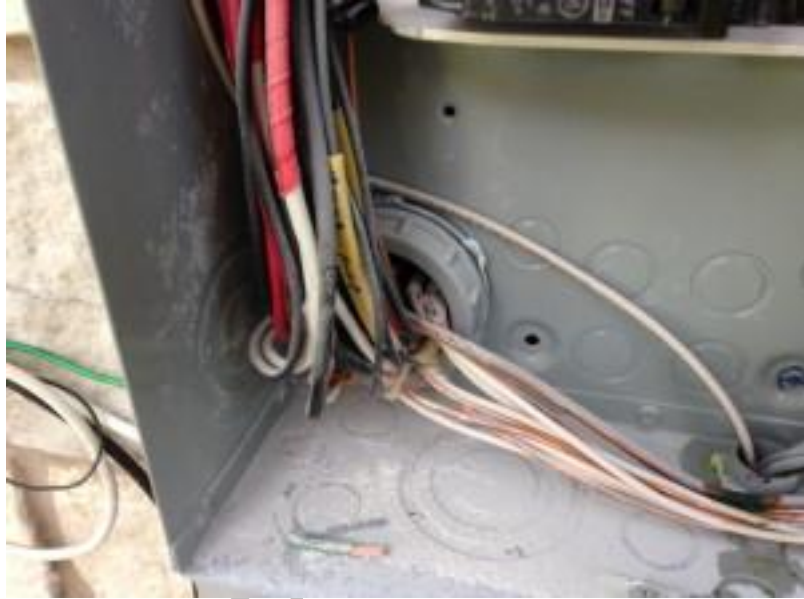
- THE MAIN BREAKER BOX - All the wires pass through one hole in the back of the box, which creates a heat issue. NOTE: Although this wiring method is not in accordance with the code, it is a common construction practice in the Central Texas area. Every house that I have inspected has been wired in this manner.

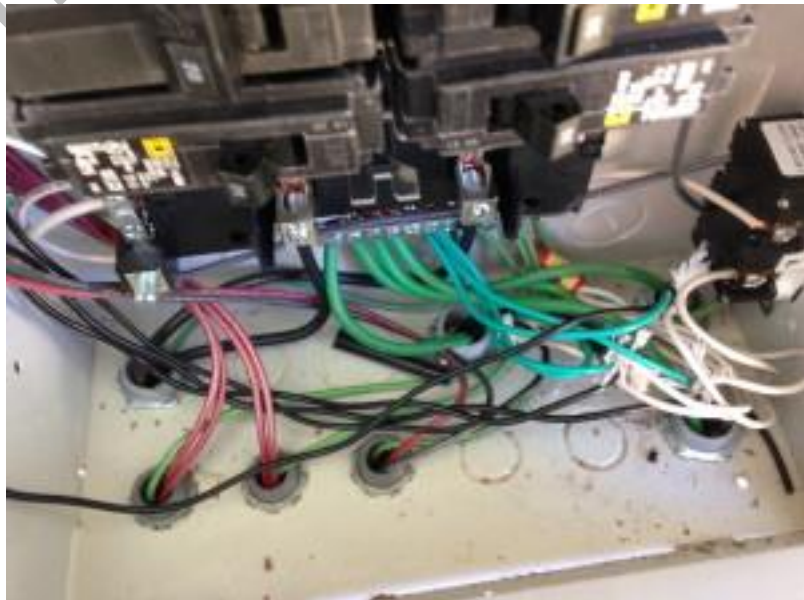
- THE POOL SECONDARY BOX – The box has 1 set of double lugged wires (more than 2 wires connected to a screw) at the ground buss bar.

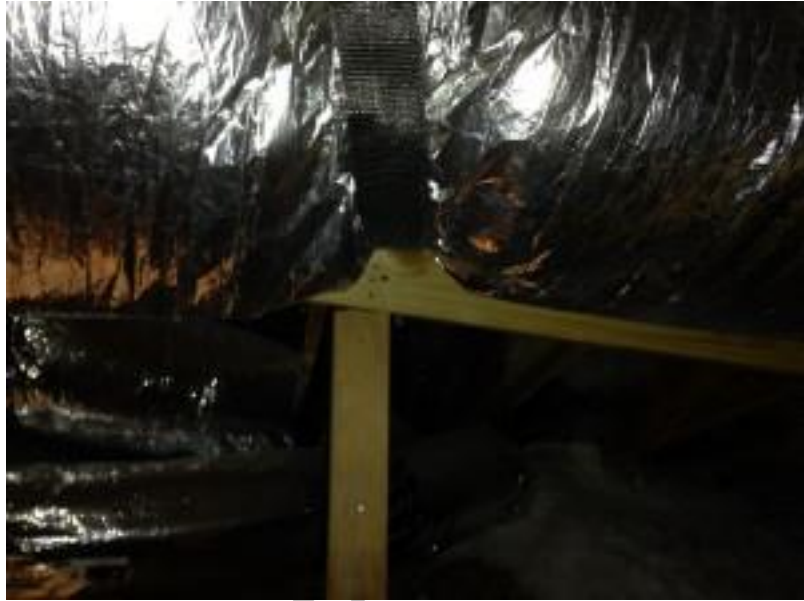
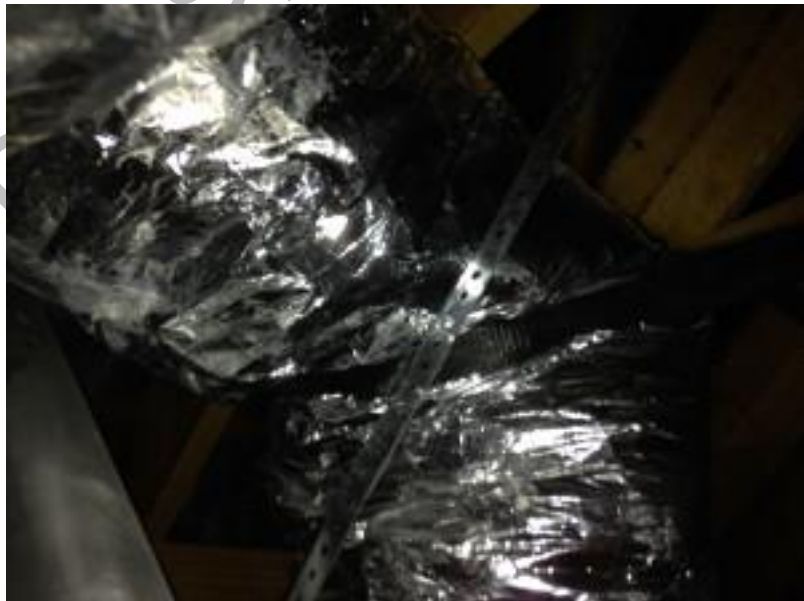
- THE ATTIC DUCTS – The ducts are crimped / constricted at various locations.

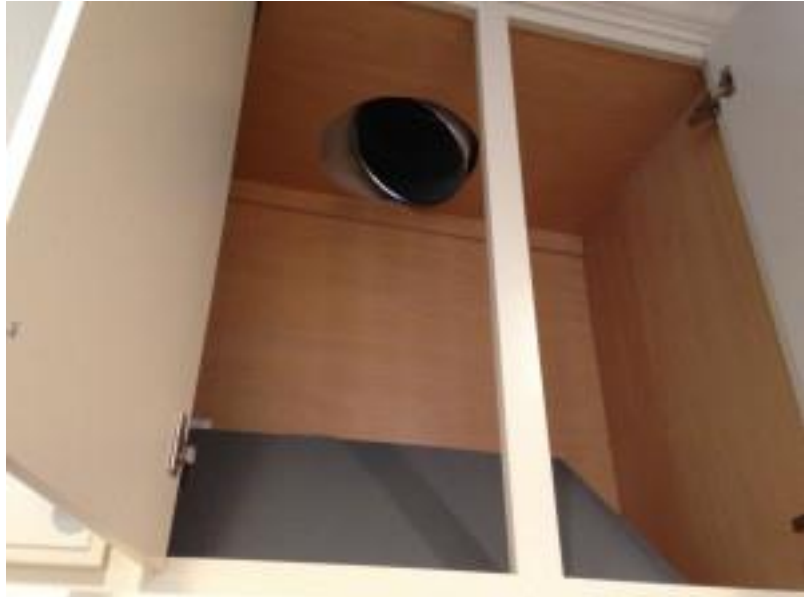
- THE KITCHEN VENT PIPE - Does not terminate to the exterior / is not connected.

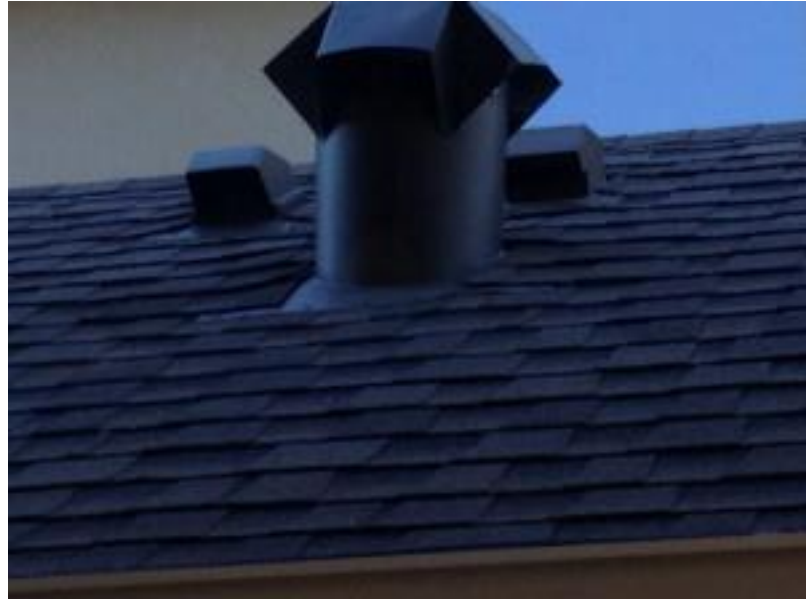
- THE DRYER VENT COVER – The cover has a prohibited large mesh screen installed.
