**INSURANCE COMPANY NAME
STANDARD REPLACEMENT COST REPORT**

ORDER #: SO011629

INSURED Happy Homeowner 123 Main Street Happyville, FL 32725	AGENT CODE: 774 ICA Insurance Agency 123-456-7890	POLICY #: ICAH0709148 Effective Date: 08/28/2011 Order Date: 8/8/2011 Inspection Date: 8/24/2011 Inspector: Inspector H
--	--	--

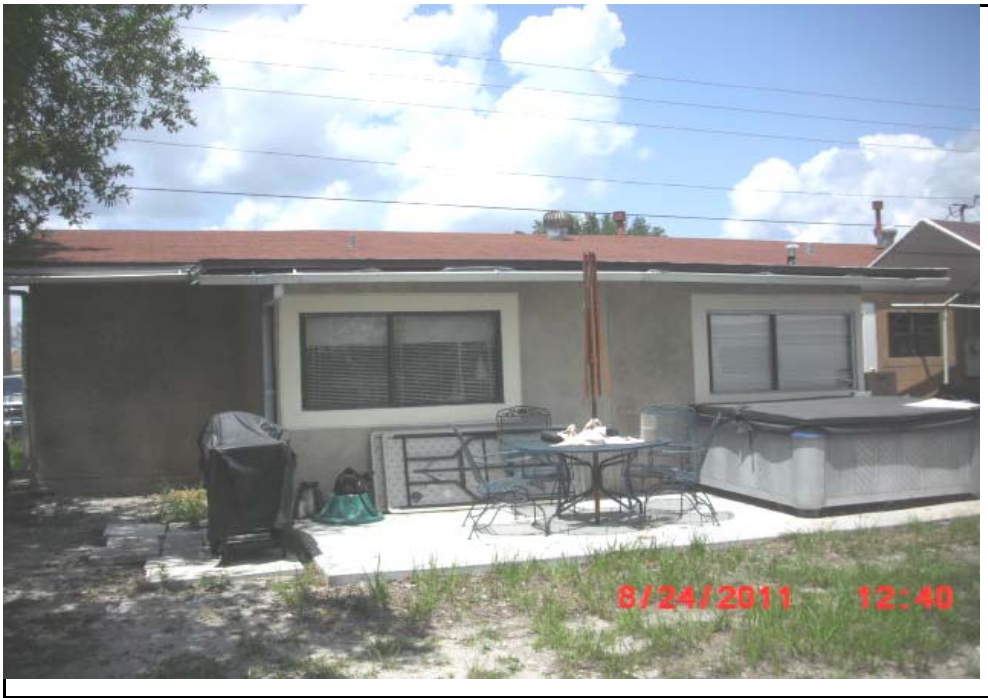
Photograph 4

Hot tub present in photo.

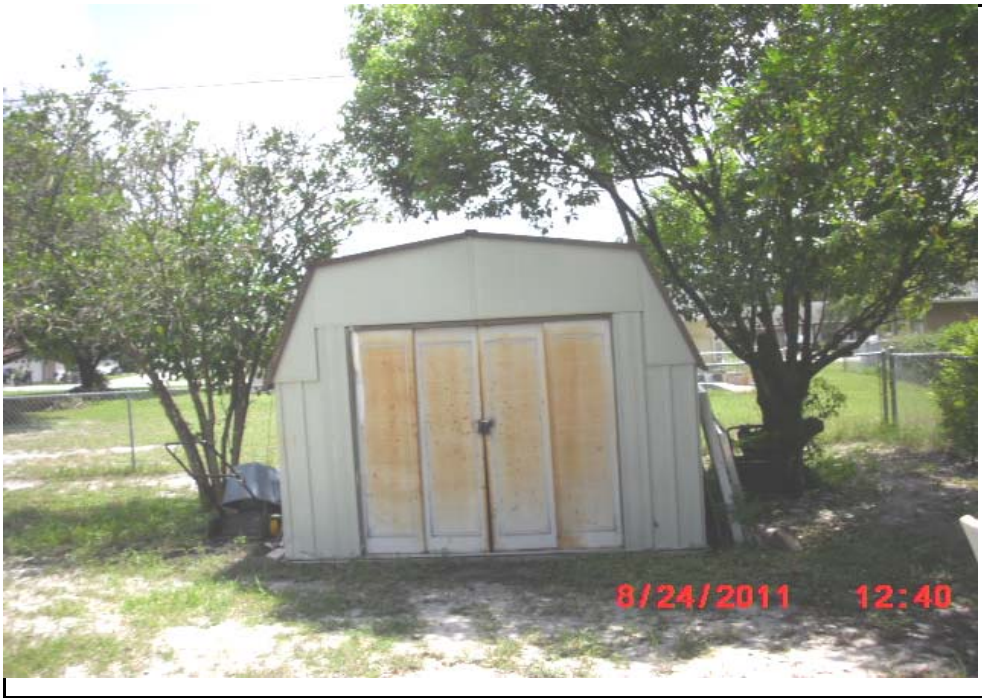
Photograph 6

Shed.
