**INSURANCE COMPANY NAME
STANDARD REPLACEMENT COST REPORT**

ORDER #: SO011629

INSURED Happy Homeowner 123 Main Street Happyville, FL 32725	AGENT CODE: 774 ICA Insurance Agency 123-456-7890	POLICY #: ICAH0709148 Effective Date: 08/28/2011 Order Date: 8/8/2011 Inspection Date: 8/24/2011 Inspector: Inspector H
--	--	--

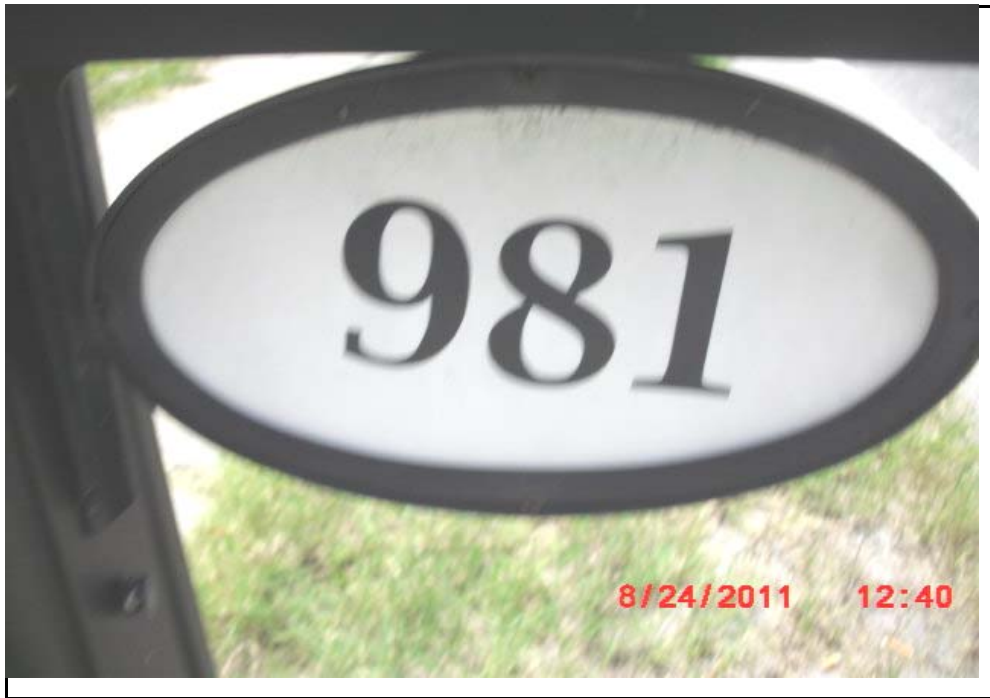
Photograph 1

Address

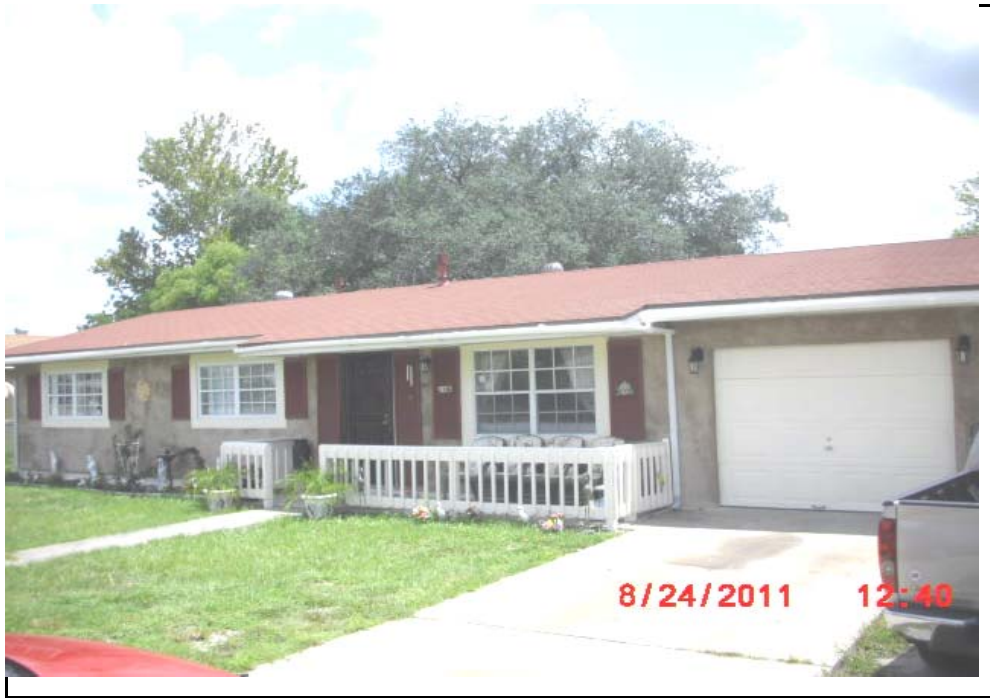
Photograph 2

Front

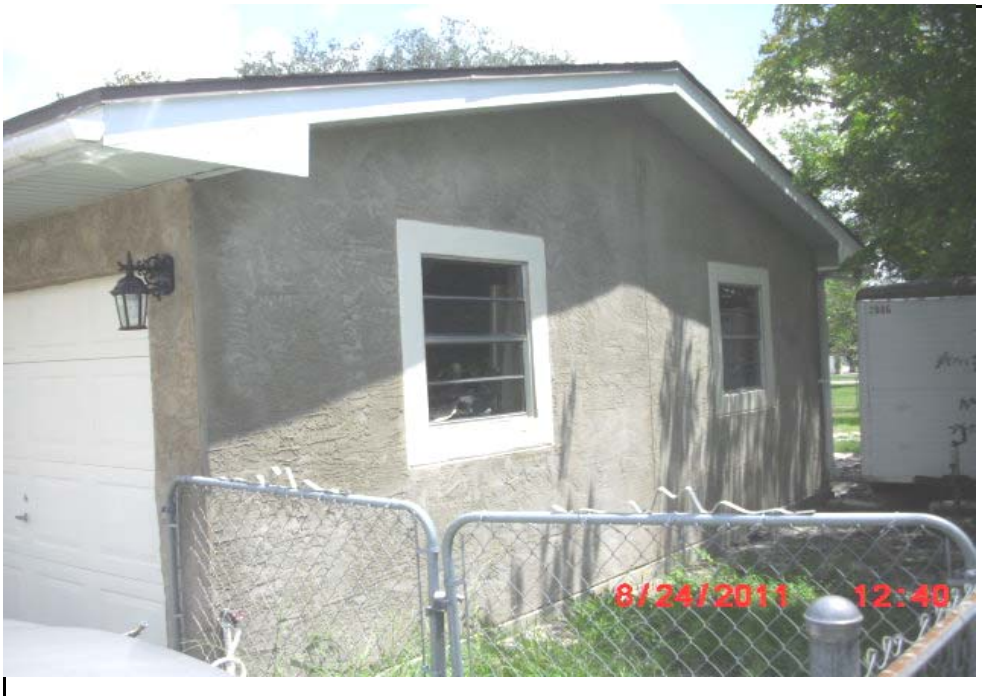
Photograph 3

Right

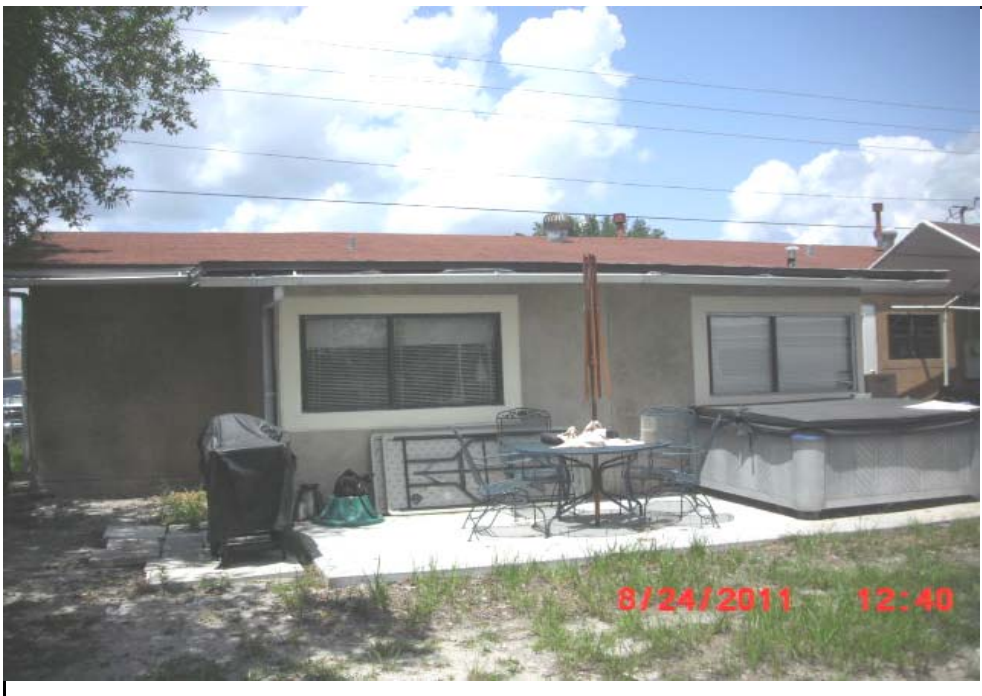
Photograph 4

Hot tub present in photo.

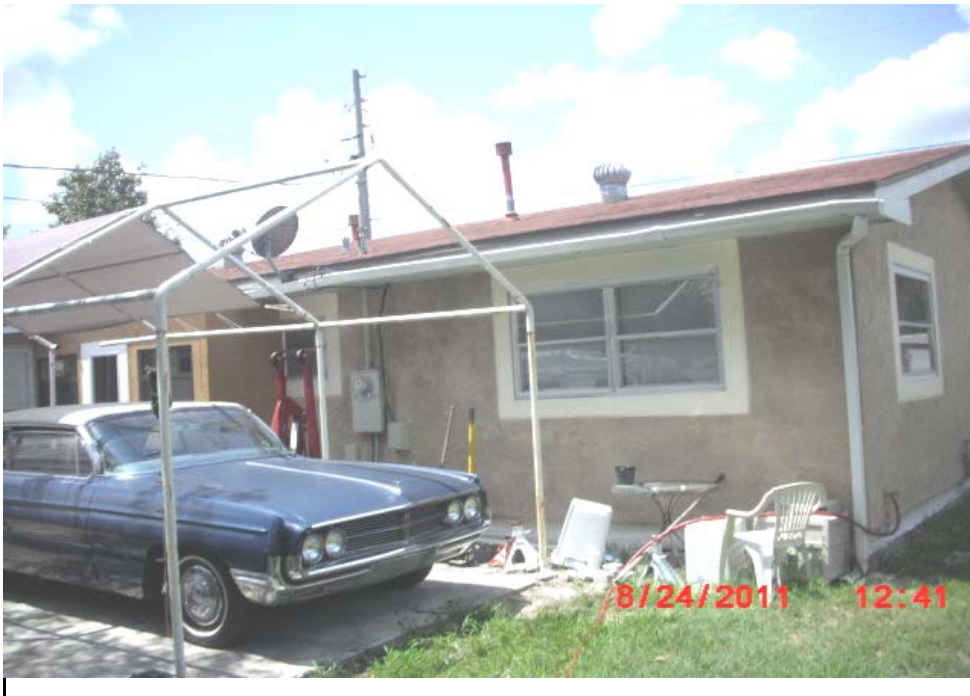
Photograph 5

Back

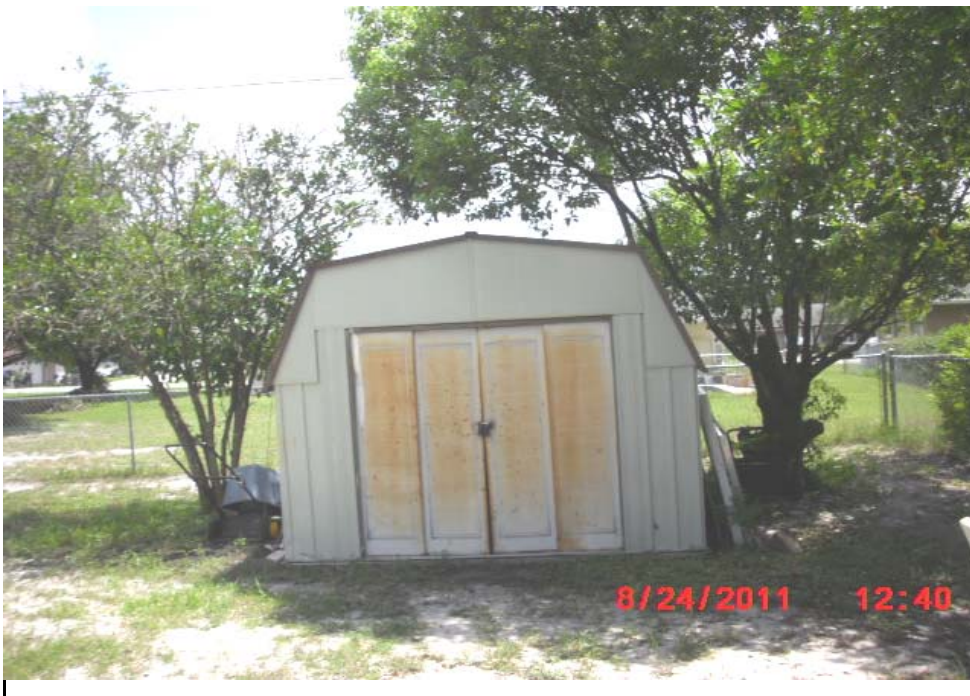
Photograph 6

Shed.

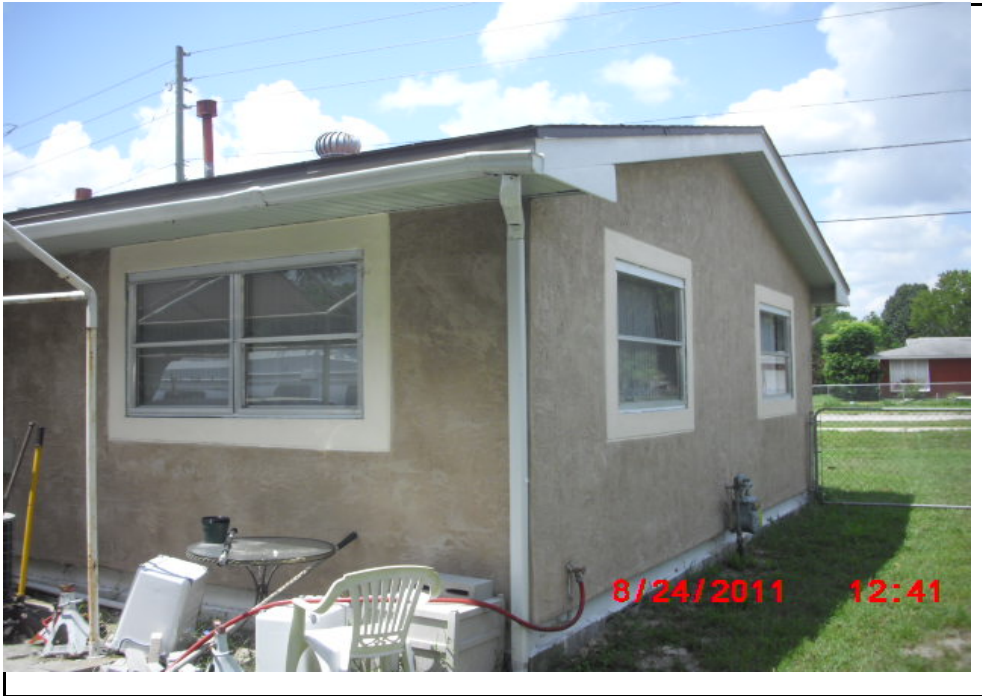
Photograph 7

Left
