Extracted from:
TESTIMONY OF LAURA KENNETT
MPUC DOCKET NOS. PL9/CN-14-916
January 31, 2017

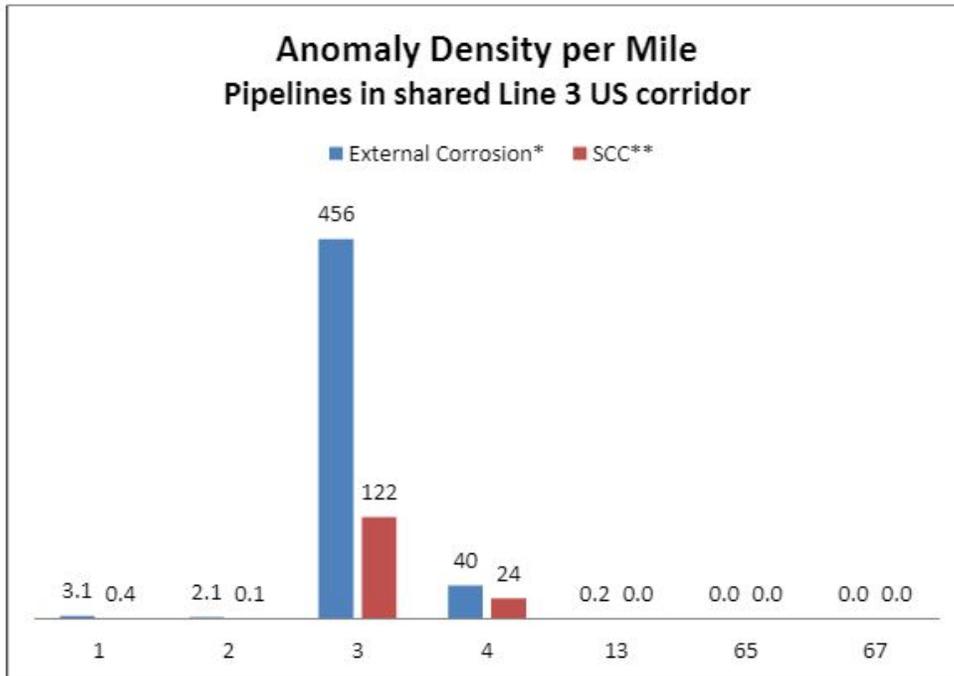
- External corrosion on over 50 percent of its pipe sections between welds (referred to as “pipe joints”).
- Ten times as many corrosion anomalies per mile (with a depth of more than 20 percent of the pipe wall thickness) than any other Enbridge pipeline in the same corridor.
- SCC affecting over 15 percent of the pipe joints, and five times as many SCC anomalies per mile (with a depth of more than 10 percent of the pipe wall thickness) than any other Enbridge pipeline in the same corridor.

The figure below shows the density per mile of external corrosion and SCC anomalies for Line 3 compared to the other Enbridge pipelines located in the shared U.S.. corridor.

*Corrosion over 20 percent of wall thickness; **crack-fields over 10 percent of wall thickness

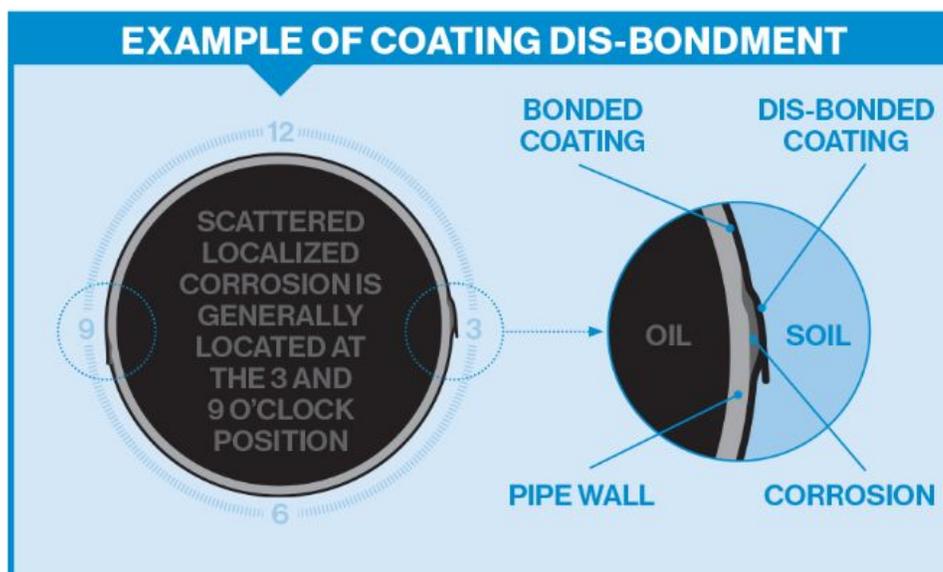
External corrosion is the oxidation of the steel and loss of metal on the exterior of the pipeline. External corrosion on Line 3 is primarily attributed to the coating disbonding from the external surface of the pipe. Disbonded coating creates entry points for water, oxygen, bacteria and acidic compounds in soil to access the surface of the steel and initiate corrosion. The figure below illustrates coating disbondment.

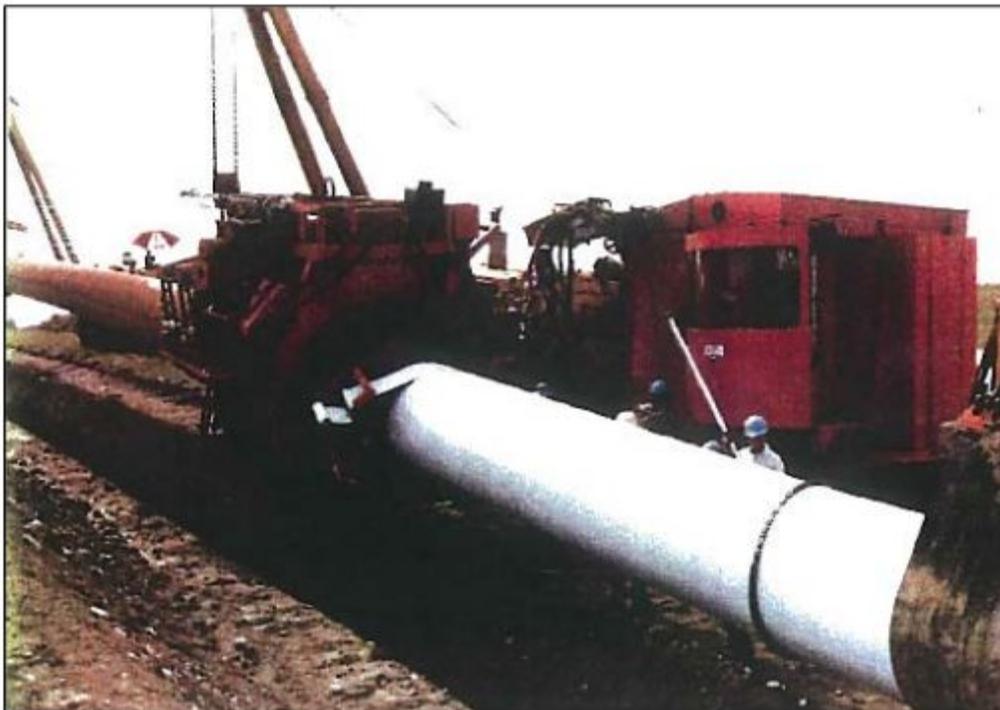
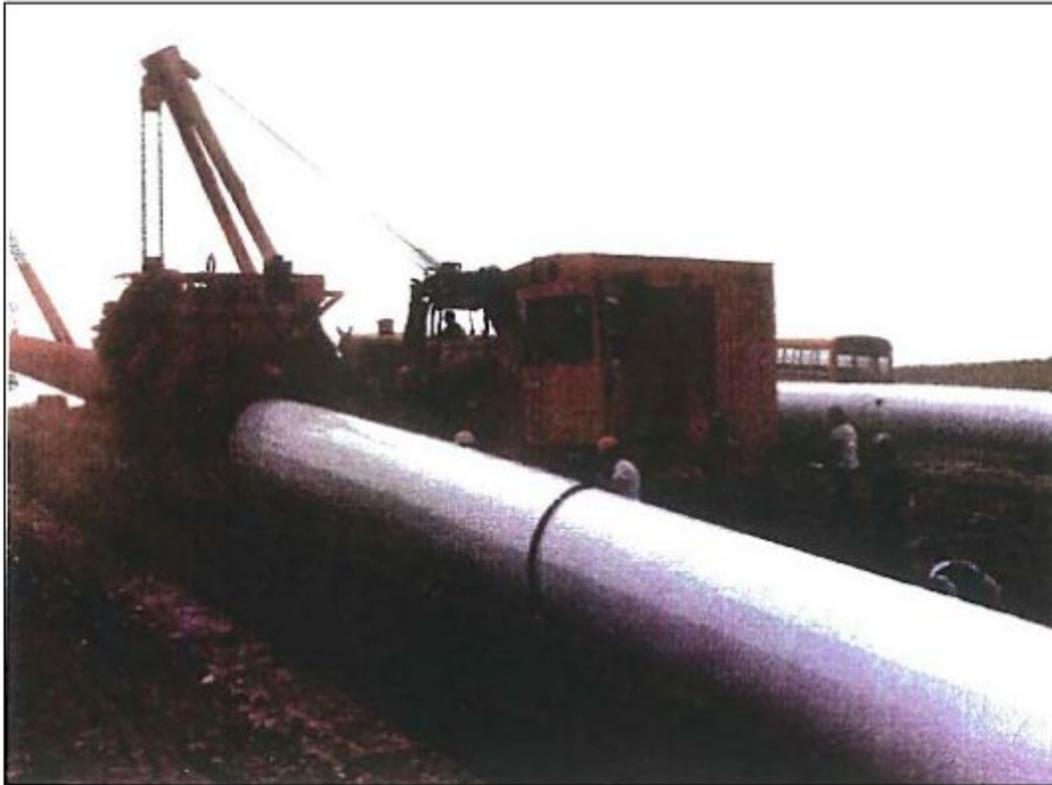
- **Surface Cleaning:** Prior to installation of the tape coating, the surface of the steel on Line 3 was cleaned by wire brushing, which later turned out to be insufficient to remove a residual oxide and mill scale layer. This layer of oxide and mill scale reduced the available surface area for the tape to bond to the steel.

- **Primer:** The adherence of the coating is improved by painting a primer onto the surface of the steel before the tape coating is applied. Primer was not painted onto Line 3 because its effectiveness was not well understood at the time of construction.

- **Dust and Debris:** The tape coating was installed over the ditch, and the action of the coating machines, along with wind, stirred up dust and debris, which became trapped under the tape, thus reducing the available surface area for bonding to the steel. The photos below show the tape coating installation process for Line 3

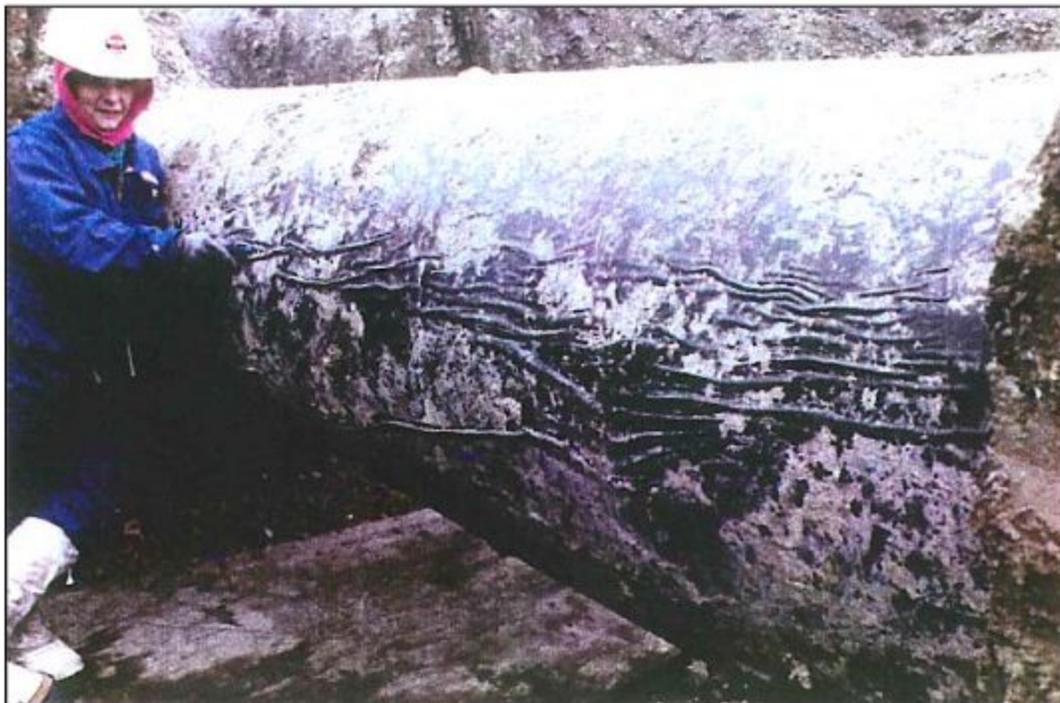
- Soil Stress: Along Line 3, soils have expanded and contracted from seasonal changes in temperature and moisture, and the friction between the pipe and soils with high clay content has stretched the tape coating and caused it to wrinkle. Pipelines in soils with more clay, such as parts of western Minnesota, exhibit more stretching of the tape coating because those soils are more prone to movement from settling and wetting. The photo below shows an example of the effect of soil stress on Line 3's tape coating

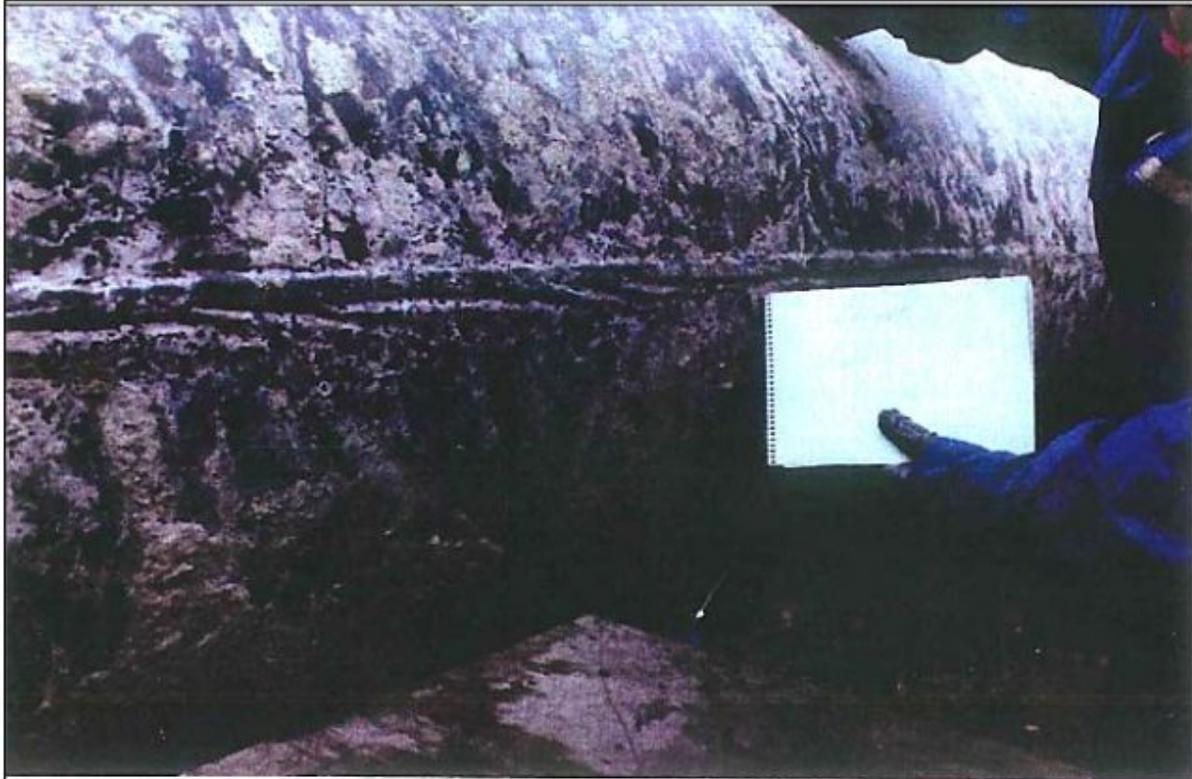
- Bridging over the Longitudinal Seam Weld: Because some longitudinal seam welds create a bump on the surface, the tape coating bridges over this bump and forms a pocket where the tape has not bonded to the surface of the steel. The photo below shows bridging of the tape coating on Line 3

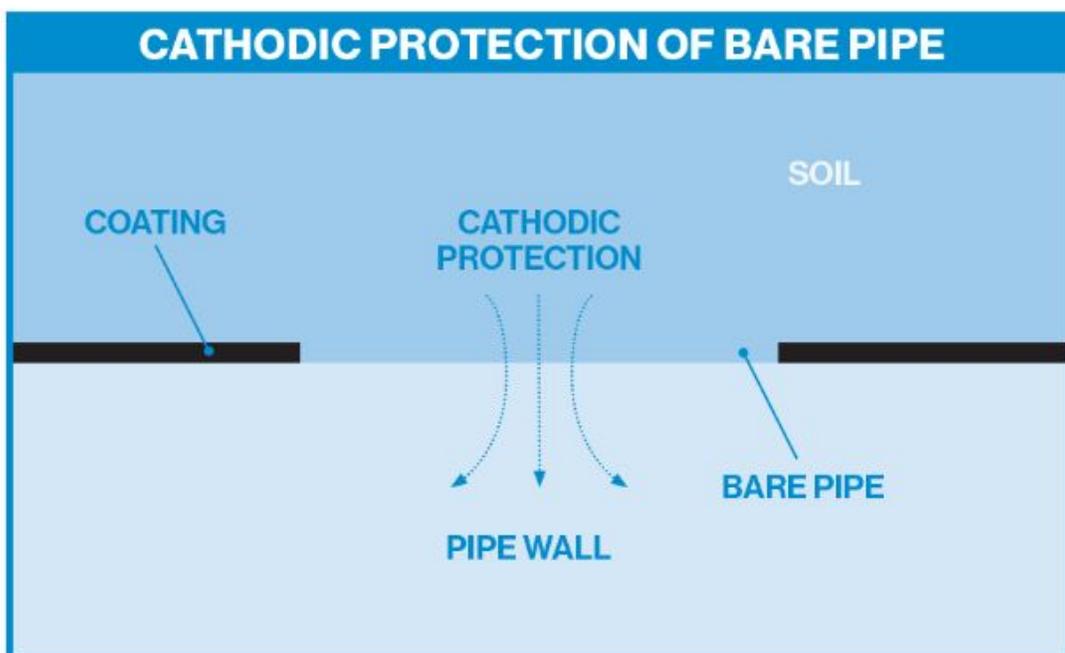
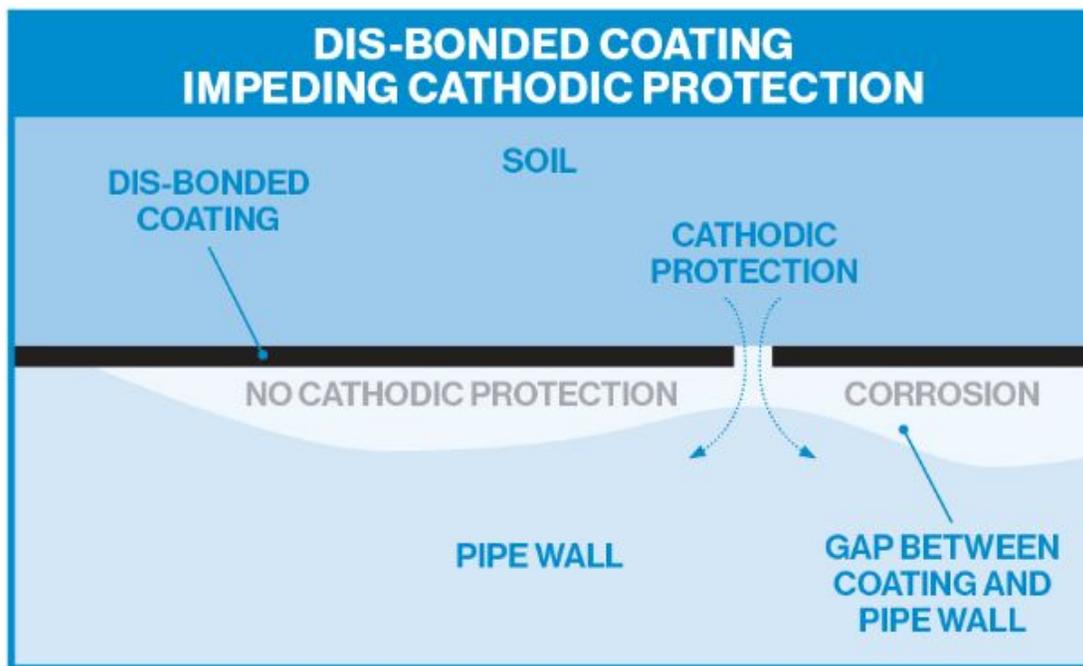
- CP (cathodic protection) Shielding: The dis-bonded tape coating also acts as a shield to the impressed electrical current from the CP system. Thus, the CP current is unable to reach the metal underneath the disbonded coating, reducing the effectiveness of the CP system. The first figure below shows how CP typically works to prevent corrosion on a bare pipe, and the second figure below shows how the disbonded coating on Line 3 interferes with CP, allowing corrosion to occur.

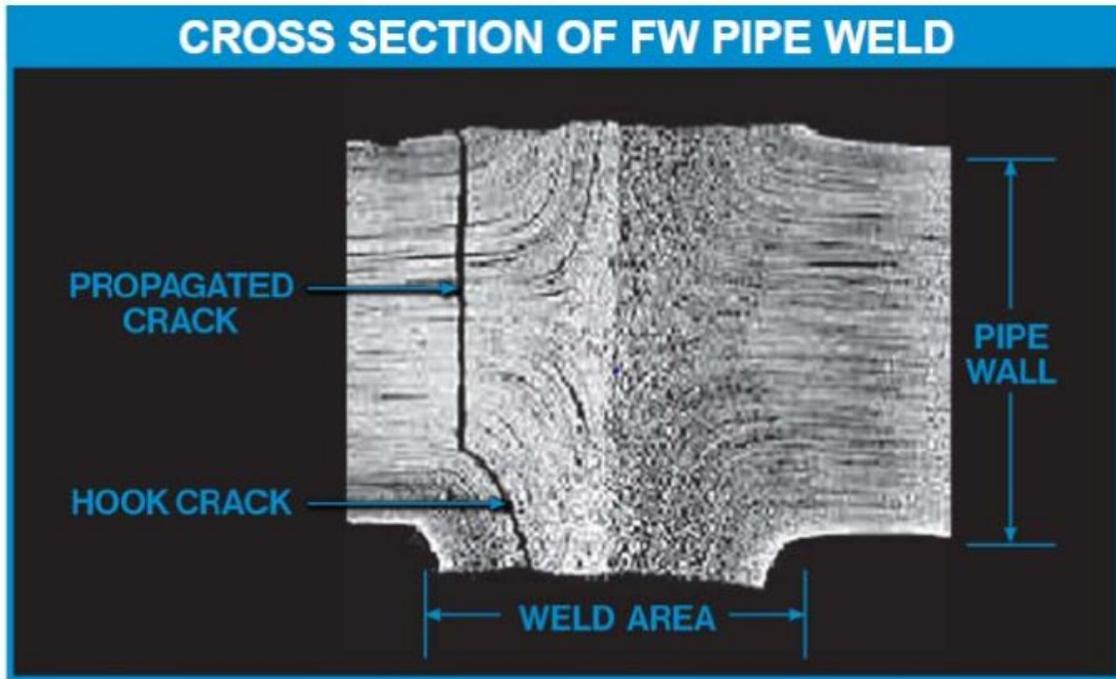
Some of the manufacturing defects on the FW pipe on Line 3 are “hook cracks.” Hook cracks develop when inclusions and impurities in the steel become trapped in the weld. The photo below shows an example of hook cracks in a cross-section of a pipe weld. In this example, we can see one of the hook cracks has led to a crack that propagated all the way through the thickness of the pipe wall. This type of failure has occurred on Line 3.

Due to the susceptibility of the FW manufacturing process to defects, FW is no longer used in pipe manufacturing. **Prior to self-imposed pressure restrictions, pressure-cycle-induced fatigue, coupled with defects in the seam welds on Line 3, caused four major releases in Line 3's operating history.** The last large failure from long-seam cracking occurred in 2002 near Cohasset, Minnesota. Enbridge has since permanently lowered the operating pressure on Line 3 and increased the number of monitoring activities to reduce the threat of long-seam cracking and has not had any subsequent failures on Line 3 from long-seam cracking. The susceptibility of the pipeline to this threat would return if Line 3's operating pressure were increased.
