FINAL REPORT ~ FHWA-OK-17-03

OVERTURNING FORCES AT BRIDGE ABUTMENTS AND THE INTERACTION OF HORIZONTAL FORCES FROM ADJACENT ROADWAYS

January 2018

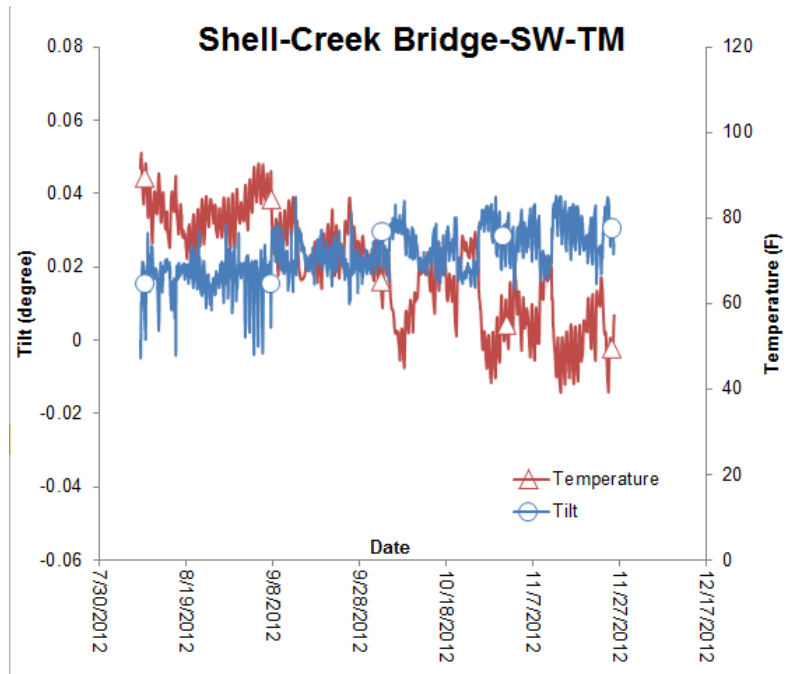
Figure 17. US 64 over Shell Creek Bridge – Southwest Tiltmeter data (SW_TM)

Figure 17 depicts SW-TM tiltmeter data on the south side of the abutment backwall. The spikes seen in the tiltmeter data are caused by vehicle vibrations. It can be seen that the trend in the tiltmeter data corresponds inversely with temperature trends. As the average temperature decreases from July through October, the tilt increases. Similar trend can also be seen in for the tiltmeter on the north side (Figure 18). These data indicates that as the deck cools the abutment backwall is rotating towards deck.

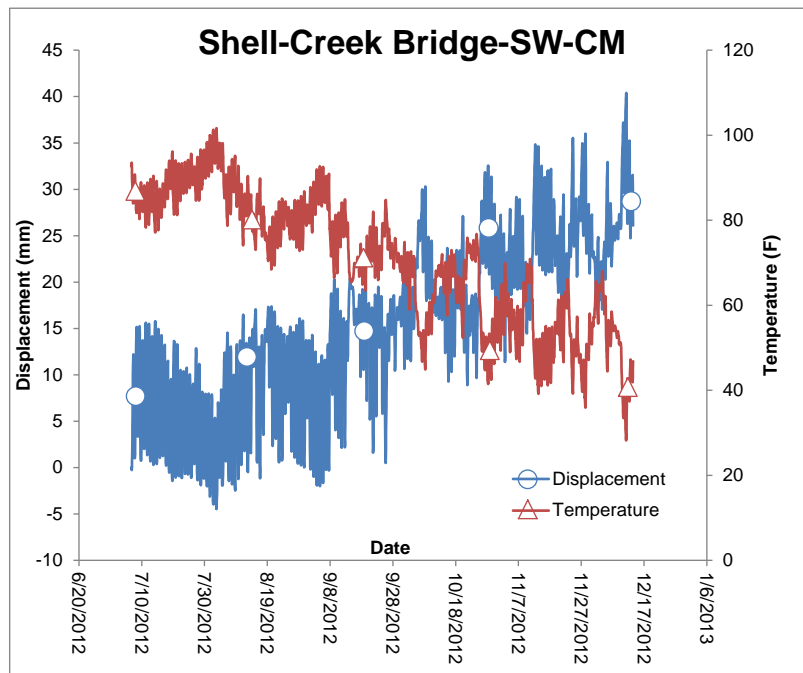
Figure 19. US 64 over Shell Creek Bridge – Southwest Crackmeter data (SW_CM)

Crackmeters are attached between the bridge deck and the approach slab, near the expansion joint, as shown in Figure 16. Figure 19 and Figure 20 show measured displacements and temperatures for crackmeters SW-CM and NW-CM, respectively. As the temperature decreases, deck and the approach slab move away from each other and the relative displacement between them increases as shown in Figure 19 and Figure 20.

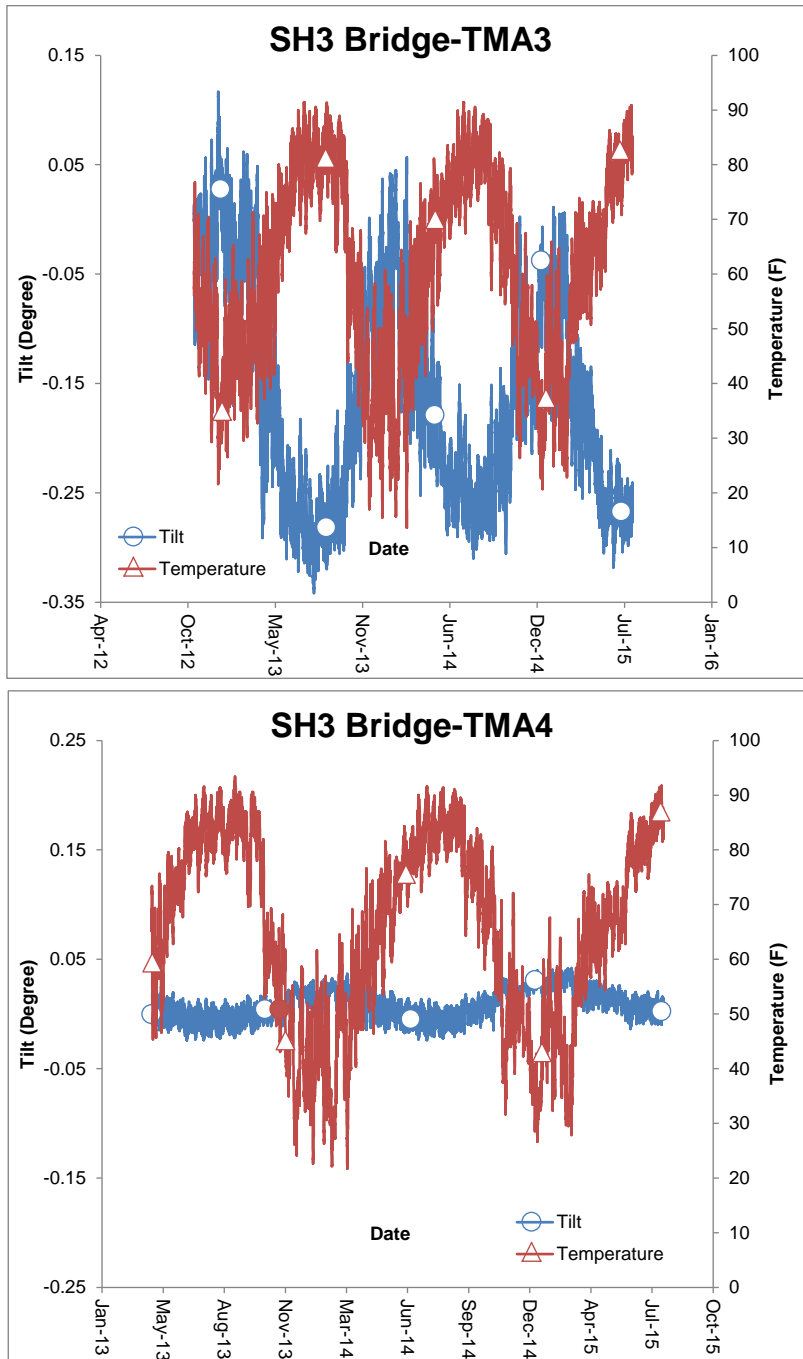
Figure 41. East abutment of SH-3 south bridge over BNSF railroad – TMA3 and TMA4 tiltmeter data before repairs

Figure 41 depicts TMA3 and TMA4 tiltmeter data installed on the east abutment backwall of the South Bridge. It can be seen that the trends in the tiltmeter data corresponds inversely with temperature trends. Similar trends can also be seen for the tiltmeter TMA1 and TMA2 on the east abutment backwall of the North Bridge (Figure 42). These tiltmeters indicate that the abutment back walls rotate toward the approach slab as the temperature increases and then rotate back toward the bridge deck as the temperature decreases. In both abutment backwalls, more tilt can be seen in the insides of the abutments (TMA2 and TMA3) than outsides (TMA1 and TMA4). This indicates that more forces are being transmitted through the insides of the abutments due to the interactions between the North and the South Bridge.

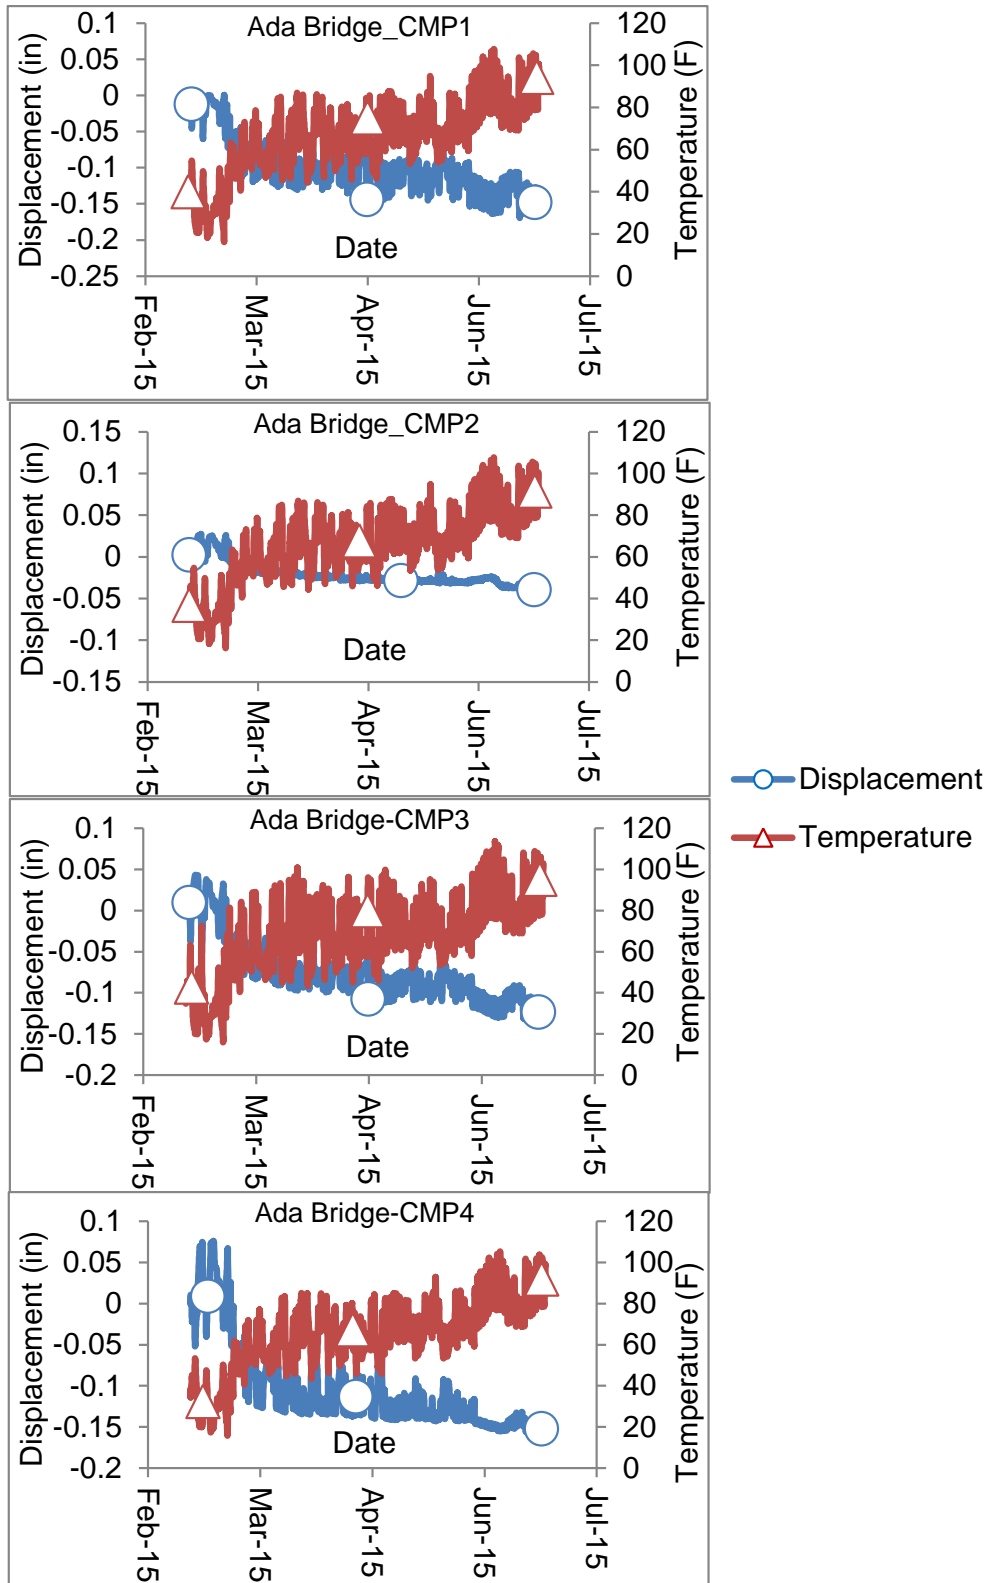
Figure 66. Expansion joints of SH-3 north bridge over BNSF Railroad - CMP1-4 crackmeter data before repairs

Expansion joint movements along with temperature variations for the western and eastern sections of the north bridge are shown in Figures 66 and 67, respectively. Based on the recorded data during the monitoring period, temperature varied between 15° F and 105° F. Measured displacements during this period were between 0.06"-0.23". However, the estimated displacement was 0.51" indicating that most of the expansion joints were practically locked before the repairs.

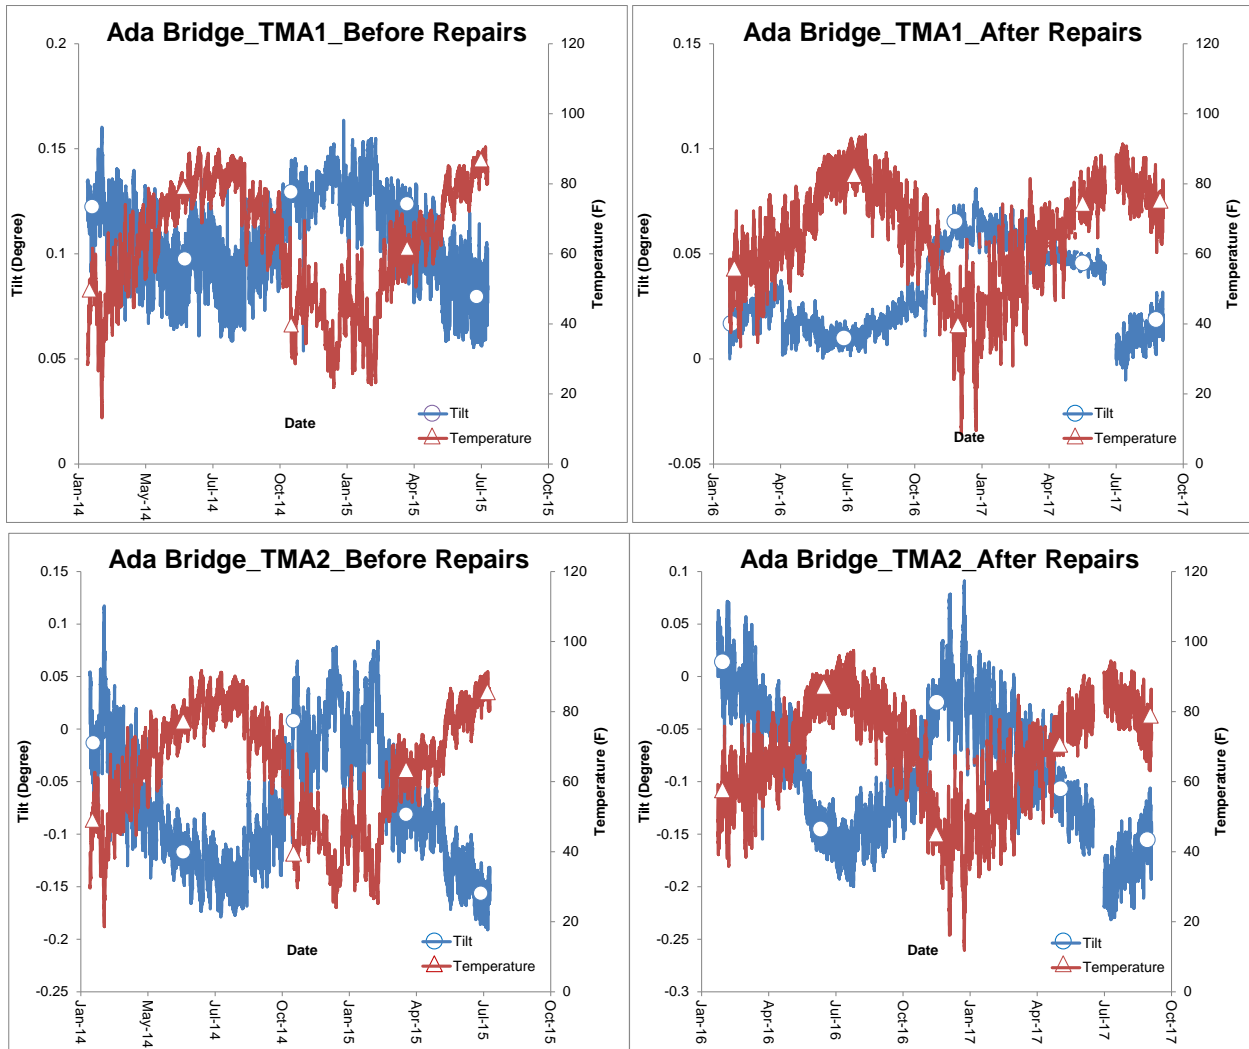
Figure 72. East abutment of SH-3 north bridge over BNSF Railroad – Comparisons of TMA1 and TMA2 tiltmeter data before and after repairs

Data from tiltmeters TMA1 and TMA2 installed on the east abutment backwall (see Figure 38) of the north bridge before and after repairs are compared in Figure 72. While the trends are similar before and after the repairs, significantly more tilt is being recorded on TMA2 than TMA1 after the repairs. It appears that the new expansion joint at Pier No. 4 has isolated the eastern most portion of the deck and now the skew of the bridge is causing more tilt of the abutment backwall on the south side.

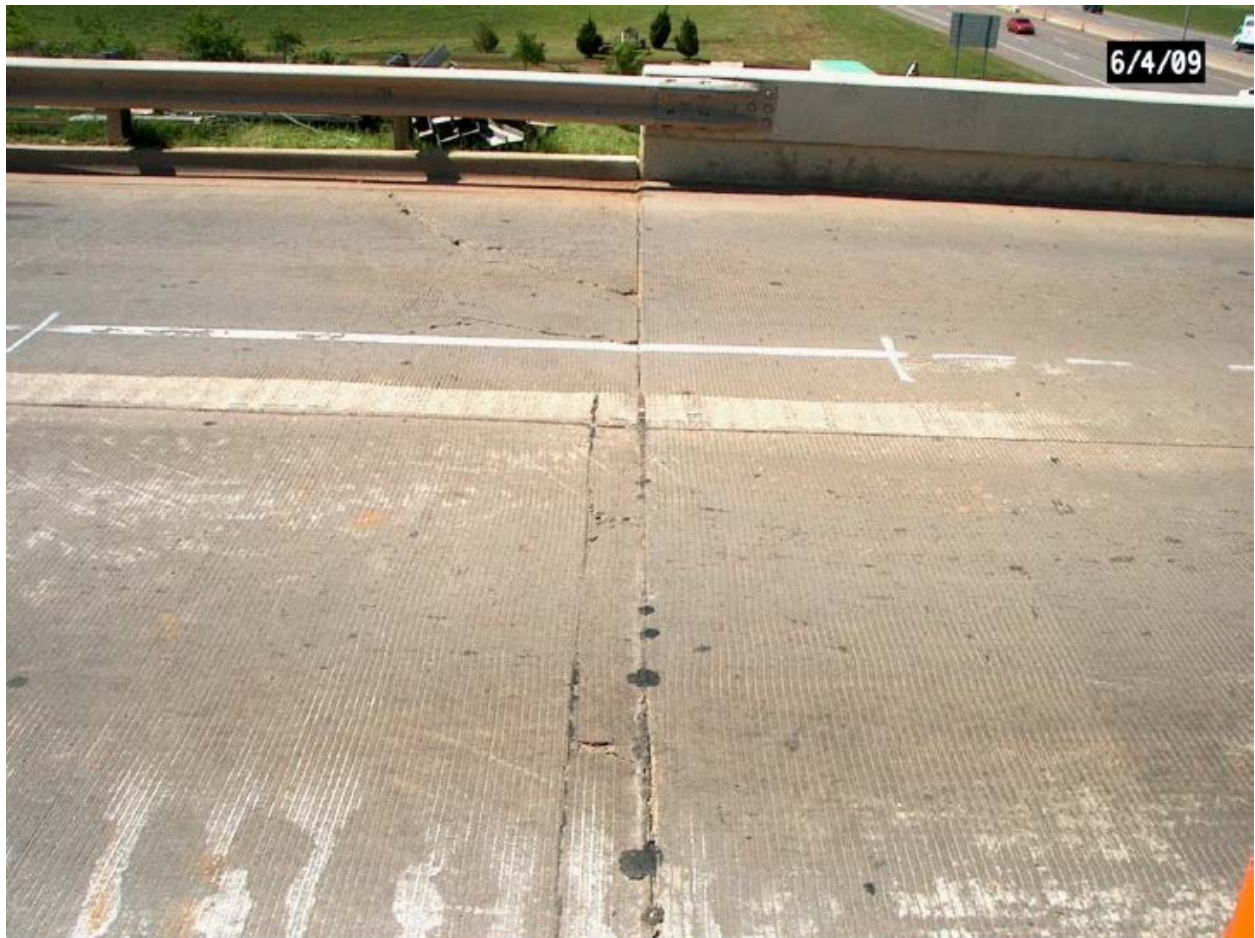
Figure 90. Cracking of the south eastern approach slab adjacent to south bridge deck in 2009

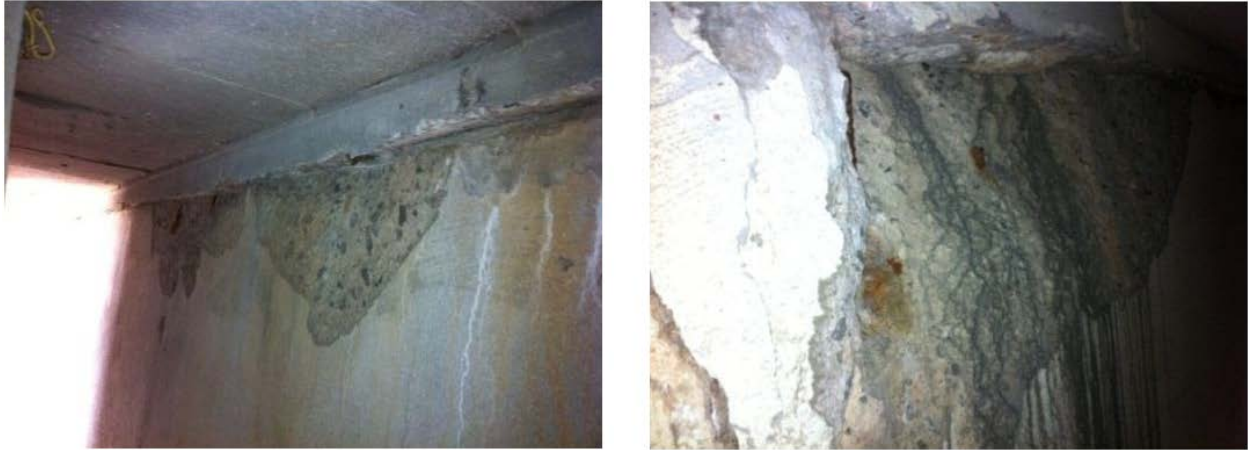
Figure 91. U-shaped cracking at 19th Street/I-35 Bridge eastern abutment back wall in 2011
