FIBER REINFORCED POLYMERS (FRP) AND CURED-IN-PLACE LINERS (CIPL)

– A Match Made in Heaven

By: George Ragula, Public Service Electric & Gas

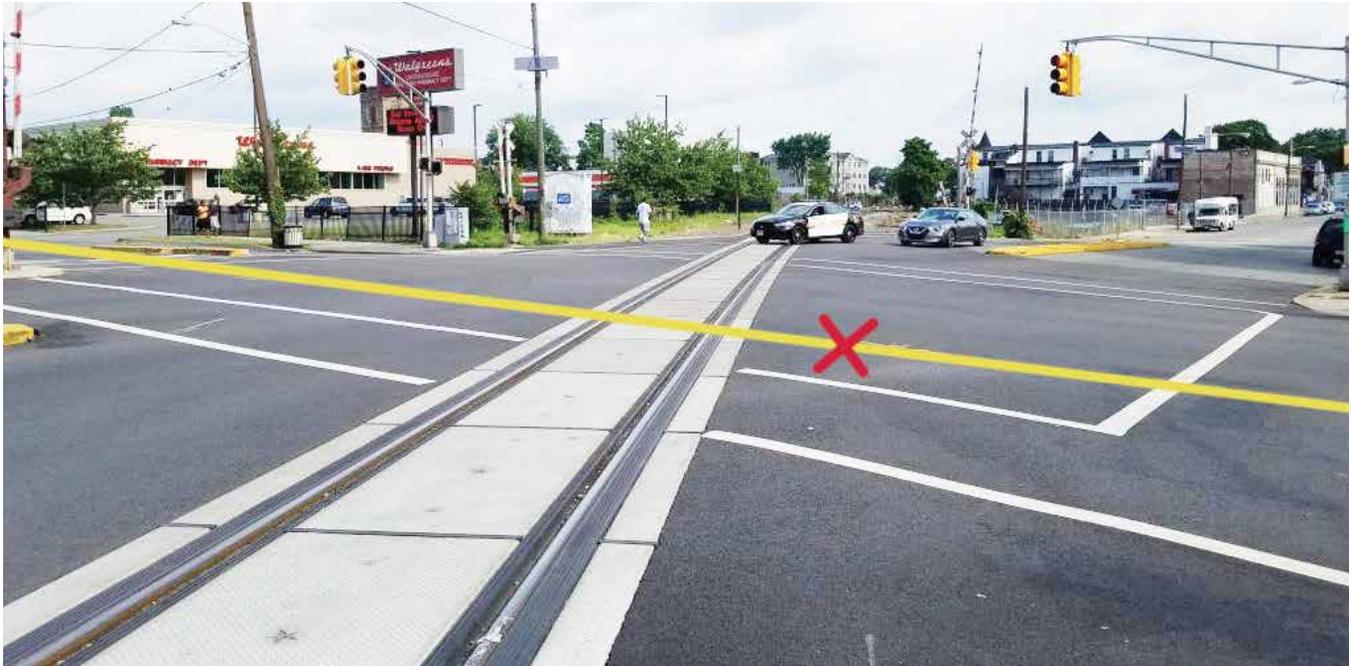
A strong odor of gas emanated from a RR right-of-way where an 8-inch cast iron main crossed under the tracks

crossing. After a comprehensive leak investigation, it was determined that the leak was emanating from a RR right-of-way (ROW) where an 8-inch diameter CI main crossed under the tracks. It was suspected that the crack was caused by non-uniform stresses on the main created by frost in the ground and prior excavation work performed by the RR authority to modernize and update the at-grade crossing.

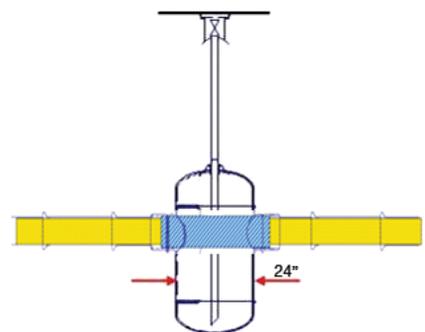
The first installation of FRP in a CIPL renewal of a gas main bridged a 24-inch gap in pipe due to a drip pot

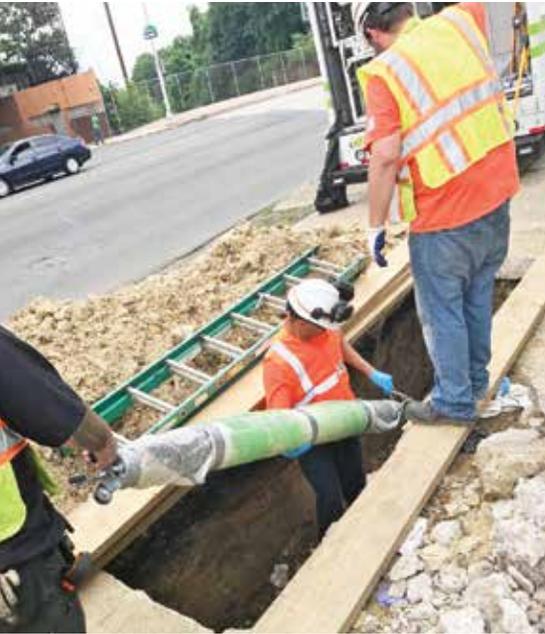
The 4-foot wide SRS was mounted on an expandable pig and pulled to location over the break

Fortunately, with extensive experience gained through the use of FRP for gas mains in a wide variety of gas applications going back to its first use in 2011, we were confident the break could be bridged with FRP acting as an internal structural reinforcement sleeve (SRS). The 4-foot wide SRS mounted on an expandable pig would be centered over the break and then the pig expanded to hold the FRP against the ID of the pipe until cured.

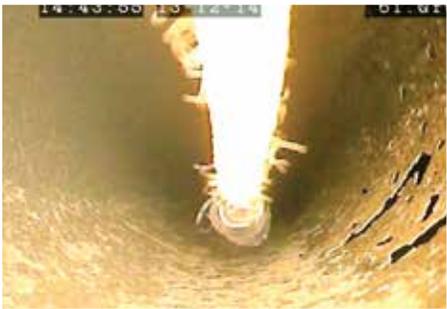
FRP has been previously used to bridge corrosion holes in pressure pipe

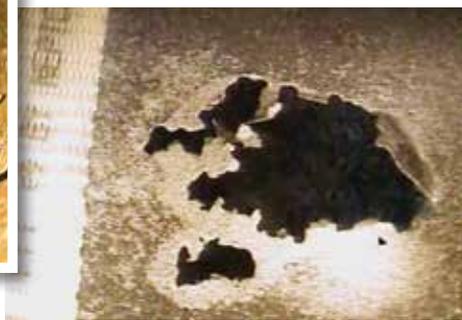
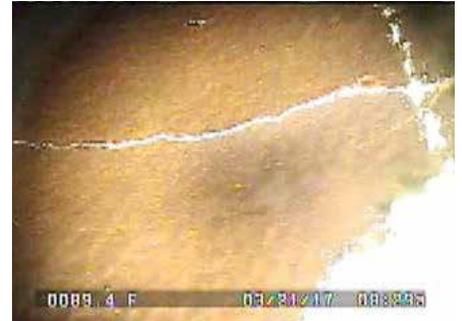
Circumferential break in main pre-cleaning

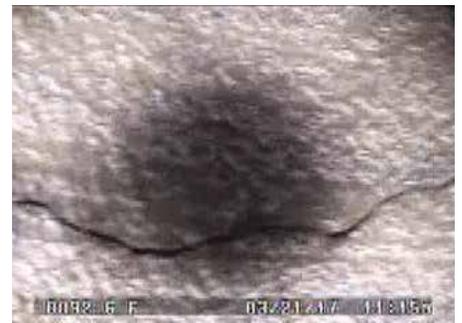
Extent of break was more evident post-cleaning

The entire 174-foot section of main was then grit-blasted internally to a bright white metal finish while the debris-laden grit was simultaneously collected and contained using a vacuum truck. This material was eventually delivered to PSE&G's Environmental Department for analysis and proper disposal according to environmental regulations. After cleaning, the main was again CCTV inspected and the break was now considerably more evident and easier to see. Exact measurements to the break were taken from one end of the cut pipe and double-checked.

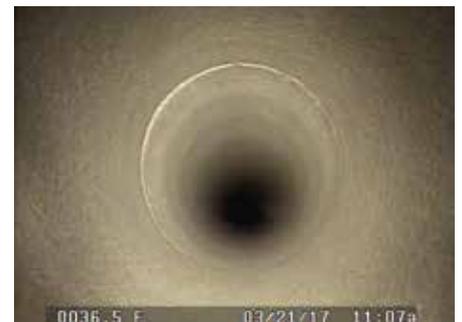
SRS in place before lining

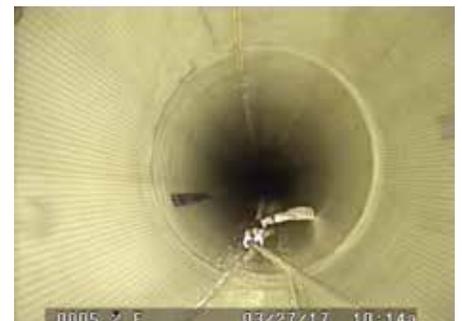
CIPL installed through SRS

Because the work started on a Friday the SRS cured over the weekend. On Monday, the pig was deflated and removed, followed with an additional CCTV inspection to confirm a successful installation. The entire 174-foot segment of 8-inch CL pipe was then lined by PPM using the Starline liner and then cured over a 2-day period. Once cured, the liner ends were trimmed flush with the host pipe and a final CCTV inspection was performed to ensure a

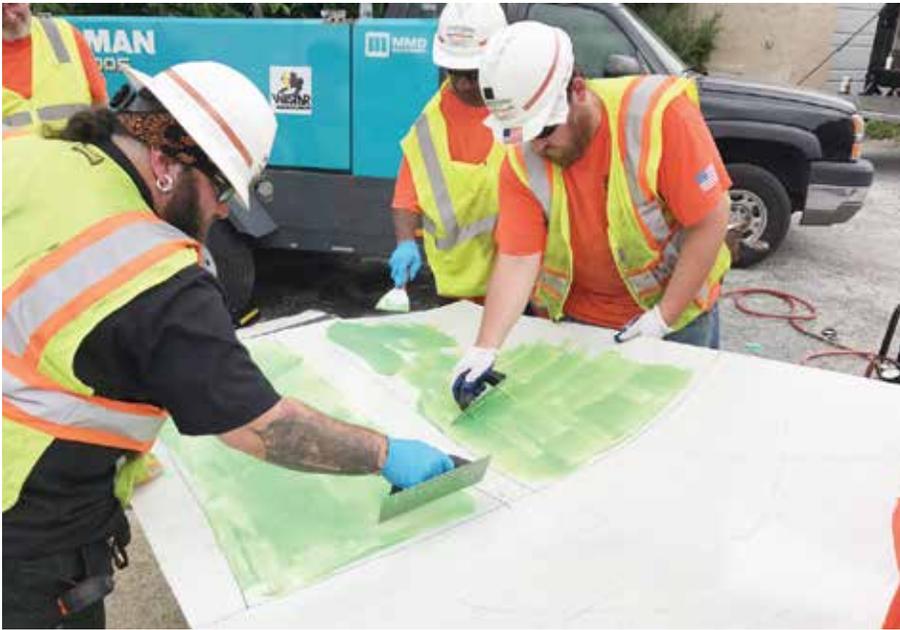
The SRS installation process involved wetting-out the nearly 13-foot long section of biaxial glass laminate material

The SRS installation process involved wetting-out the nearly 13-foot long section of biaxial glass laminate material and

tightly wrapping it onto an expandable pig using a two-part water repellent epoxy. The expandable bladder was protected from the epoxy by plastic wrap. After the final wrap, duct tape was used to prevent unwrapping, and a fishing line installed under the duct tape in order to cut through the duct tape once the pig was pulled to the location of the break, which was approximately 84 feet in from one end. Using a measuring tape attached to the rear of the pig extending to the sending pit, the pig was centered over the break. The fishing line was then pulled cutting the duct tape to allow the SRS to unroll and expand as air was fed into the expandable pig from a compressor hose attached to the pig.

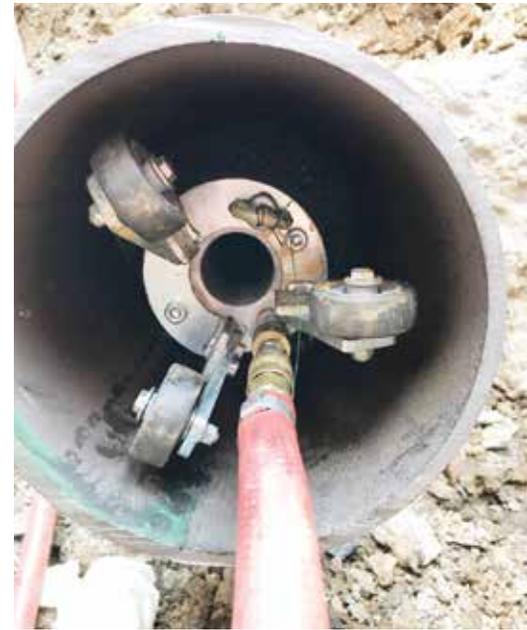
Air was fed into the expandable pig from a compressor hose attached to the pig. This held the FRP against the ID of the pipe until cured
