**SEPTIC SYSTEM □  
SANITARY SURVEY □  
for □  
Santa Barbara County □  
California □**

**Prepared For:  
Santa Barbara County  
Environmental Health Services**

**March 2003**

Project #210029

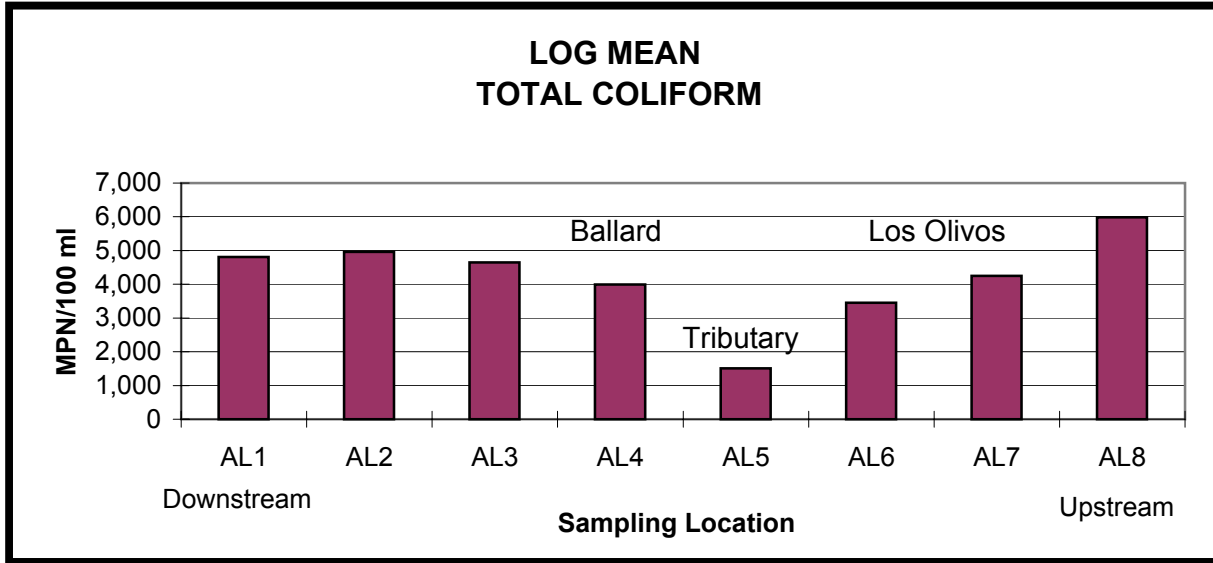
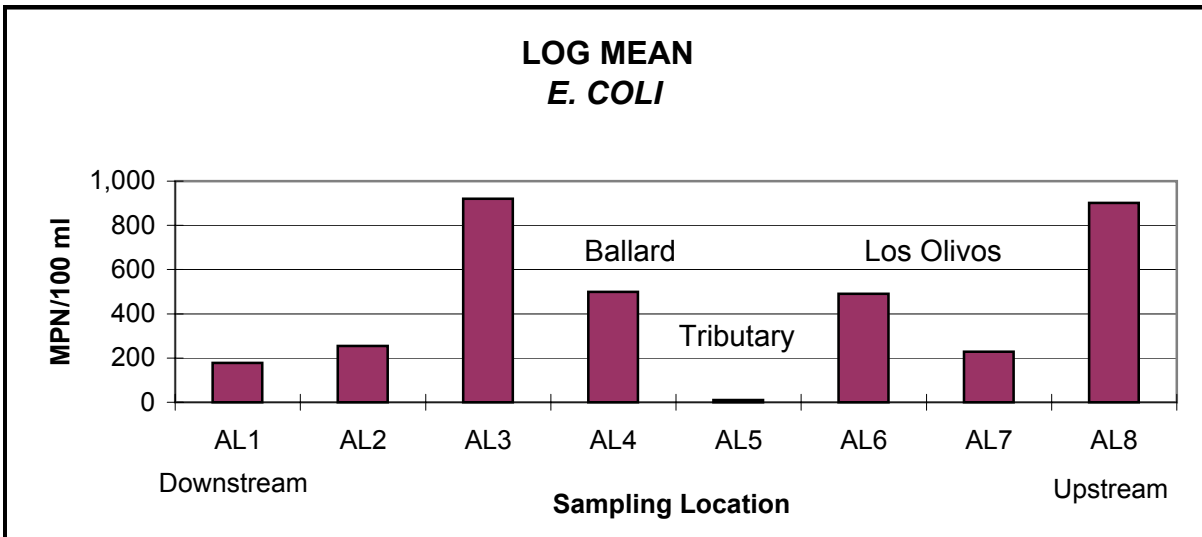
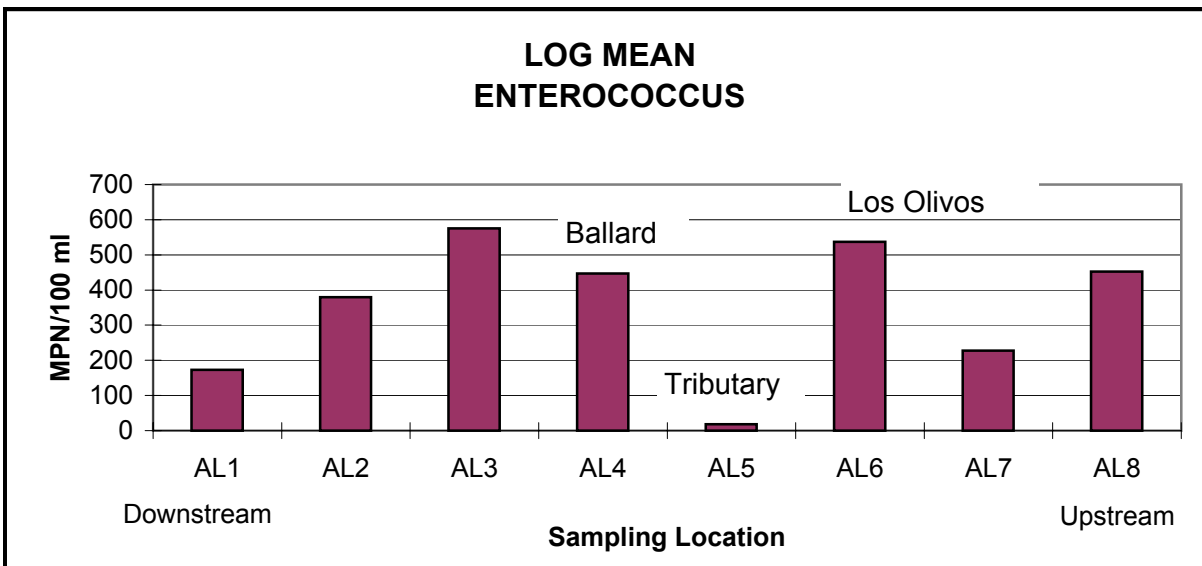
FIGURE 6-4

**ALAMO PINTADO CREEK  
Bacteriological Sample Results**

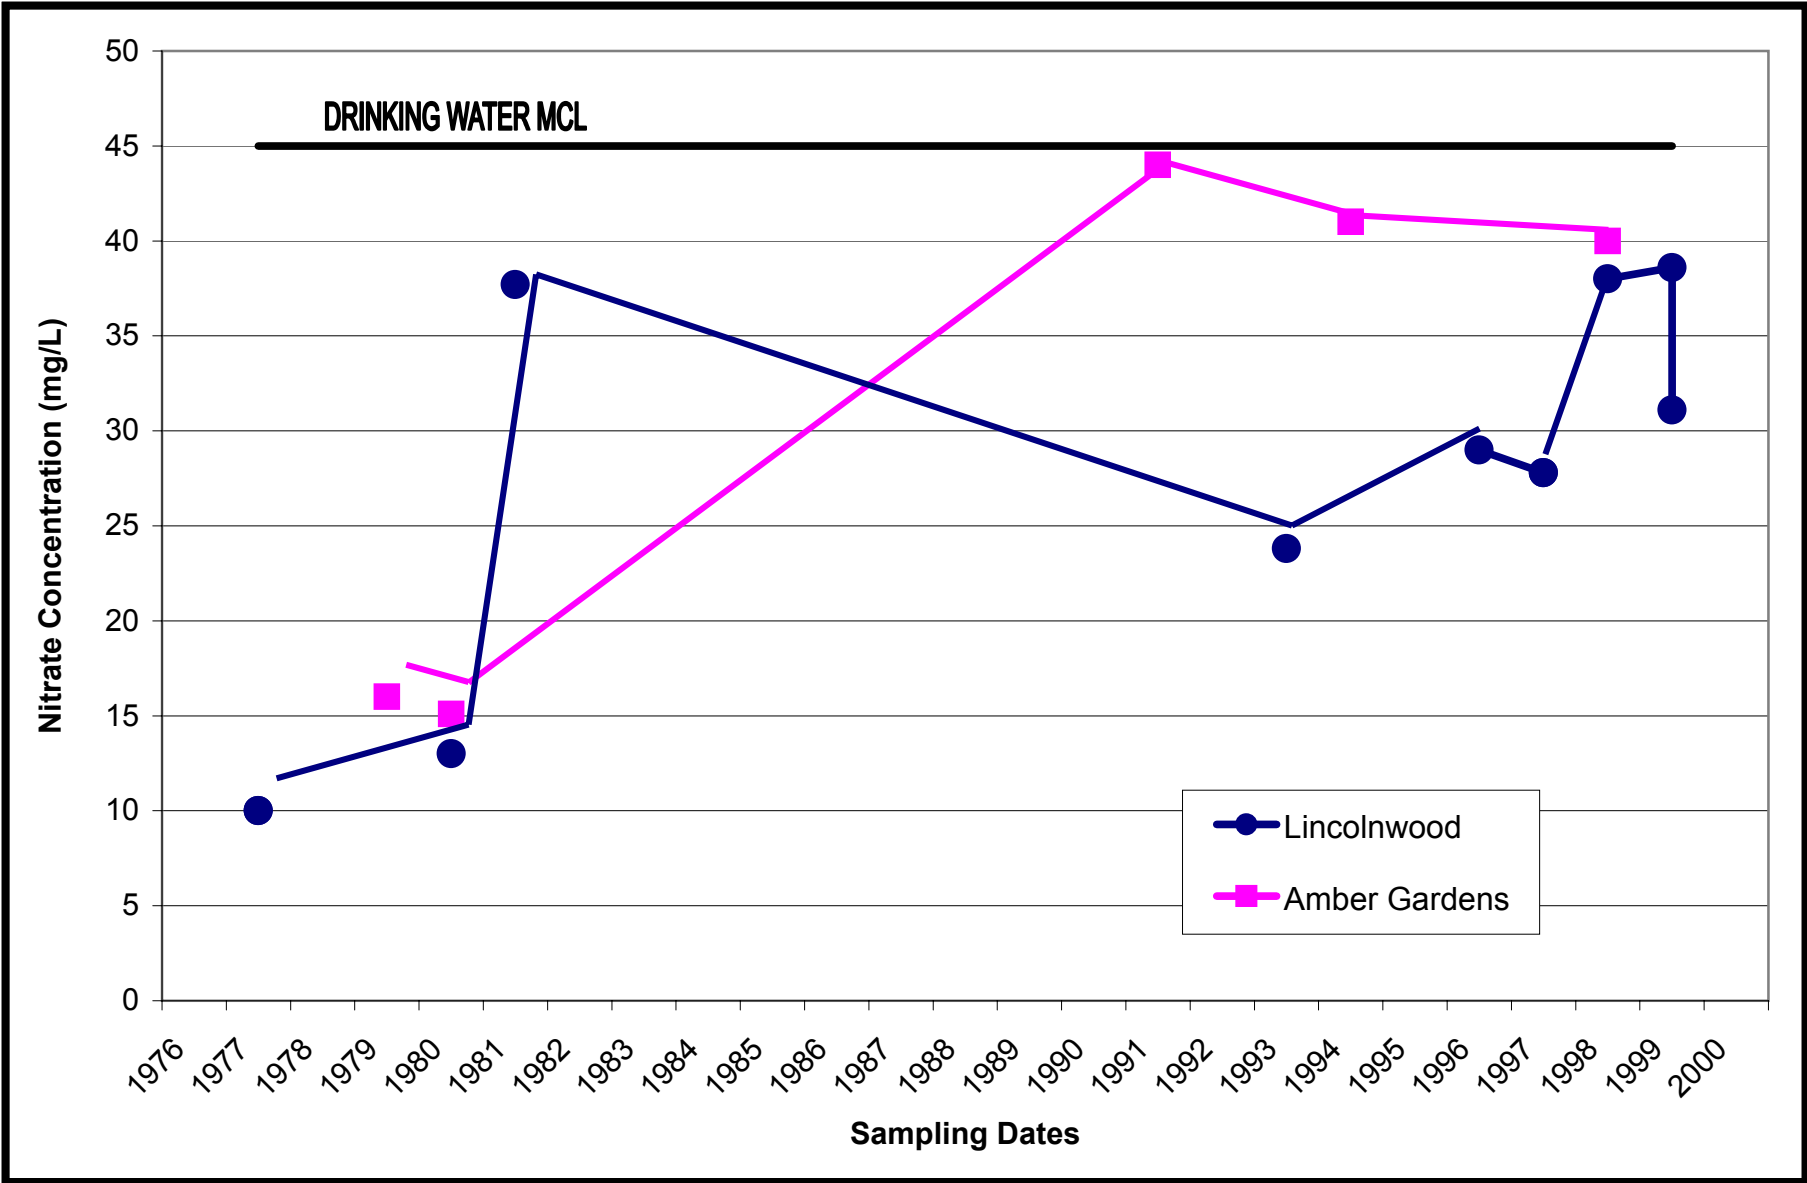
FIGURE 7-3

2. **Sunset Road/Carol Avenue Area.** Nitrate data for the Amber Gardens and Lincolnwood Subdivision water wells in the Sunset Road/Carol Avenue area of Santa Barbara show an increasing trend in nitrate concentration over the past 20 years, as displayed graphically in **Figure 7-3**. A map showing the location of these wells in relation to the septic systems in the Sunset Road/Carol Avenue area is provided in **Figure 7-4**. Also shown are the approximate groundwater flow directions in the area. As can be seen, the Amber Gardens well lies downgradient of the main concentration of septic systems in this area, which is otherwise primarily an urbanized sewered area. The Lincolnwood well lies approximately at the groundwater divide (between the Goleta and Santa Barbara Basins) according to a 1982 U.S. Geological Survey study; and the recharge influence of septic systems is not as clear for this well. However, there may be localized drawdown effects from the well that are not reflected in the 1982 USGS study.

According to available record, many of the systems in this remaining “pocket” of septic systems utilize drywells. The water depth reported in the supply wells ranges from about 70 to 90 feet. Given the dense concentration of septic systems on relatively small lots so close by, there is a reasonable likelihood that the elevated nitrate concentrations in these wells is due mainly to septic system discharges.

GROUNDWATER NITRATE CONCENTRATION (as NO<sub>3</sub>)  
 Amber Gardens and Lincolnwood Water Systems

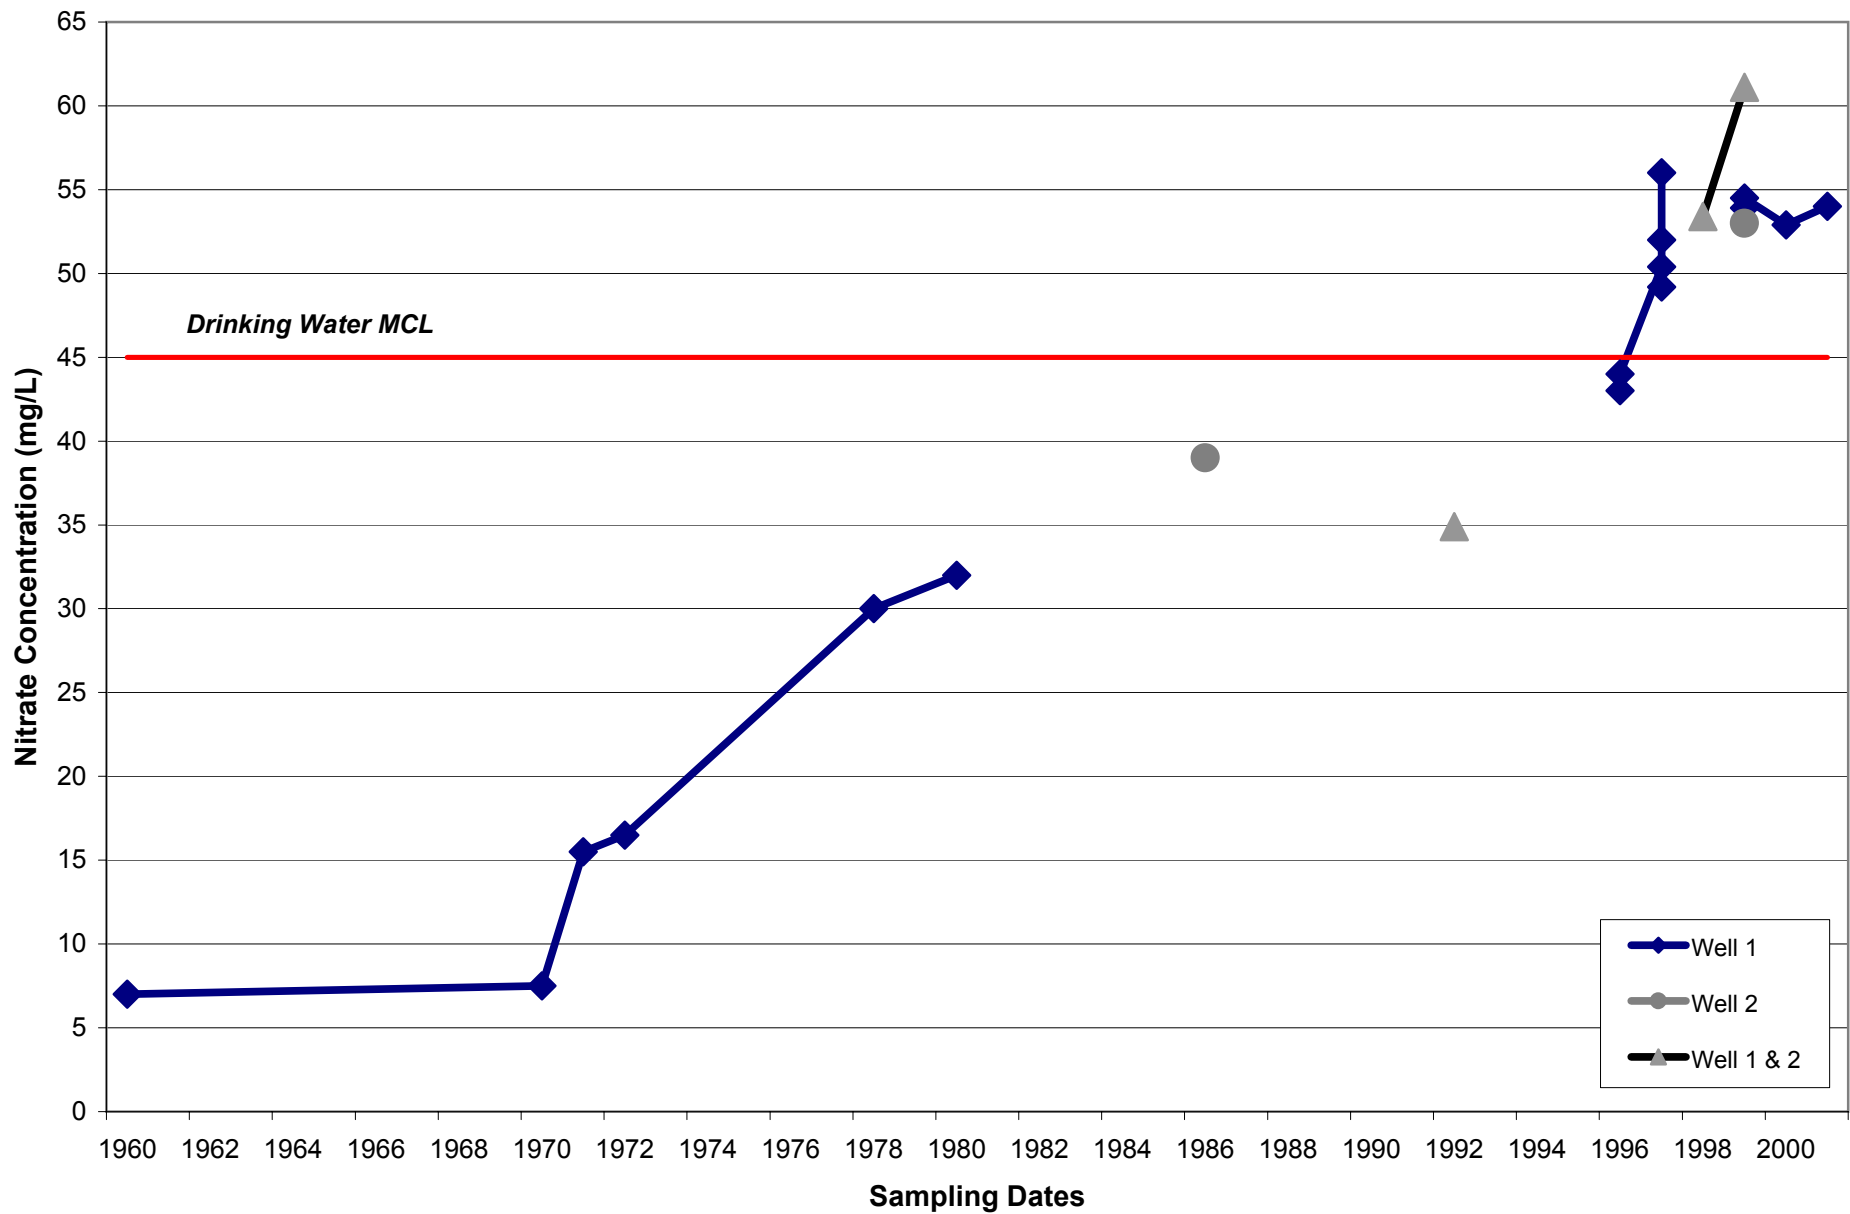
**Figure 7-7**  
**Groundwater Nitrate Concentration (as NO<sub>3</sub>)**  
**Janin Acres Water Supply Wells**

Sampling of the Rancho Marcelino water wells has indicated a dramatic increase in nitrate concentration that coincides with the development of the subdivision and the use of onsite sewage disposal systems in the area. The groundwater-nitrate readings in the water supply wells from 1960 to the present are shown graphically in **Figure 7-7**. As indicated, the nitrate concentrations found in the wells has increased from less than 10 mg/l to over 50 mg/L (i.e., exceeding the drinking water MCL). The data show a strong correlation between groundwater quality degradation and the installation and use of septic systems in the Janin Acres Subdivision and neighboring areas in Santa Ynez (to the north). All septic systems contribute nitrate to the soil and groundwater environment. Deep trench and drywell disposal systems, which are used extensively in Janin Acres, are more problematic because they allow less opportunity for nitrate removal/uptake by soil and vegetation, as compared with shallow leachline designs. In this case the impact on the water wells is further exacerbated by the relatively high density of deep trench and dry well disposal system in such close proximity to the wells.
