### **SUBJECT: EVALUATION AND REPORTING ON CONTAMINANT HYDROGEOLOGICAL CONDITIONS AT THE TAJIGUAS LANDFILL**

**EVALUATION OF THE  
DRAFT EIR  
AND SELECTED REGULATORY CASE FILE  
TECHNICAL REPORTS  
ASSOCIATED WITH THE  
TAJIGUAS SANITARY LANDFILL**

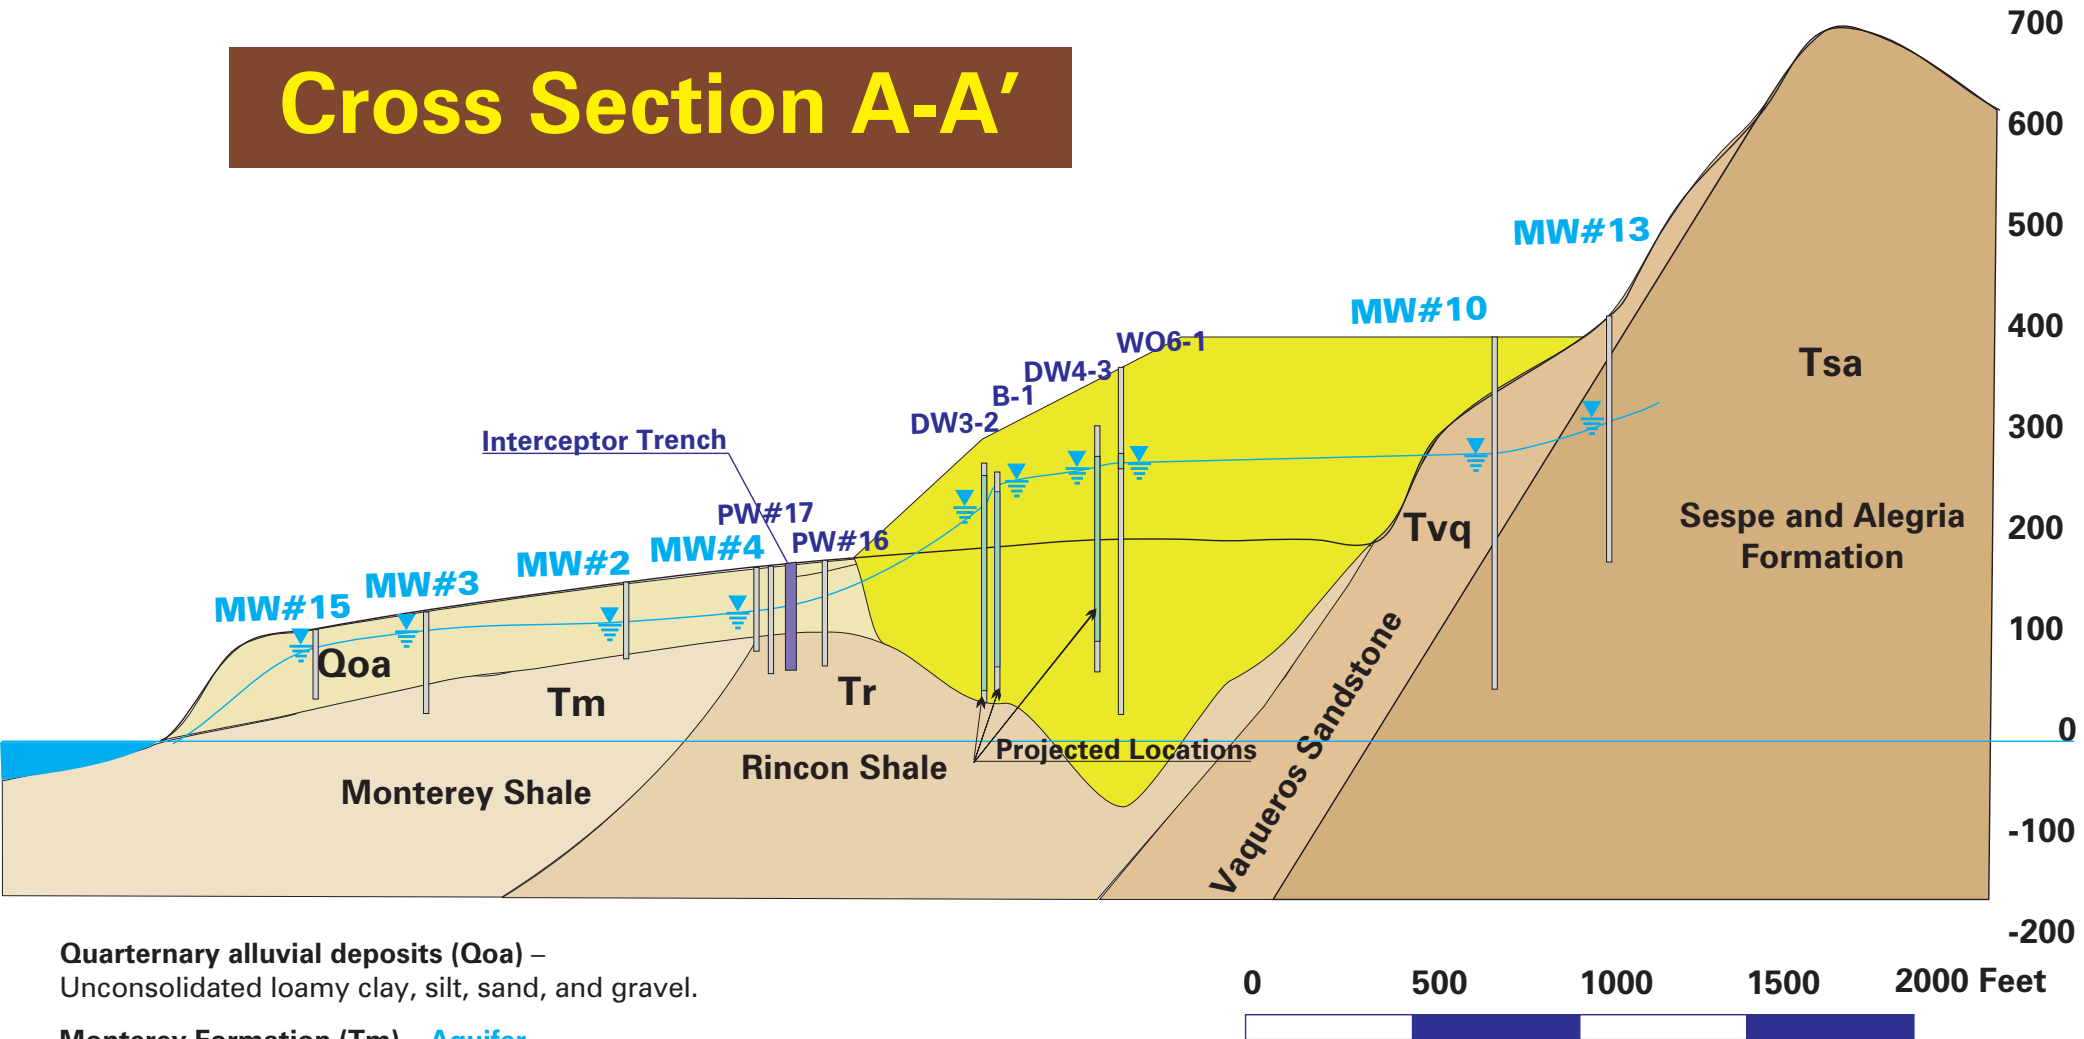
# Cross Section A-A'

The Collection Trench Profile and Details cross section also verifies that the 20 to 35 feet of soil exposures on the east and west sides of the trench are permeable alluvium. (**See GeoSolv Tajiguas Landfill Map**) This provides migratory pathways for contaminated groundwater to bypass the trench and contaminate groundwater in the Monterey Shale formation, at the Arroyo Quemada community and the beaches beyond.

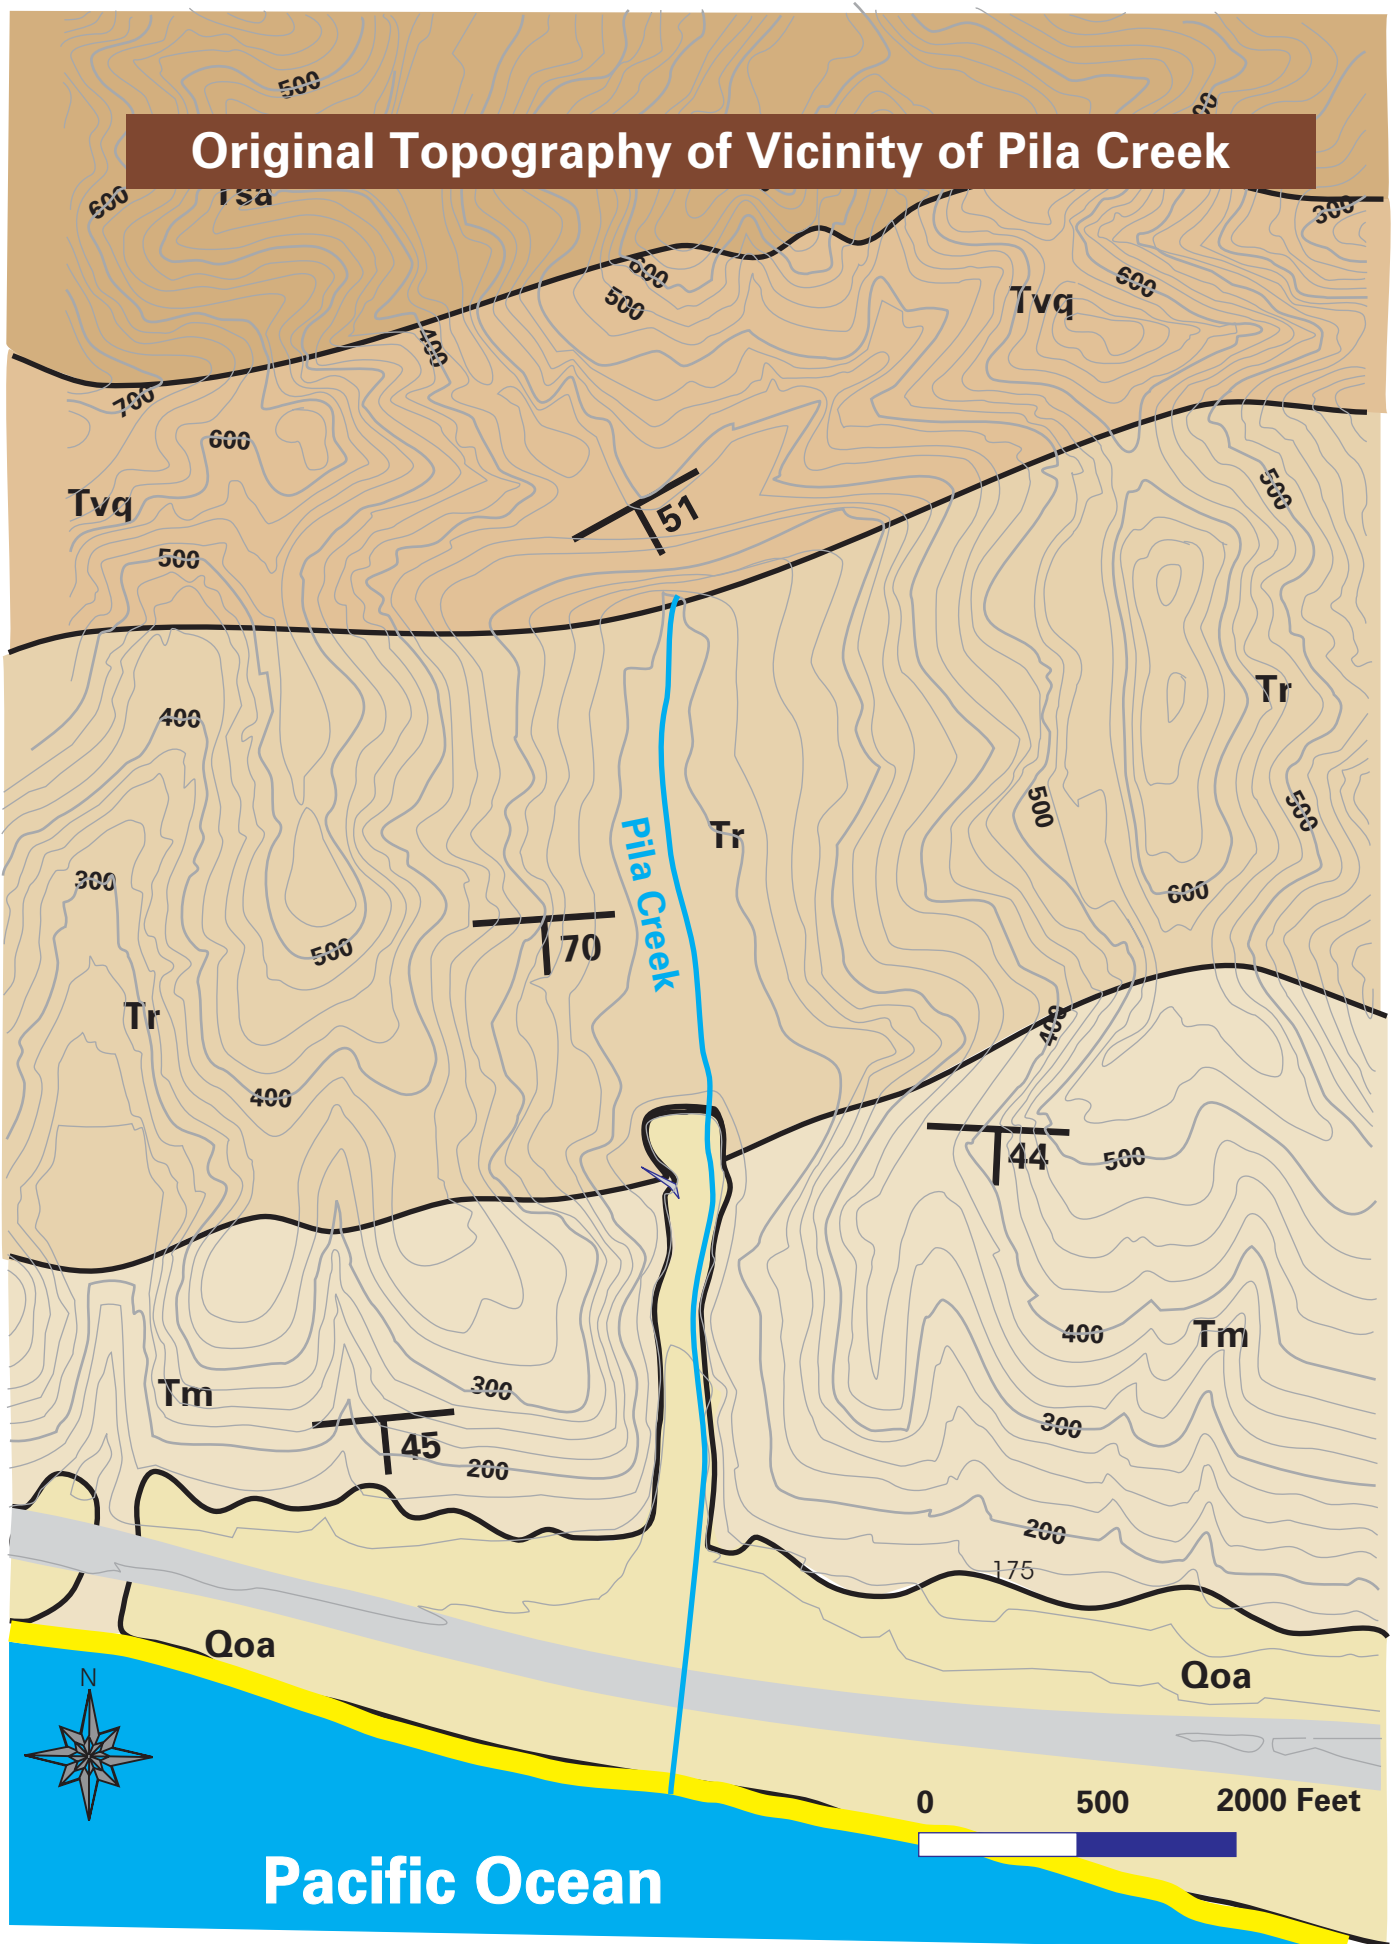
# Original Topography of Vicinity of Pila Creek

enough or **as underflow** in alluvial fill or **fractured bedrock below the channel.**” It is clear that intensely fractured rock likely exists in bedrock below the channel and can be very permeable allowing contaminated underflow to bypass the interceptor trench. The original topography and Pila Creek bed are shown on GeoSolv **Original Topography of Vicinity of Pila Creek** map.
