Service Bulletin

PRELIMINARY INFORMATION

Subject: Malfunction Indicator Lamp Illuminated With DTC P0300

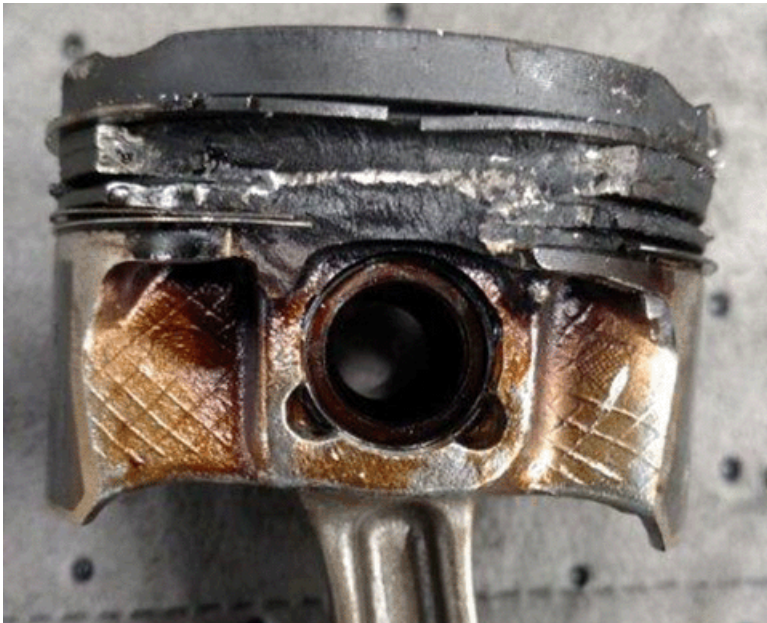
Involved Region or Country	North America
Condition	Some customers may comment on a rough running engine with the Malfunction Indicator Lamp ON. Upon inspection, a technician may find DTC P0300 set along with a misfire low compression in one or more cylinders.
Cause	This condition may be caused by a damaged piston.

Shown below are examples of pistons with varying levels of damage.

If the cylinder wall surface has not been compromised, only piston replacement is required.

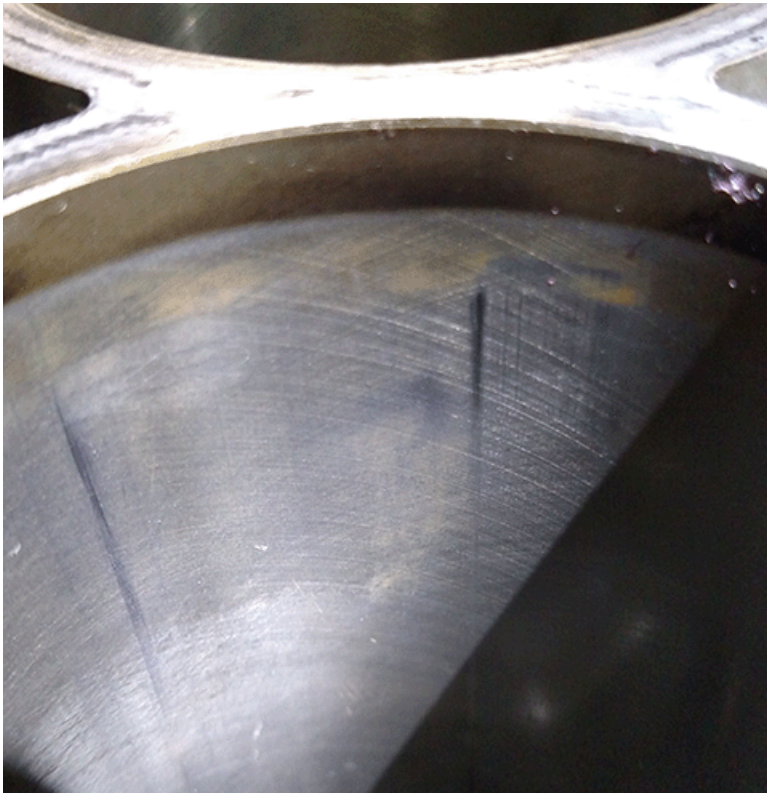
Shown below are several examples of light vertical marks visible on the cylinder wall.

In these examples, none of the marks in the cylinder walls could be felt with the finger tip or nail and engine replacement is not recommended.
