Blade Incident Response and Action Plan Overview

AW-38 Blade Incident: Overview

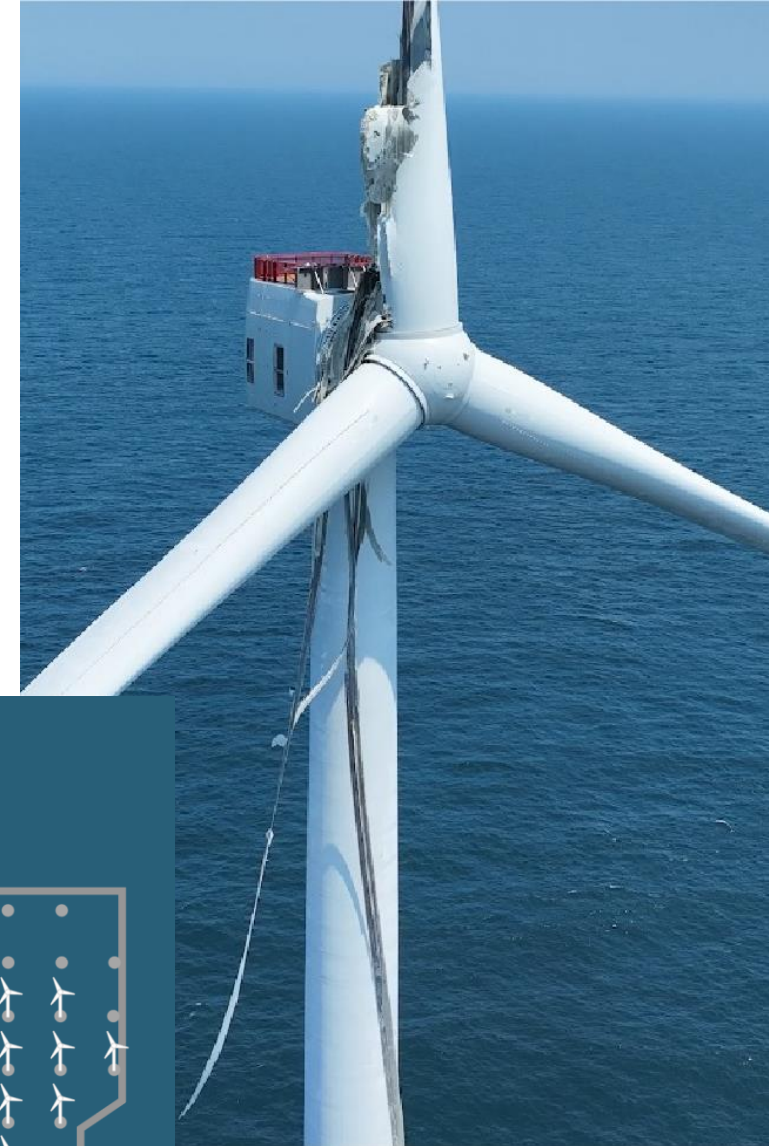
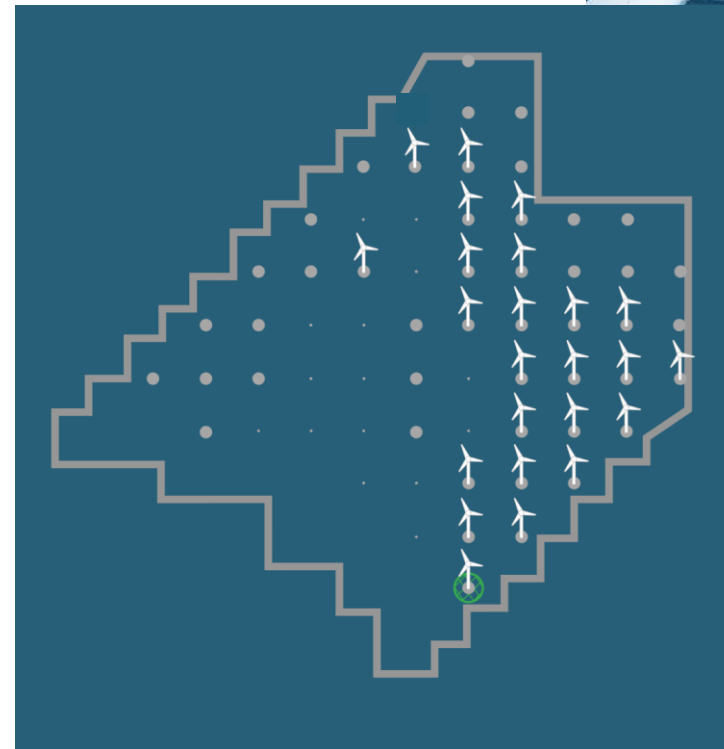
- July 13, 2024 (approx. 6 pm): Blade experienced damage on turbine AW-38 while undergoing testing
- No injuries reported from the incident to date
- AW-38 immediately shut down through automated safety controls. Remaining turbine operations and construction activity halted & 500-meter safety zone created by United States Coast Guard
- Activated existing incident management protocols
 - Tailoring as needed to situation
 - Notifications to Coast Guard and regional emergency planning committees
 - Mariners' notices issued
- U.S. Bureau of Safety & Environmental Enforcement (BSEE) issued suspension and preservation orders
- Immediate focus: Unity of effort to ensure personnel safety and assist in the clean-up and recovery of debris through a combined land/air/sea operation

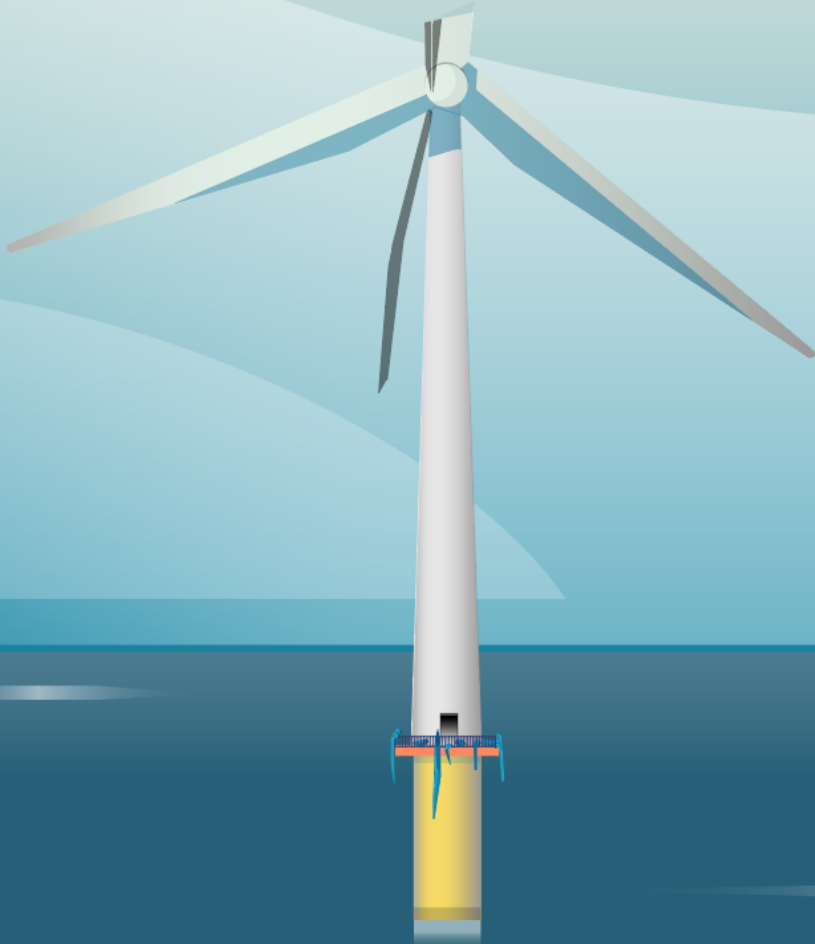
- GE Vernova and Vineyard Wind have developed a comprehensive plan to recover the remaining AW-38 blade in incremental steps
- Exhaustive preliminary root cause analysis completed with independent ultrasound testing (UT) review identifying specific and readily identifiable manufacturing deviation at issue
- Thousands of combined work-hours devoted to plan development, review, and testing
- Safety of personnel intensely scrutinized both within the plan and against all available alternatives to arrive at safest approach to successful operation
- Federal Interagency review to oversee and guide plan development and implementation
- Crews have inspected turbine for safety and integrity
- Containment of any potential debris release a key component at every step
