## SAMPLE ROOFING INSPECTION REPORT

### ROOFING DESCRIPTION

ROOFING ITEMS

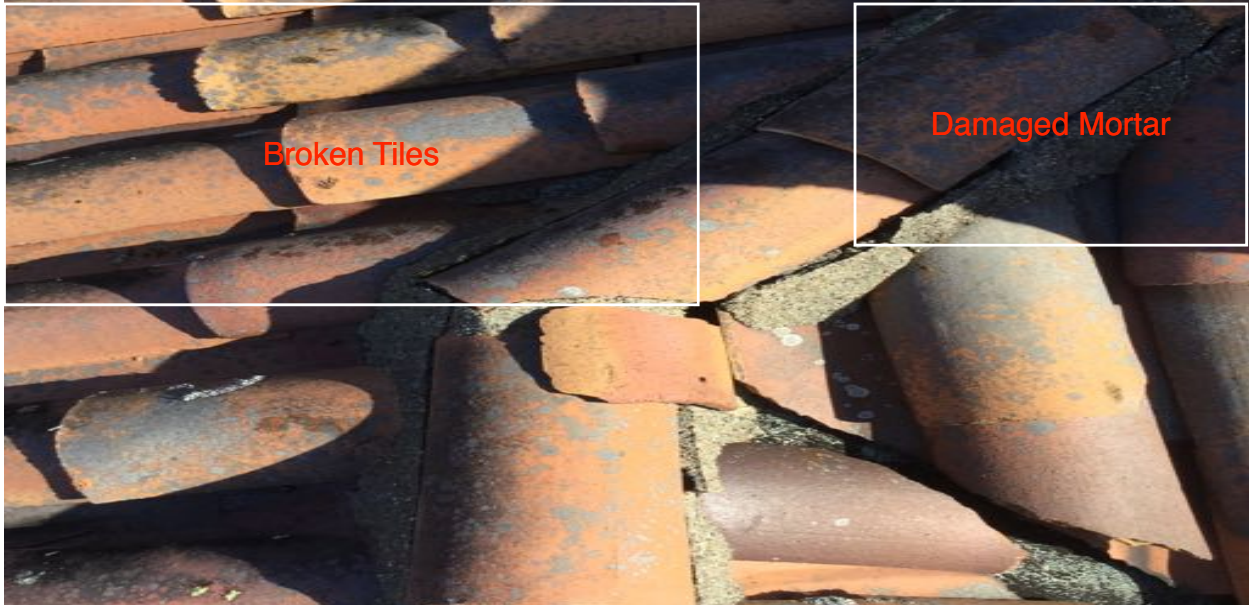
**REPLACE** – LOCATED AT MULTIPLE SECTIONS OF THE BUILDING'S ROOF AND THROUGHOUT TOP ROOFING SYSTEM. LARGE AMOUNT OF CLAY TILES ARE DAMAGED OR MISSING AND ARE IN NEED OF REPLACEMENT IN THE TIMELY MANNER DUE TO EXISTING WATERPROOFING ISSUES. CURRENTLY LOOSE PIECES OF CLAY TILES ARE DISCONNECTED AND ARE LAYING AROUND SLOPED PORTIONS OF THE ROOFING SYSTEM PRESENTING WATERPROOFING ISSUES AND PRESENTING RISK OF INJURY IF FALL DOWN IF DISTURBED BY WIND OR SUDDEN EARTH MOVEMENT.

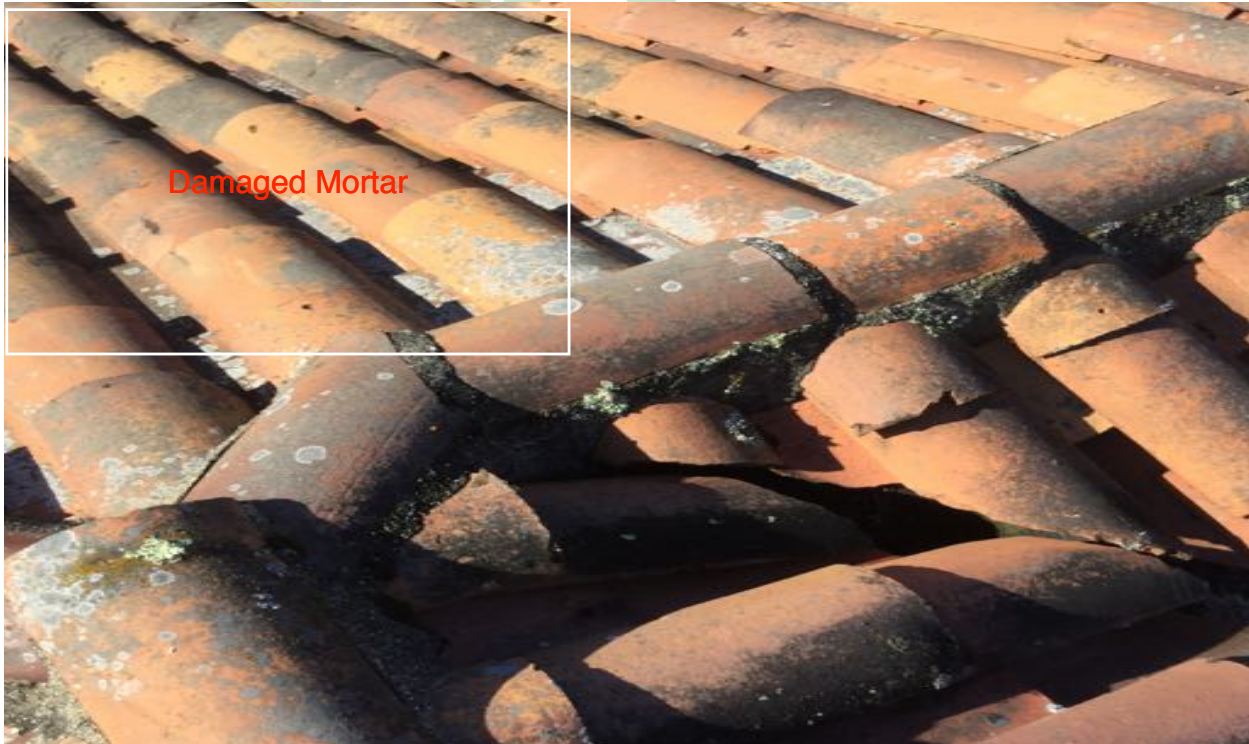
**REPLACE** – LOCATED THROUGHOUT ROOFING SYSTEM, MORTAR LINES BETWEEN CLAY TILES HAVE FAILED AND HAVE SHIFTED PRESENTING WATERPROOFING ISSUES AND A RISK OF INJURY IF SEPARATED COMPLETELY.

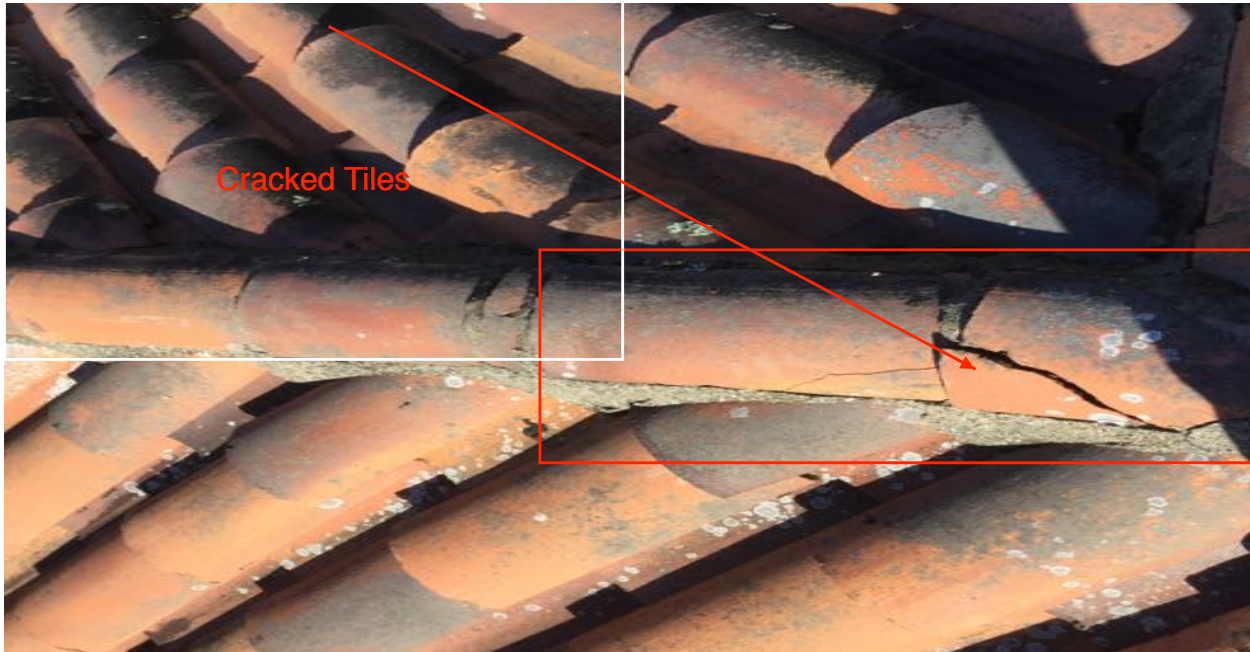
**REPLACE** – CRACKED CLAY TILES DUE TO AGE, HEAT CYCLES AND TRAFFIC CAN BE FOUND THROUGHOUT MULTIPLE LOCATIONS ON THE ROOF. SOME TILES ARE STILL HELD BY THE METAL WIRE. IN SOME LOCATIONS SEPARATION IS DRASTIC AND IN SOME LOCATIONS WIRE HOLDING THE TILE IS RUSTED. APPROXIMATE AGE OF THE ROOFING SYSTEM IS 60-70 YEARS OLD. ROOFING SYSTEM IS BEYOND EXPECTED SERVICE LIFE. LIFE EXPECTANCY OF THE CLAY ROOFING SYSTEM IS 50 YEARS.

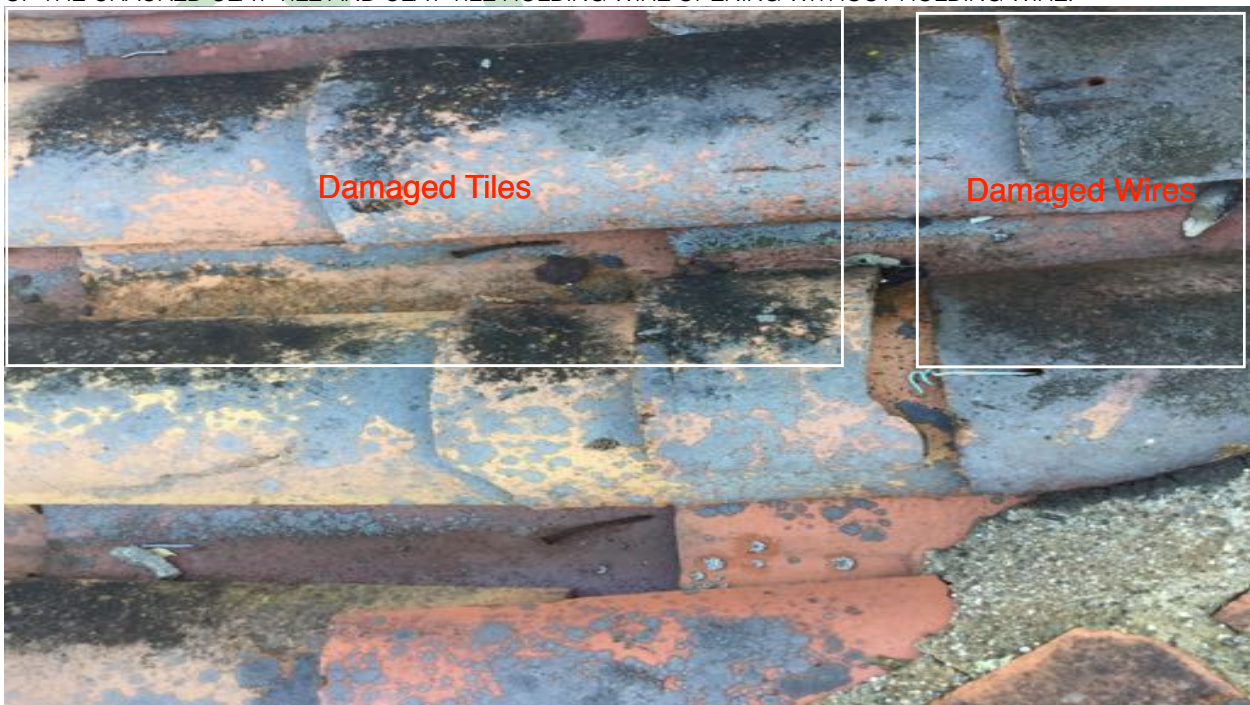
**REPLACE** – LOCATED AT MULTIPLE SECTIONS OF THE BUILDING'S ROOF AND THROUGHOUT MIDDLE OF THE STREET FACING ROOFING SYSTEM. LARGE AMOUNT OF CLAY TILES ARE DAMAGED OR MISSING AND ARE IN NEED OF REPLACEMENT IN THE TIMELY MANNER DUE TO EXISTING WATERPROOFING ISSUES. CURRENTLY LOOSE PIECES OF CLAY TILES ARE DISCONNECTED AND ARE LAYING AROUND SLOPED PORTIONS OF THE ROOFING SYSTEM PRESENTING WATERPROOFING ISSUES AND PRESENTING RISK OF INSURY IF FALL DOWN IF DISTURBED BY WIND OR SUDDEN EARTH MOVEMENT. SHOWN BELOW IS THE SEPARATION OF HOLDING WIRE OF THE CRACKED CLAY TILE AND CLAY TILE HOLDING WIRE OPENING WITHOUT HOLDING WIRE.

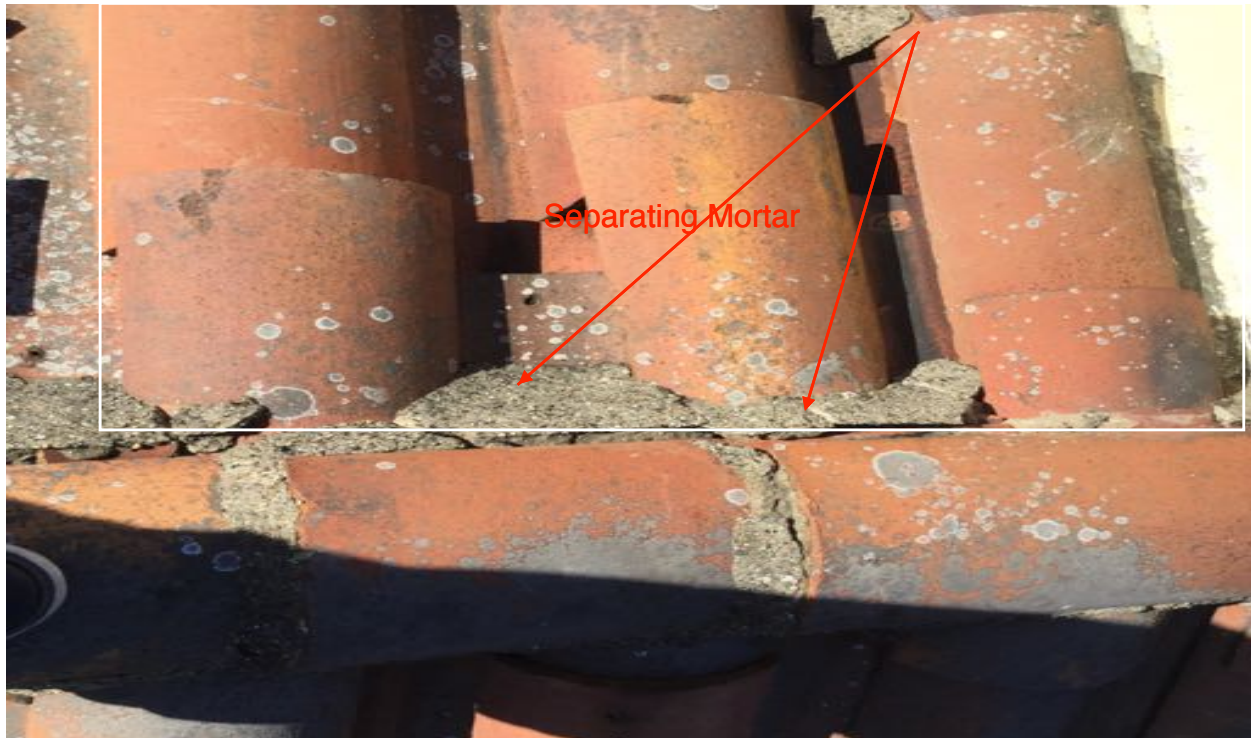
**REPLACE** – LOCATED THROUGHOUT ROOFING SYSTEM, MORTAR LINES BETWEEN CLAY TILES HAVE FAILED AND HAVE SHIFTED PRESENTING WATERPROOFING ISSUES AND A RISK OF INJURY IF SEPARATED COMPLETELY. SHOWN BELOW IS AN AREA AT THE RIDGE OF THE ROOFING SYSTEM WITH LOOSE PIECES OF MORTAR.

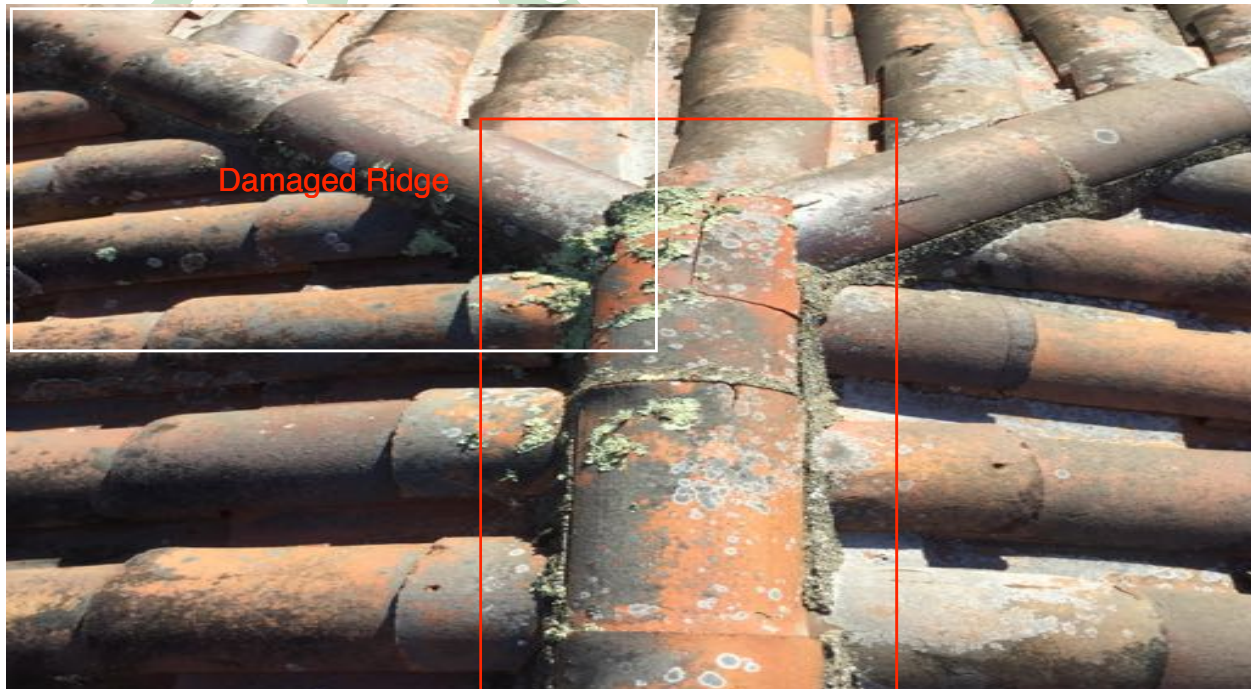
**REPLACE** – CRACKED AND LOOSE CLAY TILES HAVE BEEN IDENTIFIED THROUGHOUT ROOFING SYSTEM IN MANY LOCATIONS. WE SUSPECT THAT THE CLAY TILES ARE AT THIS POINT FRAGILE DUE TO AGE AND DRASTIC HEAT CYCLES. TRAFFIC OVER CLAY TILES IN ORDER TO REPLACE CHIMNEY CAP AND IN ORDER TO PAINT STUCCO CHIMNEY BOX HAVE CAUSED MANY OF THE CLAY TILES TO DEFORM AND CRACK. LOOSE PIECES OF CLAY TILES HAVE BEEN IDENTIFIED THROUGHOUT ROOFING SYSTEM THAT PRESENT WATERPROOFING ISSUES AND ALSO RISK OF FALLING DOWN THE SLOPE OF THE ROOFING SYSTEM.

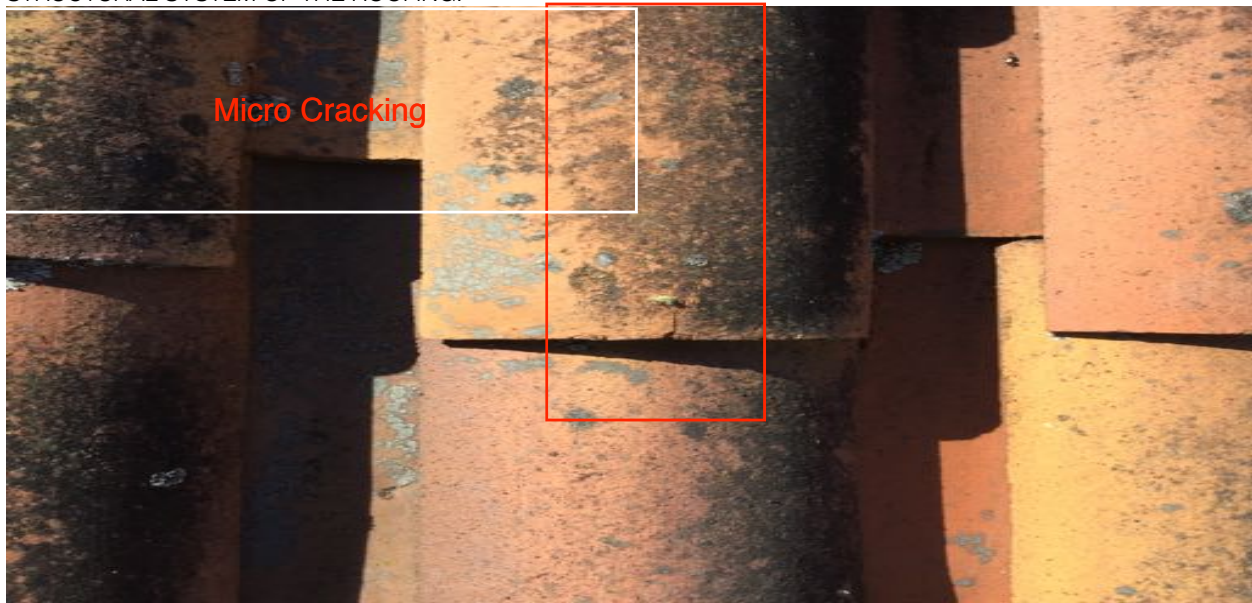
**REPLACE** – SHOWN BELOW IS ONE OF MANY CLAY TILES THAT SHOWS MICRO CRACKING AT EDGE OF TILE. MICRO CRACKING IS VISIBLE ONLY AT THE LOWER EDGE OF THE CLAY TILE BUT SPANS ACROSS TOP SECTION OF THE CLAY TILE. MICRO CRACK IS RUNNING THROUGH CENTER OF THE CLAY TILE AND THROUGH HOLDING WIRE OPENING DIVIDING CLAY TILE INTO TWO SEPARATE PORTIONS THAT ARE NOT SECURED TO THE STRUCTURAL SYSTEM OF THE ROOFING.

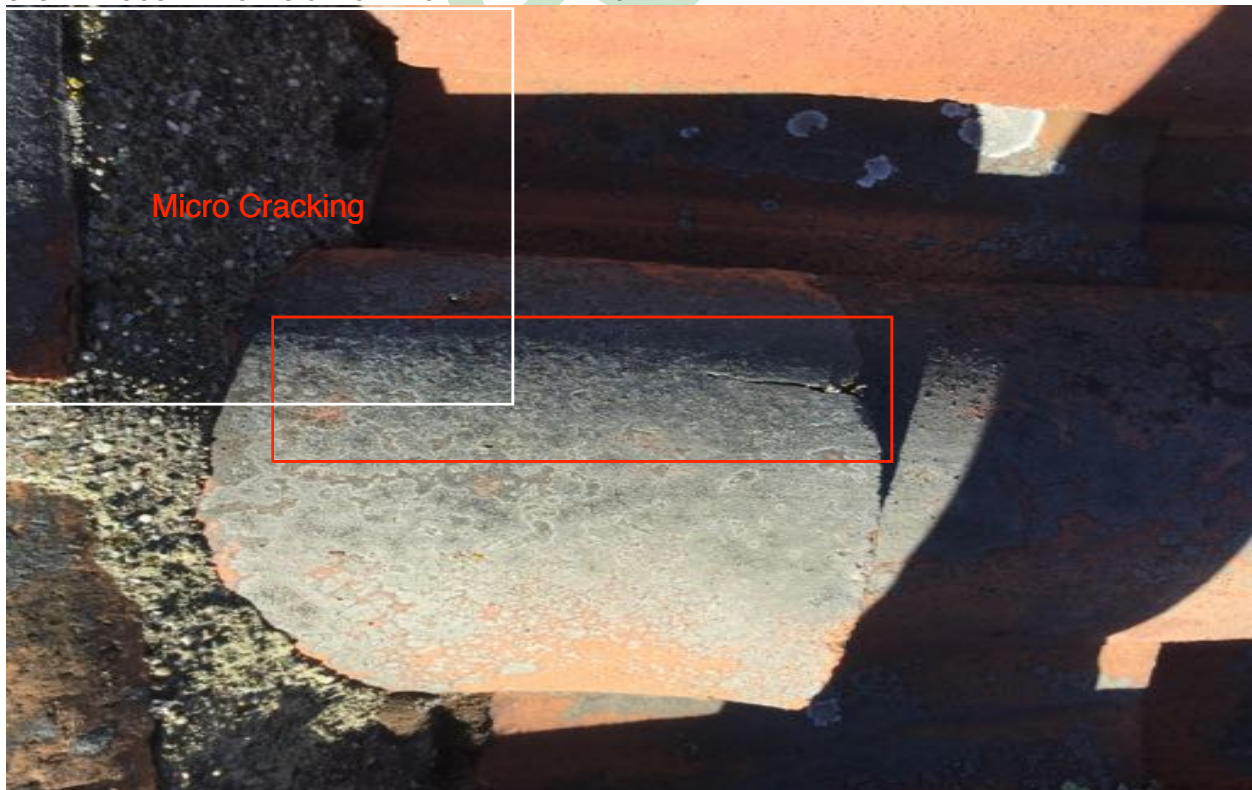
**REPLACE** – SHOWN BELOW IS ANOTHER EXAMPLE OF CLAY TILE THAT SHOWS CRACKING AND MICRO CRACKING AT EDGE OF TILE. MICRO CRACKING IS VISIBLE ONLY AT THE LOWER EDGE OF THE CLAY TILE BUT SPANS ACROSS TOP SECTION OF THE CLAY TILE. THE CRACKED MORTAR LINE AT THE RIDGE OF THE ROOFING SYSTEM LOOSELY HOLDS CRACKED CLAY TILE IN PLACE.

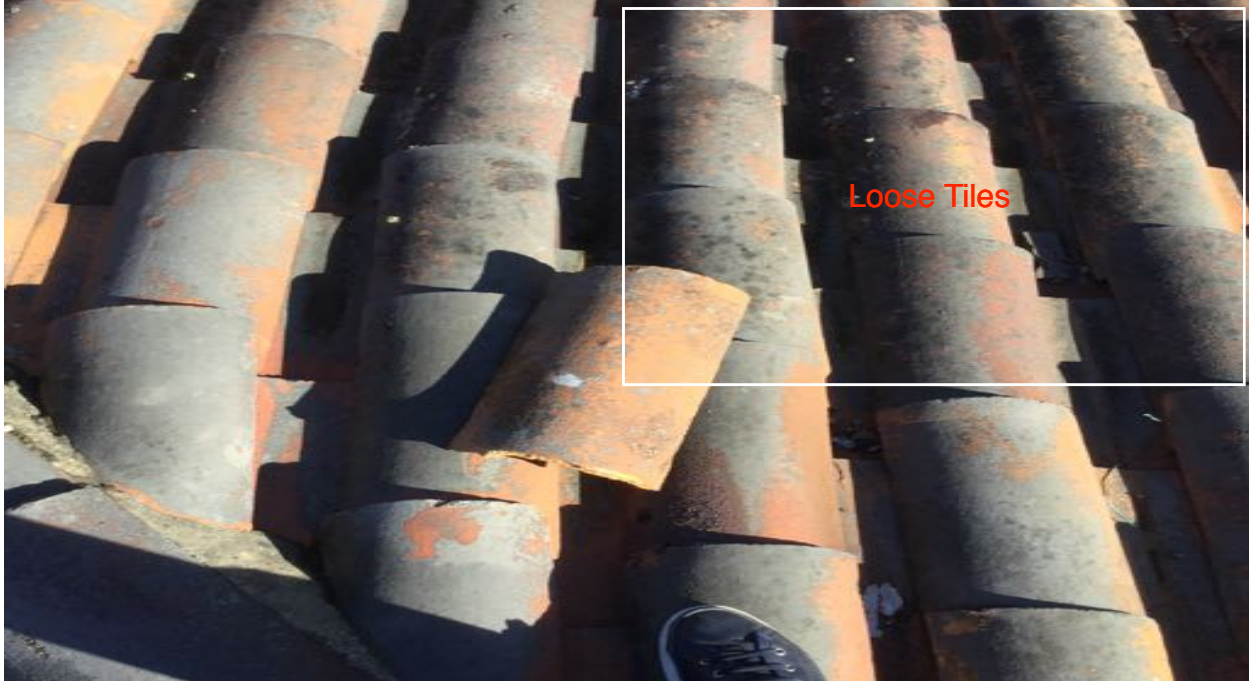
**REPLACE** – SEPARATED LARGE PIECE OF THE CLAY TILE IS SHOWN BELOW. TILE HAS SEPARATED AT THE RIDGE OF THE ROOFING SYSTEM AND IS MAKING IT'S WAY DOWN THE SLOPED ROOFING SYSTEM. CRACKED TILES ON THE BOTTOM OF THE CLAY SYSTEM ARE ALSO ILLUSTRATED BELOW.

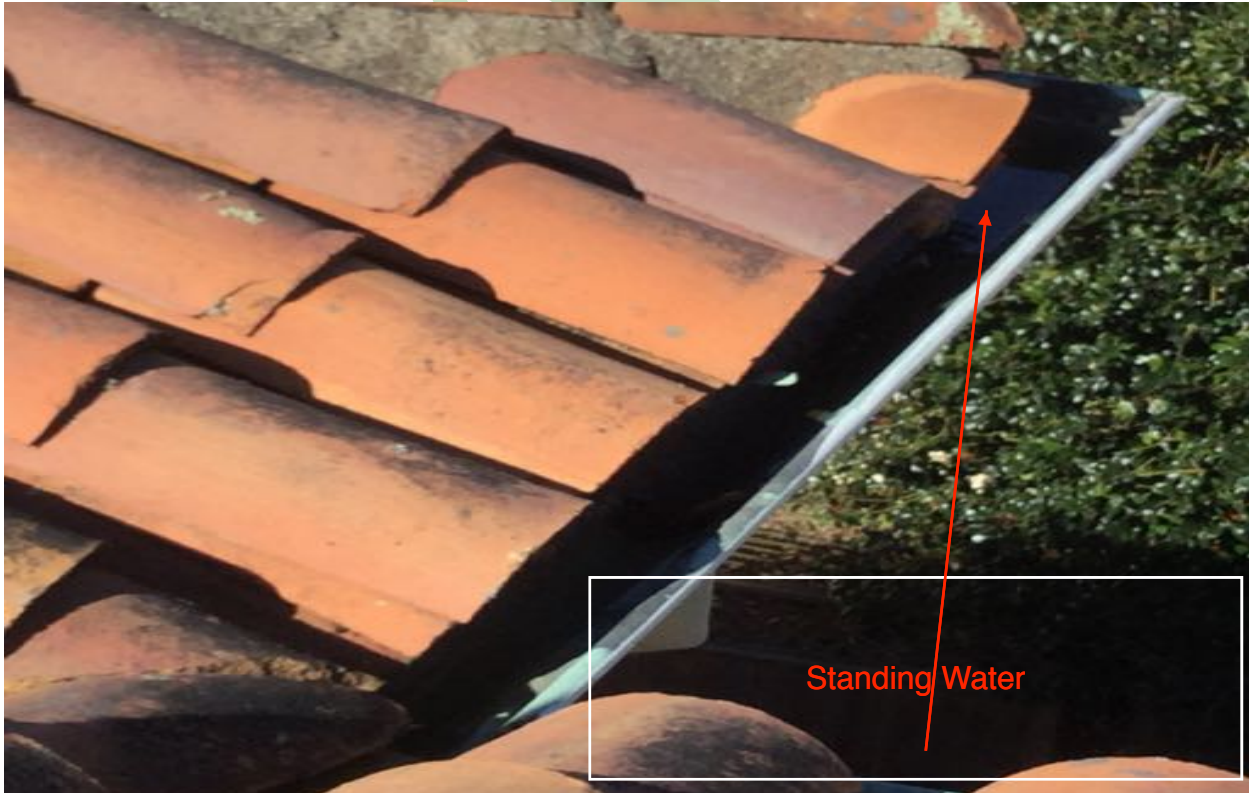
**REPAIR** – SHOWN BELOW ARE THE CRACKED CLAY TILES AT THE EDGE OF THE ROOFING SYSTEM AND CLOGGED GUTTER WITH NEGATIVE SLOPE THAT HAS STANDING WATER INSIDE ALONG WITH DEBRIS AND DIRT.

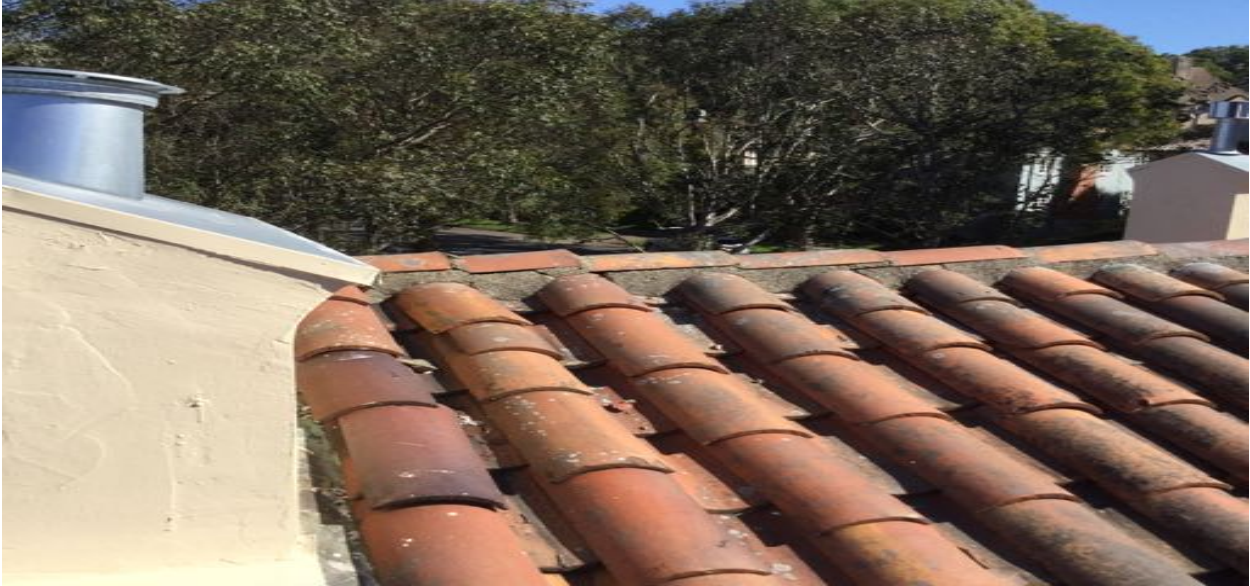
**REPLACE** – NEWLY PAINTED AND INSTALLED STUCCO CHIMNEY BOX AND CHIMNEY CAPS ARE SHOWN BELOW. WE SUSPECT THAT THIS REPAIR HAS BEEN RECENTLY PERFORMED BY THE SELLERS IN CONNECTION WITH PRE SALE INSPECTION SERVICE THAT HAS IDENTIFIED THE ISSUES WITH UNREINFORCED BRICK CHIMNEY SYSTEMS THAT WERE IN VIOLATION OF SAFETY CODE AND NEEDED TO BE CORRECTED. WE BELIEVE THAT MOST OF THE DAMAGE TO THE ROOFING TILES WAS DONE AT THE TIME WHEN CHIMNEY, STUCCO AND PAINTING CONTRACTORS WERE ON SITE. DUE TO AGE THE EXISTING CLAY TILES ARE FRAGILE AND ANY TRAFFIC OVER THEM MAY HAVE CAUSED FURTHER DAMAGE, SEPARATION AND CRACKING. DAMAGE TO THE RIDGE TILES AND CRACKING OF THE CLAY TILES ARE ALSO IDENTIFIED IN THE PICTURE BELOW.

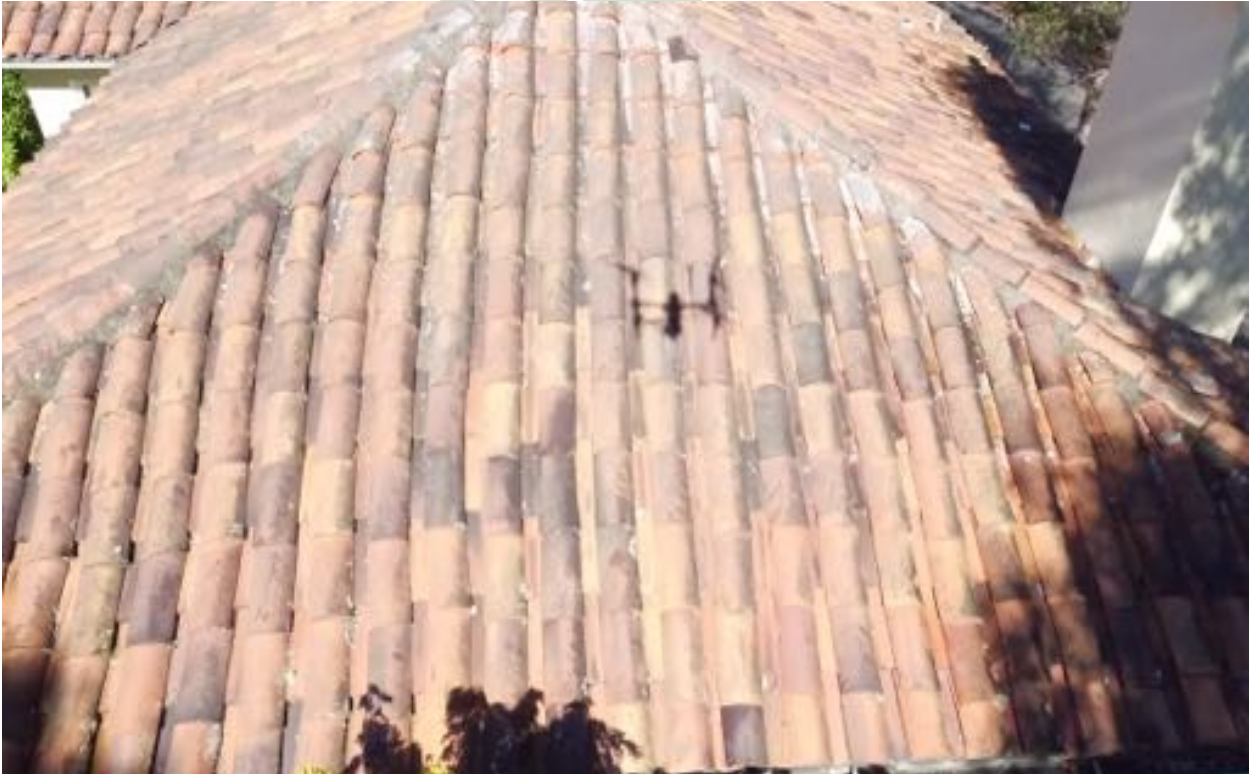
**REPLACE** – DAMAGED TILE AREAS ARE OUTLINED IN THE PHOTO BELOW TO IDENTIFY THE MOST DAMAGE AROUND THE ROOFING SYSTEM.

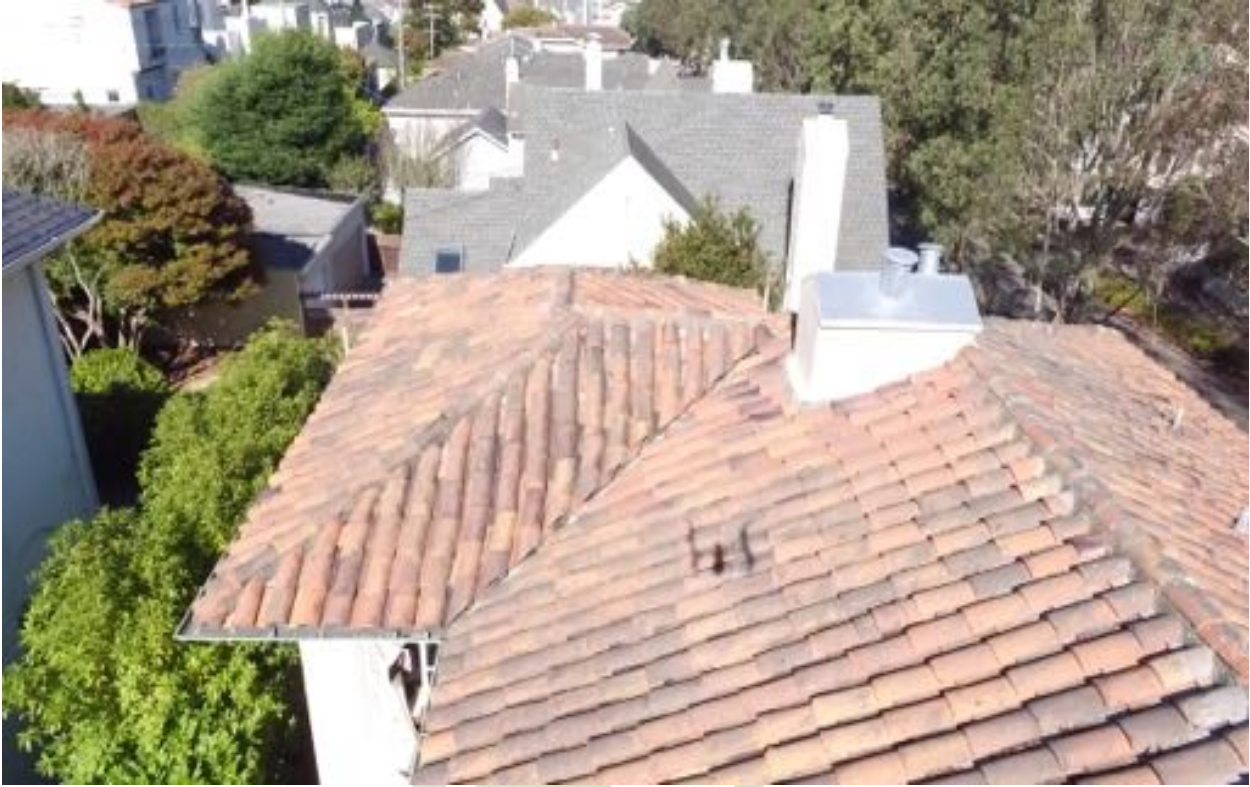
**REPLACE** – DAMAGED TILE AREAS ARE OUTLINED IN THE PHOTO BELOW TO IDENTIFY THE MOST DAMAGE AROUND THE ROOFING SYSTEM.

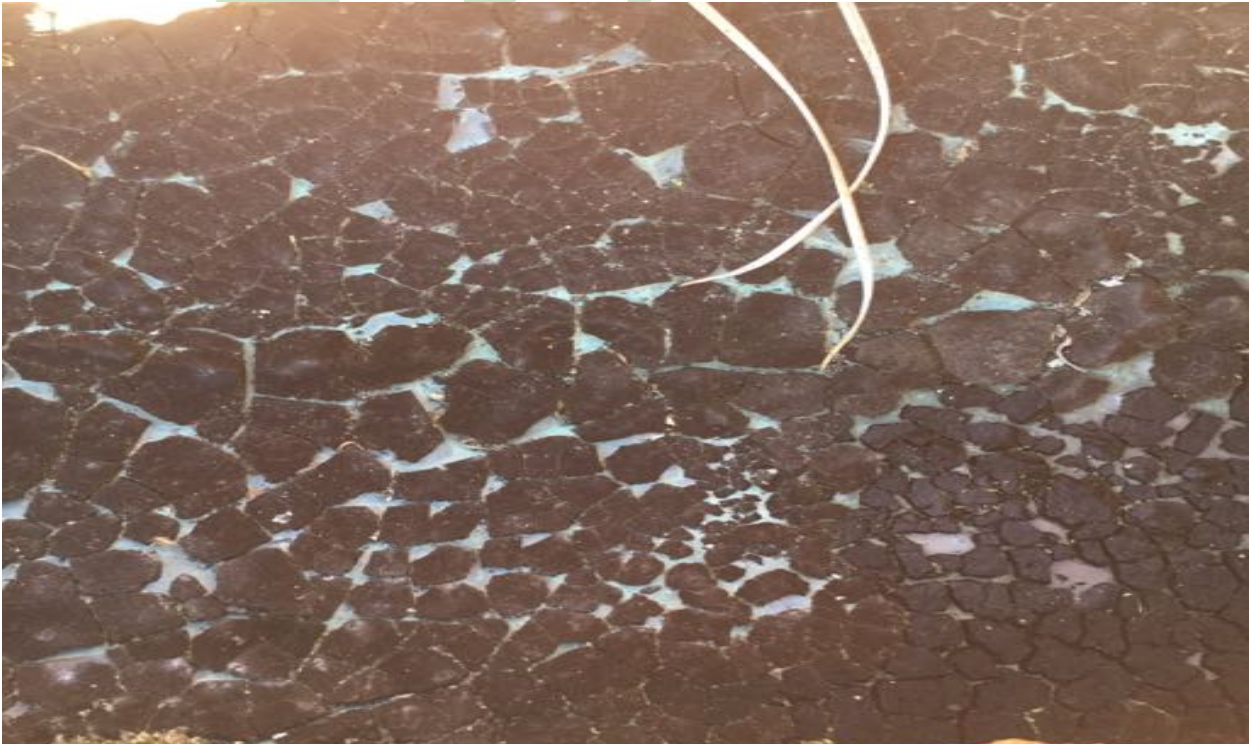
**REPLACE** – SHOWN BELOW IS THE MEMBRANE OVER FLASHING AT ONE OF THE ROOFING VALLEYS OF THE ROOFING SYSTEM. MEMBRANE IS CRACKED EXPOSING FLASHING SYSTEM. FLASHING SYSTEM IS MADE OUT OF GALVANIZED STEEL AND IS RUSTED IN MANY LOCATIONS PROVIDING NO WATERPROOFING.

15 POUND ROOFING MEMBRANE UNDERLAYMENT IS BEYOND EXPECTED SERVICE LIFE AND IS IN NEED OF REPLACEMENT. WE RECOMMEND REMOVAL OF CLAY TILES AND EXISTING MEMBRANE, INSTALLATION OF ICE AND WATER SHIELD PREMIUM MEMBRANE OVER NEW STRUCTURAL PLYWOOD ROOFING DECK (STRUCTURAL SUB STRUCTURE OF THE ROOFING SYSTEM). WE RECOMMEND INSTALLATION OF TORCH DOWN GTA MEMBRANE OVER ICE AND WATER SHIELD FOR ADDED PROTECTION AND TO EXTEND EXPECTED SERVICE LIFE OF THE ROOFING SYSTEM. INSTALL NEW CLAY TILES AND SECURE WITH COPPER WIRE AND COPPER NAILS TO EXTEND EXPECTED SERVICE LIFE OF THE ROOFING SYSTEM.

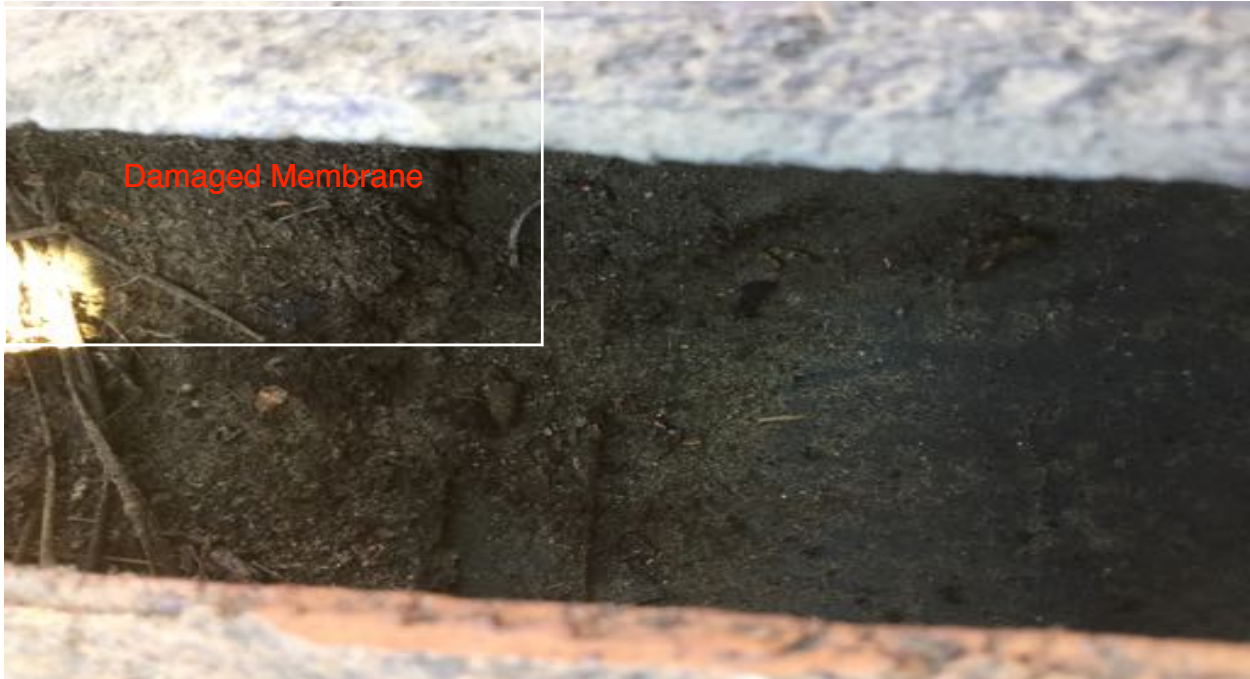
**REPLACE** – SHOWN BELOW IS THE DETERIORATED MEMBRANE UNDERNEATH CLAY TILE SYSTEM. MEMBRANE CURRENTLY HAS CRACKS AND IS DRY TO TOUCH. MEMBRANE IS COMPOSED OF 15 POUND TAR UNDERLAYMENT THAT IS OUTDATED AND IS CURRENTLY FRAGILE. MEMBRANE PROVIDES NO WATERPROOFING AND IS CRACKED IN MULTIPLE LOCATIONS.

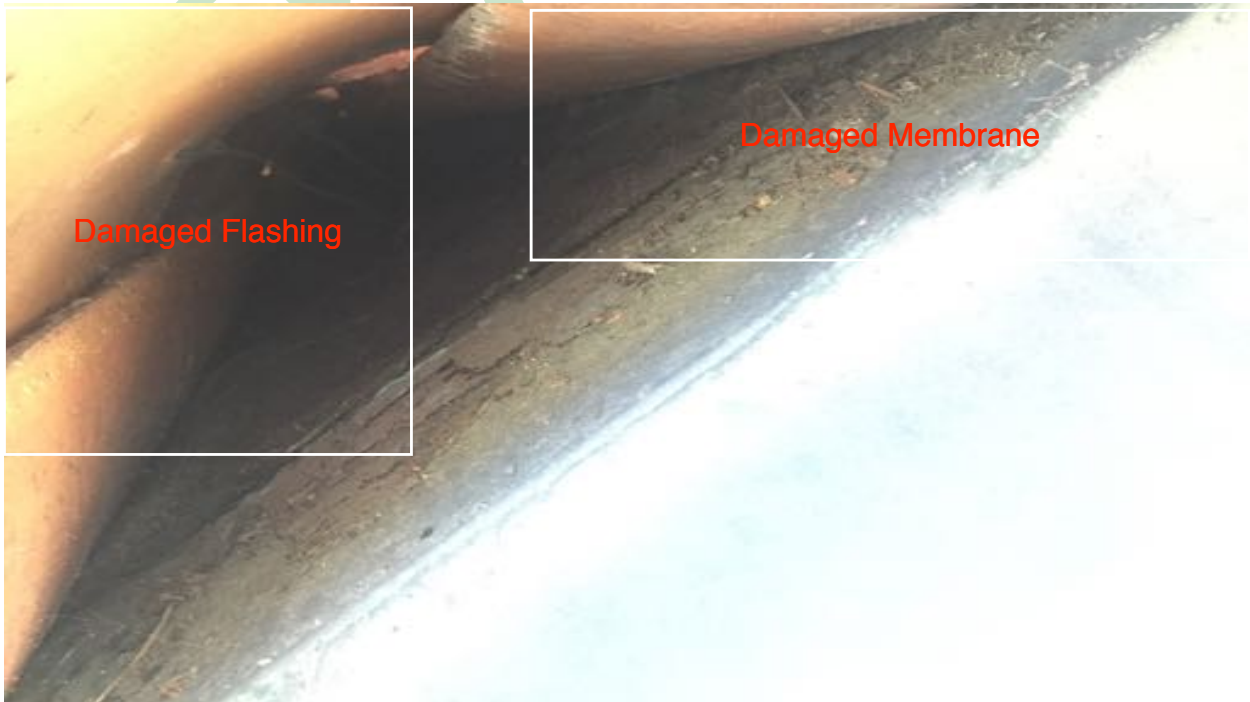
**REPLACE** – SHOWN BELOW IS THE DETERIORATED MEMBRANE UNDERNEATH CLAY TILE SYSTEM. MEMBRANE CURRENTLY HAS CRACKS AND IS DRY TO TOUCH. MEMBRANE IS COMPOSED OF 15 POUND TAR UNDERLAYMENT THAT IS OUTDATED AND IS CURRENTLY FRAGILE. MEMBRANE PROVIDES NO WATERPROOFING AND IS CRACKED IN MULTIPLE LOCATIONS. RUSTED FLASHING IS SHOWN BELOW WITH CRACKING THROUGHOUT.

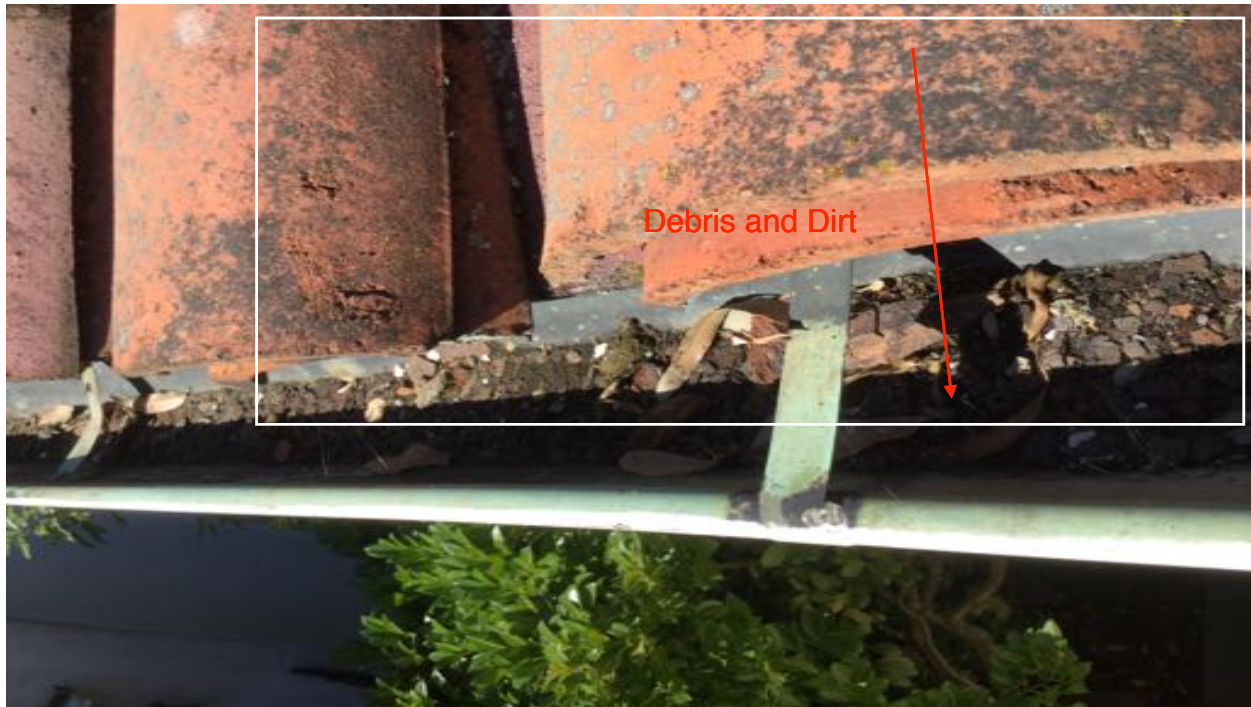
**REPAIR** – SHOWN BELOW IS A GUTTER ON ENTRANCE FACING WALL OF THE BUILDING. GUTTER IS CLOGGED WITH DEBRIS AND DIRT. MOST OF THE DEBRIS COMPOSED OF PIECES OF CRACKED MEMBRANE FROM UNDERNEATH TILE SYSTEM AND PIECES OF RUSTED FLASHINGS. GUTTER HAS ALSO COLLECTED PIECES OF CLAY TILES. GUTTER HAS NEGATIVE SLOPE AND IS IN NEED OF TIMELY SERVICE.

GUTTERS DO NOT NEED TO BE REPLACED COMPLETELY BUT ARE IN NEED OF MAJOR SERVICE DUE TO NEGATIVE SLOPE AND EXCESSIVE DEBRIS CLOGGING DOWNSPOUTS AND WATER ESCAPE WAYS.

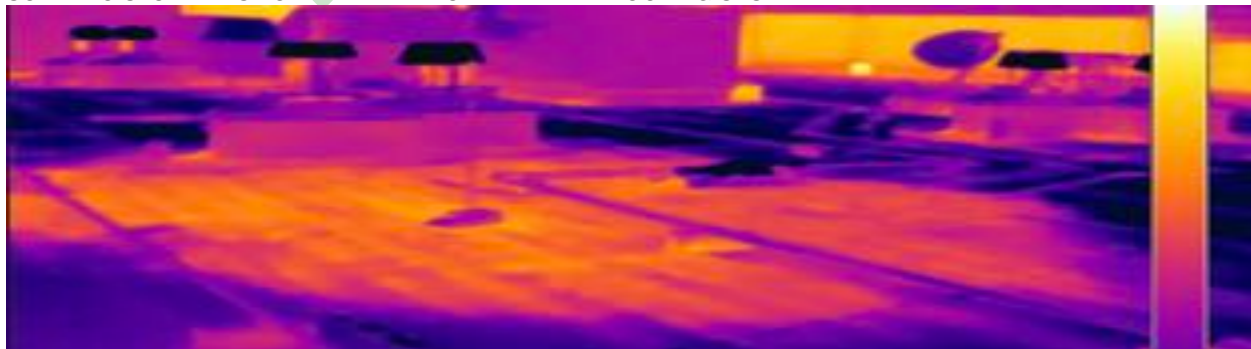
*ROOFING THERMAL IMAGING*

THERMAL IMAGING PROJECTION OF THE BUILDING'S ROOF HAS BROUGHT POSITIVE RESULTS DUE TO THE NATURE OF THE ROOFIGN IN ORDER FOR OUR INTERNALLY DEVELOPED THERMAL IMAGING SYSTEM TO WORK, SOME MOISTURE HAS TO BE TRAPPED UNDERNEATH ROOFING SYSTEM.
