# AdvanSix Partners with Balboa Inspection and Maintenance for the Inspection of Cooling Water Headers

*By: Tory Tingen of AdvanSix and Brian Carlson of Balboa Inspection and Maintenance*

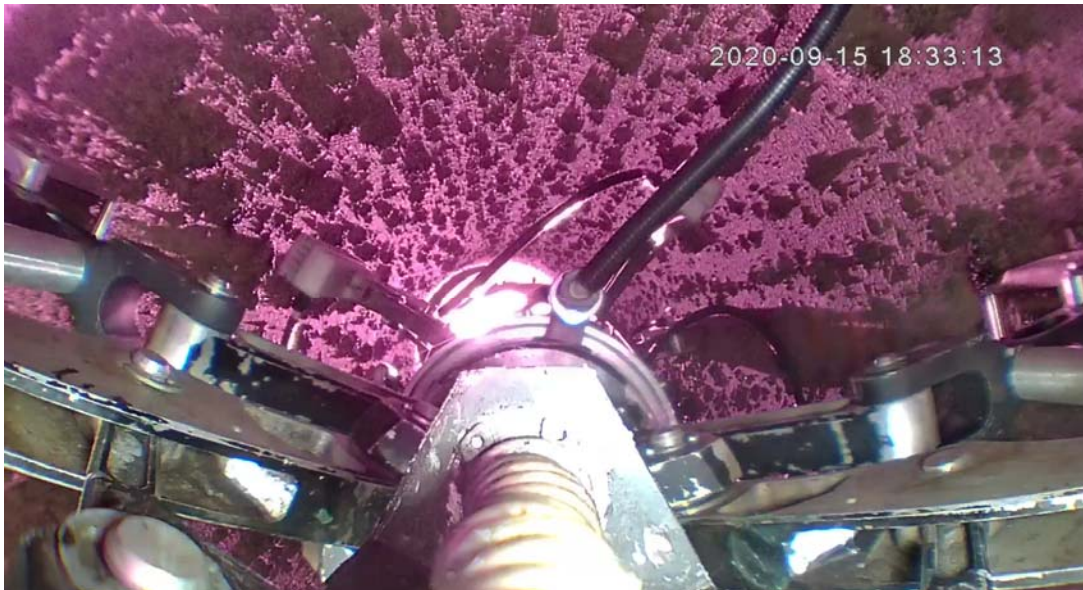
The AdvanSix inspection commenced on September 15, 2020 at 7AM. Prior to the start of the inspection, the AdvanSix team cut through a small section of concrete. Once the concrete was removed, a vacuum excavation truck was utilized to remove the soil around the header endcaps. The soil for this bell hole was comprised mostly of sand with high water content. As a result, every square inch of the bell hole had to be shored to prevent ingress, which also led to the presence of numerous hydraulic shoring jacks around the launch point. After the excavation, the endcaps for the two 30-inch headers were removed. To launch the MOCCASIN, the tool was broken down into three sections and hand carried to the pipe entry point. The tool was then re-assembled in the pipe opening, powered on, and the inspection commenced. Almost immediately after the inspection began the MOCCASIN encountered tubercles in the pipe. They were 20 to 25 millimeters high and were evenly spread across the surface, averaging 1-3 tubercles for every 6-inch square. Fortunately, the MOCCASIN was designed to accommodate the larger standoff and the inspection continued without incident.

Figure 5: Tuberculation as see from Crawler Camera 3
