Inspection Report for John Smith

Property Address: 123 Main St, Anywhere, BC V1Z1Z1

Gold Star Home Inspections

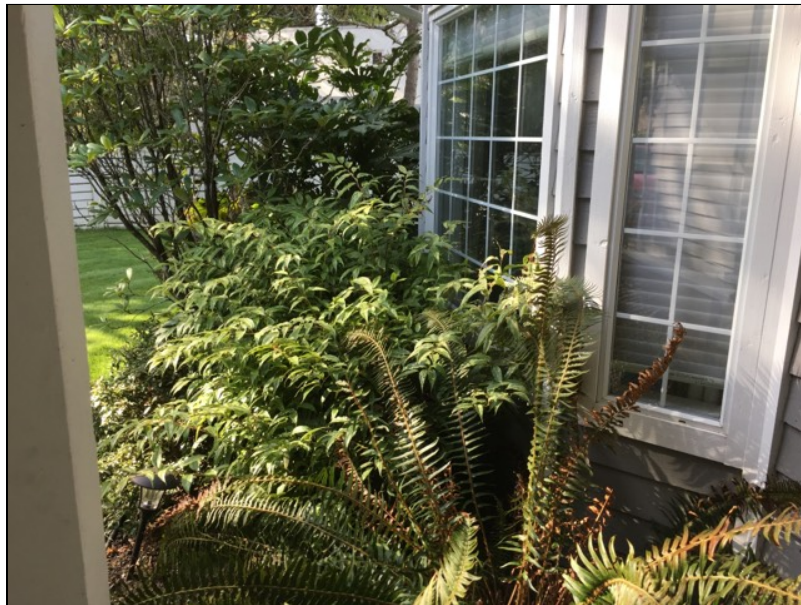
1.1 Item 1(Picture) Shrubs too close to building

Trim and maintain vegetation away from structure to increase ability of building to dry and thereby reduce moisture related damages.

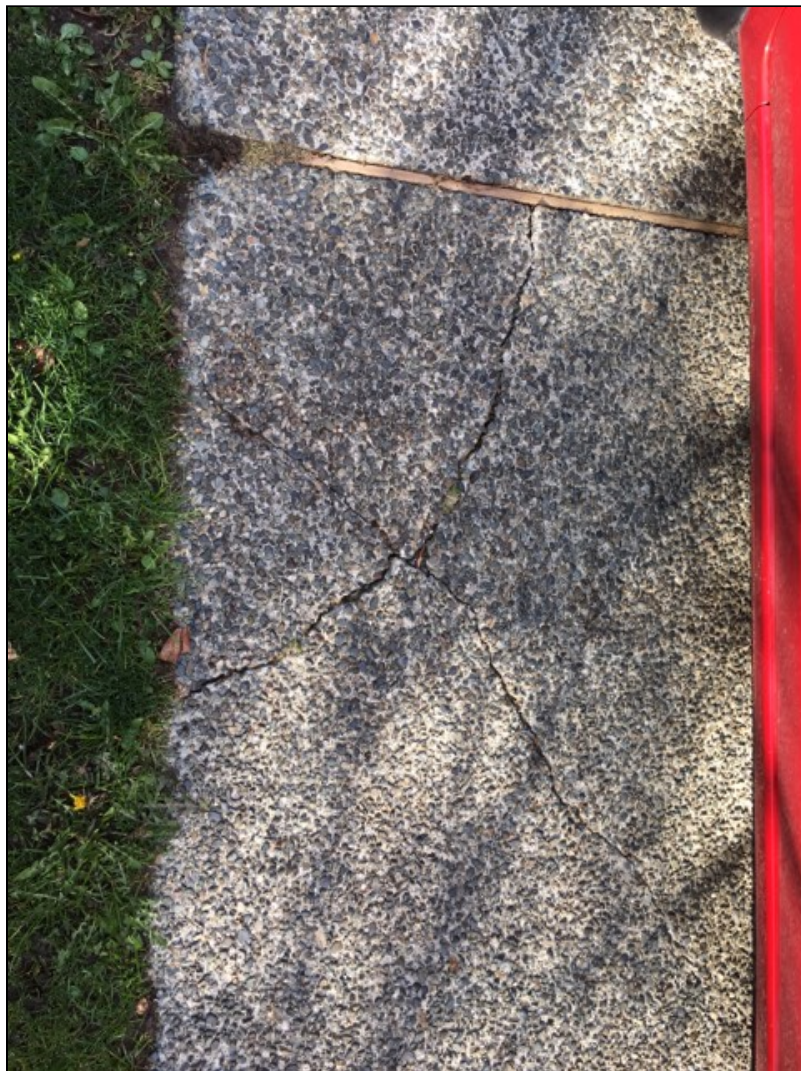
1.3 Item 1(Picture)

Some cracking noted in driveway. Should be sealed to limit water entry and further damage.

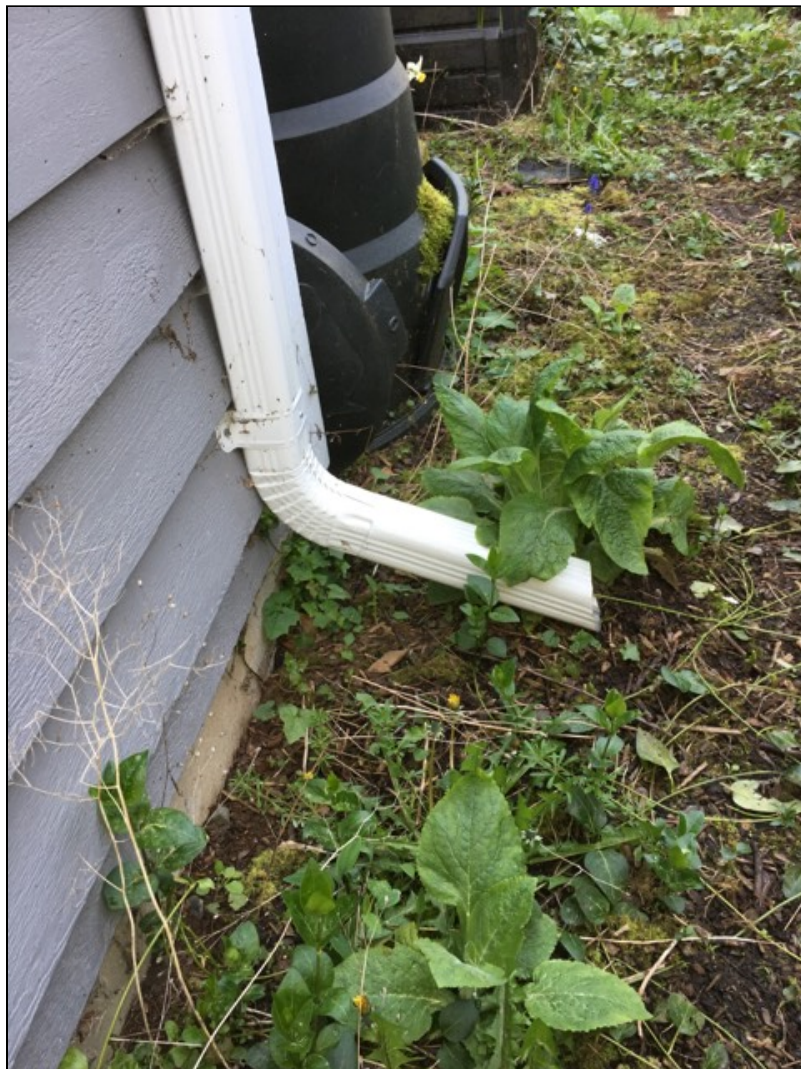
2.1 Item 1(Picture) Downspout at side of house

Downspouts should terminate into a collection system or at least six feet away from the house to limit water ingress into the house.

The gutters are full of debris in areas and needs to be cleaned. The debris in gutters can also conceal rust, deterioration or leaks that are not visible until cleaned, and I am unable to determine if such conditions exist.

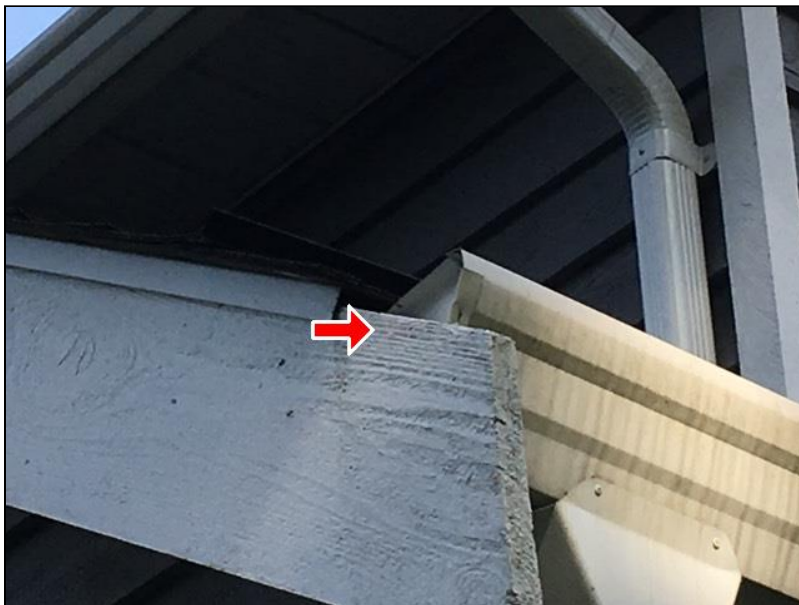
2.2 Item 1(Picture) Fascia boards exposed

Recommend extending roofing or flashing over tails of boards to limit water entry and deterioration.

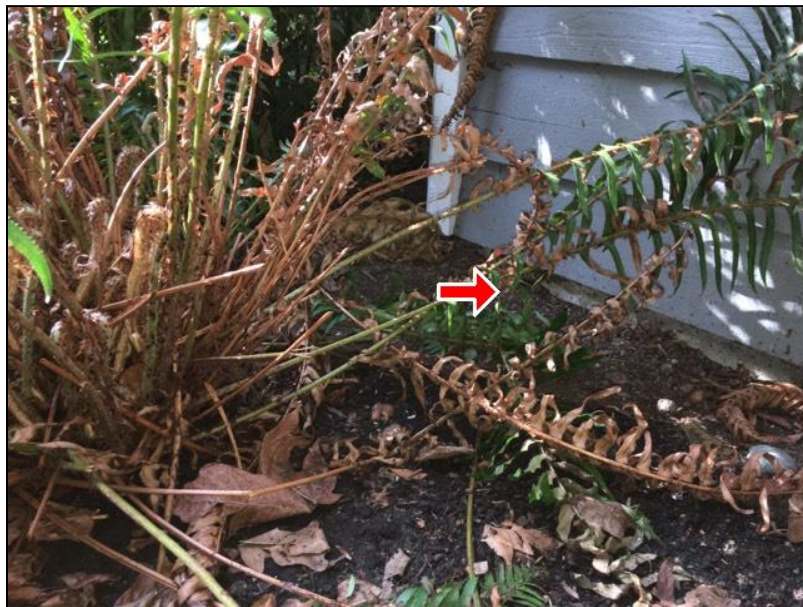
3.0 Item 1(Picture) Less than 6 inches to wood siding

Siding in contact with ground at exterior in some areas. Because the siding is in contact with ground it is possible for framing to be deteriorated. We did not inspect behind this siding. Recommend a ground clearance of six to eight inches where possible.

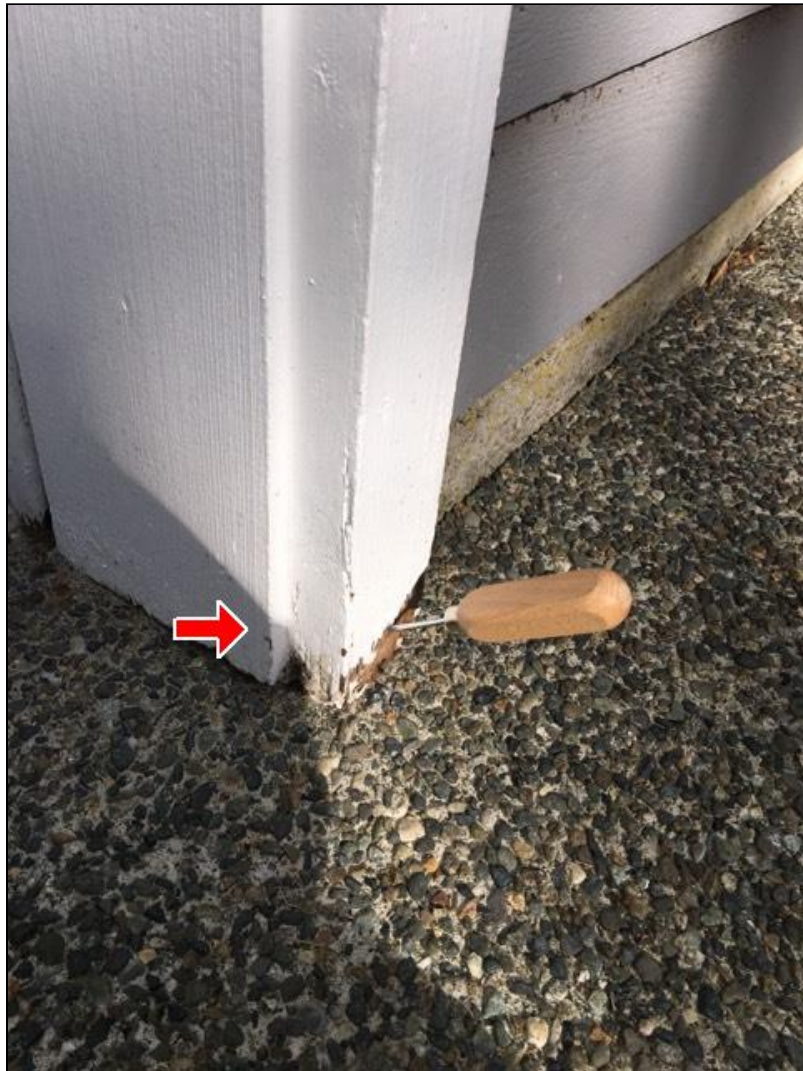
3.0 Item 2(Picture) Some rot noted at ground/wood junctions.

Some rot noted in a few areas. Recommend repair of deteriorated wood.

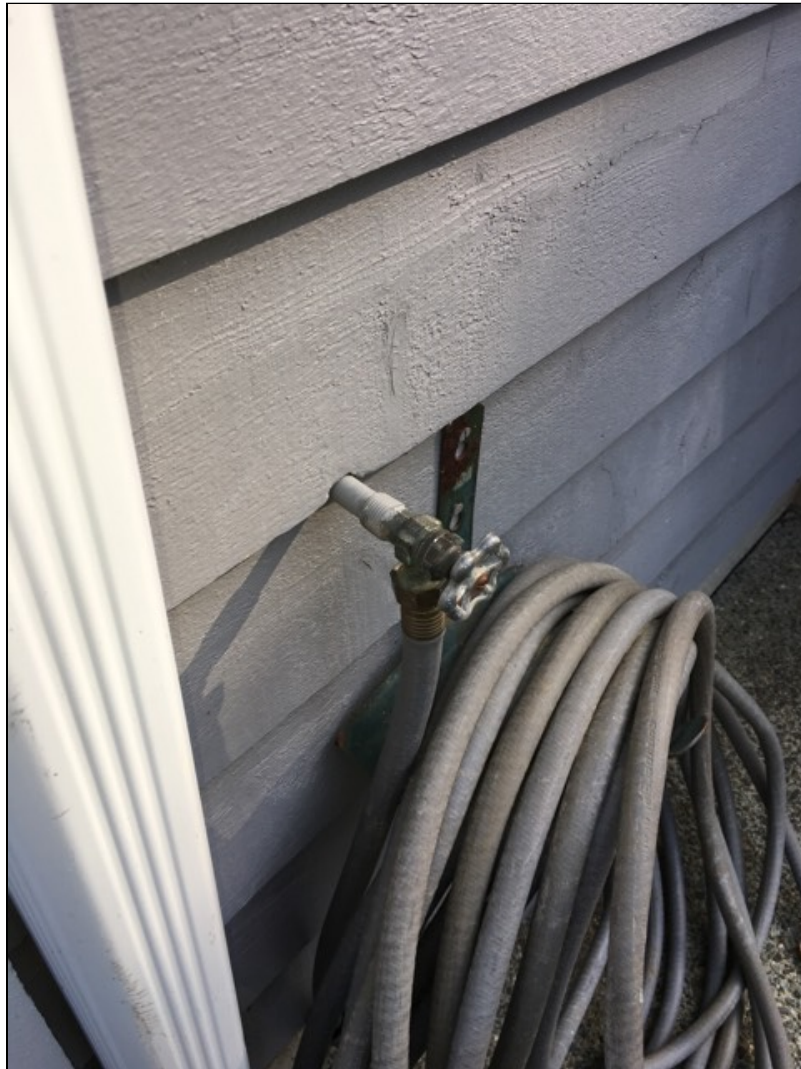
3.7 Item 1(Picture) Standard Hose Bib

Recommend installation of frost free and anti siphon hose bibs to prevent frozen pipe water related damage and to prevent accidental siphon and contamination of the drinking water supply.

Recommend disconnect hoses at frost free hose bib to prevent possible freeze related damages during cold weather.

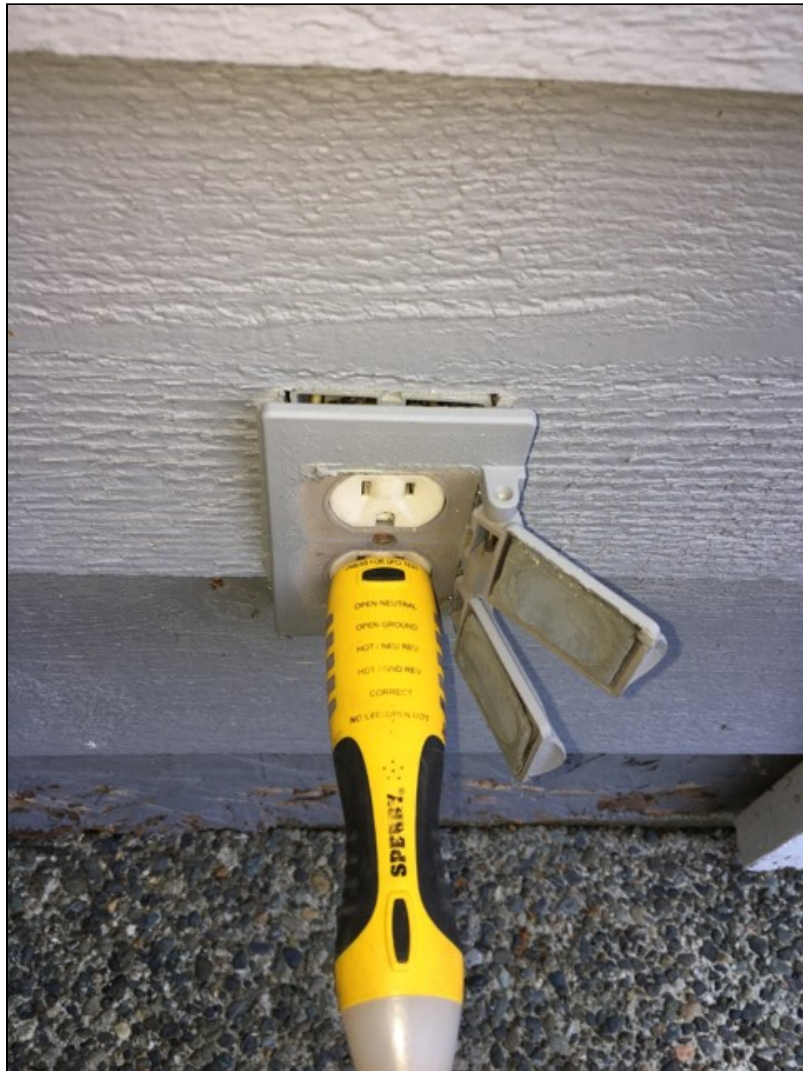
3.8 Item 1(Picture) Not working

Electrical receptacles not working. Gap to siding should be sealed to limit water entry. Recommend repair.

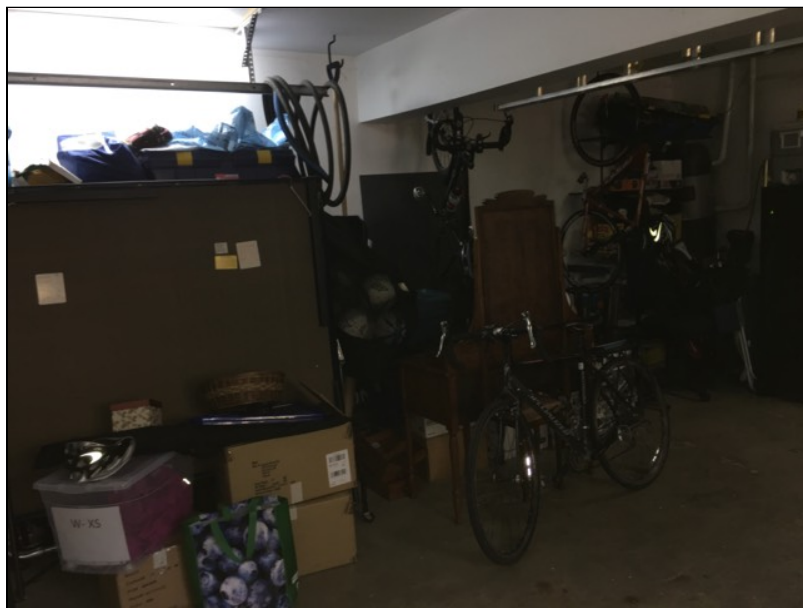
4.5 Item 1(Picture) Storage limited access and inspection

Garage being used for storage, limited access and inspection.

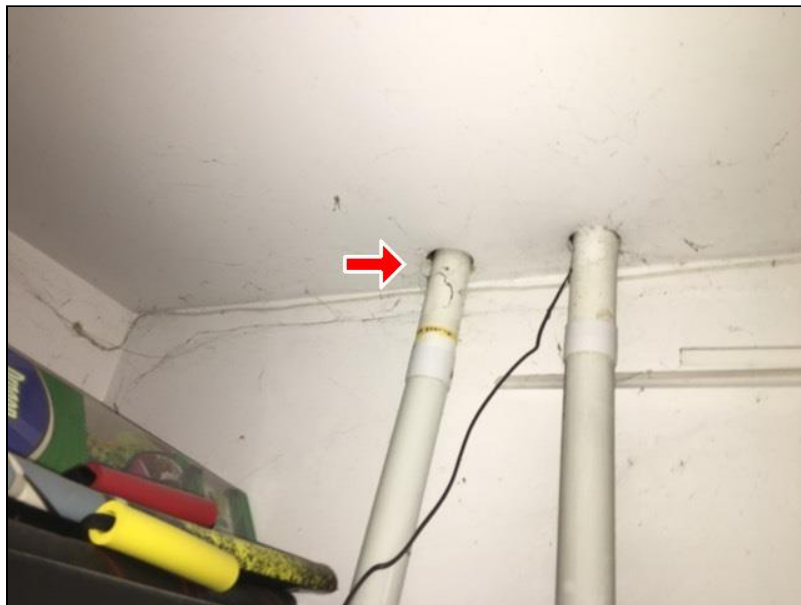
4.5 Item 2(Picture) Gap in drywall.

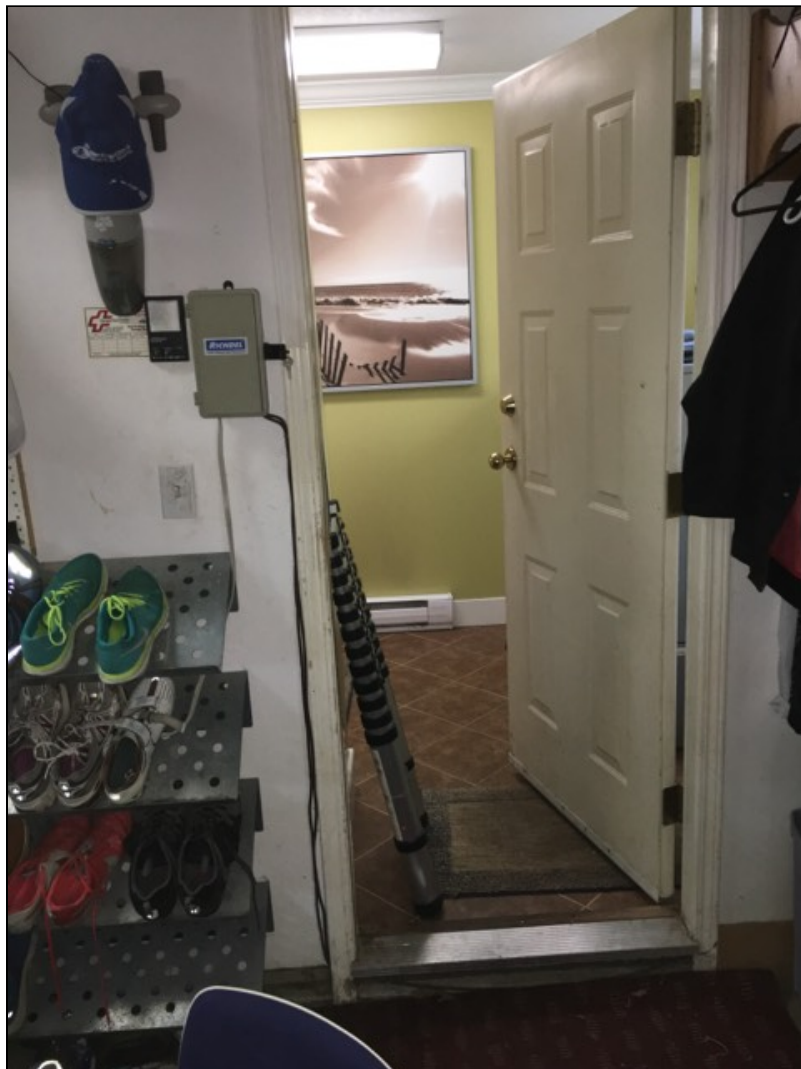
4.8 Item 1(Picture) Door does not automatically close and seal.

Automatic closing door does not work or close door fully. This malfunction can allow noxious gases to enter the living area of the house. These gases can cause illness or injury to occupants. Have unit serviced and/or replace to ensure correct closing and sealing.

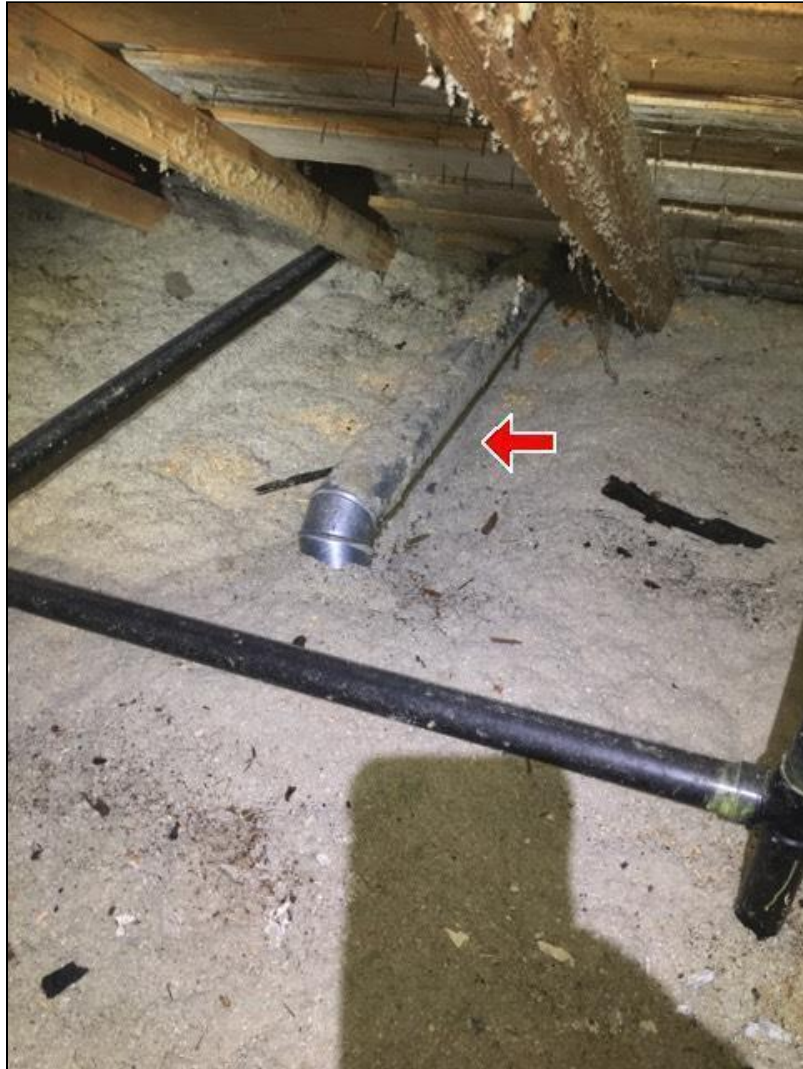
6.7 Item 1(Picture) Main bath vent duct

Main Bath vent duct is not insulated as it passes through attic. This can lead to condensation forming on the inside of the duct which may damage interior structures. Recommend insulating this duct.

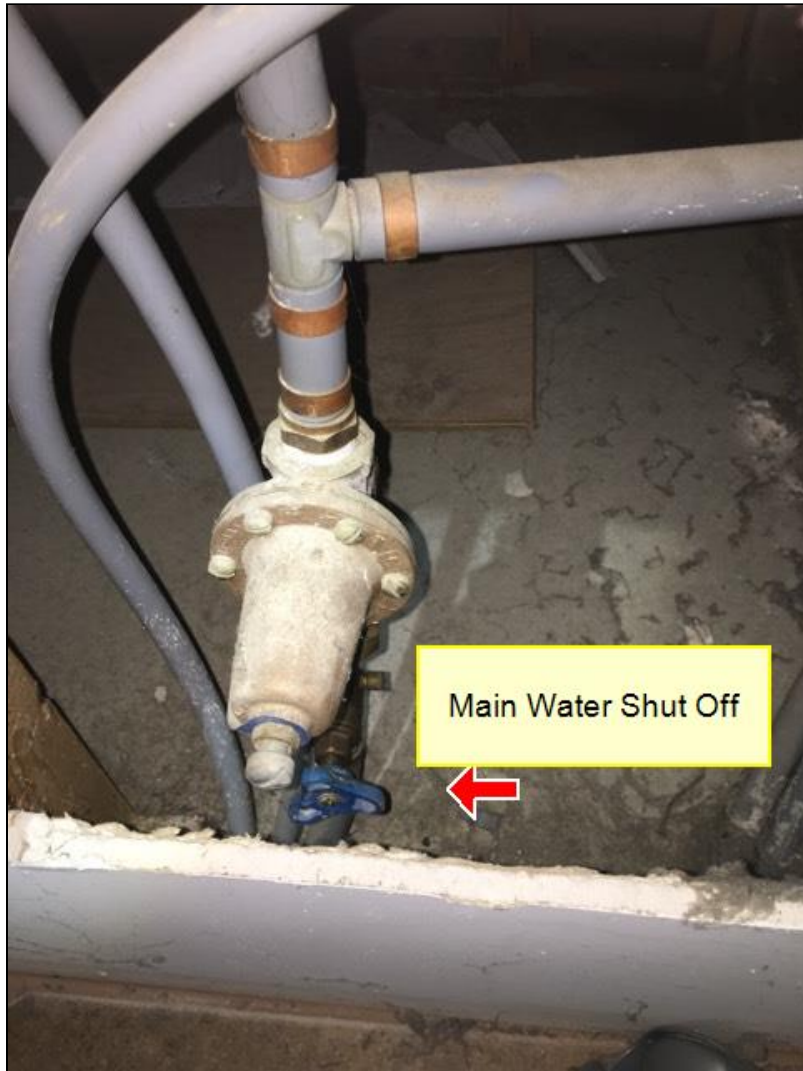
7.0 Item 1(Picture) Main shut off

Main shut off for house is located in the main floor closet behind hot water tank.

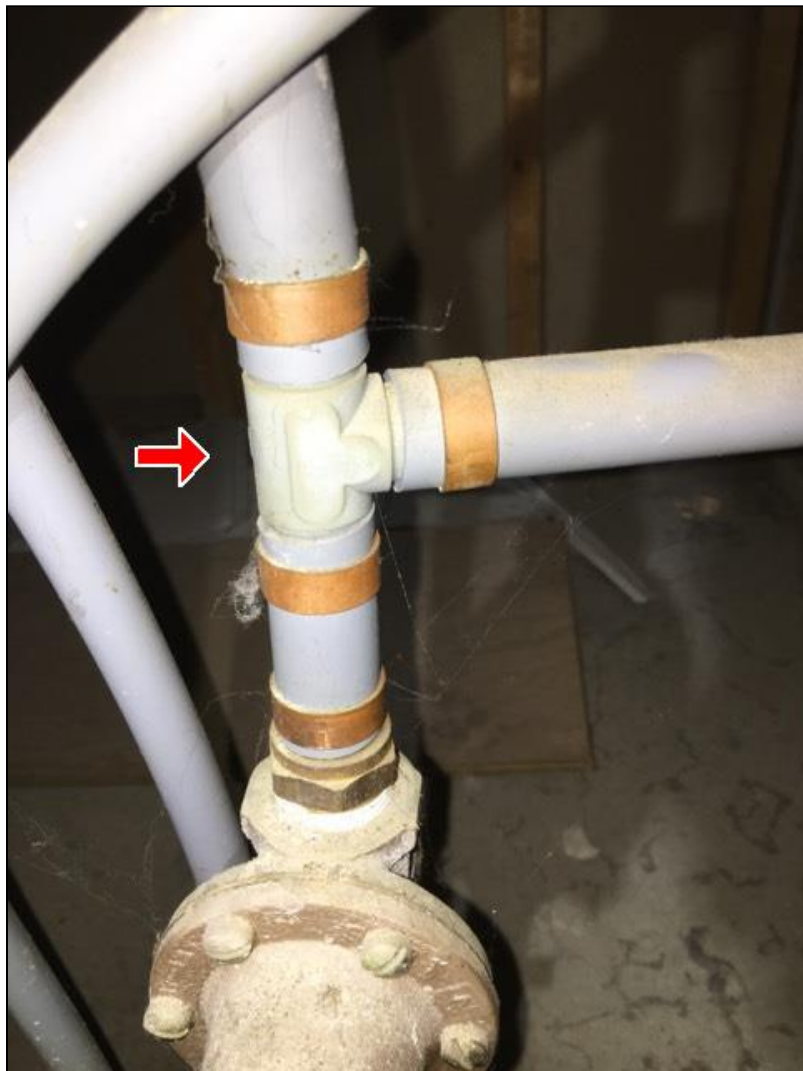
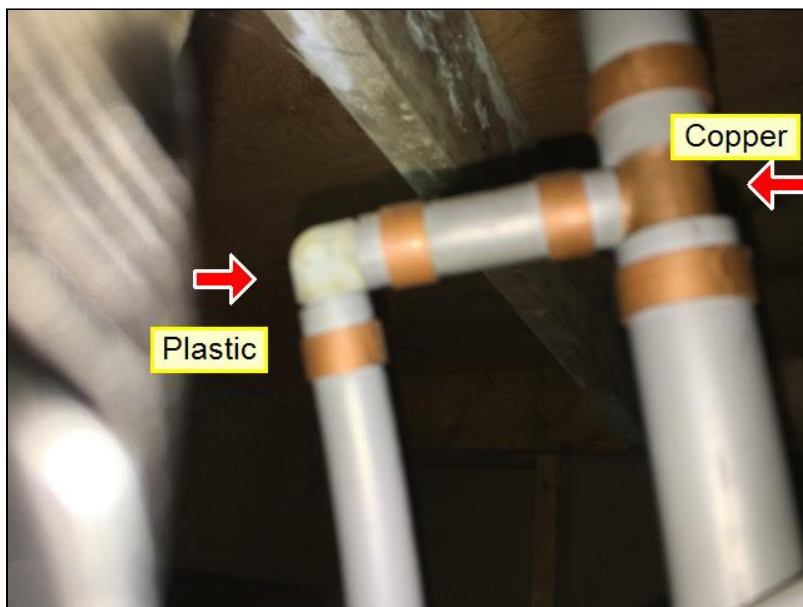
7.2 Item 1(Picture) Plastic fittings

7.2 Item 2(Picture) Mix of copper and plastic fittings.

Polybutylene has been used in this area for many years, but has had a higher than normal failure rate, and is no longer being widely used. Copper and Brass fittings used in later years have apparently reduced the failure rate. **You should be aware that some insurance companies may charge a higher premium with this type of piping installed. A qualified tradesperson should review/repair/replace these pipes and fittings as required.**

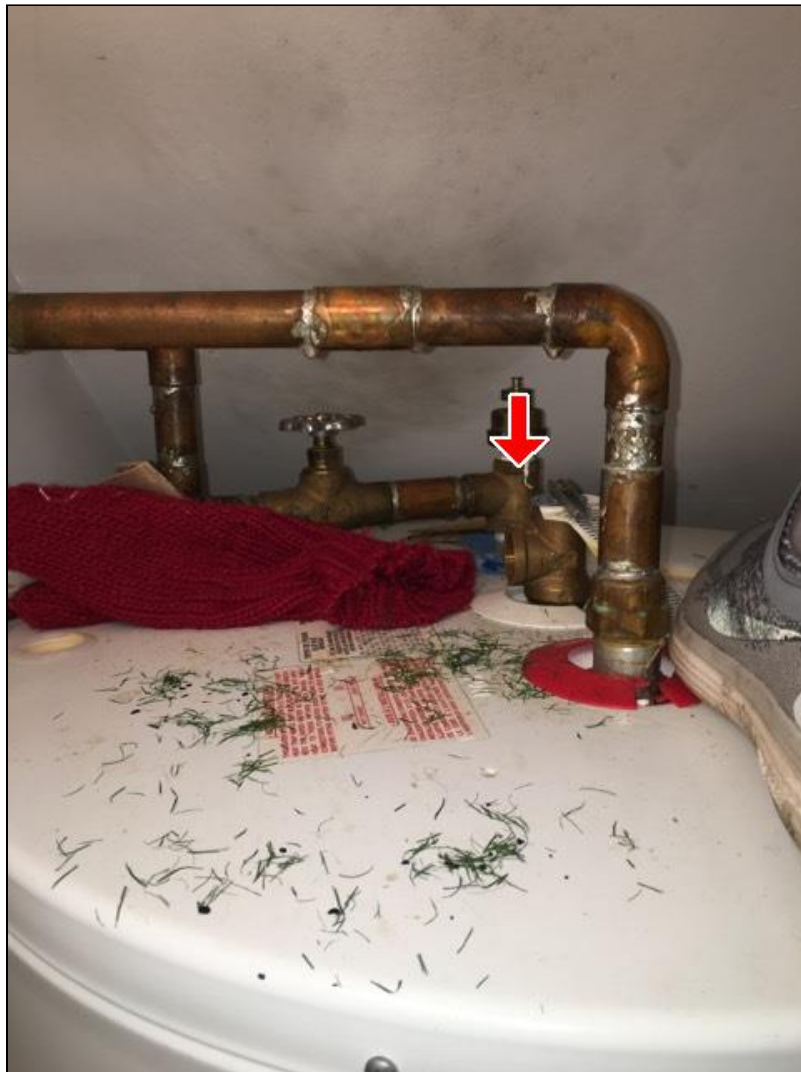
7.4 Item 1(Picture) Drain tube required for T and P valve

The T&P (Test and Pressure) valve on water heater needs a 3/4 threaded pipe to extend within 6 inches of floor for safety. Water spraying from this valve from a point short of the floor can cause scalding of occupants and damage to interior finishing. It is recommended that this be repaired.

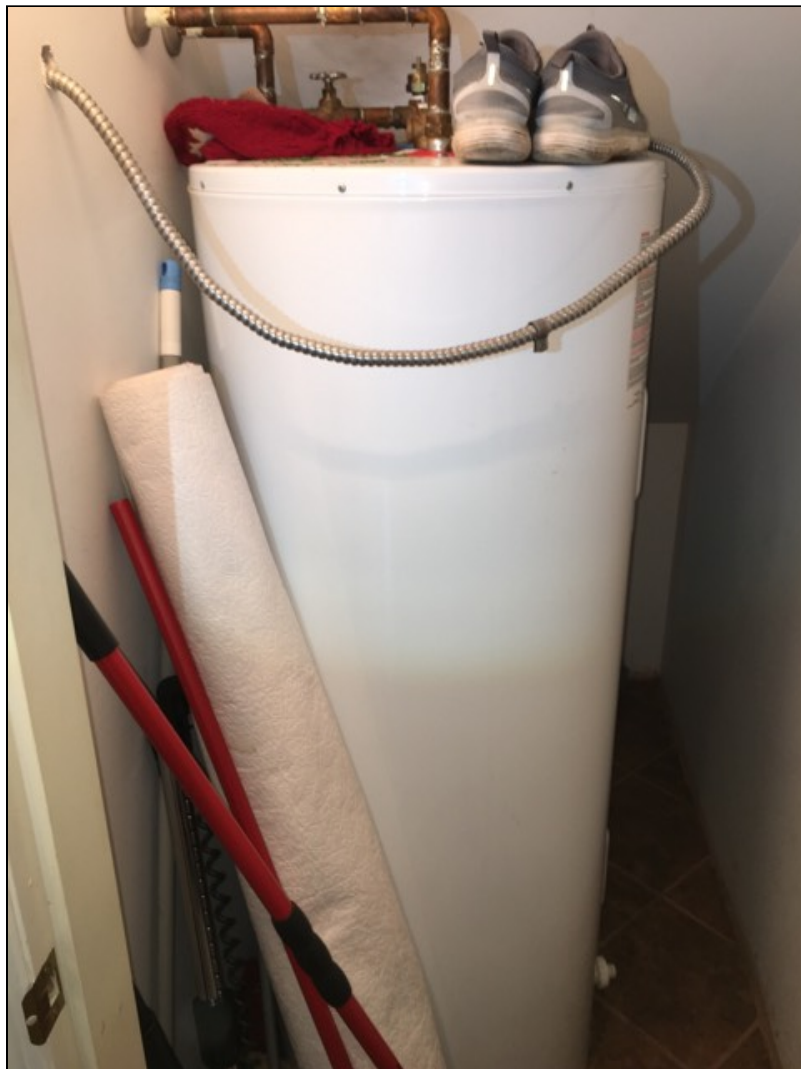
7.4 Item 2(Picture) No earthquake strapping

Recommend strap tank for additional safety during an earthquake event.

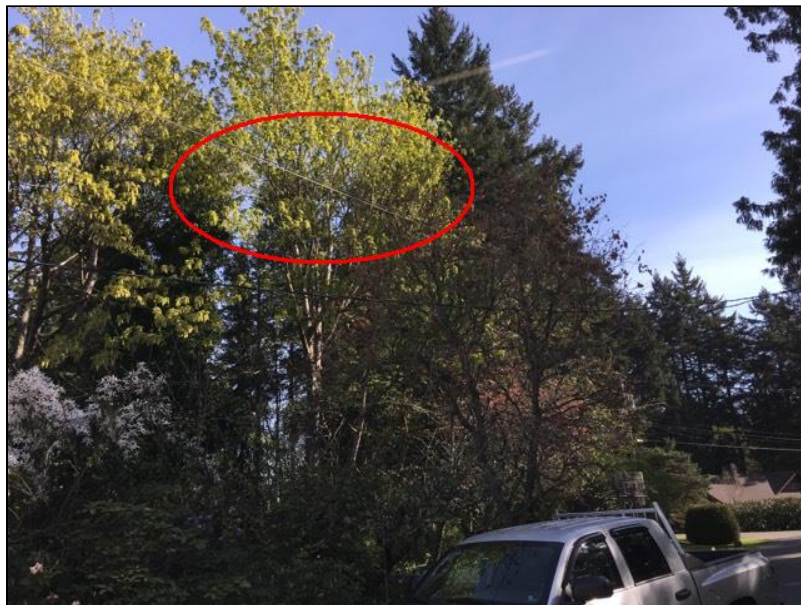
8.0 Item 1(Picture) Service Wire in trees

Service entrance wires pass through tree. Recommend qualified tradesperson trim branches and provide clearance on cables to prevent possible damages. BC Hydro may provide this service for free. Recommend contact them first.

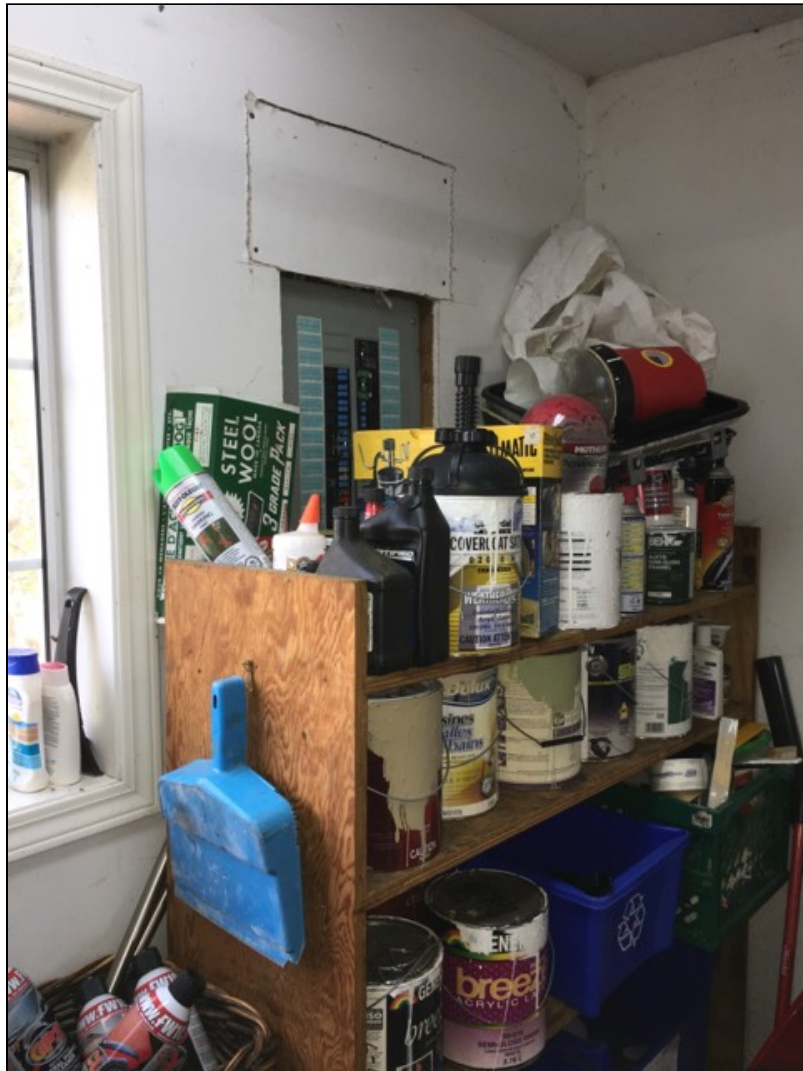
8.2 Item 1(Picture) Obstructed access.

Electrical panels should have three feet of clearance in front of them and one foot either side to provide access during normal and emergency access situations.

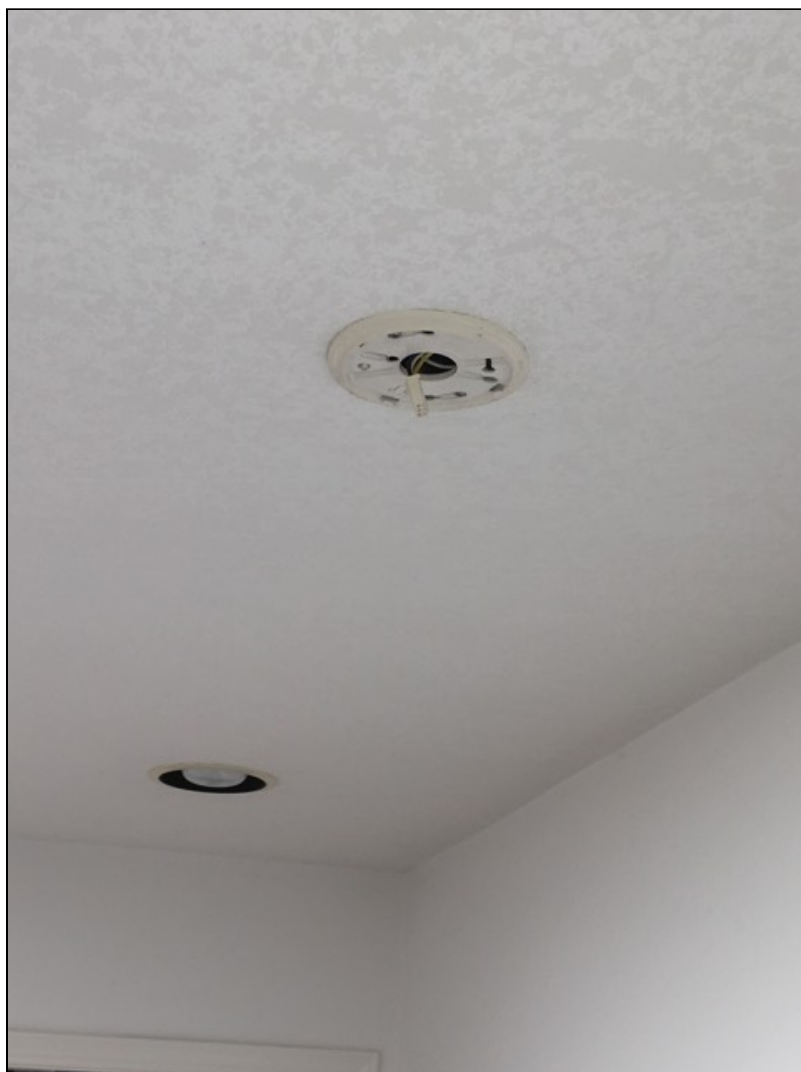
8.9 Item 1(Picture) Missing detector

Upstairs main hallway smoke detector removed. No other smoke or carbon monoxide detectors noted. This is a safety hazard that requires immediate placement of smoke detectors and carbon monoxide detectors at all sleeping areas and at least one detector on each floor.

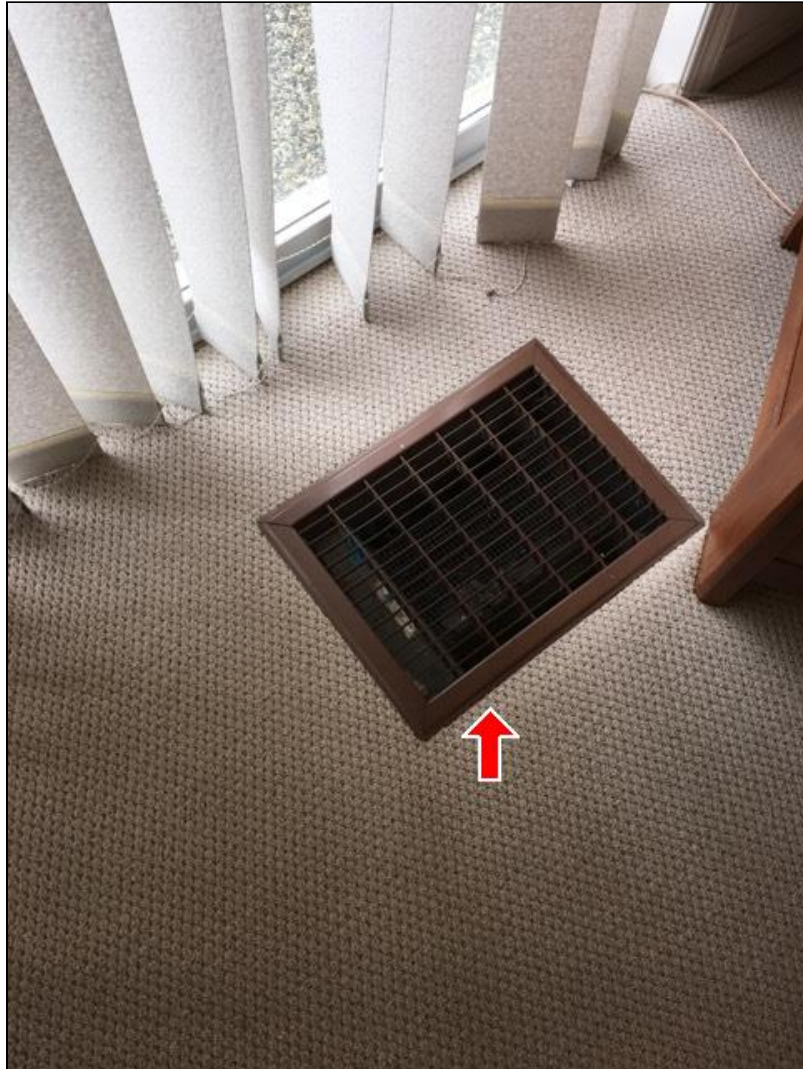
9.4 Item 1(Picture) Heater not working.

This in floor electric heater in the family room was not operational upon inspection. Recommend repair.

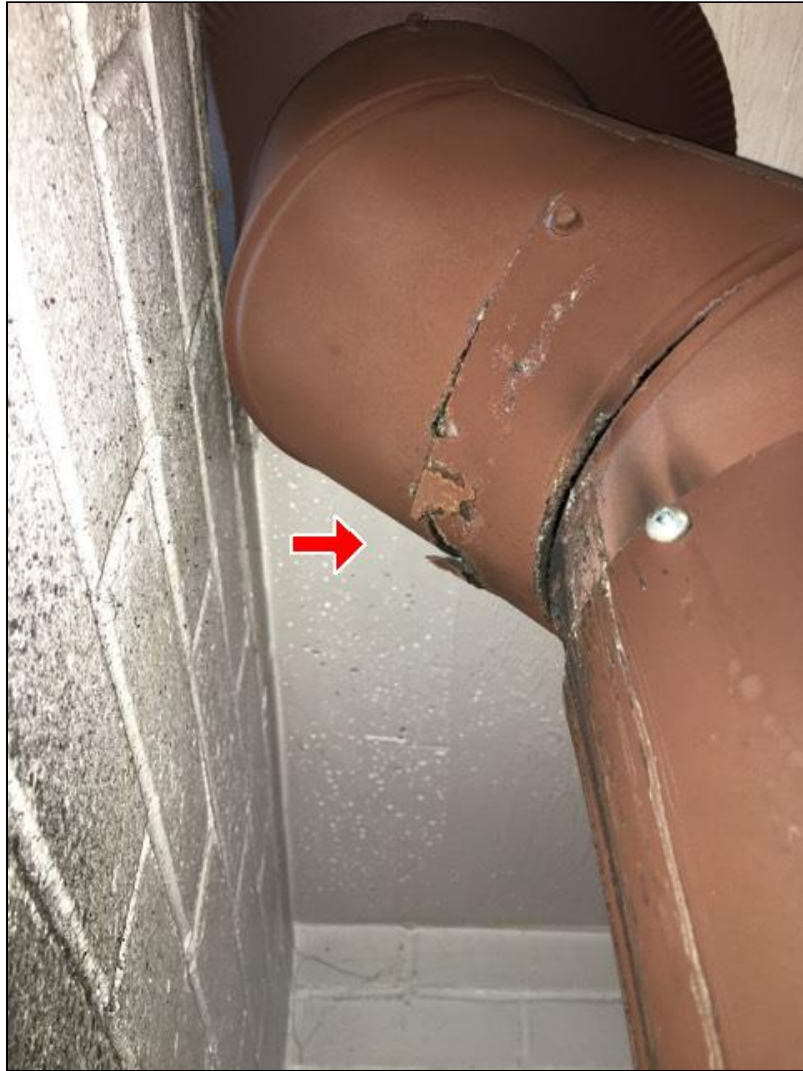
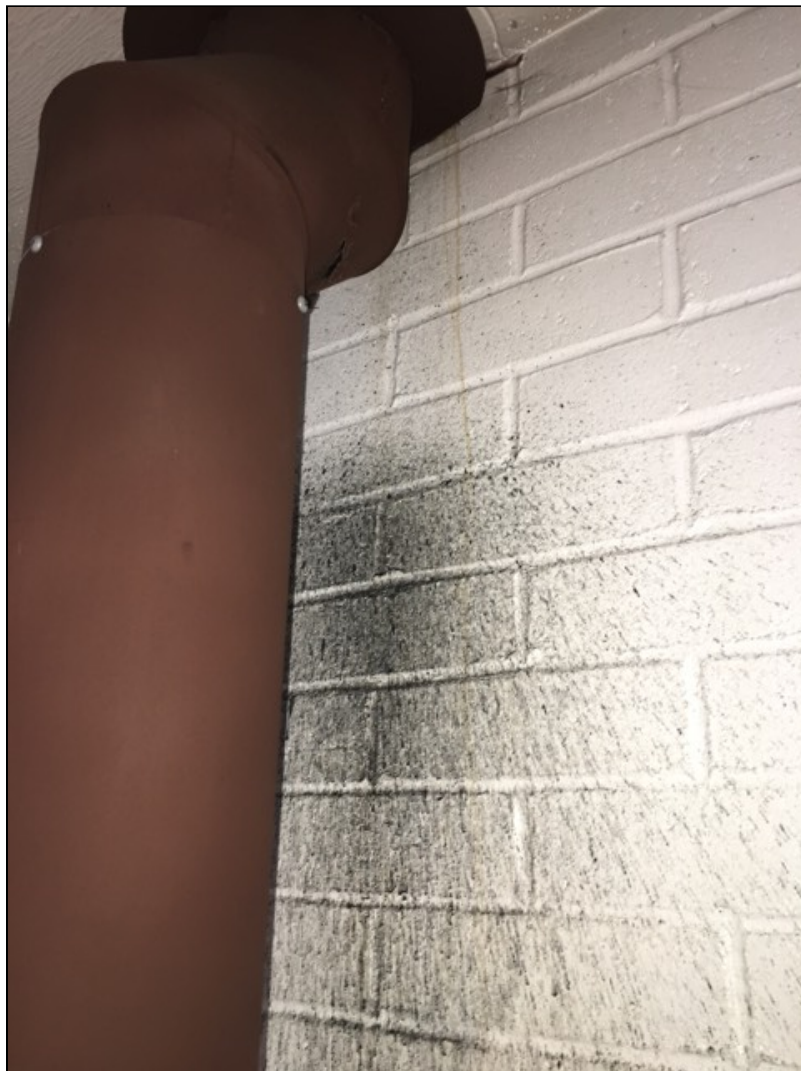
9.14 Item 1(Picture) Rusted out.

📌 Flue on wood stove in family room is rusted out on back surface. This is an safety hazard and should be repaired by a qualified tradesperson prior to any further use.

📌 (2) It is recommended that a Wood Energy Technical Training (WETT) certified technician service all solid fuel burning appliances prior to use to ensure they are safe and working efficiently. A Home Inspector is not able to inspect these appliances other than visually.

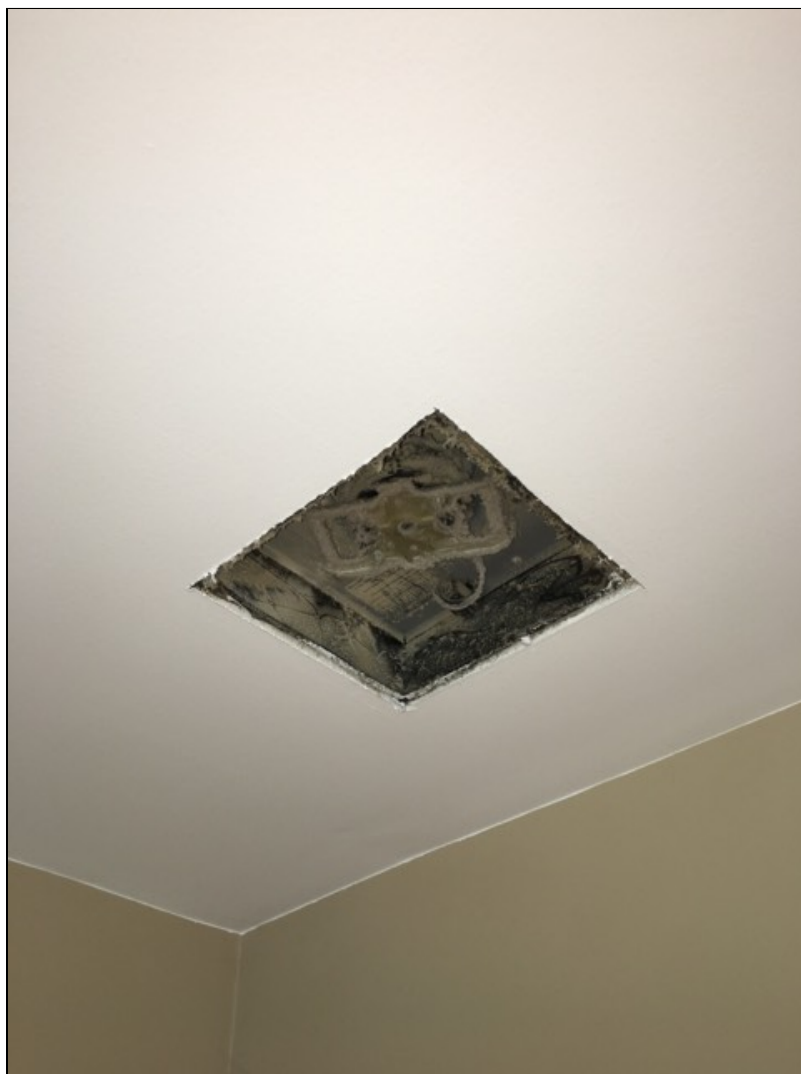
10.7 Item 1(Picture) Main bath fan

Cover is missing and fan is dirty. Recommend replacing cover and cleaning ductwork to ensure the fan is working efficiently.

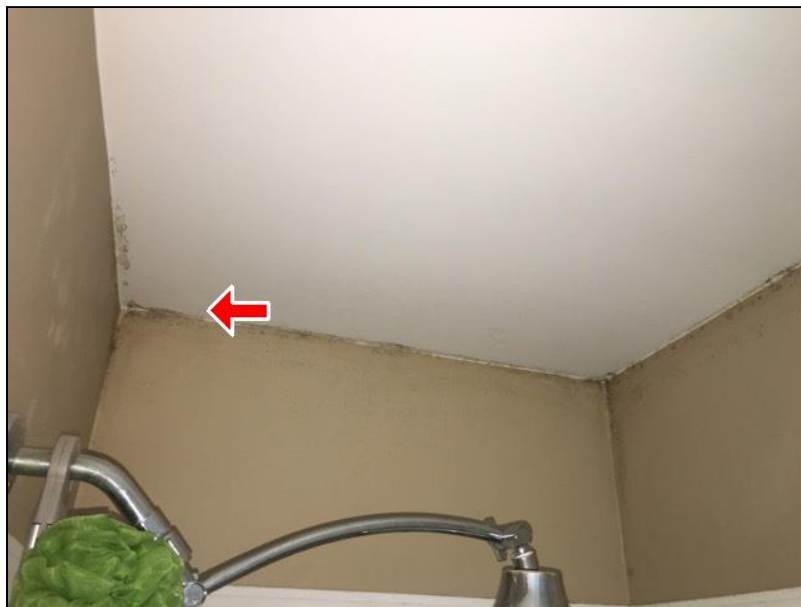
10.12 Item 1(Picture)

Some discoloration noted above shower in ensuite bathroom. No moisture present at time of inspection. Ask owner history of condition. May be hidden damage.

Recommend cleaning with a mild soap and water and improving ventilation in the bathroom (start with use of fan while shower is being used).

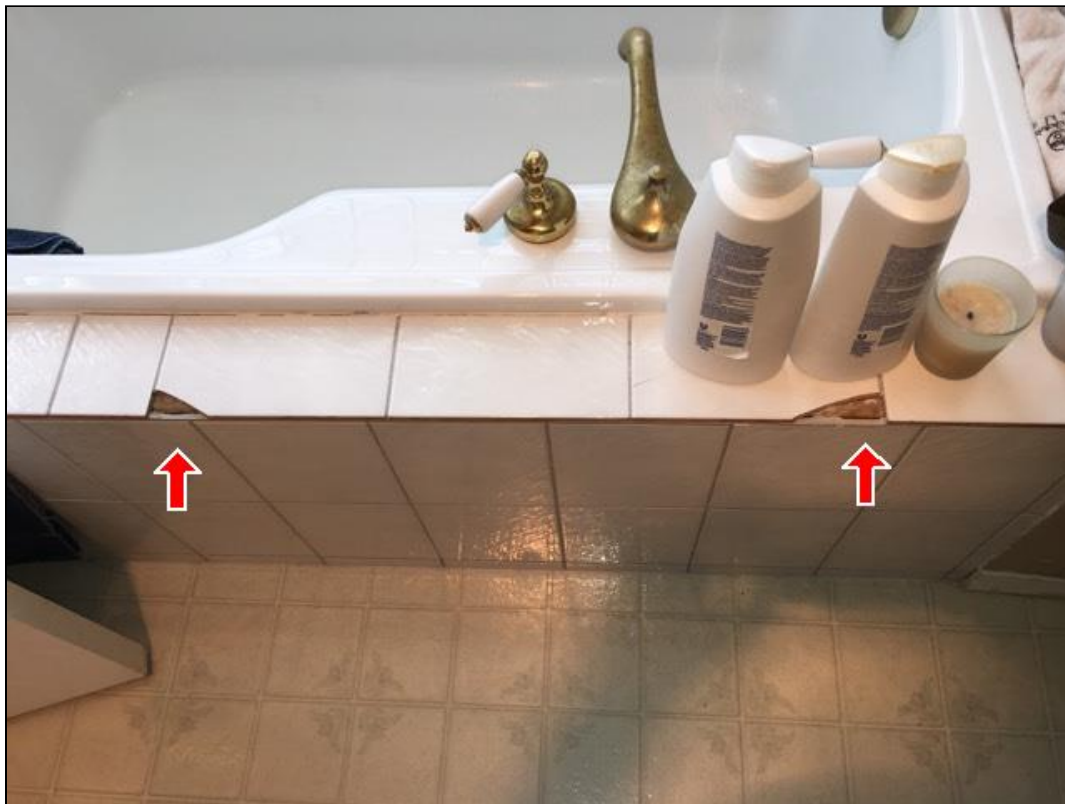
10.13 Item 1(Picture) Broken tiles

Damaged tiles on tub deck should be repaired to limit water entry and damage to wood structure underneath. No moisture noted at time of inspection.

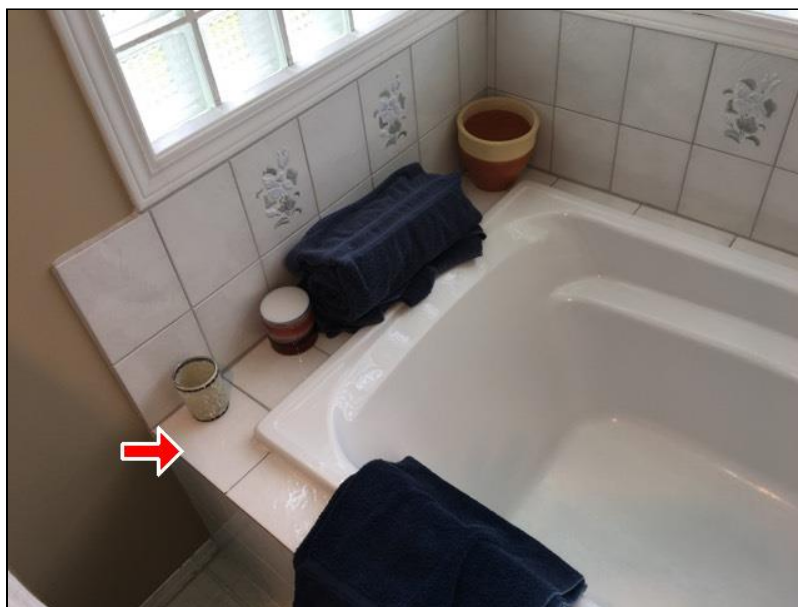
10.13 Item 2(Picture) Flat deck

This kind of tub deck can be susceptible to water entry on flat surface. Recommend removing any standing water on this deck after use.

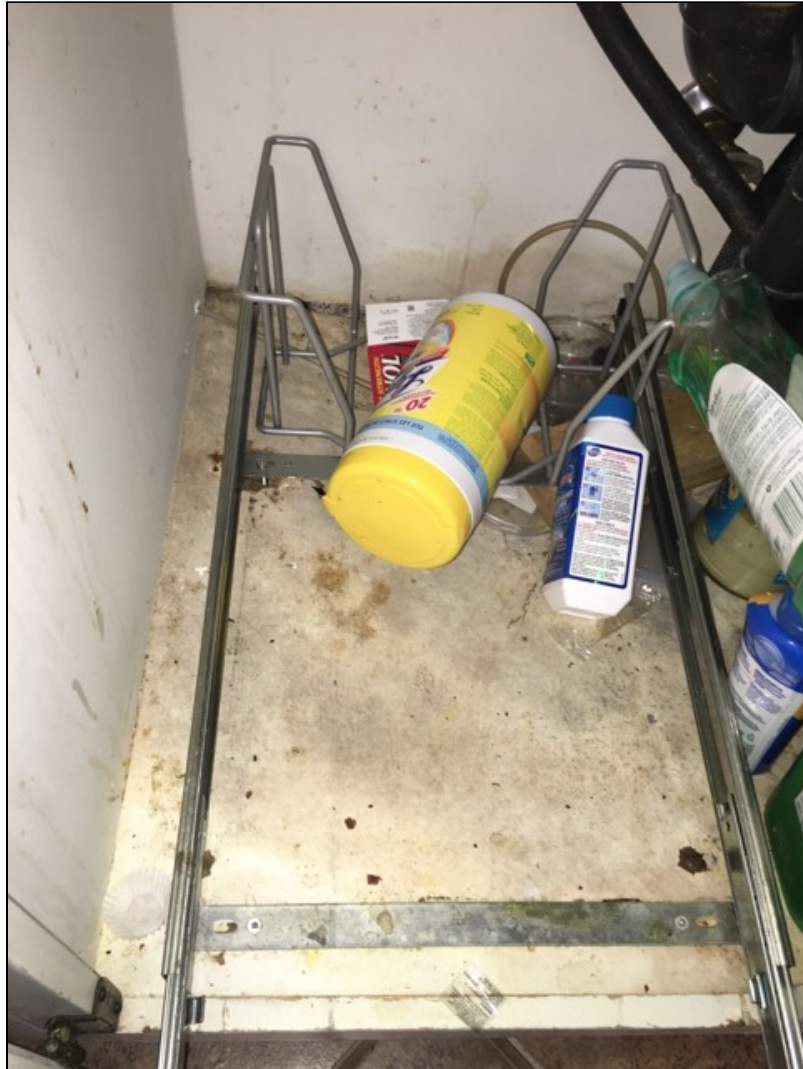
12.8 Item 1(Picture) Some damage from previous moisture

Evidence of prior leak apparent under sink. No moisture present at time of inspection. Ask owner history of leak and repairs. Recommend repair to ensure integrity of cupboard.
