Inspection Report for John Smith

Property Address: 123 Main St, Anywhere, BC V1Z1Z1

Gold Star Home Inspections

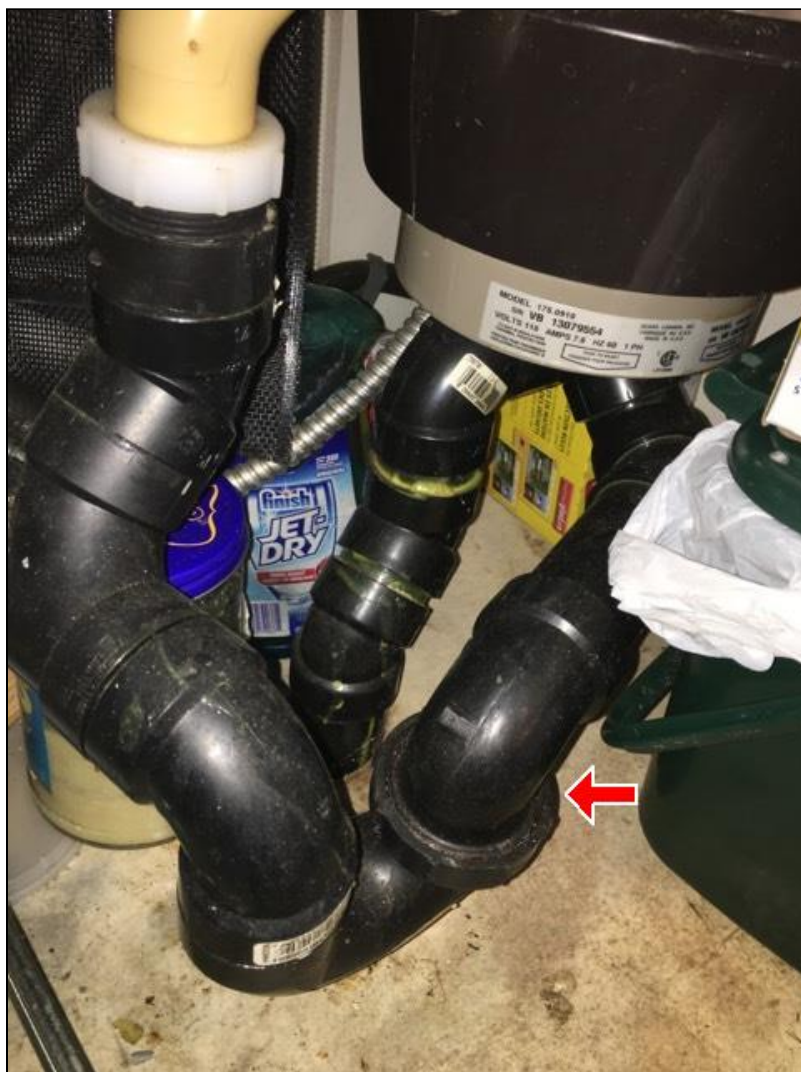
12.8 Item 2(Picture) S trap

S trap noted under sink. Recommend replacement to ensure working efficiently and safely. Improperly operating drains can allow sewer gases to back up into the house and cause illness or injury to occupants.

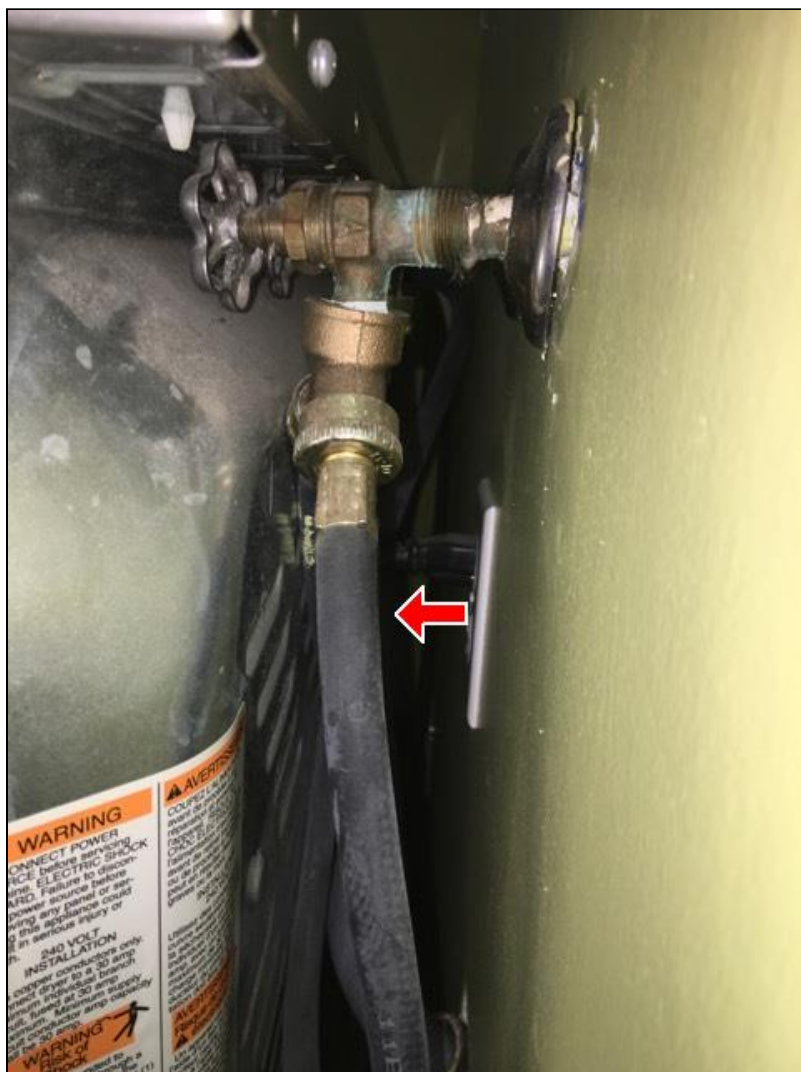
13.5 Item 1(Picture) Rubber hoses

Rubber supply hoses. Recommend installing steel braided hoses to prevent possible bursting/flooding and water related damages. Steel braided hoses are the only hoses rated for continuous use.

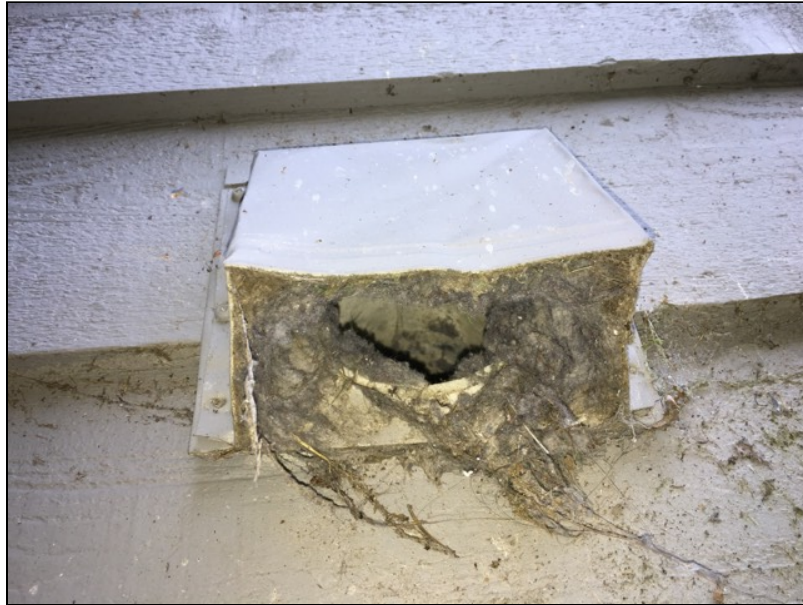
13.6 Item 1(Picture) Lint build up

Dryer vent cap does not have a vermin screen on the outside. Recommend installing a new vent cap specifically manufactured for dryer venting. Use of a different vent cap can lead to build up of lint and a fire hazard.

Recommend clean dryer ducts regularly to help reduce condensation and lint build up which can be a fire hazard.

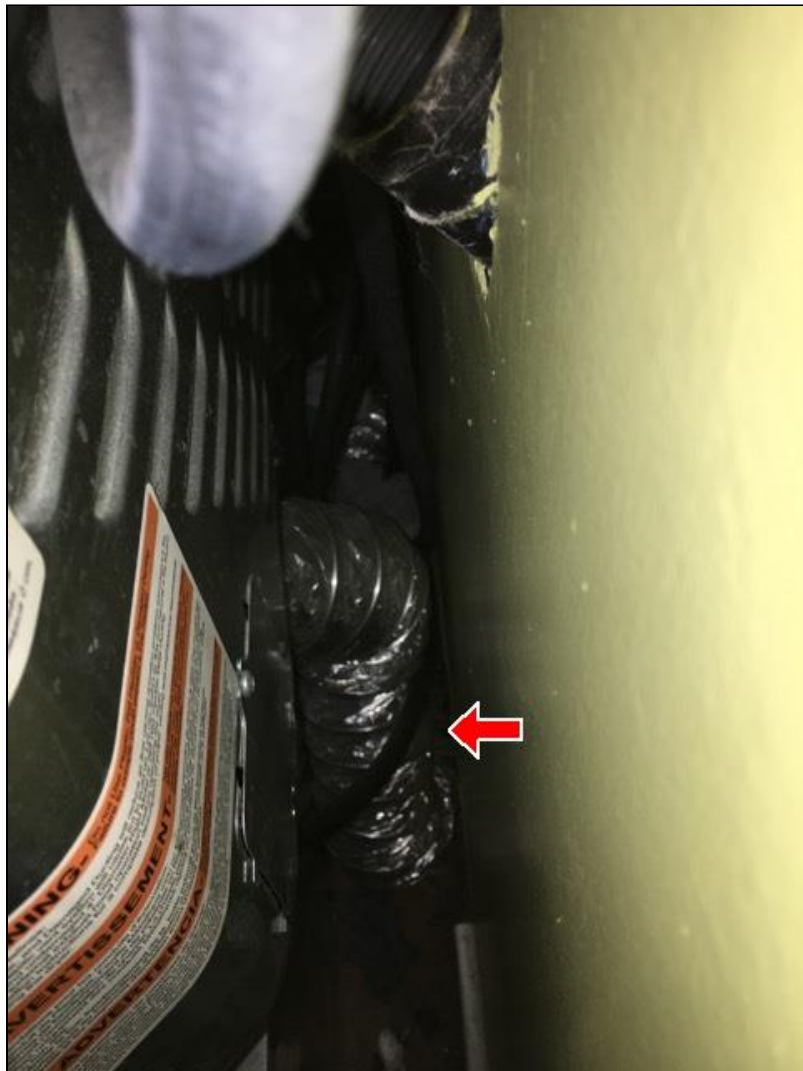
13.6 Item 2(Picture) Flex hose

Dryer vent is flexible foil coiled tubing. This type of tubing can collect lint and present a fire hazard. Recommend replacing with smooth walled metal pipe to allow for full air/lint extraction.

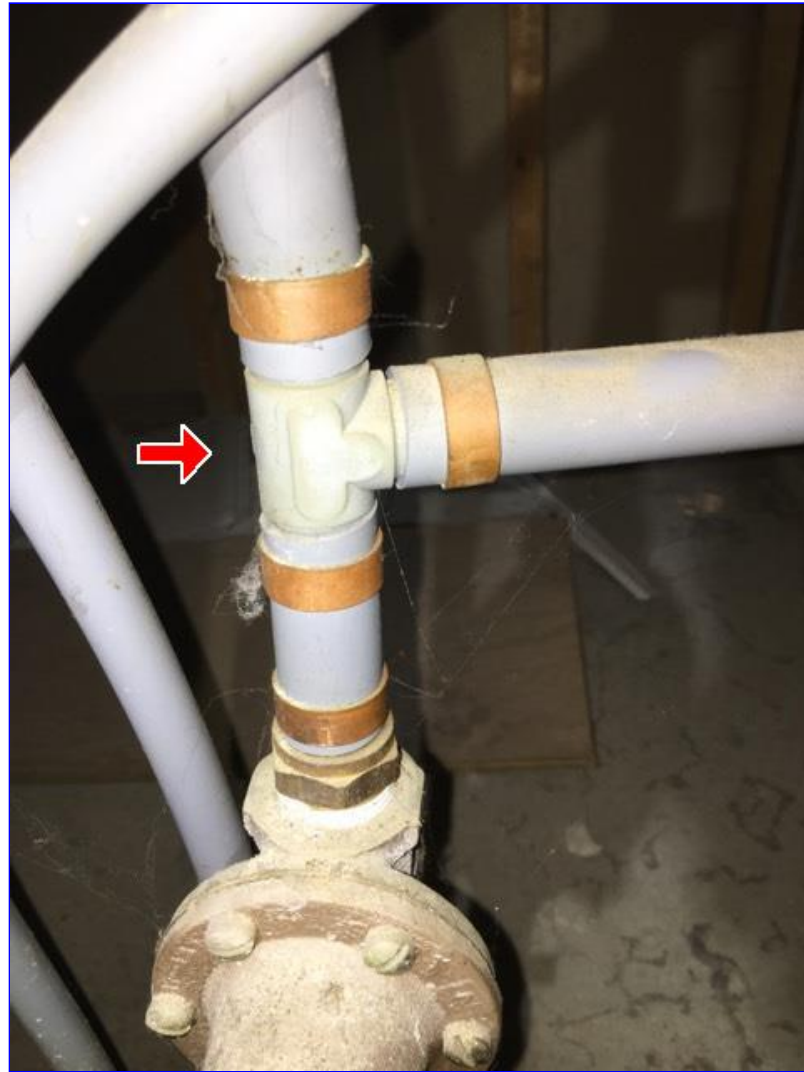
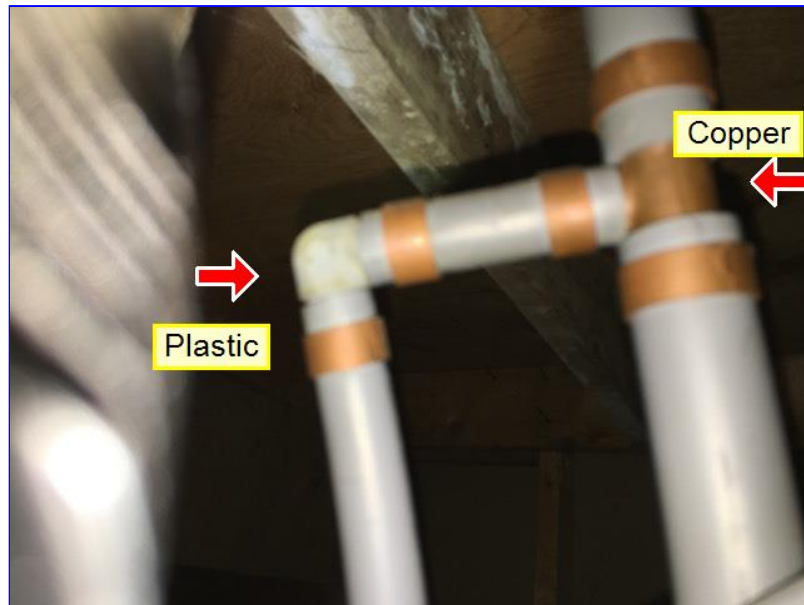
7.2 Item 1(Picture) Plastic fittings

7.2 Item 2(Picture) Mix of copper and plastic fittings.

Polybutylene plastic plumbing supply lines (Poly B) are installed in the subject house. This house contains a mix of plastic and copper fittings.

Polybutylene has been used in this area for many years, but has had a higher than normal failure rate, and is no longer being widely used. Copper and Brass fittings used in later years have apparently reduced the failure rate. **You should be aware that some insurance companies may charge a higher premium with this type of piping installed. A qualified tradesperson should review/repair/replace these pipes and fittings as required.**

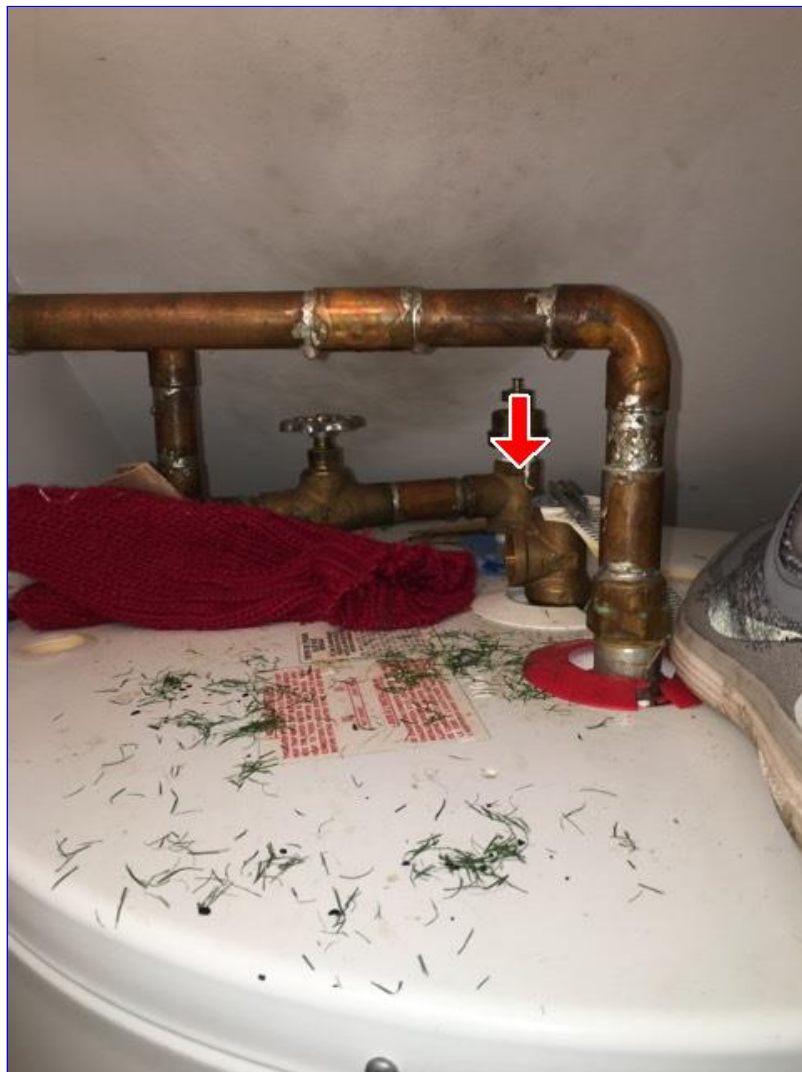
7.4 Item 1(Picture) Drain tube required for T and P valve

The T&P (Test and Pressure) valve on water heater needs a 3/4 threaded pipe to extend within 6 inches of floor for safety. Water spraying from this valve from a point short of the floor can cause scalding of occupants and damage to interior finishing. It is recommended that this be repaired.

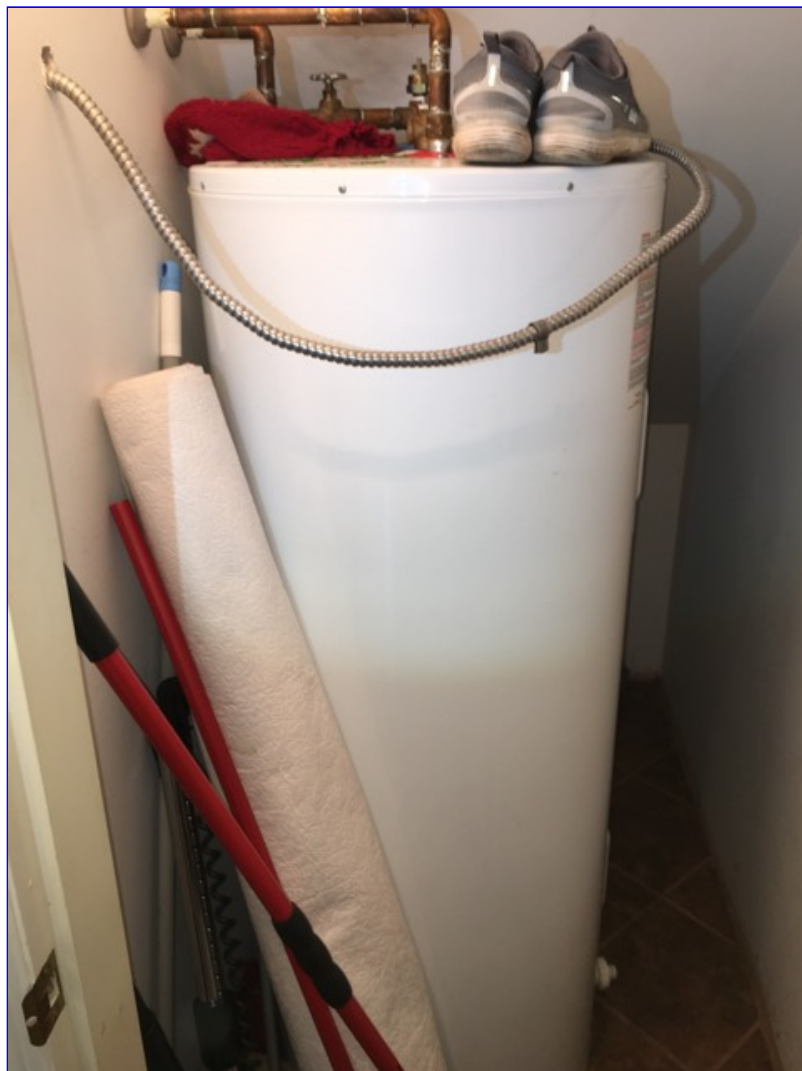
7.4 Item 2(Picture) No earthquake strapping

Hot water tank under stairs in closet.

Recommend strap tank for additional safety during an earthquake event.

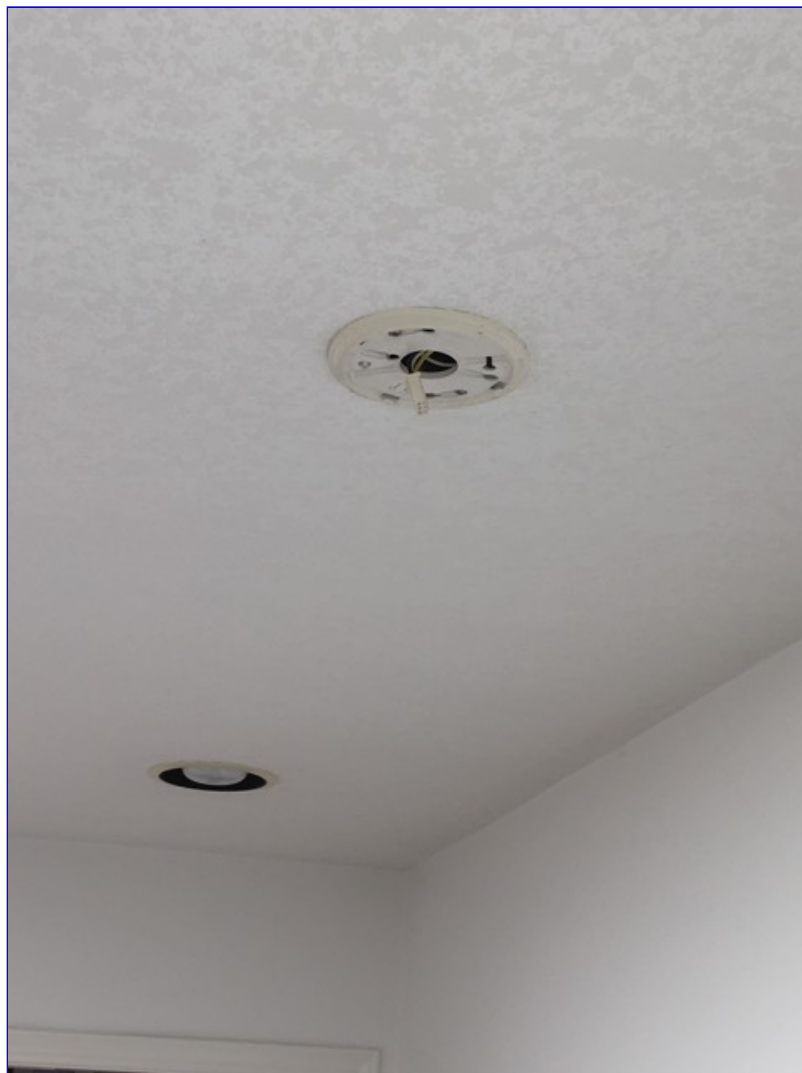
8.9 Item 1(Picture) Missing detector

Upstairs main hallway smoke detector removed. No other smoke or carbon monoxide detectors noted. This is a safety hazard that requires immediate placement of smoke detectors and carbon monoxide detectors at all sleeping areas and at least one detector on each floor.

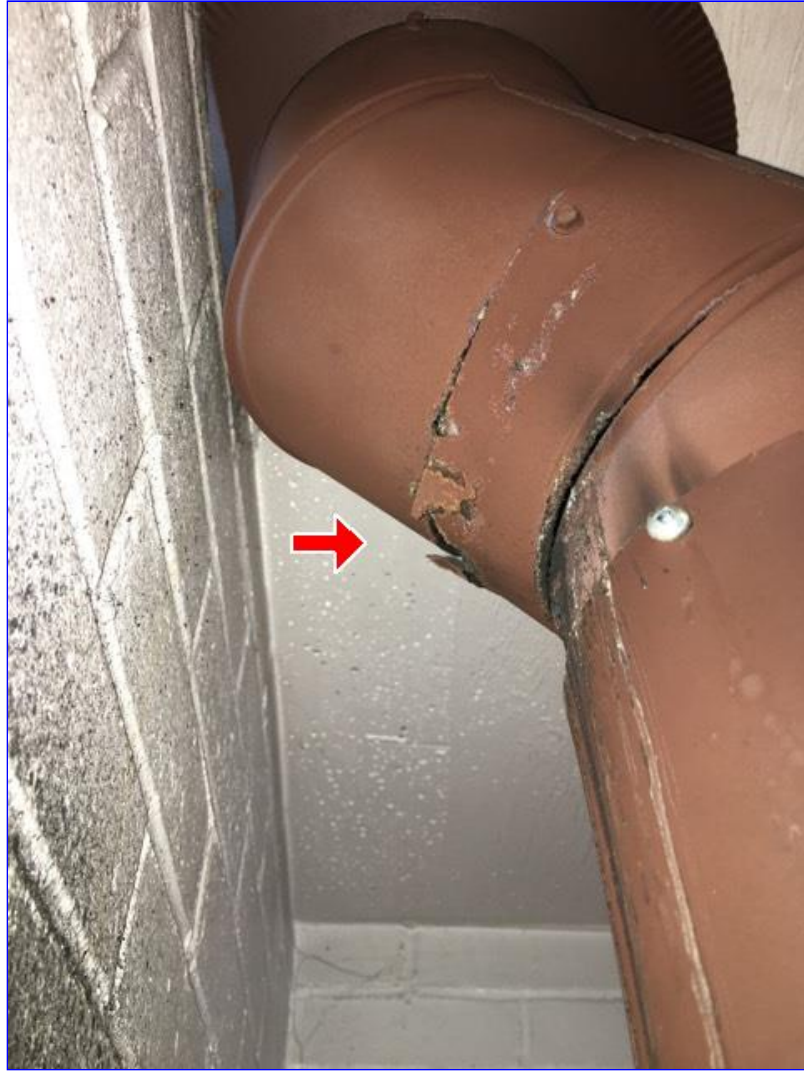
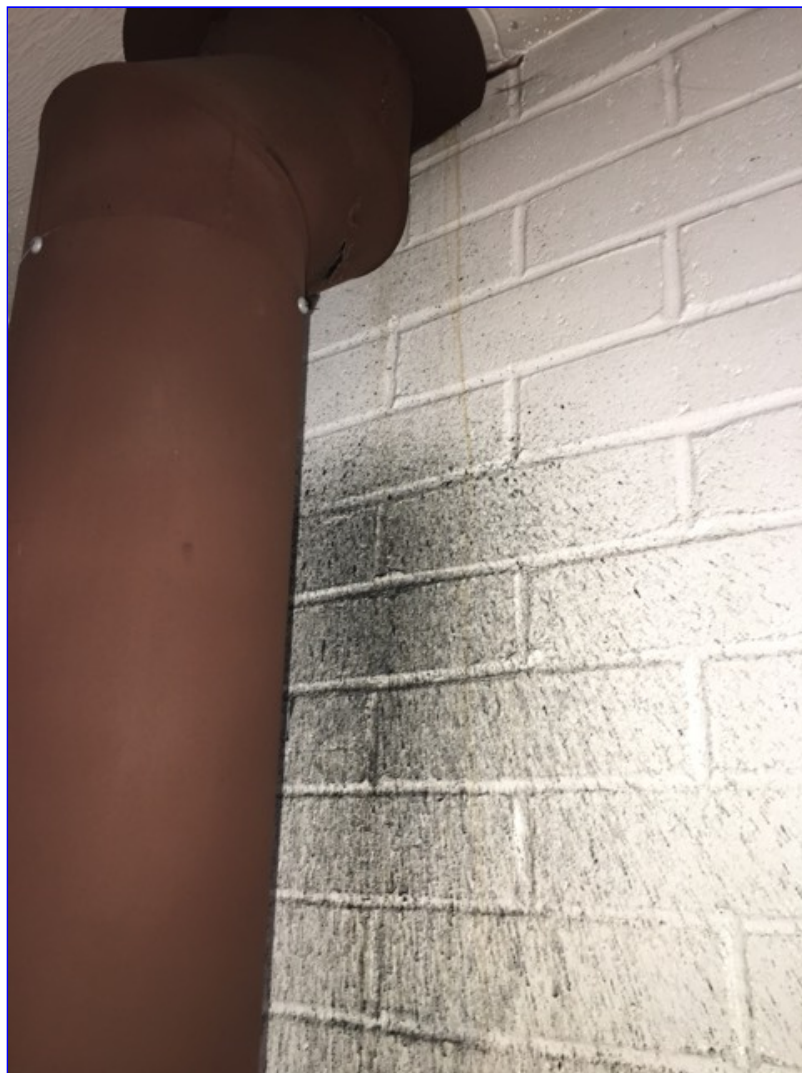
9.14 Item 1(Picture) Rusted out.

Flue on wood stove in family room is rusted out on back surface. This is an safety hazard and should be repaired by a qualified tradesperson prior to any further use.

(2) It is recommended that a Wood Energy Technical Training (WETT) certified technician service all solid fuel burning appliances prior to use to ensure they are safe and working efficiently. A Home Inspector is not able to inspect these appliances other than visually.
