REPORT NO: BNR32-XXXXXX

1990 NISSAN SKYLINE GT-R NISMO (SAMPLE)

Report generated on 2020-05-14

CONDITION SHEET & PHOTOS

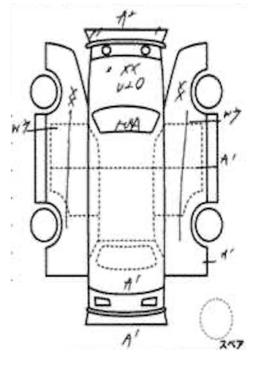
Hood has been replaced XX

Front right fender replaced XX

Front left fender replaced XX

Repair marks

- Scratch marks A, V
- Scratch mark on windscreen

Repair history on both left & right body W

Dirty Interior

Left back door part exchange history X
