Repairing TR6 Taillight Sockets

TR6 Taillight Sockets

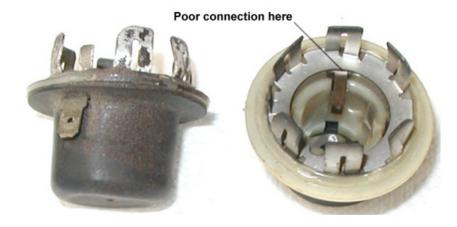
In most cases the grounding problem is caused by corrosion in the socket. Typical sockets are shown the photo below. The little strip on the inside of the socket is a bronze spring that makes the ground contact to the side of the lamp. The top of the strip is bent under the steel ring with the prongs. The ground current flows from the lamp though the bronze strip and then the steel ring and prongs to the tail lamp housing. The problem point is the connection between the bronze strip and the steel ring. The two pieces just rest against each other. After many years, the surfaces between the dissimilar metals corrode. Replacement at ~\$10 a pop isn't much of a remedy since the last new ones I saw are the same design.

The permanent solution is to solder the bronze strip to the steel ring. This is not so easy since it's pretty hard to solder steel, the ring is pretty big so a lot of heat is required, but not too much or the plastic will melt. And, we can't get too much solder on the bronze strip or it will no longer be springy.

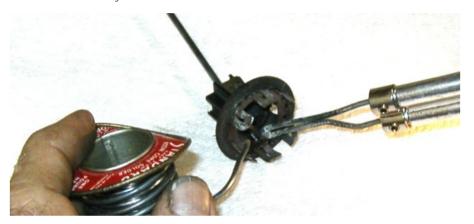
Once the joint is hot, the solder is touched to the joint and held till a small amount flows into the crack between the two metals, see next photo.
