Olga Store Feasibility Study & Report

Prepared for: Friends of The Olga Store Building
By Martin Development Services

August 02, 2019

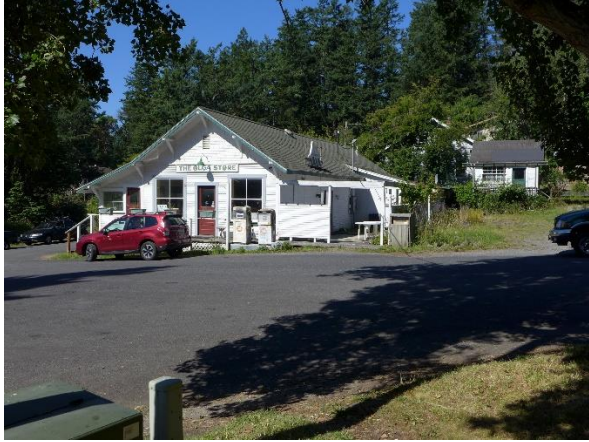
Fig. 1: East façade and vacant lot to the North

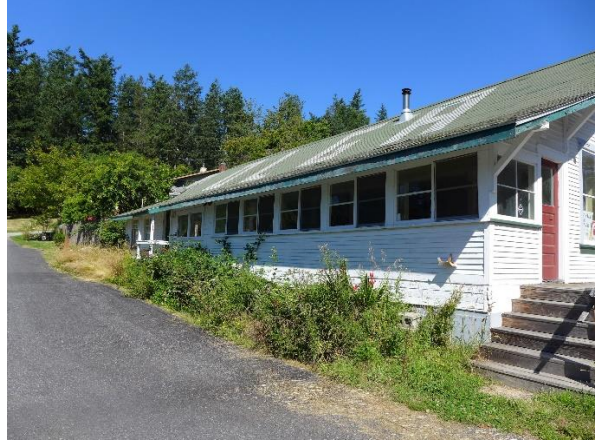
The siding appears sound, with no observed rot; the south and west facing exterior paint is cracked and chipping in many locations. A complete exterior paint job is recommended as part of the renovation scope. Sanding and prep work may uncover specific carpentry restoration needs, and mitigation of potential lead dust (if sanding) may be required. Exterior windows and doors may need to be replaced or infilled at locations where interior modifications occur, based on energy or functional requirements, including panic hardware at doors for emergency egress. The main entrance door, and interior hardware

Fig. 2: South façade, entrance to apartment.

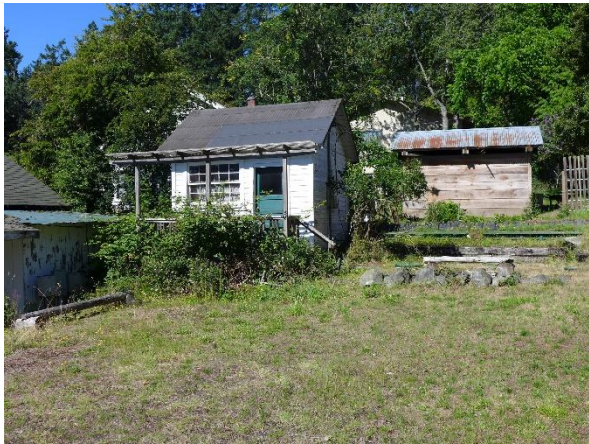
The commercial kitchen grade septic system vault access lids (4) are directly to the north of the building and (2) adjacent to the small cottage. The leach field for the system is off-site, to the west and north by way of an easement. The tank at the SW corner (2 lids) appears to be an initial pumping vault for the

apartment. The tanks for the commercial and residential use may be separated but combined at the back of the north lot as the secondary pump vault (in front of cottage – see photos).

Fig. 3: Neighbor sheds to the west of vacant lot. Leach field tank lids, right foreground.

It is recommended that the underground piping and septic system locations be verified prior to any excavation for new foundation systems, utilities, ramps or other site paving designs.

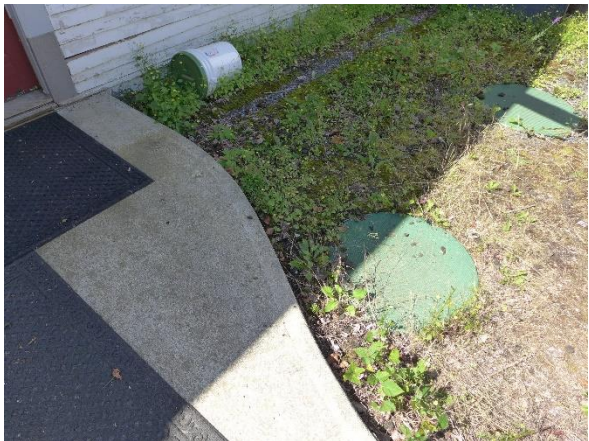
Fig. 5: Pump vault lids adjacent to N. patio slab & side double door, store entrance.

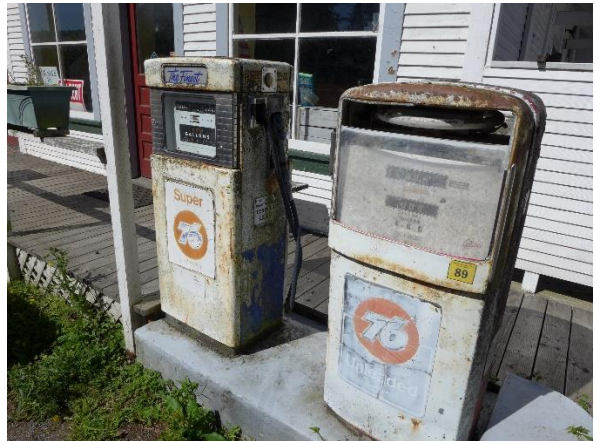
The existing 2 gas pumps, without hoses are in poor condition and sit on an elevated concrete pedestal. See Appendix 'E' for decommissioning and removal report of the tanks and surrounding soils performed in 1991. Since the anticipated renovation does not include excavations or expansion of the existing building footprint; at this time, soil contamination mitigation efforts are unlikely necessary.

The existing wood stairs and railings serving the front boardwalk entry and at the residential Unit (if Option 2) need replacing. Recycled plastic decking material is recommended for low maintenance and environmental considerations (not pressure treated wood). Stair, ramp (future) and walk railing systems requires upgrading to current IBC & FHA (Building Code & Accessibility) standards, without compromising the historic nature of the building façades.

Fig. 6: Historic gas pumps on concrete podium, front boardwalk to main Store entrance.

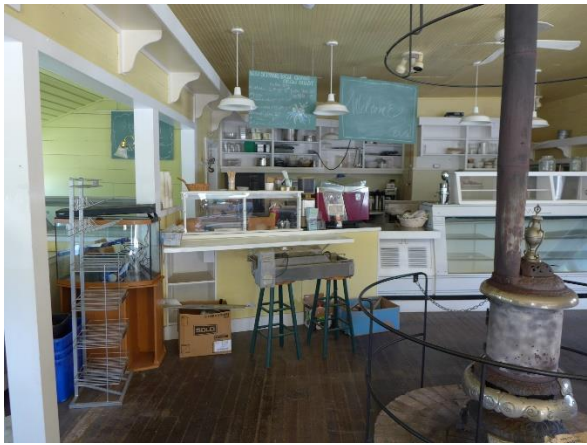
It is understood that a Phase I Environmental Report has not yet been prepared, however for scopes involving removals and other improvements, that an Environmental Consultant prepare this report along with material samplings for presence of potentially hazardous materials. This may pertain to any exterior or interior paint stripping (lead), presence of asbestos at pipe insulation or insulation, or other interior surfaces. Since the interiors are almost entirely wood and the apartment constructed in the mid-1990's and the interior store finishes painted; we believe that the predominant concern will be older lead based paint coatings. See further discussion under "Envelope" for insulation and roofing materials. The flooring in the café kitchen serving area, appears to be linoleum and the adhesive mastic should be checked. Other possible concerns include any older fluorescent light ballasts and the stove pipe above the ceiling (if insulated).

Fig. 7: Café interior looking west, wood fired stove.

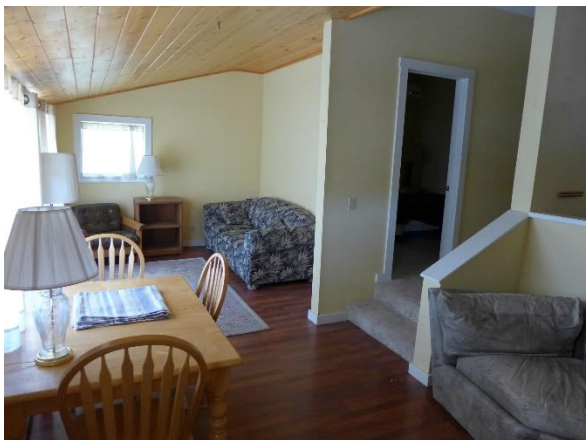
The north half of the back residential apartment is approx. 14-16" higher than the rest of the building floor level, reportedly raised to accommodate the plumbing and waste lines for the apartment bathroom at the north wall added during the 1990's renovation.

Fig. 11: Apartment interior looking west, stairs up and back to bathroom.

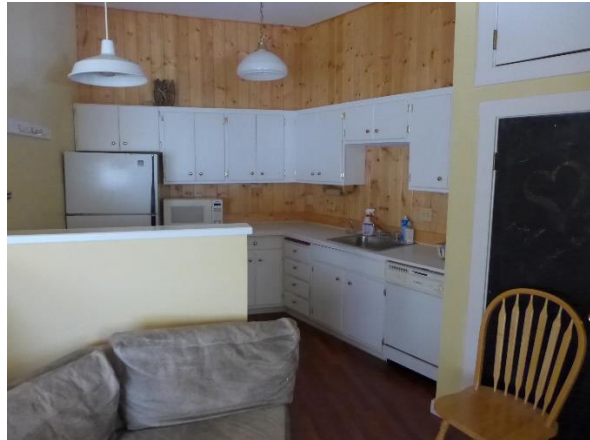
The residential Unit is equipped with all typical appliances including; stove, hood, washer, dryer, water heater and fans. All appliances appear to be functional, albeit dated to the original construction of that interior.

Fig. 12: Apartment kitchen looking north.
