Archaeological Excavation and Repair at Nordy Bank Hillfort, Clee Liberty

| Project | Historic Landscape Survey and Audit of Clee Liberty Common |
| Doc ref | 034-NordyBank-fieldwork082021-v1.0.docx |
| Author | Matthew Williams |

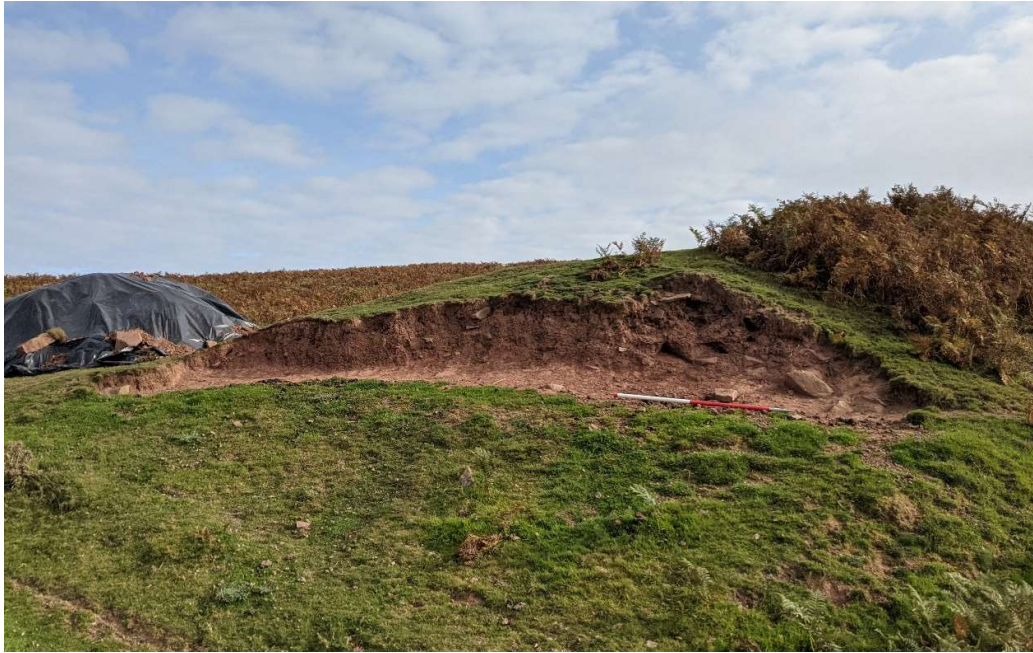
Plate 2 - Scrape 5 prior to excavation, looking east, 1m scale

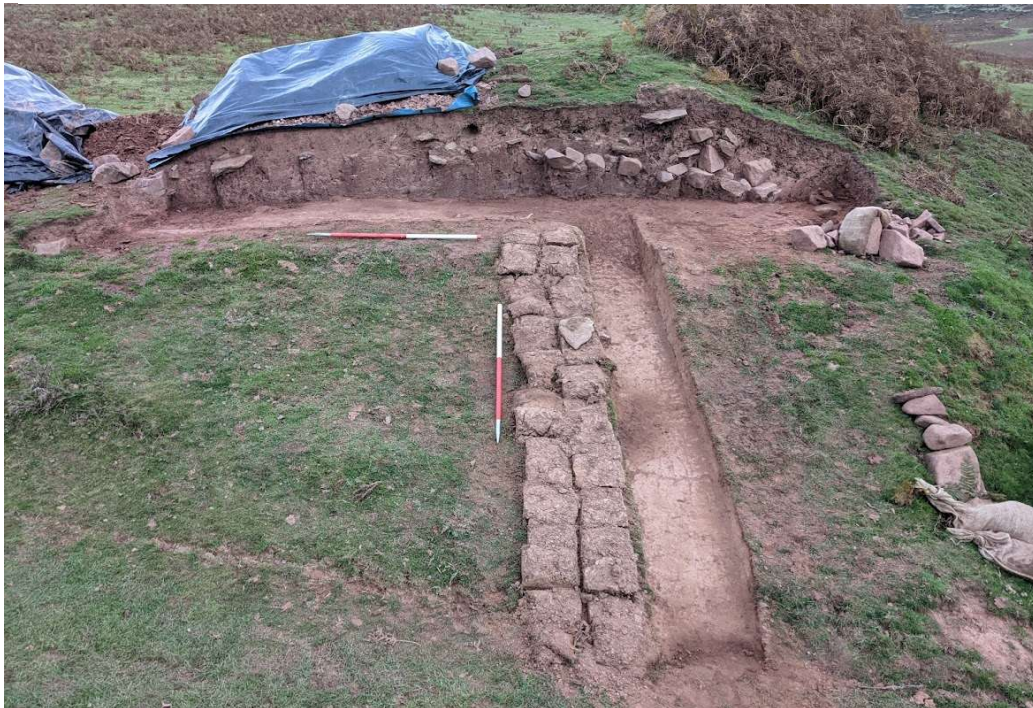
Plate 1 - Scrape 5 after excavation (cut [6] unexcavated), looking east, 2 x 1m scale

The results from the main section show a large homogeneous deposit of clay (2) forming the core of the rampart. It is clean and there are no obvious laminations, indicating it was probably deposited quickly e.g. by an organised workforce. Some clay may have come from the ditch excavation on the outside of the rampart bank, although most must have been imported as much of the ditch appears to have been cut through rock. The profile across the top of (2) is uneven; this may be the result of structures on the bank or wear from a path.

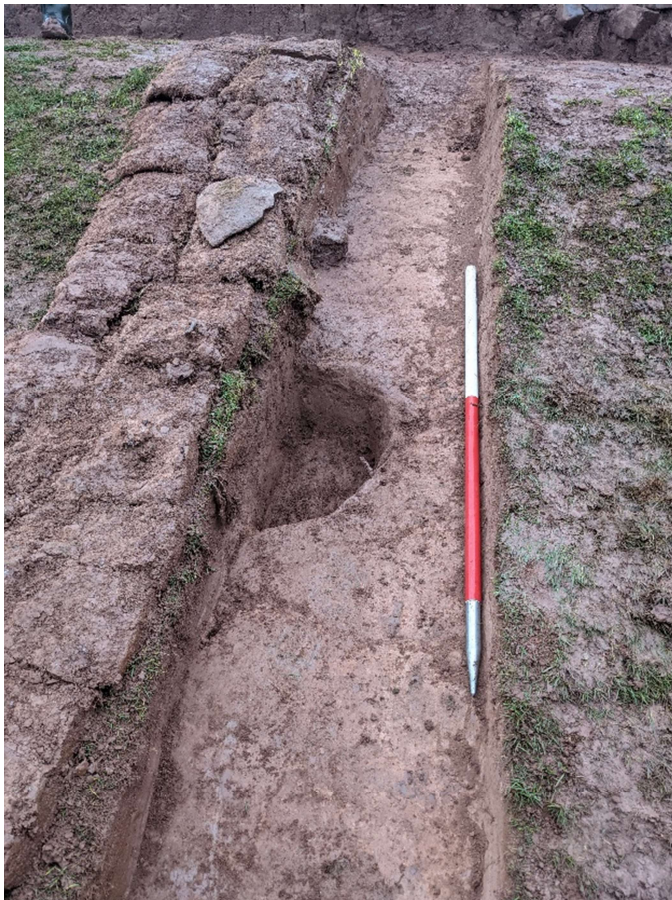
The cut feature [6] is difficult to interpret - In plan it resembled one half of a posthole although it was too shallow to support a large post, however it is possible that the surrounding surface has eroded.

It was sealed by the upper turf deposit (5) but cut the topsoil (1). Given that (1) sealed the rampart construction deposits it is likely that [6] is later than the rampart. The true character of this feature could not be clarified as it was not fully exposed. This cut represents a final phase of use, possibly long after the hillfort was abandoned.

Plate 3 - Scrape 5 extension showing cut [6]. 1m scale, looking east.

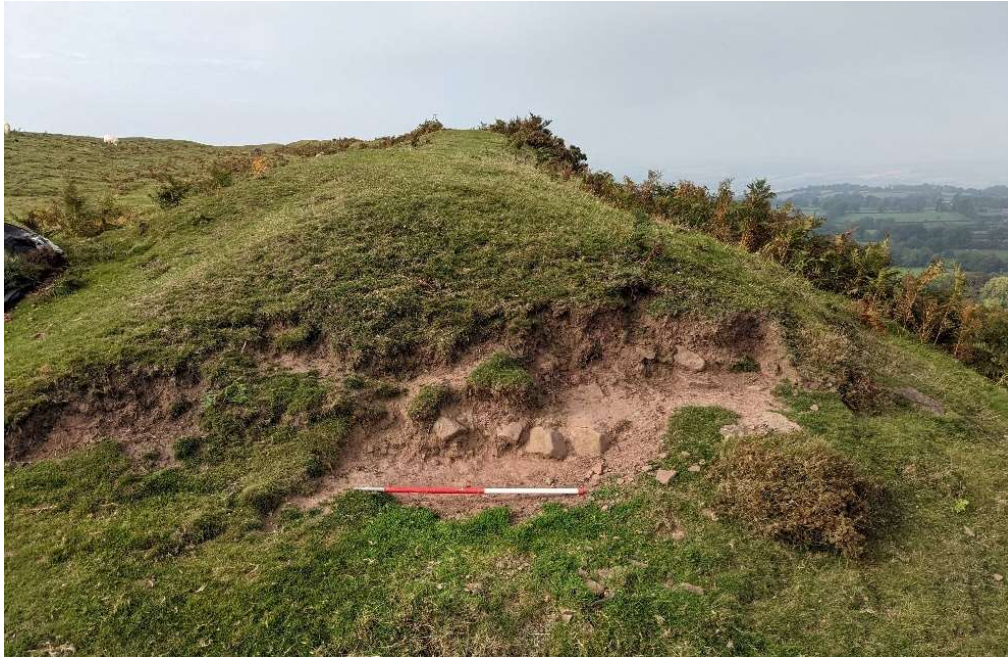
Prior to excavation a row of stones (2) was visible near the base of the scrape. The section was cut back to the level of these stones (about 0.70m out from the face of the section) but the surrounding area was cleaned. This allowed the stones to be recorded in plan and preserved in situ. The section measured 4.80m E – W and 0.68m high. The cleaned area in plan measured 5.00m E – W and 1.30m N – S.

Plate 4 - Scrape 8 prior to excavation, looking west. 1m scale

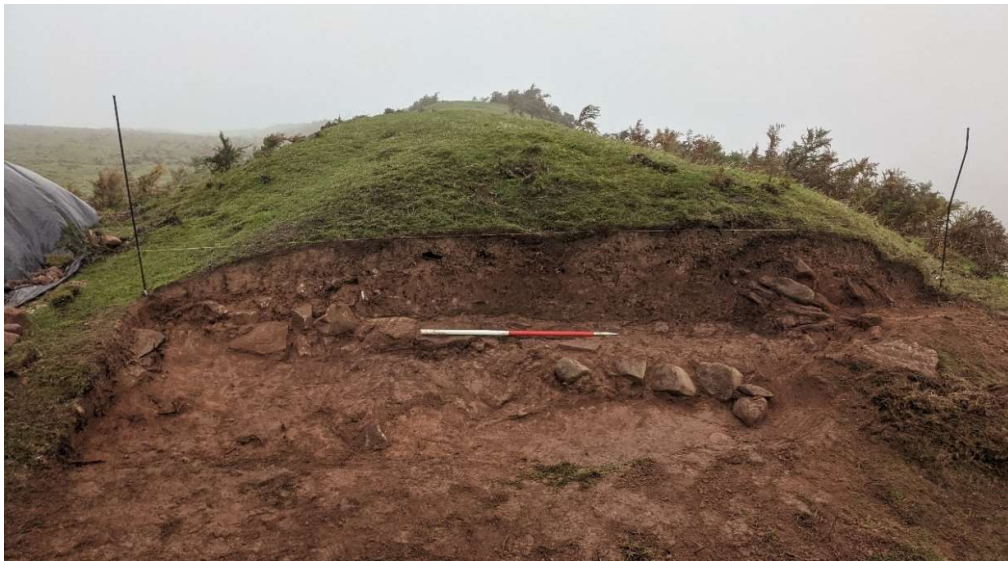
This section is very similar to the scrape 5 section. The core of the rampart is a thick clay deposit with tumbled revetting stones on the outer face. Flatter stones, which could be the remnant of paving, continue to the south. This horizon is overlain by a deposit of silt; it is very thick and would not have built up naturally on the crest of the rampart, so is interpreted as a deliberate later re-construction or heightening of the bank. On the outer northern face of this is a layer of tumbled flat stones and silt, perhaps the remains of a structure. At this level, towards the inner face, is a possible posthole containing post packing stones which could have supported a palisade or walkway.

Plate 5 - Scrape 8 after excavation, looking west. 1m scale

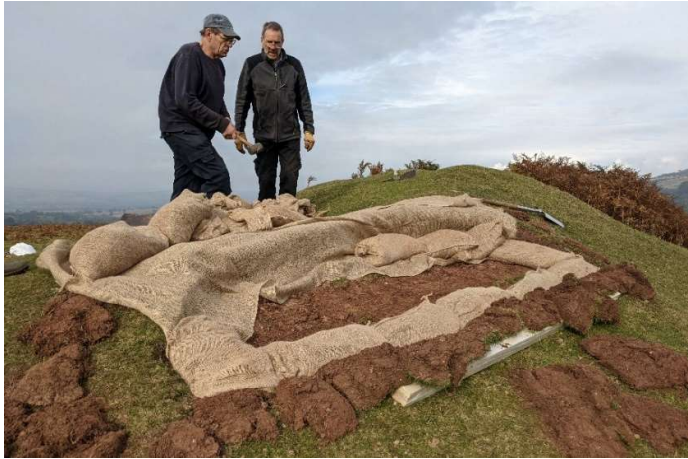
Plate 10 - Scrape 3, turf has been peeled back and hessian roll placed on inner edge held. It is held down with sandbags.

For some repairs 20cm of turf was peeled back from the edge of the scrape. The scrape was then cleared of loose soil and a length of hessian roll was placed around the inner edge. Filled sand bags were packed around the edge which formed a firm edge to the repairs and also held the hessian in place. The scrape was then filled with soil and compacted.

The hessian roll was then pulled over the bags and additional hessian was used to cover the centre. Finally, the turf was rolled back over the edge of the scrape (plates 10 and 11).

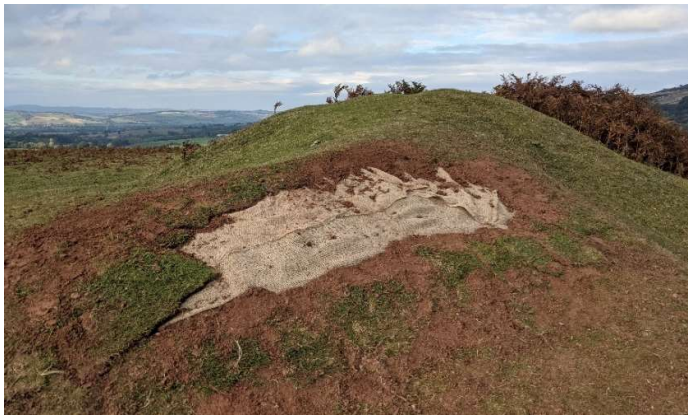
Plate 11 - Scrape 3 repaired with turf replaced

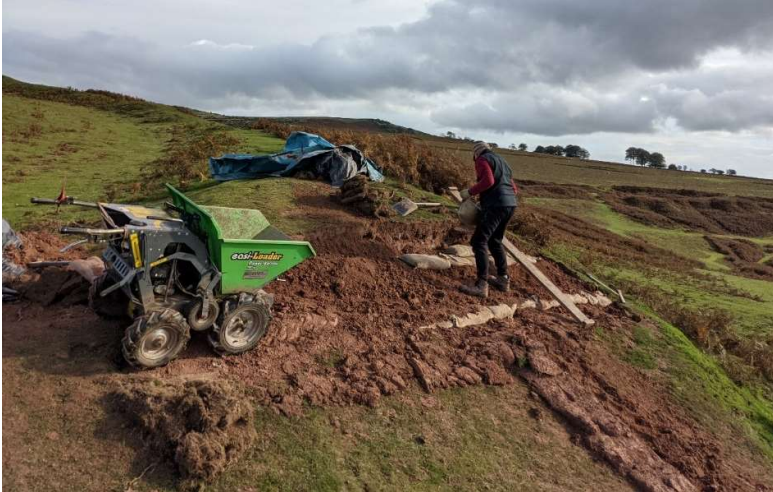
Scrape 5 was very large and the gradient of the repair made it difficult to hold the soil in place. Toe boards were inadequate to hold back the soil, so rows of sandbags were built into the fill: Hessian was laid over the filled scrape to hold the soil in place. Compacting the soil during filling was critical.

Plate 12 - Scrape 5 during repair, looking south

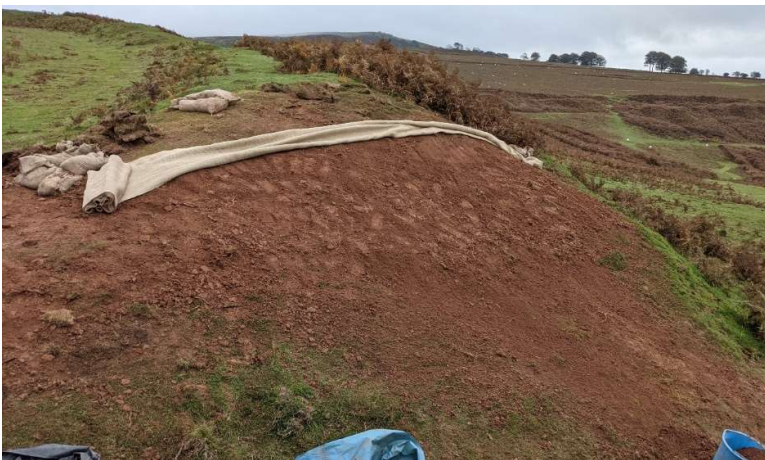
Plate 13 - Scrape 5 after filling, looking south. Hessian was placed over the repairs.
