Video Analysis of Motorcycle and Rider Dynamics During High-Side Falls

2017-01-1413

Nathan A. Rose, Neal Carter, David Pentecost, and Alireza Hashemian

Kineticorp LLC

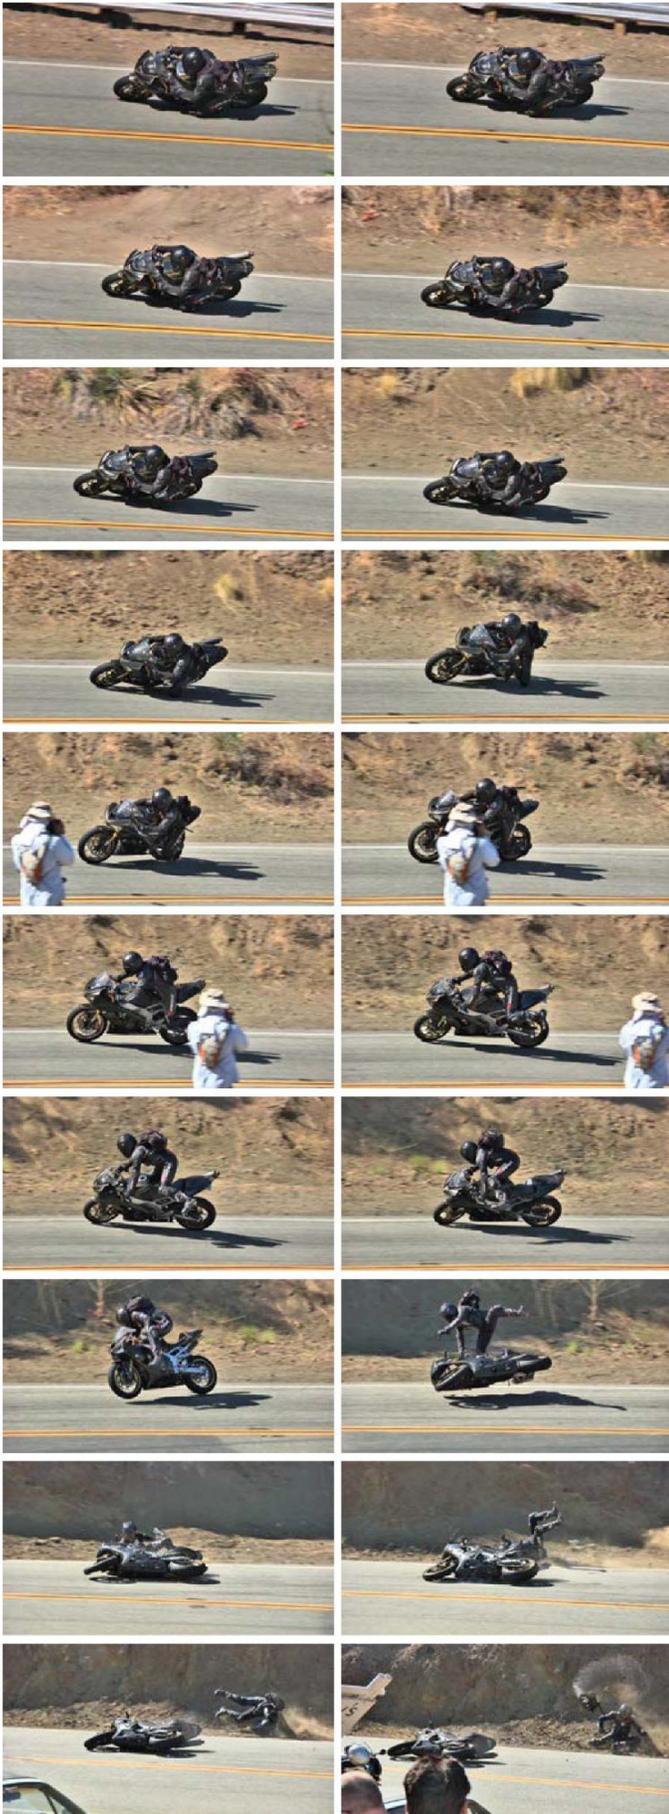
Figure 8. Video Sequence for Case #1

chosen so that Figure 8 would give the reader a sense for the motion of the motorcycle and rider during the loss of control and the fall. The frames of Figure 8 begin after the motorcyclist has driven into the curve and developed a leftward lean of the motorcycle and his body. This leftward lean developed over approximately 1.4 seconds. The frames of Figure 8 end after both the rider and motorcycle have struck the ground and they are both still in the process of sliding to rest.

In quantifying the speeds and motion of the motorcycle and rider in this video (and the other videos discussed later), tar marks and dark patches of asphalt were used as reference points to determine travel distances. These are visible in the video frames of Figure 8 (the tar marks straddle the centerline). Also, Figure 9 is a photograph from the authors' site inspection in which some of the tar marks are also visible. The locations of these tar marks and dark patches were documented during our site inspection. Calculations based on the distances traveled by the motorcycle between these reference points and on the known frame rate of the video revealed that this motorcyclist was traveling a speed of approximately 40 mph as he approached the exit of the curve, a speed that is maintained until the rider begins losing control of the motorcycle.

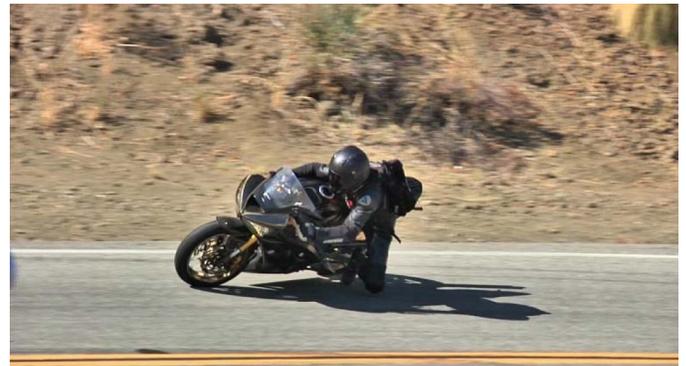
Figure 10. Contact with the Roadway Pulls the Rider's Left Knee Back and Pulls His Foot Off the Foot Peg

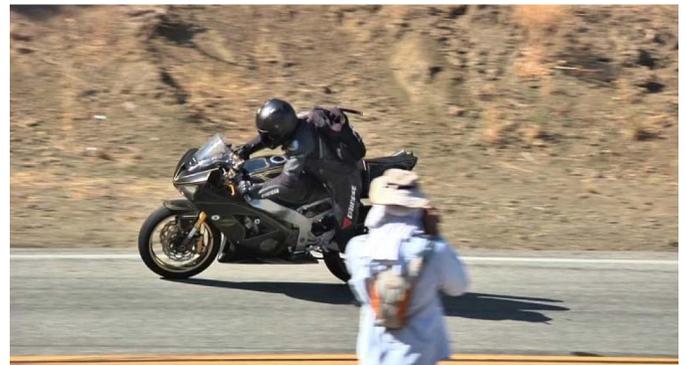
Figure 11. The Counterclockwise Yaw Ceases, the Motorcycle Yaws Clockwise and Rights Itself

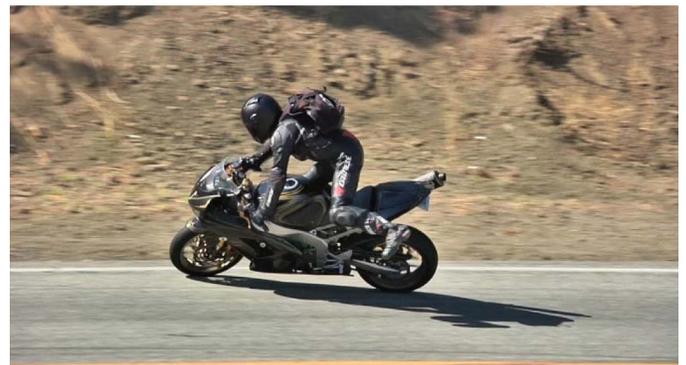
When the rider releases the throttle, the longitudinal force demand on the rear tire decreases and the available traction for cornering increases. This results in the leftward lean of the motorcycle beginning to decrease. Eventually, the counterclockwise yaw ceases and the motorcycle yaws clockwise as the motorcycle rights itself (Figure 11). As the heading of the motorcycle comes into alignment with its velocity direction and the motorcycle rights itself, the front tire is steered to the left (Figure 12). The momentum of the motorcycle initially continues to carry it towards a leftward lean/fall with a clockwise yaw rotation (also visible in Figure 12). A left leading sideslip develops. As this occurs, the rider's buttocks separate from the motorcycle (Figure 12).

Figure 12. Rider Steers to the Left, Motorcycle Initially Continues to Towards a Leftward Lean/Fall, and a Left Leading Sideslip Develops

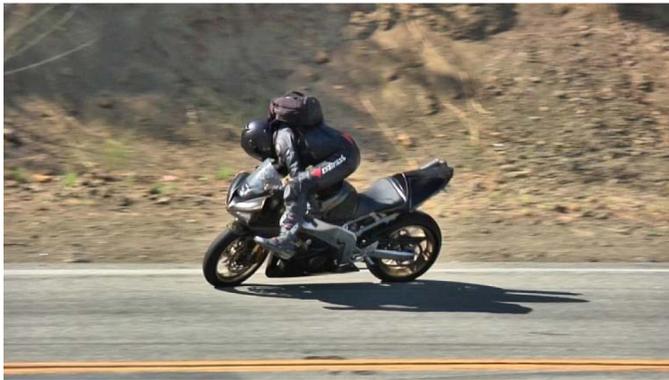
The leftward steer input reverses the yaw direction and the motorcycle again develops a right side leading sideslip (Figure 13). By this point in the sequence, the motorcycle speed has dropped to approximately 30 mph. The lateral force that develops during this right side leading sideslip throws the motorcycle into a rightward lean (Figure 14). As the motorcycle transitions from a leftward lean to a rightward lean, the motorcyclist's buttocks impact the fuel tank of the motorcycle. The motorcycle tires lose contact with the ground and the rider is projected upward, out ahead of, and to the right of the motorcycle (also visible in Figure 14). The rider initially continues to grasp the handlebar grips during this time, but eventually his trajectory and the motorcycle's diverge to the point that he releases his grip. From the position depicted in Figure 12 to the position depicted in Figure 14, the motorcycle and rider travel approximately 13 feet over 0.28 seconds.

Figure 13. Right Side Leading Sideslip

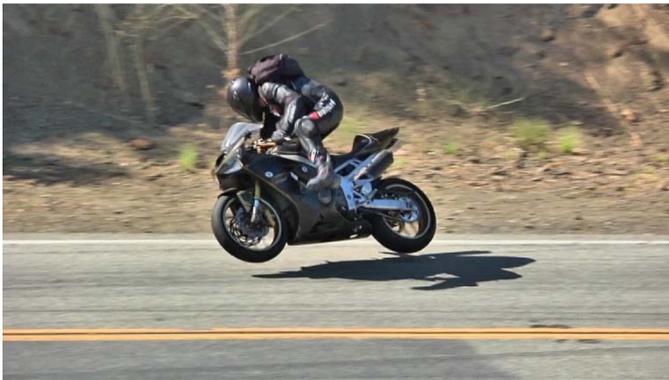
Figure 14. Lateral Force from Right Side Leading Sideslip Throws the Motorcycle into a Rightward Lean and Launches the Rider Ahead of the Motorcycle

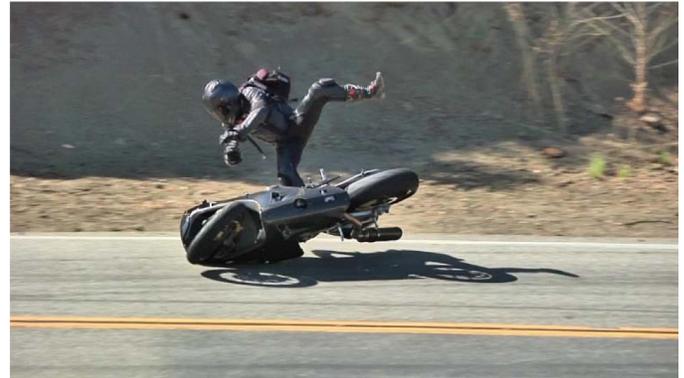
The motorcycle lands on its right side (Figure 15) and then the rider lands in a seated posture facing rearward, opposite his initial direction of travel, after a launch of 44 feet (Figure 16). The motorcycle remains on its right side while sliding on the ground for approximately 95 feet, decelerating at a rate of approximately 0.33g. The motorcycle does not tumble. As the rider travels to rest, his torso and head rotate toward the ground and ultimately strike it (Figure 17). He then tumbles heels-over-head and again comes to a seated posture striking the ground with his buttocks and legs and then flopping onto his back into the dirt shoulder. As a result of impacting the ground and then sliding and tumbling to rest, the rider decelerates at a rate of approximately 1.0g. This deceleration rate is consistent with the

Figure 15. Motorcycle Lands on Its Right Side

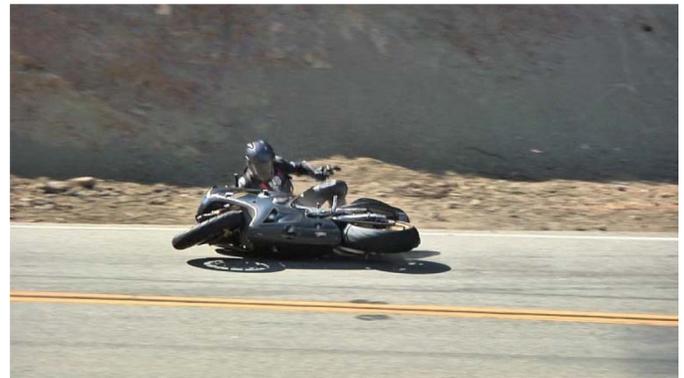
Figure 16. Rider Lands in a Seated Posture Facing Opposite His Initial Direction of Travel

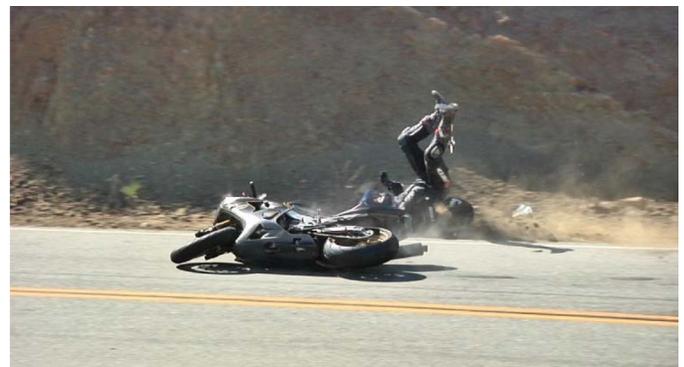
Figure 17. Rider Head and Torso Strike the Ground

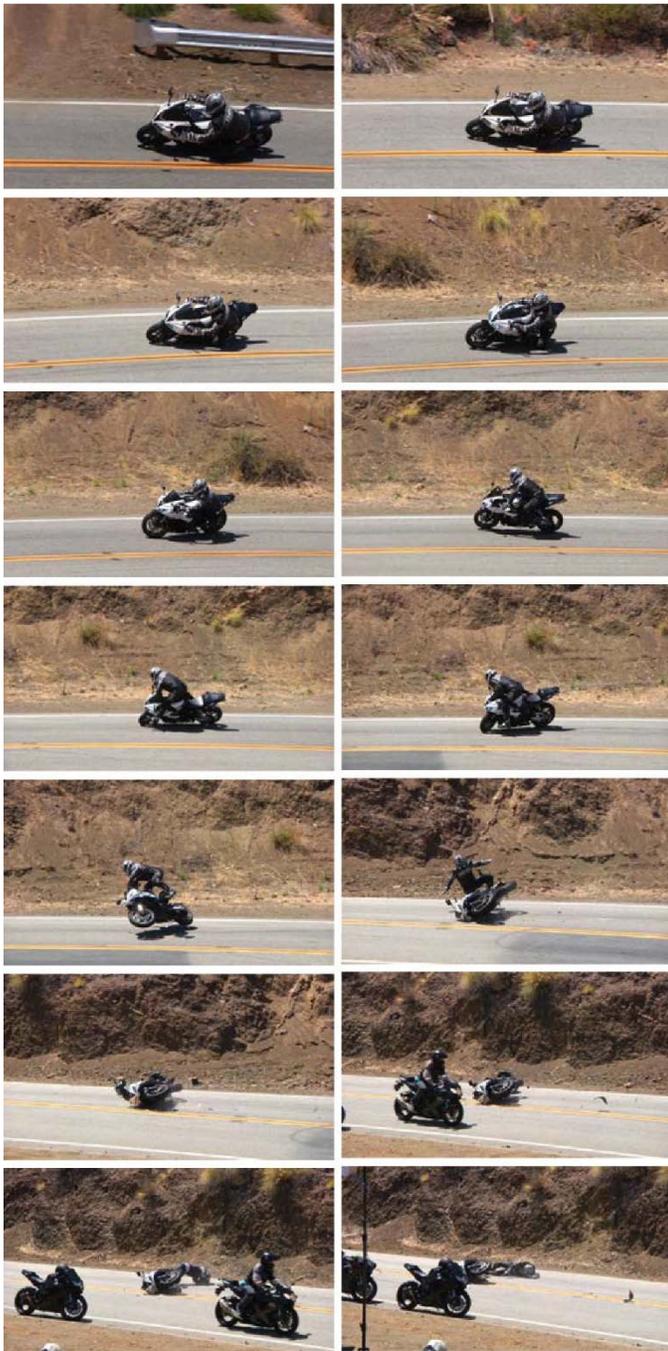
Figure 18. Video Sequence for Case #2

The frames of Figure 18 begin after the motorcyclist has driven into the curve and developed a leftward lean of the motorcycle and his body. This leftward lean developed over approximately 1 second. The

frames of Figure 18 end after both the rider and motorcycle have struck the ground and they are both still in the process of sliding to rest.

The tar marks and dark asphalt patches on the roadway were again used as reference points to determine travel distances. These are visible in the video frames of Figure 18. Calculations based on the distances traveled by the motorcycle between reference points and on the known frame rate of the video resulted in a speed for this motorcyclist as he approached the exit of the curve of approximately 43 mph. Prior to this, the rider had been applying throttle to increase his speed, as indicated by the audio. Beyond this point, the speed begins to decrease.

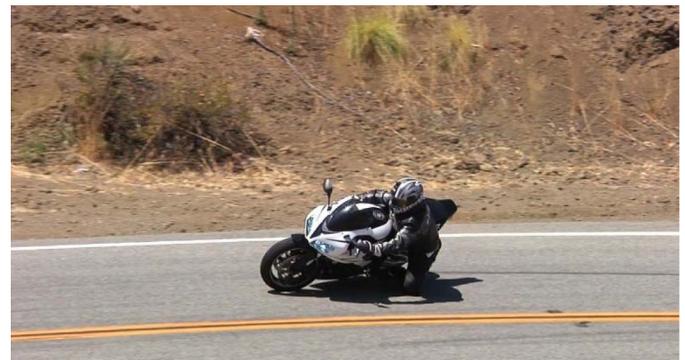
The development of right side leading sideslip at the rear tire becomes evident in the video and the motorcycle begins yawing in a counterclockwise fashion (Figure 19). During this yaw, the rear tire of the motorcycle deposits a tire mark on the roadway (visible in Figure 19). As the yaw progresses, the front wheel is steered to the right and the rider decreases the throttle input.

Figure 19. Right Side Leading Sideslip, Counter-Steer, and Tire Mark

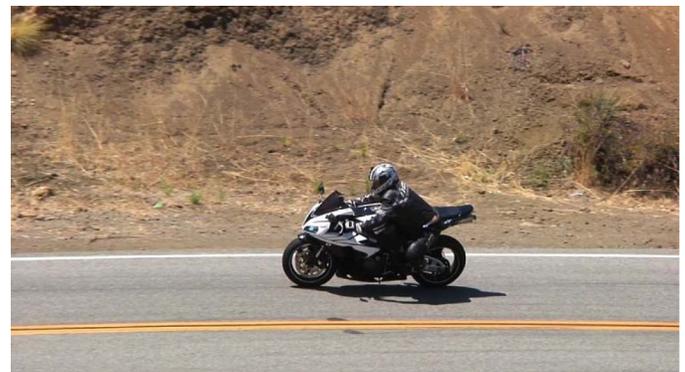
Figure 20. The Counterclockwise Yaw Ceases, the Motorcycle Yaws Clockwise and Rights Itself

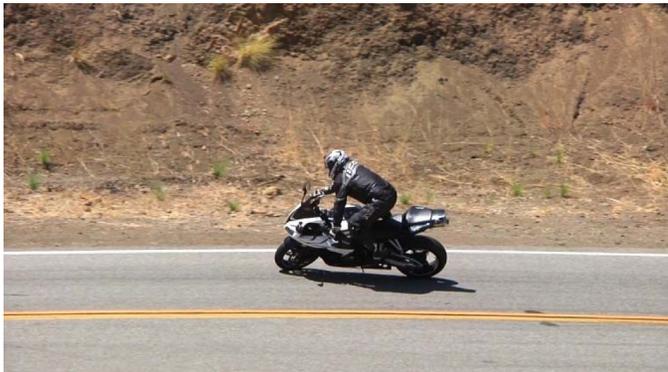
As the heading of the motorcycle comes into alignment with its velocity direction and the motorcycle rights itself, the front tire is steered to the left (Figure 21). The momentum of the motorcycle initially continues to carry it towards a leftward lean/fall with a clockwise yaw rotation (also visible in Figure 21). A left leading sideslip develops. As this occurs, the rider's buttocks separate from the motorcycle (Figure 21).

Figure 21. Rider Steers to the Left, Motorcycle Initially Continues to Towards a Leftward Lean/Fall, and a Left Leading Sideslip Develops

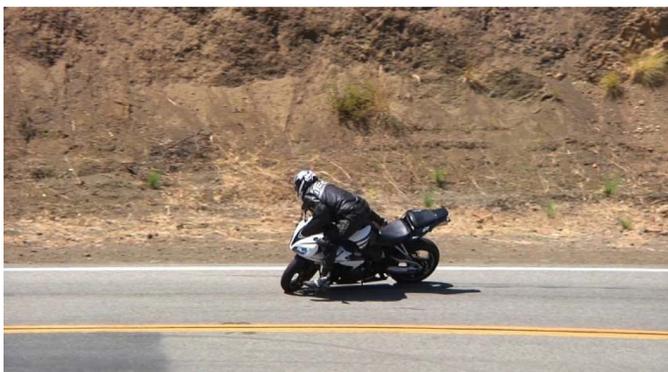
Eventually, the leftward steering reverses the yaw direction and the motorcycle again develops a right side leading sideslip (Figure 22). The rear tire of the motorcycle deposits a tire mark on the roadway and the lateral tire forces throw the motorcycle into a rightward lean (Figure 23). As the motorcycle transitions from a leftward lean to a rightward lean, the motorcyclist's groin and left thigh impact the fuel tank of the motorcycle. The motorcycle tires lose contact with the ground and the rider is projected upward, out ahead of, and to the right of the motorcycle (also visible in Figure 23).

Figure 22. Right Side Leading Sideslip

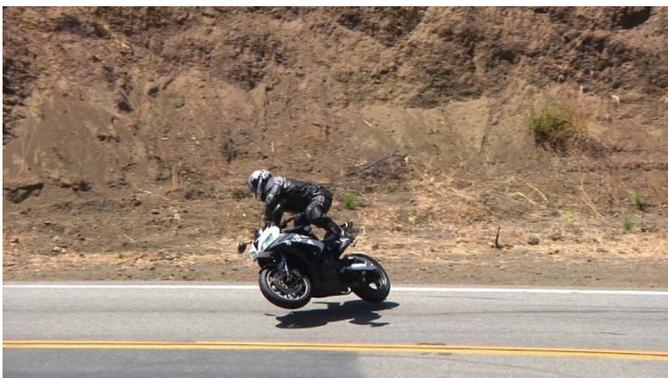
Figure 23. Lateral Forces from the Right Side Leading Sideslip Throw the Motorcycle into a Rightward Lean and the Rider is Launched Ahead of the Motorcycle

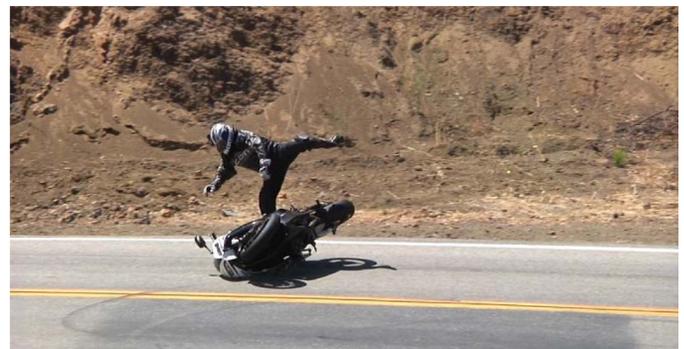
The motorcycle lands on its right side (Figure 24), and then the rider lands in a seated posture facing rearward, opposite his initial direction of travel (Figure 25). The rider was launched in the air a distance of approximately 54 feet. The motorcycle stays on its right side throughout its entire slide on the ground and does not tumble. It decelerates at an average rate of approximately 0.4g and then comes to rest on its right side facing opposite its initial direction of travel. As the rider travels to rest, his torso and head rotate toward the ground and ultimately strike it. He then tumbles to rest. As a result of impacting the ground and then sliding and tumbling to rest, the rider decelerates at a rate of approximately 1.07g, a rate higher than the rate at which the motorcycle decelerates. Because of this, the motorcycle comes to rest further down the road than the rider.

Figure 24. Motorcycle Lands on Its Right Side

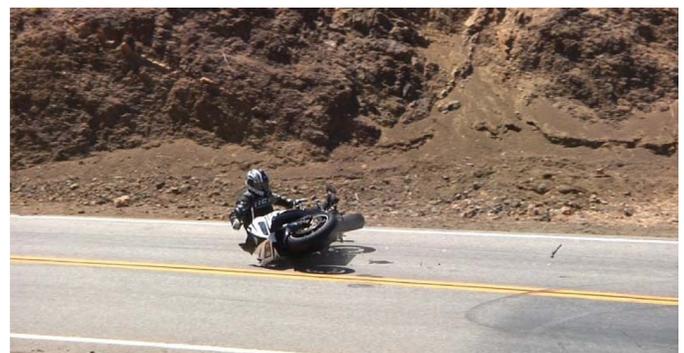
Figure 25. Rider Lands in a Seated Posture Facing Opposite His Initial Direction of Travel

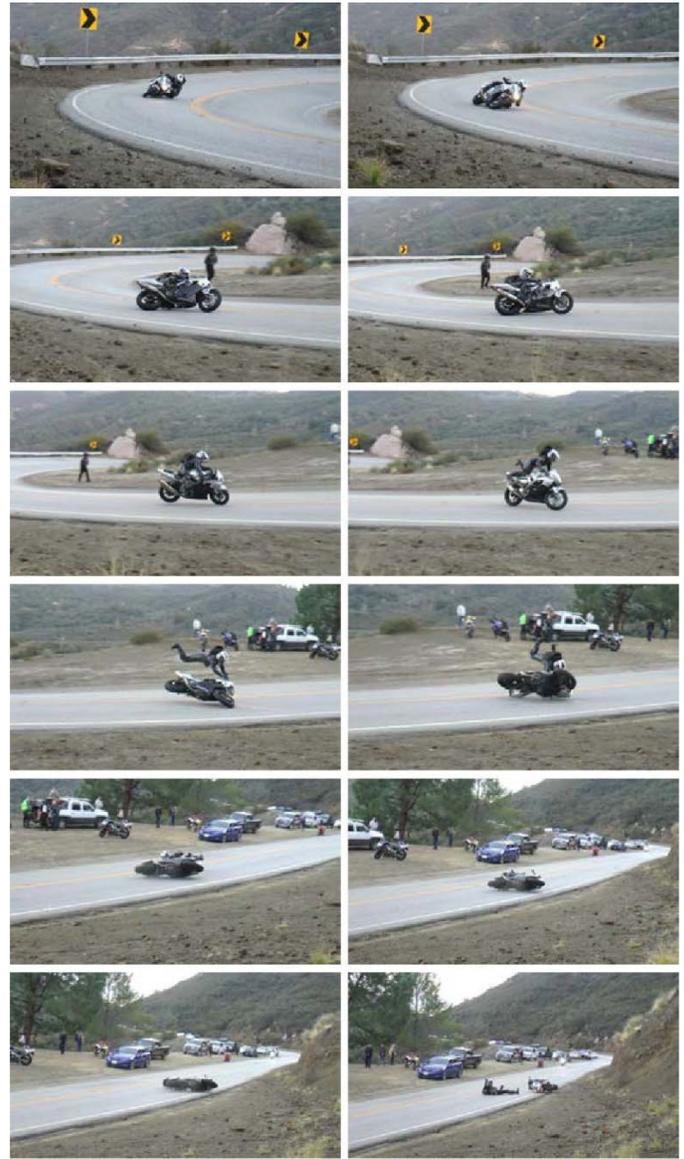
Figure 26. Video Sequence for Case #3

The third crash analyzed here involved a Honda CBR600 F4i (MY 2001) traveling westbound through Edwards Corner [11]. [Figure 26](#) contains a series of frames from the video showing the motorcycle and rider motion during this crash. The frame rate of this video was 59.94 frames per second. Again, the time intervals between these frames are not constant, but instead were chosen so that [Figure 26](#) would give the reader a sense for the motion of the motorcycle and rider during the loss of control and the fall. The frames of [Figure 26](#) begin after the motorcyclist has driven into the curve and developed a leftward lean of the motorcycle and his body. The frames of [Figure 26](#) end after both the rider and motorcycle have struck the ground and then slid to rest.

The tar marks and dark asphalt patches on the roadway were again used as reference points to determine travel distances. Travel distances were converted to speeds through the known frame rate. In this instance, the rider was traveling approximately 39 mph as he passed the end of the guardrail. A loss of traction occurs at the rear tire and the motorcycle enters a right side leading yaw ([Figure 27](#)). The front wheel is steered to the right (also visible in [Figure 27](#)).

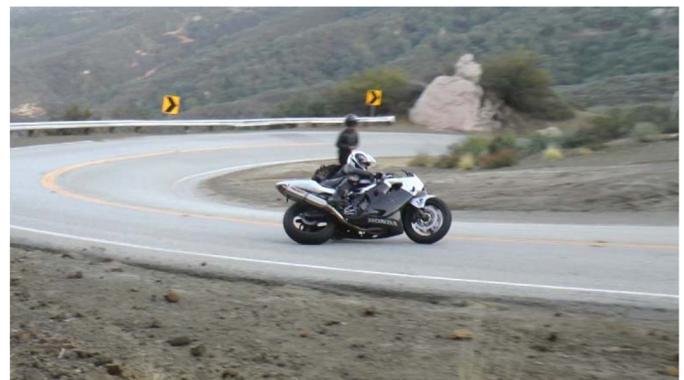
Figure 27. Right Side Leading Sideslip and Counter-Steer

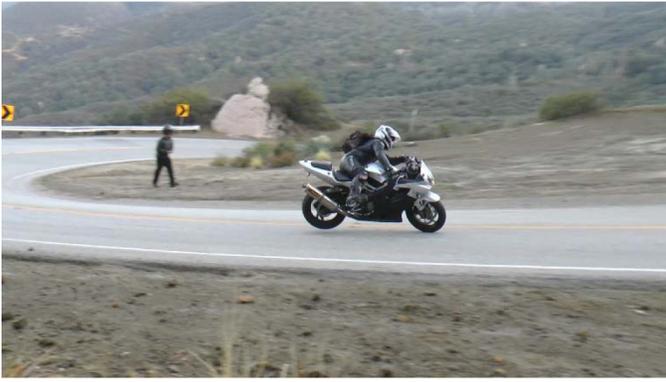
As this yaw develops, the engine speed remains relatively constant until shortly after the rider begins to counter steer. At that point, the engine speed rapidly decreases and the rear tire begins screeching as it slides across the pavement. When the screeching stops, the motorcycle quickly begins to roll into an upright position and to decrease its yaw angle ([Figure 28](#)).

In this instance, the rear tire leaves the roadway as the motorcycle rights itself (also visible in [Figure 28](#)). This leads to a quickly developing left side leading yaw that results in a left leading high-side fall when the rear tire lands ([Figures 29 and 30](#)). The rider is projected upward and forward relative to the motorcycle.

Figure 28. The Right Side Leading Yaw Ceases, the Motorcycle Yaws Clockwise and Rights Itself

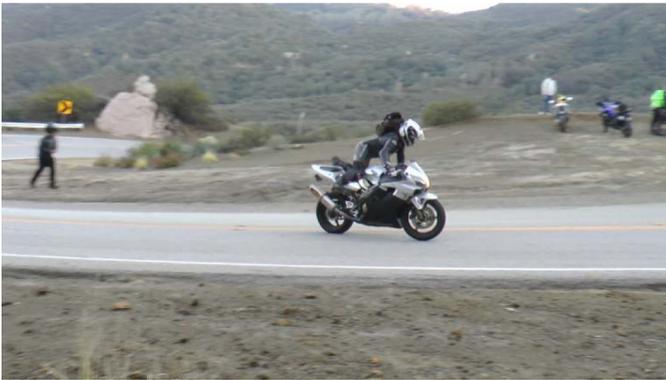
Figure 29. Left Side Leading Yaw

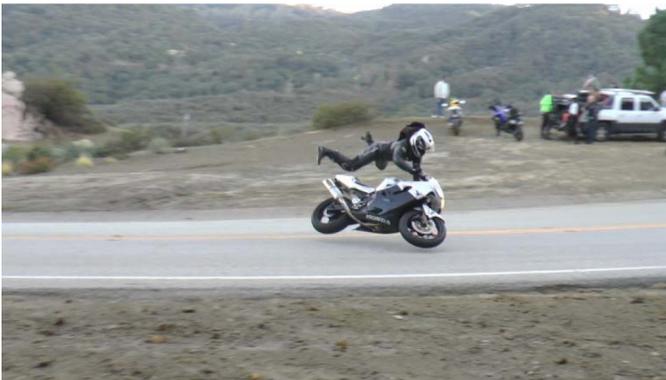
Figure 30. Left Side Leading High-Side Fall

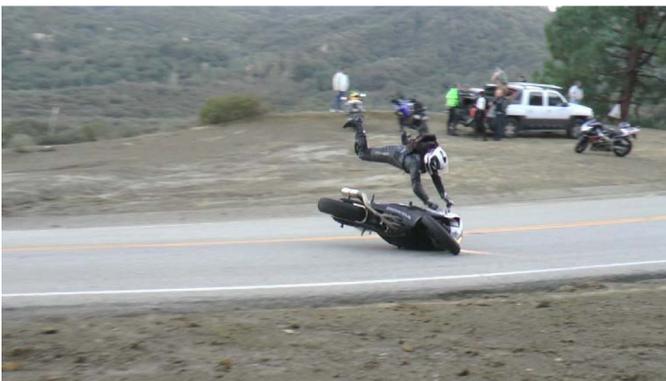
The motorcycle lands on its left side ([Figure 31](#)), while the rider is still airborne. Eventually, the rider lands feet leading, in a prone position having been thrown approximately 33 feet in the air. The motorcycle remains on its left side throughout its entire slide on the ground, decelerating at an average rate of 0.48g. After contacting the ground, the rider decelerates at a rate of 0.79g, higher than the motorcycle, and thus, during the sliding phase, the motorcycle catches up with and passes the rider. The motorcycle comes to rest just downstream of the rider, after sliding for approximately 52 feet.

Figure 31. Motorcycle Lands

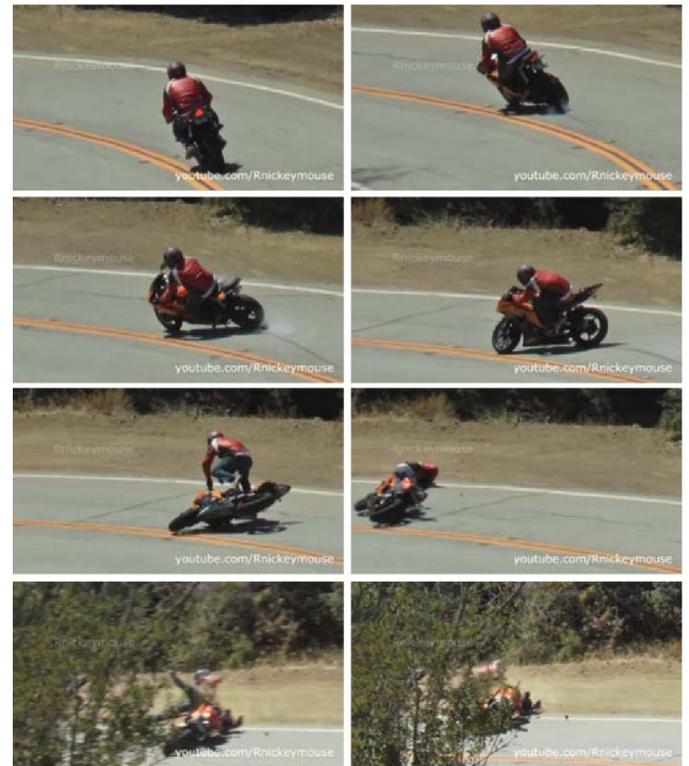
Figure 32. Video Sequence for Case #4

The rider in this crash had just traveled eastbound through Edwards Corner and was continuing down the hill when the video shows his motorcycle's chain coming off and beginning to drag on the ground. As the rider drives into the left turn immediately after Edwards Corner, the rear brake lamp becomes illuminated, indicating the rider has applied the brakes. The rider continues to brake as he enters the turn and develops a leftward lean. The rear tire of the motorcycle stops rotating and begins depositing a tire mark on the roadway. The vehicle's rear tire begins to off-track to the right and a right side leading yaw develops. The front tire is steered to the right and the

rider reduces the rear brake application. The available lateral traction increases and the motorcycle quickly transitions into a right side leading roll, vaulting itself and the rider into the air. The rider is projected out ahead of and to the right of the motorcycle. The motorcycle lands on its right side and slides to rest. The rider eventually lands and tumbles to rest.

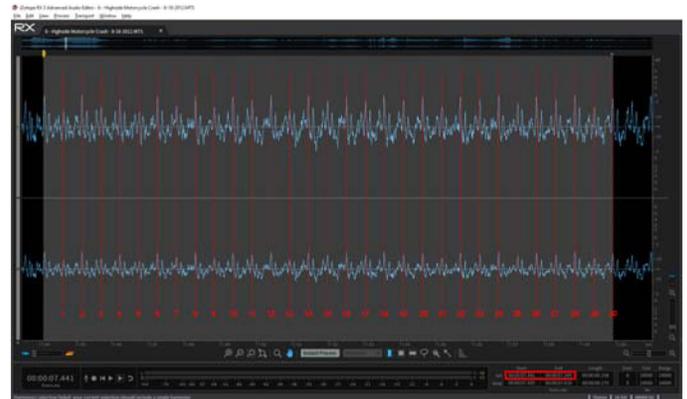
Figure 34. Audio Analysis, Case #1

To conduct our audio analysis, we imported the video file from Case #1 into RX 5 Audio Editor [13] to analyze the left and right waveforms. This revealed a cyclical pattern from the sound of the motorcycle engine. The number of cycles were counted for the segment of audio in which the rider traversed the dark patch in the asphalt, as depicted in [Figure 34](#). This led to the conclusion that the cyclical pattern occurred at a frequency of 190 Hz. A four-cylinder, four-cycle engine will produce two exhaust notes for every rotation of the engine. So the engine would be rotating at $\frac{1}{2}$ the frequency of the cyclical pattern in the sound. Thus, we determined that the engine was rotating at a rate of approximately 5700 RPM.

We obtained drivetrain specifications for the motorcycle, and determined the speed that the motorcycle would be travelling in various gears at an engine speed of 5700 RPM [14]. After the crash, the camera operator records the condition of the motorcycle, and the rear sprocket is shown. We determined that the rear sprocket was an aftermarket Vortex sprocket, but that it was only available with the stock number of teeth. The front countershaft sprocket was not visible, so it's possible that an aftermarket front sprocket would change the final drive ratio. We assumed the factory drive ratio and determined that in 1st, 2nd, 3rd, and 4th gear, the motorcycle would be travelling at 26.7, 37.9, 45.2, and 53.7 mph, respectively. The analysis of the video over these two frames resulted in a speed of 37.0 mph for motorcycle, and therefore, we concluded that the motorcycle was in 2nd gear during this section.

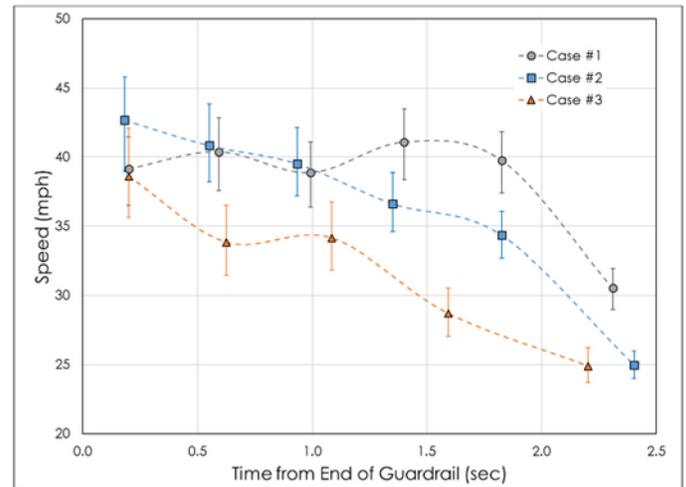
Figure 37. Speed Analysis Results

Figure 37 depicts the speed analysis results for Cases #1, #2, and #3. In these cases, the rider is requesting lateral tractive force from the rear tire to navigate the curve, while also requesting longitudinal tractive force by applying the throttle. Ultimately the resultant tractive force requested by the rider exceeds the available traction. Note that even though the riders are applying the throttle, due to the upward grade on this section of the roadway, the application of throttle does not necessarily result in a net increase in speed of the motorcycle, as seen in Cases #2 and #3.

To examine the sensitivity of the frames that we chose to represent the point at which the motorcycles passed each tar mark, the number of frames between each consecutive pair of positions was varied and the effect that the variance had on the calculated speeds was determined. For Case #1 and Case #2, the times were varied by $1\frac{1}{2}$ frames (0.025 seconds), which resulted in a speed variance of approximately ± 3 mph or less for each calculated speed. For Case #3, the camera angle was less conducive to a precise estimate of the motorcycle position, so the time component of the speed calculation was varied by 2 frames (0.033 seconds), which resulted in a speed variance of approximately $\pm 3\frac{1}{2}$ mph or less. The vertical bars in Figure 37 represent the results of the sensitivity analysis.

The authors examined the lean angle required of the riders to traverse this curve based on the speeds that were calculated just as the riders passed the guardrail, and the riders estimated path from the video analysis. We determined that the effective lean angle was around 45 to 50 degrees for each motorcycle and rider [6,7].
