Vendor Pre-Sale Building & Timber Pest Inspection Report

In accordance with Australian Standard AS 4349.1 - 2007 and AS 4349.3-2010 32 Broadfoot Avenue Marsden Park 2765 New South Wales Australia

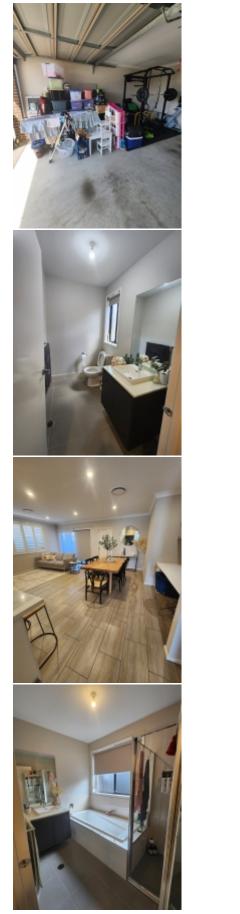
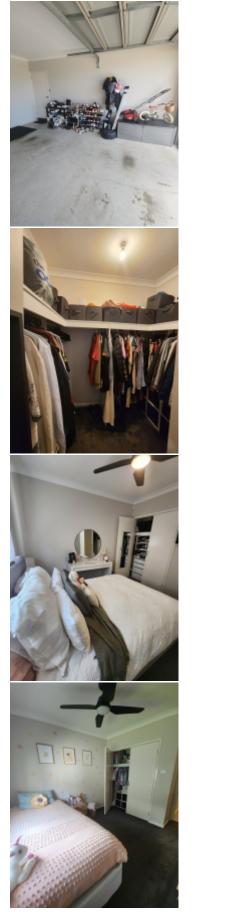
Obstruction Photos

Were there any obstructions that may conceal possible defects or timber pest attack?	Yes
Hindered Areas:	The Interior
	The Exterior
	Roof Void
	The Site
	Other
	From these
Interior Obstructions:	Furniture
	Flooring
	Fixtures
	Items/belongings stored against wall
	Items/belongings stored to cupboards
	Limited access to skirting boards
	Limited access to skirting boards due to stored items in garage
Exterior Obstructions:	Vegetation
	Stored Articles
	Air Conditioner Ducting
	Water Tanks
Roof Void Obstructions:	Insulation
	Sarking
	Air conditioning ducting
	Low clearance to the outside edges of roof void
	Low clearance in roof void
Site Obstructions:	Vegetation

It is very important to note that further inspection is highly recommended for any areas where access or visibility was hindered, restricted or obstructed in any way at the time of the Inspection.

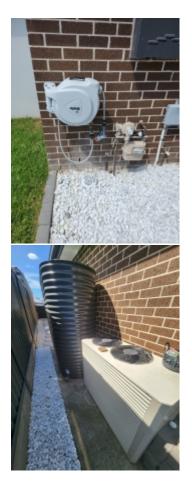
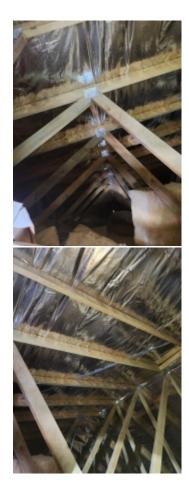
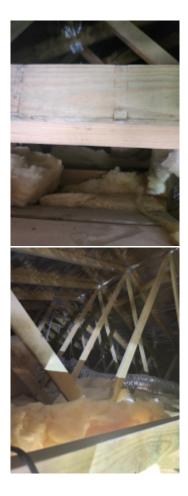
Right Side Elevation

Defect Severity	Minor Defect
Defect Classicfication	A - Damage
Defective Item	Walls
Defect	Cracks or Damage
Comment	Signs of cracks or damage observed in the exterior walls, potentially affecting their overall performance.

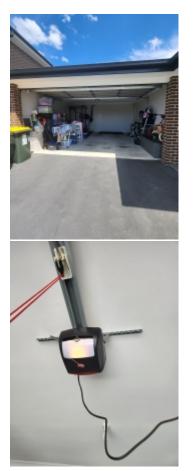
Garage

Defect Severity	Minor Defect
Defect Classification	A - Damage
Defective Item	Paths and driveways
Defect	Cracks or Damage
Comment	Signs of cracks or damage observed in the paths, potentially affecting their overall performance.

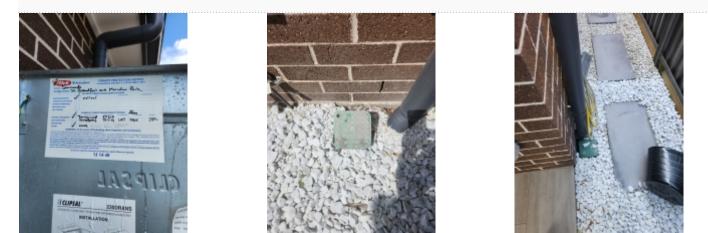
Durable Notice Photos

Is a termite treatment recommended?	No
EVIDENCE OF A POSSIBLE PREVIOUS TREATMENT	
Was evidence of a previous treatment located? (this may include drill holes, dusting or baiting)	Yes
Description of the evidence found:	Treatment sticker in meter box
	Reticulation termite treatment
