Assessment Overview

Mere Point, Brunswick, ME

Mitchell Field, Harpswell, ME

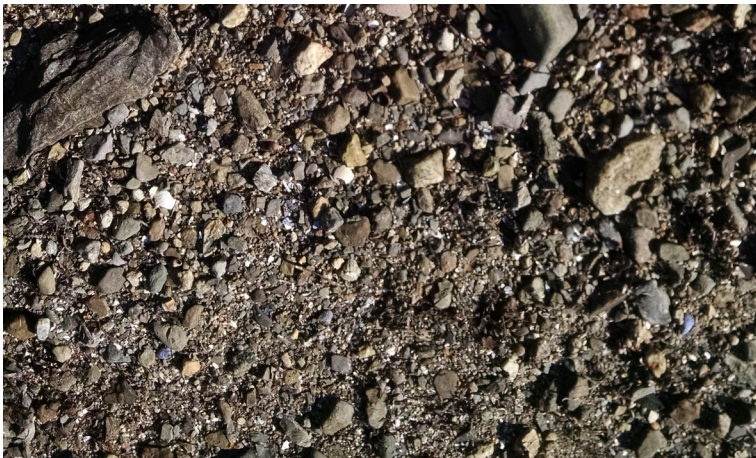
Because the soils in and around Mackworth Island consist primarily of till, the soil matrix has a high pore spacing between the sand and gravel particles. The toe of the bluff had intermittent ledge mixed with gravel and sand. Seaward of the toe intermittent beach is found consisting mainly of larger soil mixture of gravel and cobble with a scattering of boulders.

Figure 2. Soils at the Mackworth Island sites were primarily till.

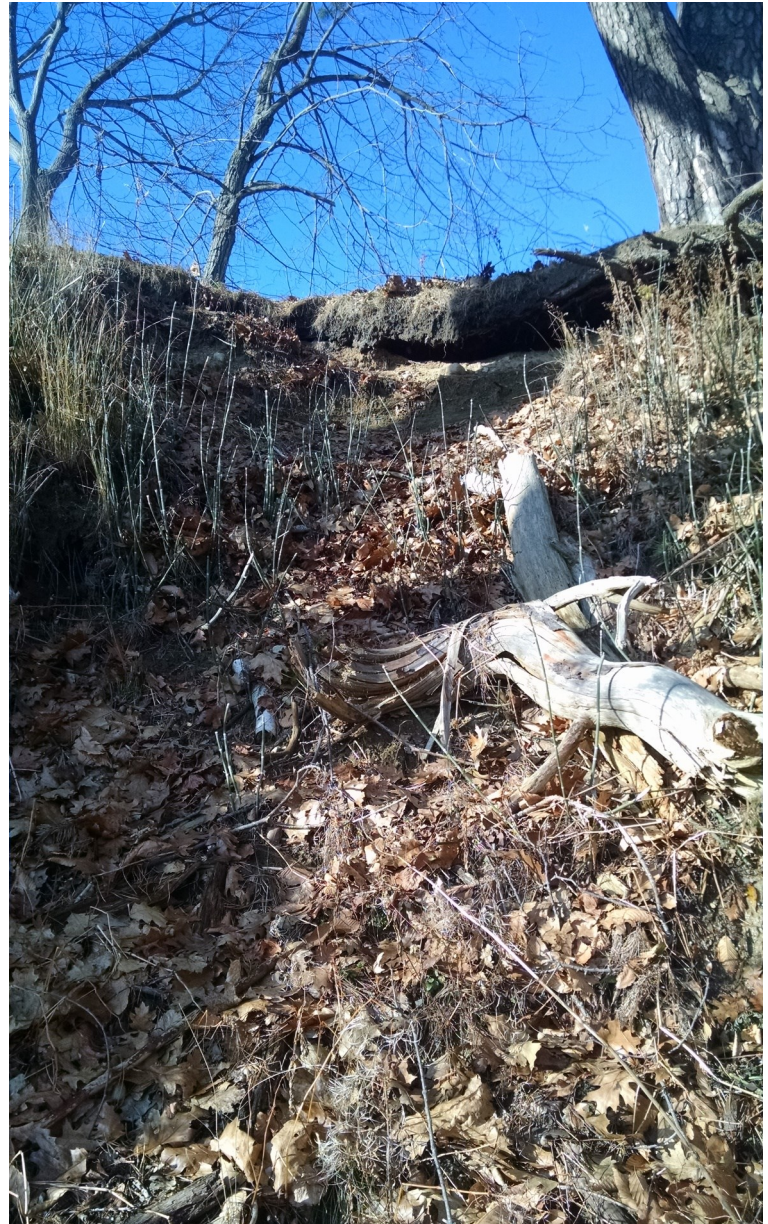
This interaction between runoff and steep exposed banks is being enhanced by the reduced vegetation in the upland area that has reduced the potential for root structure to assist in binding soil near the bluff-upland interface. Areas that have lost vegetation are seeing accelerated erosion from runoff in the form of rills, allowing the vegetated areas to be vulnerable to rapid erosive change.

Figure 3. Removal of upland vegetation increases erosion at the Mackworth Island sites.

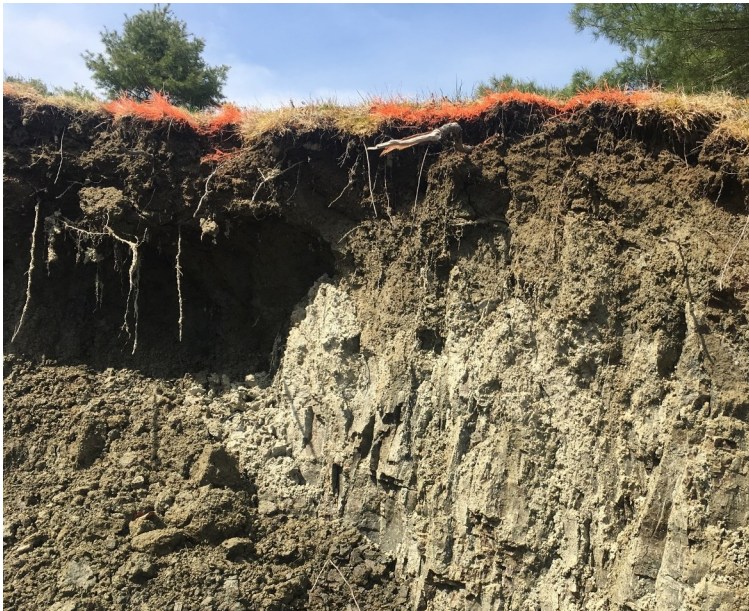
Soils exposed by the landslide are predominantly clay in nature. Because clay particles are small and generally have large aspect ratios, interactions between the particles and water can result in reduced shear strength and underground movement and contribute to landslides. The Maine Geological Survey has identified two landslides along this shoreline of Mere Point.

Figure 2. Clay soils visible in bluff failure at Mere Point Case Study location.

The drainage area that provides overland flow to the top of the failure is approximately 260' by 165' with three concentrated flow paths to the top of the bluff slope. One of these concentrated paths leads to the point of the bluff mass wasting failure (see Figure 2).

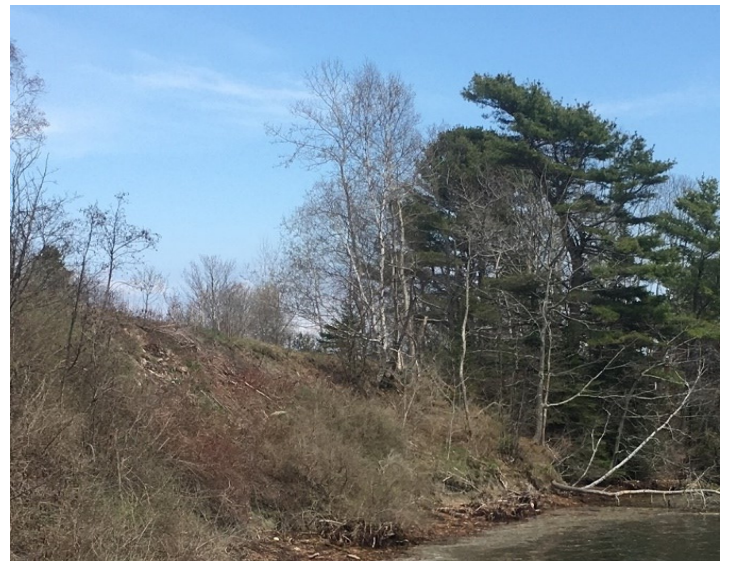
Figure 3. Saturated, clay soils with shallow slope failures.

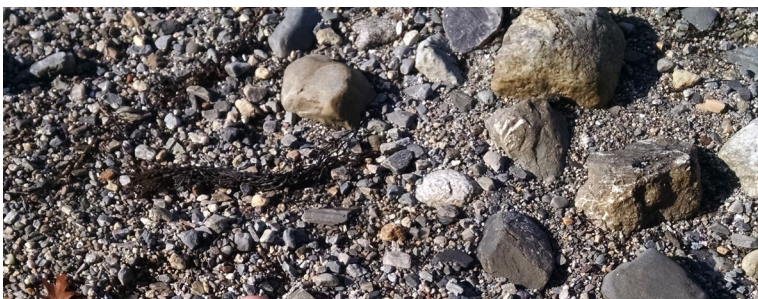
Soils in and around Mitchell Field exposed by the shallow failure appear to be predominantly sandy and gravelly, consistent with the unconsolidated sand/gravel particles common in glacial till. The toe of the bluff is comprised of clay mixed with gravel and sand. The shore beyond the toe of the bluff consists mainly of sand and gravel helping form the beach found here.

Figure 2. Sandy and gravelly soils at Mitchell Field site.

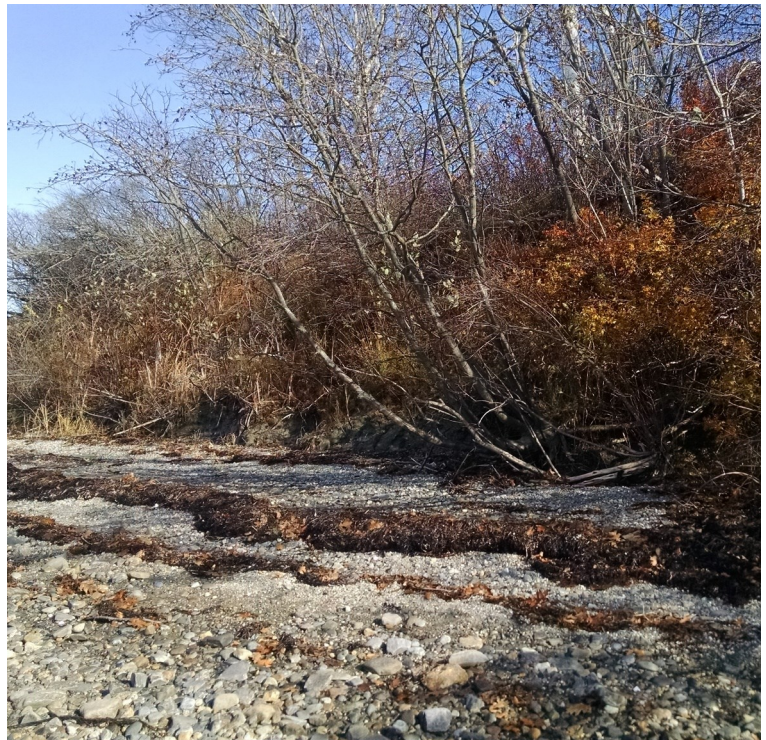
The field upland to this location is regularly mowed, and trees and both woody and herbaceous plants are intentionally removed to maintain a walking and viewing area at the top of the bluff. Several smaller trees and herbaceous growth have slid down the slope, creating exposed soil during movement. Most of the remaining vegetation is currently growing at an angle, likely due to the shallower root structure of this vegetation. Lack of vegetation to stabilize slope is exacerbated by the effect of surface runoff reaching the face at the top of the bluff.

Figure 3. Much of the vegetation at the Mitchell Field site is growing at an angle, likely due to the plants' shallow root structure.
