Robust Internal Thermal Insulation of Historic Buildings

Project no.:	637268
Project full title:	Robust Internal Thermal Insulation of Historic Buildings
Project Acronym:	RIBuild
Deliverable no.:	D3.2 (not yet approved by the European Union)
Title of the deliverable:	Monitoring Data Basis of European Case Studies for Sound Performance Evaluation of Internal Insulation Systems Under Different Realistic Boundary Conditions

Contractual Date of Delivery to the EC	31.01.2019 (M49)
Actual Date of Delivery to the EC	29.04.2019 (M52)
Organisation name of lead contractor for this deliverable	TUD
Author(s)	Peggy Freudenberg (TUD)
Participants(s)	DTU, RTU, AAU, UNIVPM, HES-SO
Internal reviewers	Morten Ørsager (EMA), Sébastien Lasvaux (HES-SO), Ernst Jan de Place Hansen (AAU)
Work package contributing to the deliverable	WP3
Nature	R
Version	1.0
Total number of pages	103
Start date of project	01.01.2015
Duration of project	31.12.2019

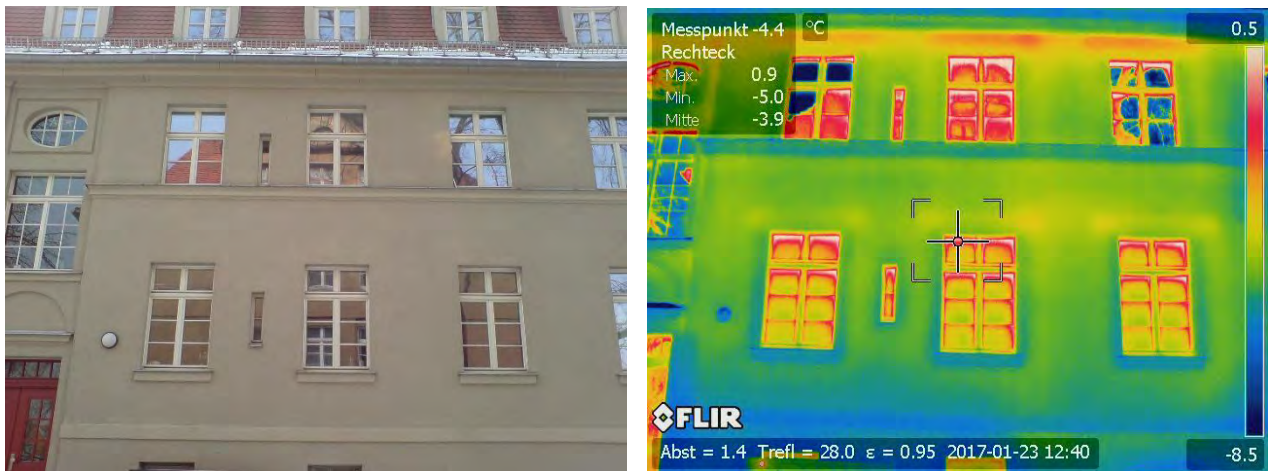
Figure 2: Photography and infrared image of the building façade taken from the case study building in Weimar, Germany. Thermal bridge areas around windows, ceiling, roof and inhomogeneity in the wall can be seen in the distribution of surface temperatures.

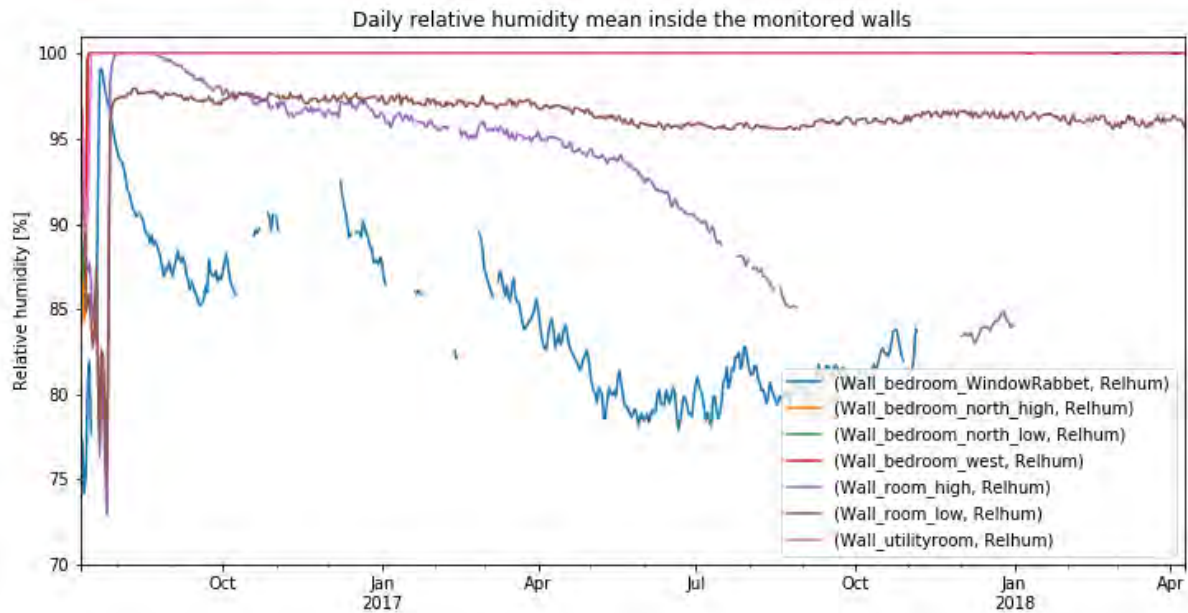
Figure 23: Extract of the measurement results for the building in Klitgaarden, Denmark for the winter period 2017-2018. The majority of the sensors (four out of seven) record a permanent moisture level of 100% (it was questioned where some of these had defects as single-point measurements showed lower values). Three sensors show a drying tendency towards summer.

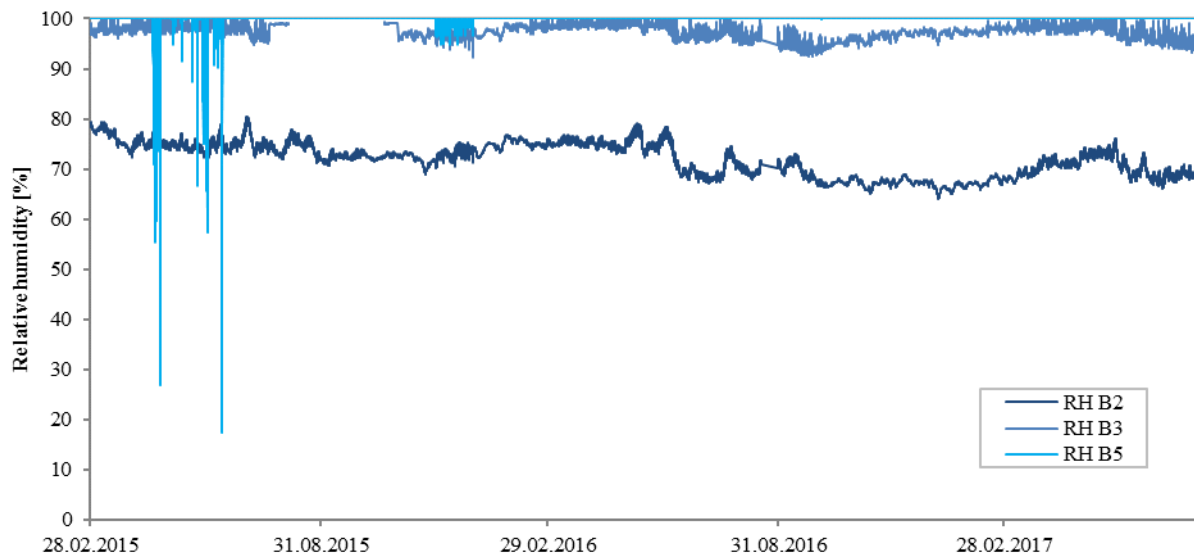
Figure 24: Extract of the measurement results for the building in Haderslev, Denmark for the period from winter 2015 until winter 2018. Two (B5 and B3) out of three sensors record a permanently high moisture level of around 97%. The third sensor (B2) shows a small drying tendency.

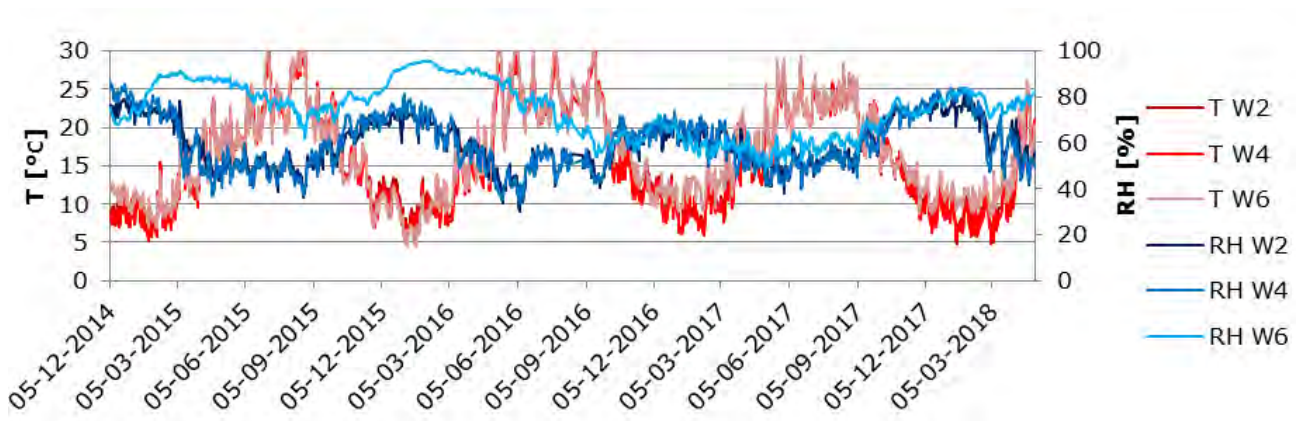
Figure 33: Relative humidity and temperature between insulation and historic wall construction measured in the case study building in Meinungsgade, Copenhagen. Relative humidity shows strong fluctuations, which are untypical for a construction with a vapour barrier.

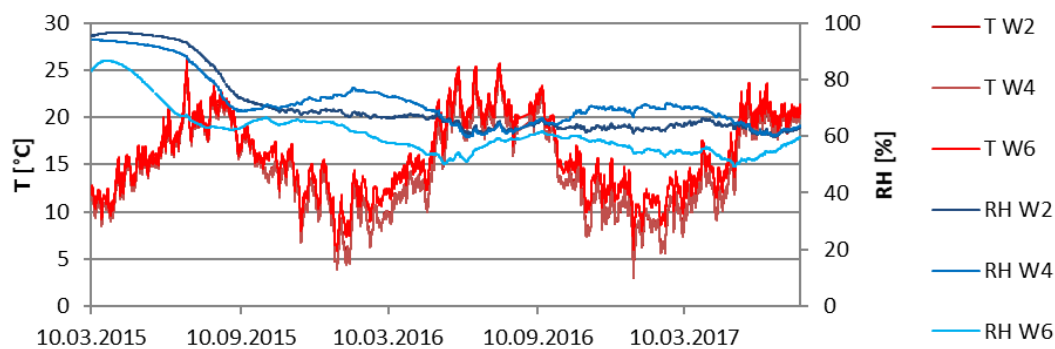
Figure 34: Relative humidity and temperature between insulation and historic wall construction measured in the case study building in Kildevaeldsgade, Copenhagen. Relative humidity shows small fluctuation. The wall construction is the same as for the building in Meinungsgade except a lower insulation thickness (25 mm compared with 60 mm in Meinungsgade).

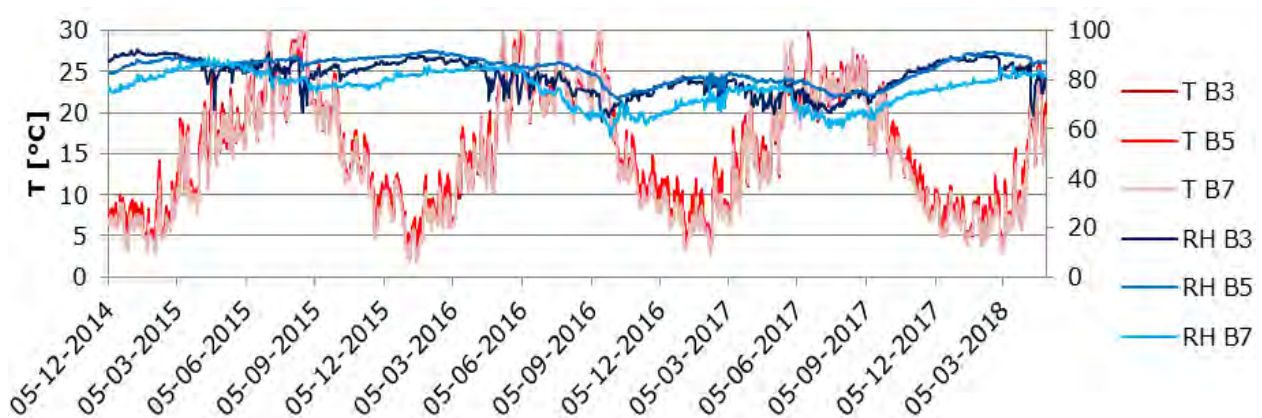
Figure 38: Joist end temperature (T) and relative humidity (RH) in the case study building in Meinungsgade, Copenhagen. Despite an initial drying process, the moisture content exceeds the 80% level in the third measurement year (2018).

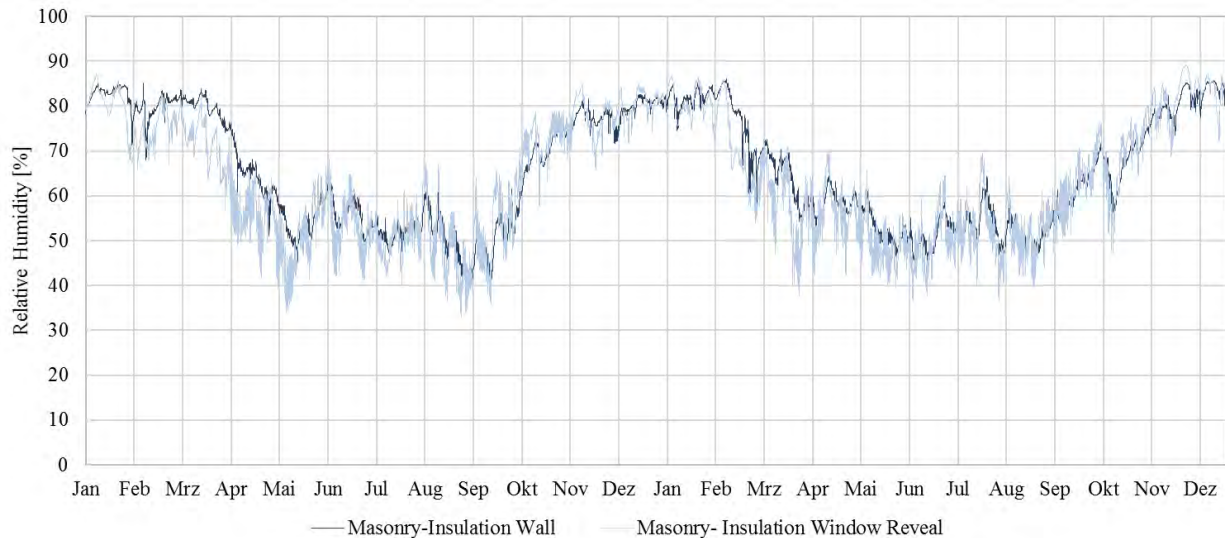
Figure 40: Conditions in the wall between insulation layer and 240 mm masonry (dark blue) compared to the condition in the window reveal area (light blue). The fluctuations of the relative humidity are higher and the moisture level is slightly higher at the window reveal area.

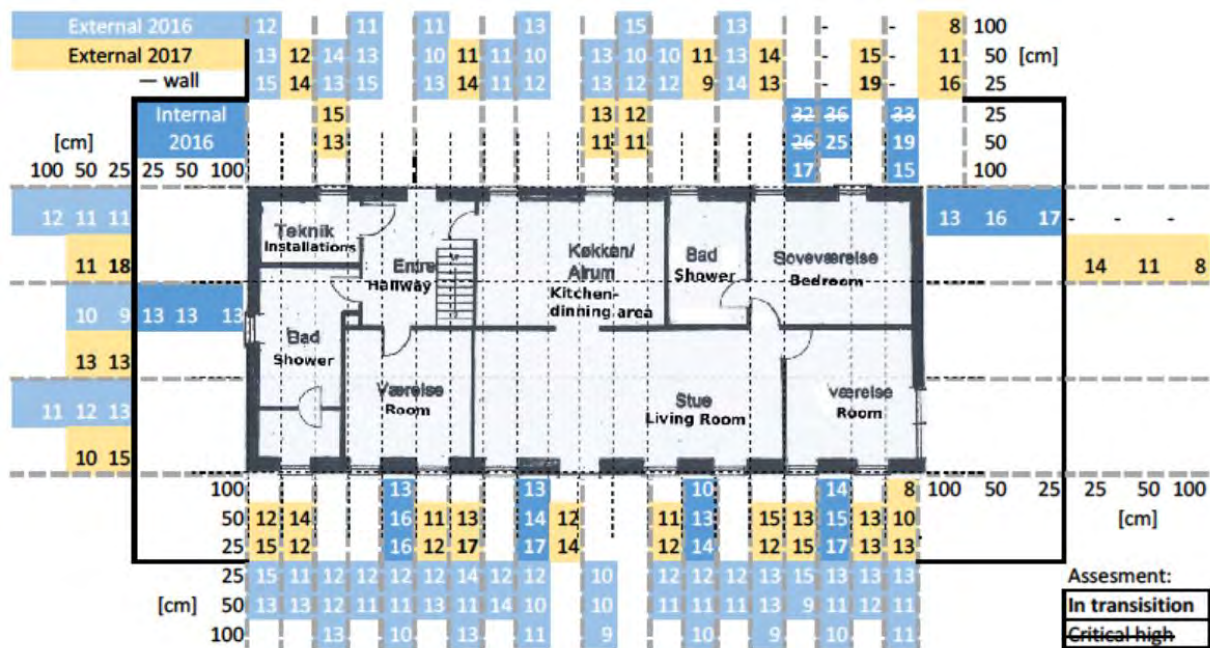
Figure 56: Troxler measurements before insulating and again after insulating. The first values in a double column (shown with faded and thick dashed line) contain 2016 and 2017 measurements (e.g. upper left: 12, 13, 15 & 12, 14) measured in the middle of the covered wall length while the following single column include 2016 and 2017 measurements (e.g. upper left: 14, 13 & 15, 13) below the window. The third column only include measurements from 2016. Heights stated are measured from the foundation. Yellow boxes are placed where possible due to space limitations. Values from 17 to 25 are assessed as in transition between non-critical and critical moisture content for bricks while above 25 is critical.
