**UNDERWATER BRIDGE INSPECTION REPORT
GROSSE ILE PARKWAY OVER
TRENTON CHANNEL
STR 12006**

WAYNE COUNTY

NOVEMBER 9, 2021

GLEG FILE No: 1020-2-704

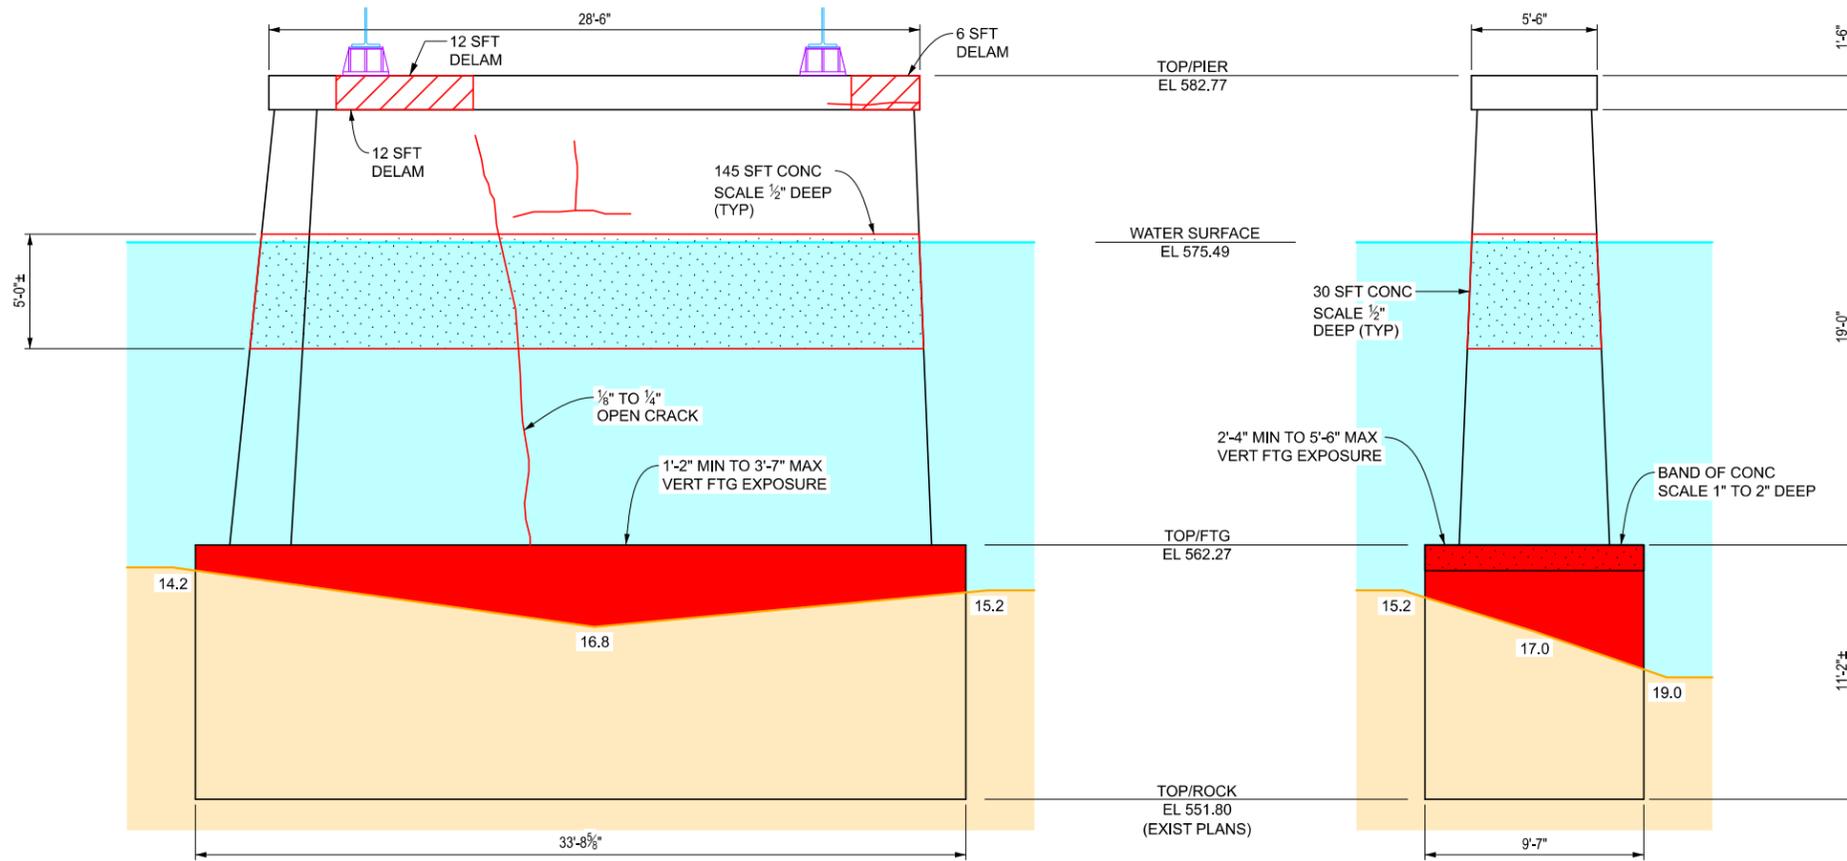
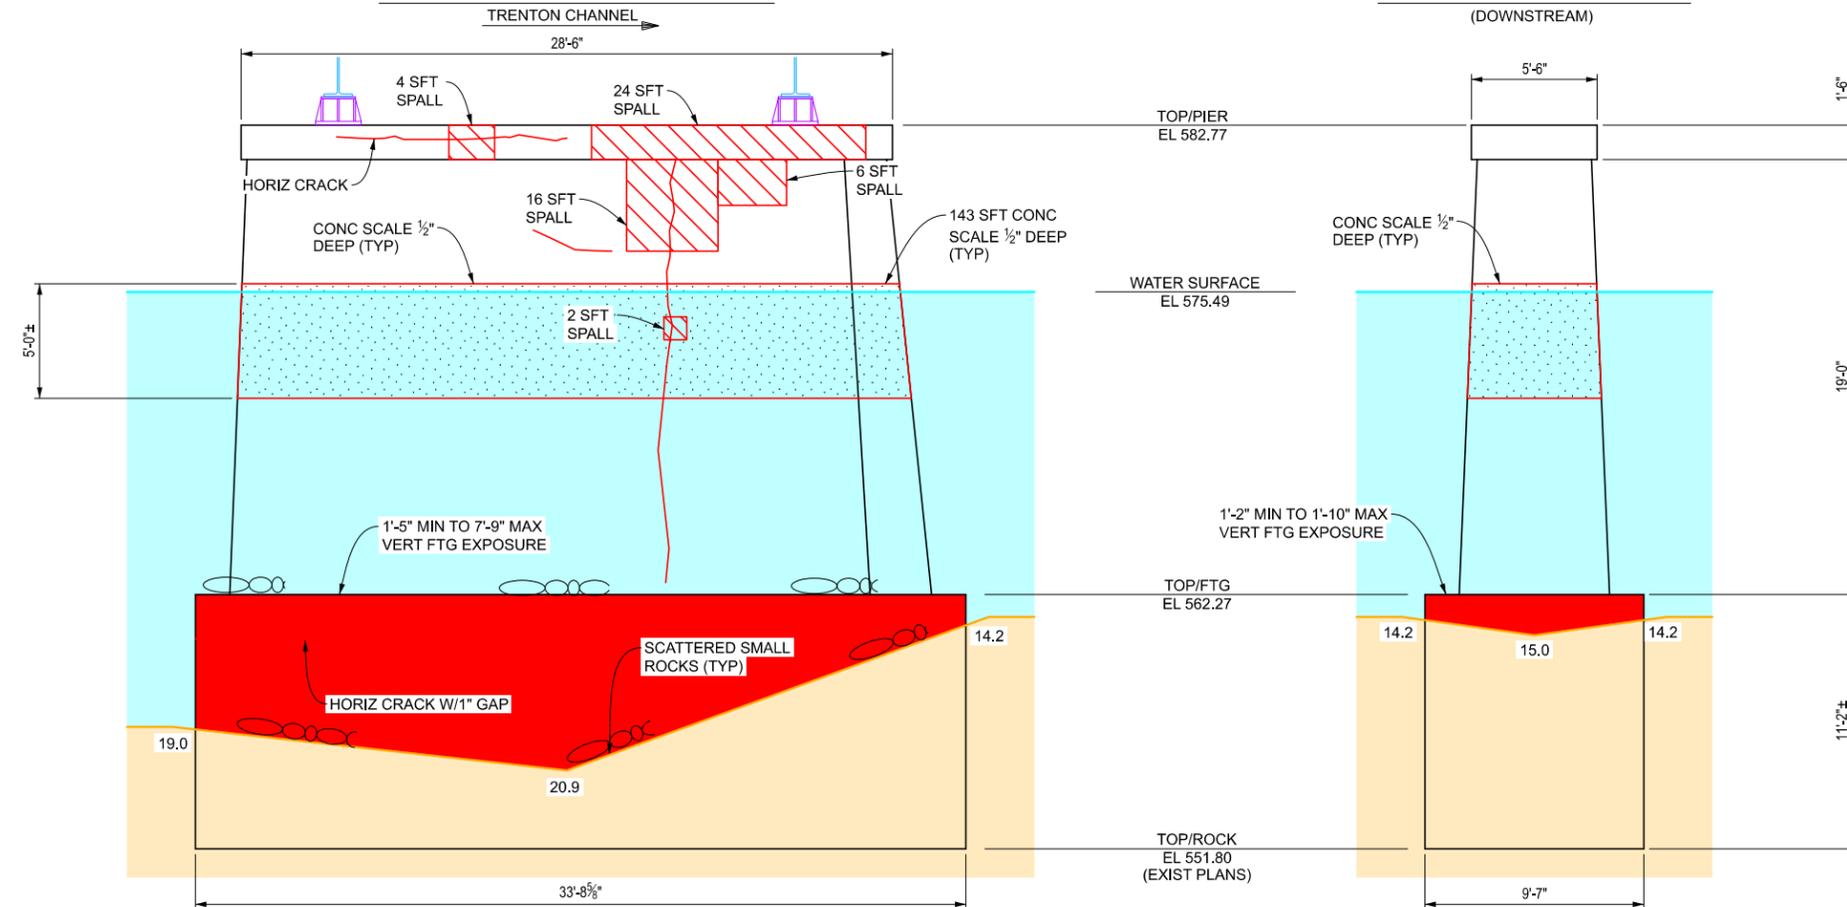
PIER 1W WEST ELEVATION

Substructure Unit	Observations Below the Waterline	Observations Above the Waterline
<p style="text-align: center;">Pier 1w</p> <p>(Refer to Substructure Elevation Drawings and Soundings Section)</p>	<ul style="list-style-type: none"> • Vertical footing exposure on all sides of pier. Maximum vertical exposure was 7'-9" inches along the east side of pier. • No undermining of footing observed. • 5' tall band of 1/2" deep scaling of the concrete starting at the waterline. Scaling surrounds perimeter of pier. • 2 sft spall in the east face of pier, located approximately 4' below waterline. • Horizontal crack in the exposed footing at the southeast end. • Deep scaling of concrete on the exposed footing at the south (downstream) end, scaling 1" to 2" deep. • Full height vertical cracks in west and east elevations of pier, extending from the bolster area down to the top of footing. • Uniform algae growth on concrete surfaces up to 1" thick. • Channel bottom consists of sand and scattered rocks up to 1' diameter. 	<ul style="list-style-type: none"> • West elevation: 12 sft and 6 sft delamination in bolster area. Vertical and horizontal cracking in pier face. • East elevation: 24 sft and 4 sft spalls in bolster area. 16 sft and 6 sft spalls in pier face. Vertical and horizontal cracks in pier face and bolster area.

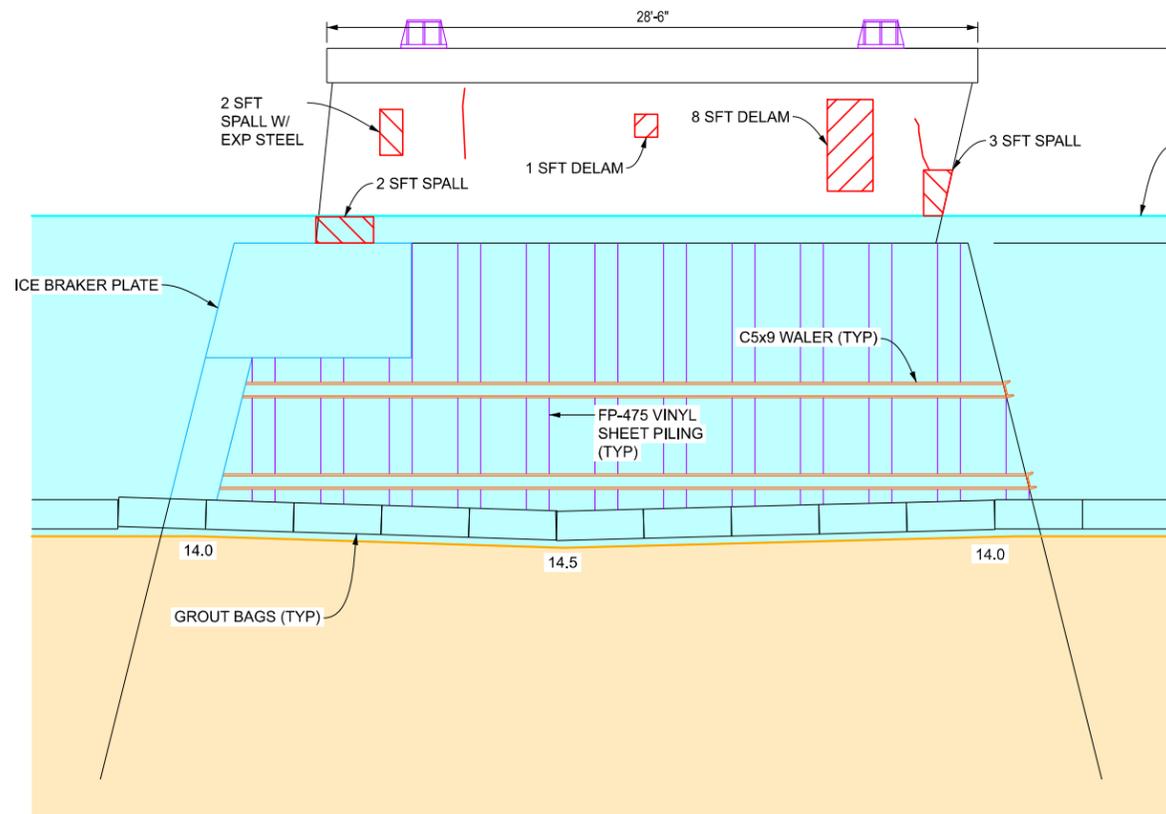
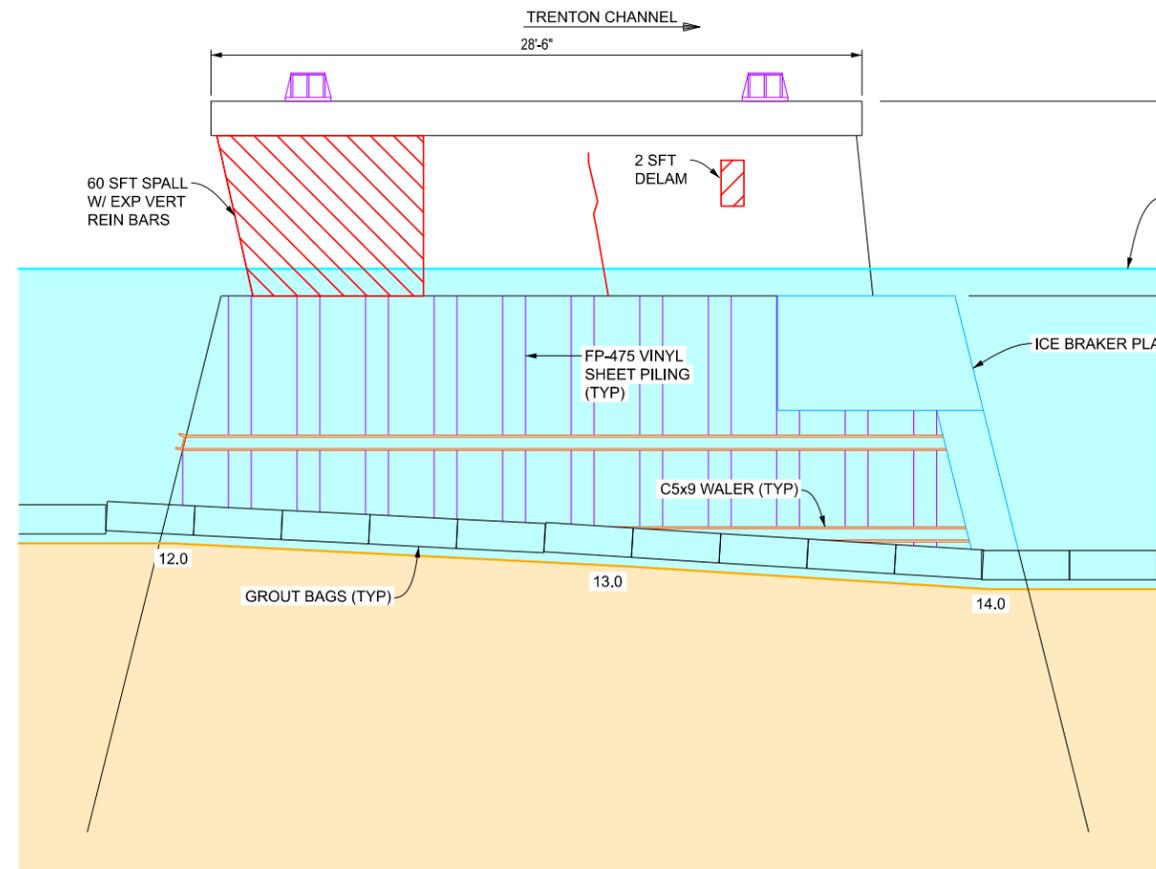
PIER 2W WEST ELEVATION

Substructure Unit	Observations Below the Waterline	Observations Above the Waterline
<p>Pier 2w (Refer to Substructure Elevation Drawings and Soundings Section)</p>	<ul style="list-style-type: none"> • Repairs made to previous timber cribbing deterioration and loss of rock infill. • FP-475 vinyl sheeting surrounds pier (used as stay-in-place formwork). • C5x9 steel walers spaced at 2'-0" vertical spacing securing formwork. • Grout backfill inside vinyl formwork. • Steel ice breaker plate at upstream end, extending 5' below waterline. • Smaller ice steel ice breaker plate extends to channel bottom. • Grout bags along channel bottom. • 2 sft spall in west pier face just below waterline. • Uniform algae growth on concrete surfaces up to 1/16" thick. • Channel bottom consists of grout bags, sand and rocks up to 1' diameter. 	<ul style="list-style-type: none"> • South end: 5 sft spall and 25 sft area of map cracking. • West elevation: 2 sft spall w/ exp steel and 3 sft spall. 8 sft delamination and 1 sft delamination. Vertical cracking in pier face. • East elevation: 60 sft spall w/ exp steel. 2 sft delamination. Vertical crack in pier face.

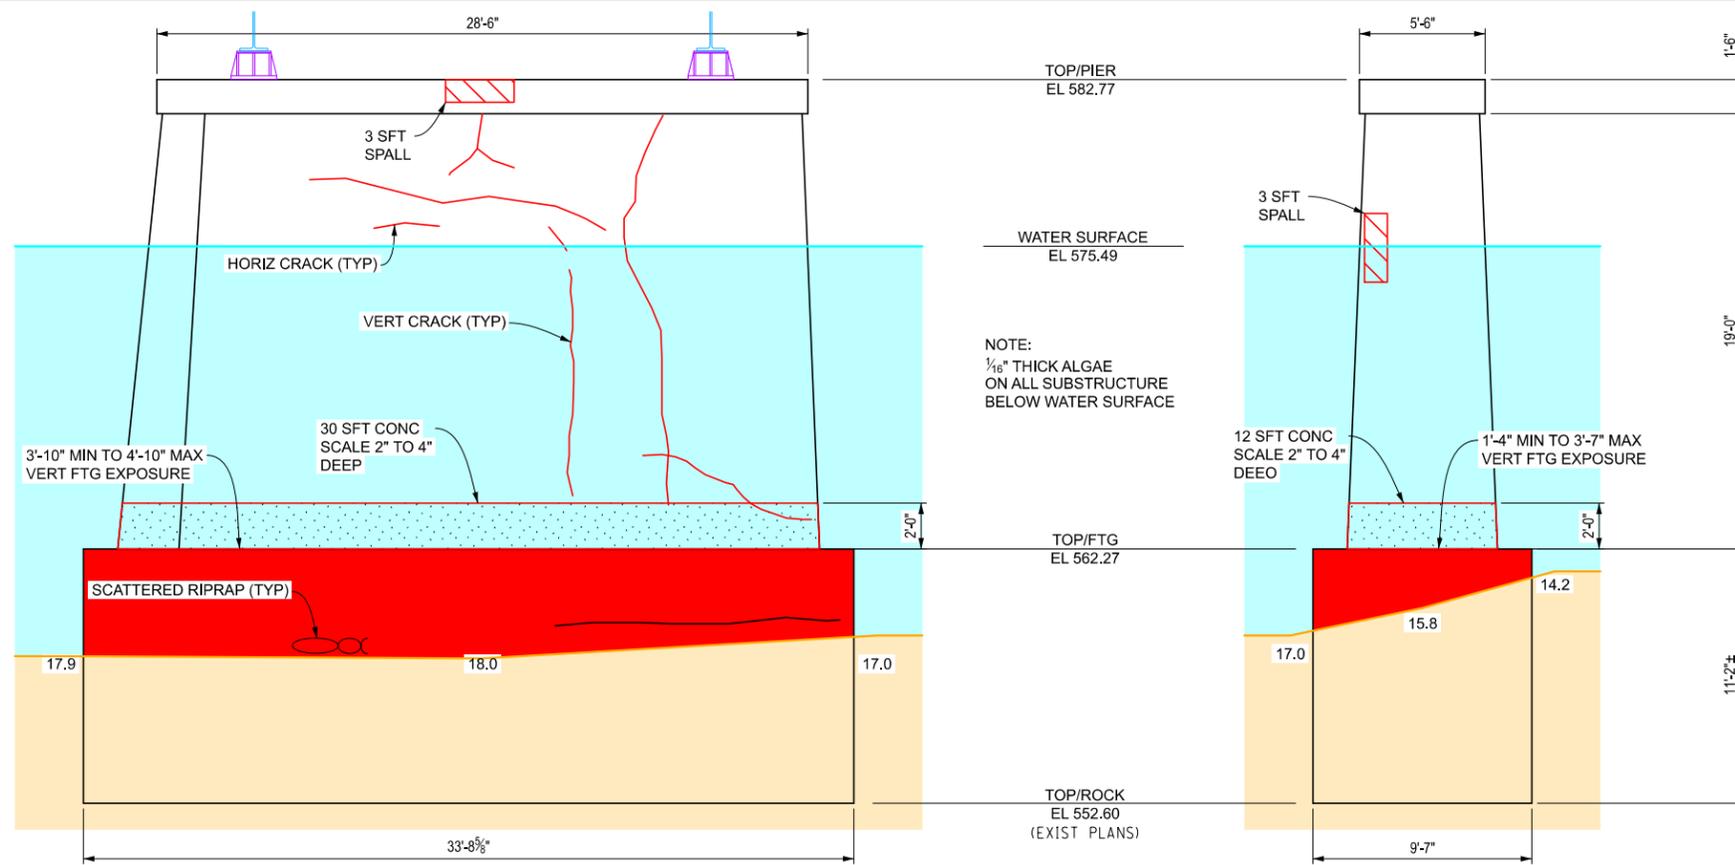
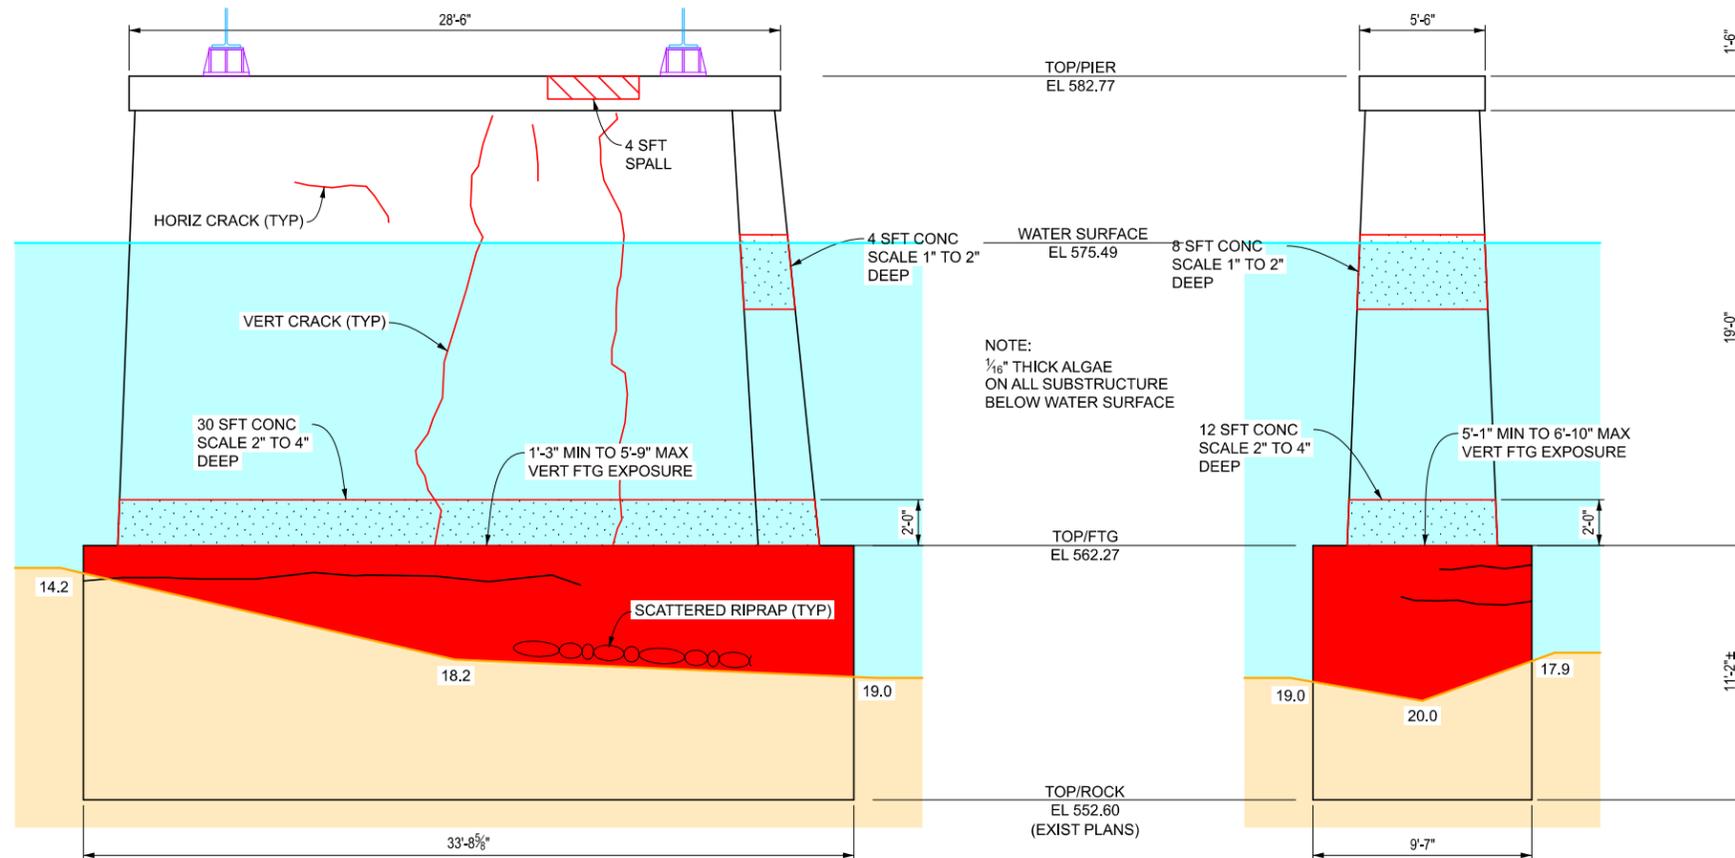
PIER 3W WEST ELEVATION
TRENTON CHANNEL

<p>Pier 3w (Refer to Substructure Elevation Drawings and Soundings Section)</p>	<ul style="list-style-type: none"> • Vertical footing exposure on all sides of pier. Maximum vertical exposure was 6'-10" inches along the north end of pier. • No undermining of footing observed. • 3 sft spall at south end, extends below and above waterline. • 2' tall band of 2" to 4" deep scaling in the pier wall starting at the top of footing and extending up 2'. Scaling surrounds perimeter of pier. • 1" to 2" deep scaling at north end of pier, extending approximately 4' below waterline. • Horizontal cracks in the exposed footing along the west elevation, east elevation, and north end. • Full height vertical cracks in west and east elevations of pier, extending from the bolster area down to the top of footing. • Uniform algae growth on concrete surfaces up to 1" thick. • Channel bottom consists of sand and scattered rocks up to 1' diameter. 	<ul style="list-style-type: none"> • South end: 3 sft spall extends above and below waterline. • West elevation: 3 sft delamination in bolster area. Vertical and horizontal cracking in pier face. • East elevation: 4 sft spall in bolster area. Vertical and horizontal cracks in pier face.

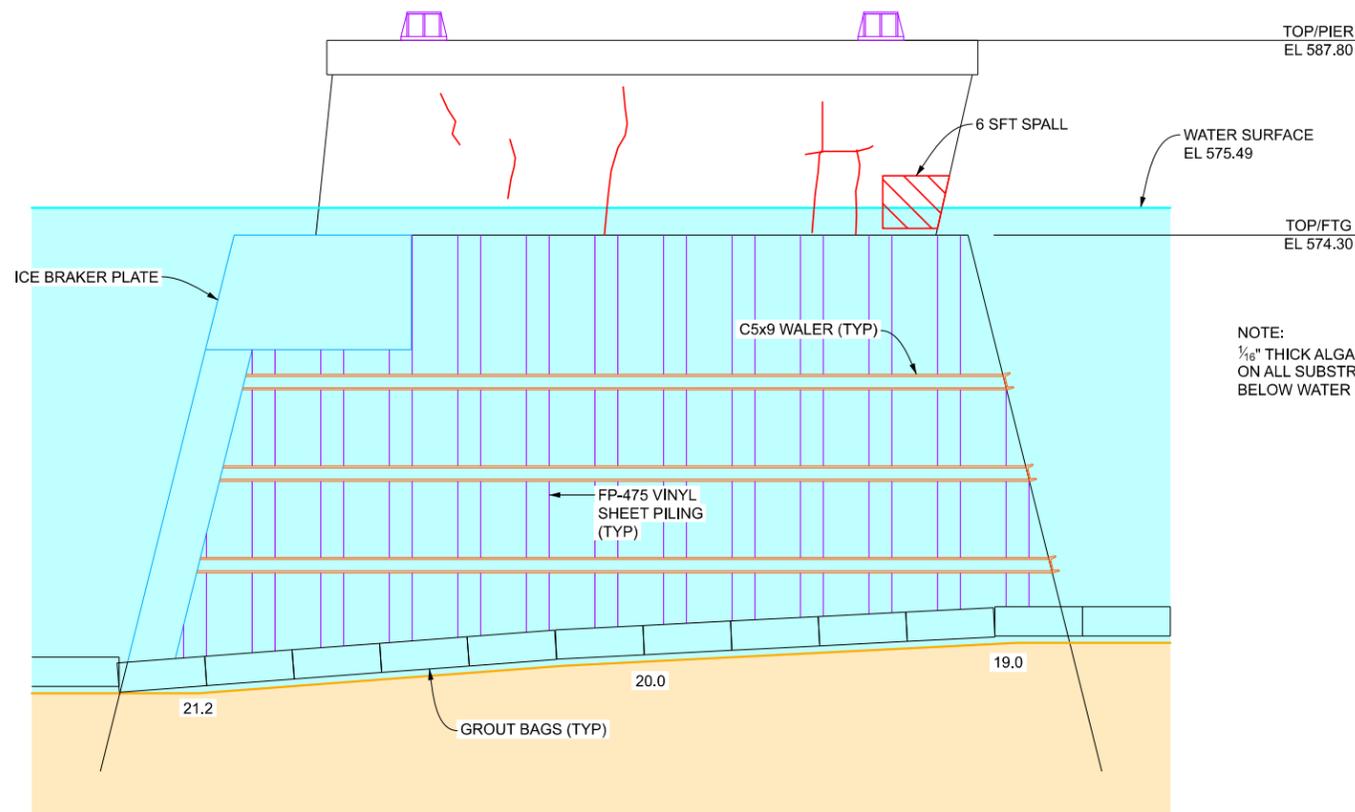
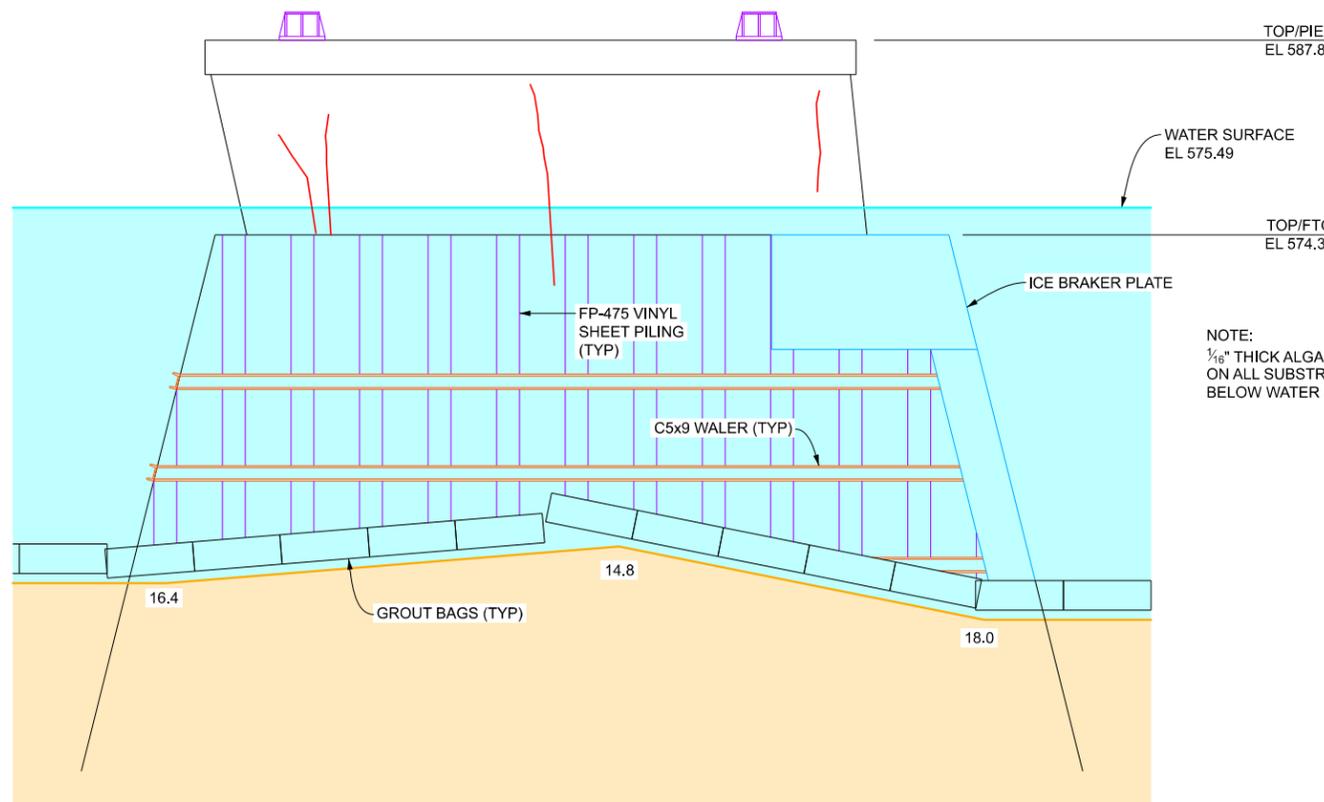
PIER 4W WEST ELEVATION

Substructure Unit	Observations Below the Waterline	Observations Above the Waterline
<p>Pier 4w</p> <p>(Refer to Substructure Elevation Drawings and Soundings Section)</p>	<ul style="list-style-type: none"> • Repairs made to previous timber cribbing deterioration and loss of rock infill. • FP-475 vinyl sheeting surrounds pier (used as stay-in-place formwork). • C5x9 steel walers spaced at 2'-0" vertical spacing securing formwork. • Grout backfill inside vinyl formwork. • Steel ice breaker plate at upstream end, extending 5' below waterline. • Smaller ice steel ice breaker plate extends to channel bottom. • Grout bags along channel bottom. • 10 sft spall at south end starting at waterline and extending 2' below waterline. • Uniform algae growth on concrete surfaces up to 1/16" thick. • Channel bottom consists of grout bags, sand and rocks up to 1' diameter. 	<ul style="list-style-type: none"> • South end: 25 sft area of map cracking. • West elevation: 6 sft spall at south end. Vertical cracking in pier face. • East elevation: Vertical cracks in pier face.

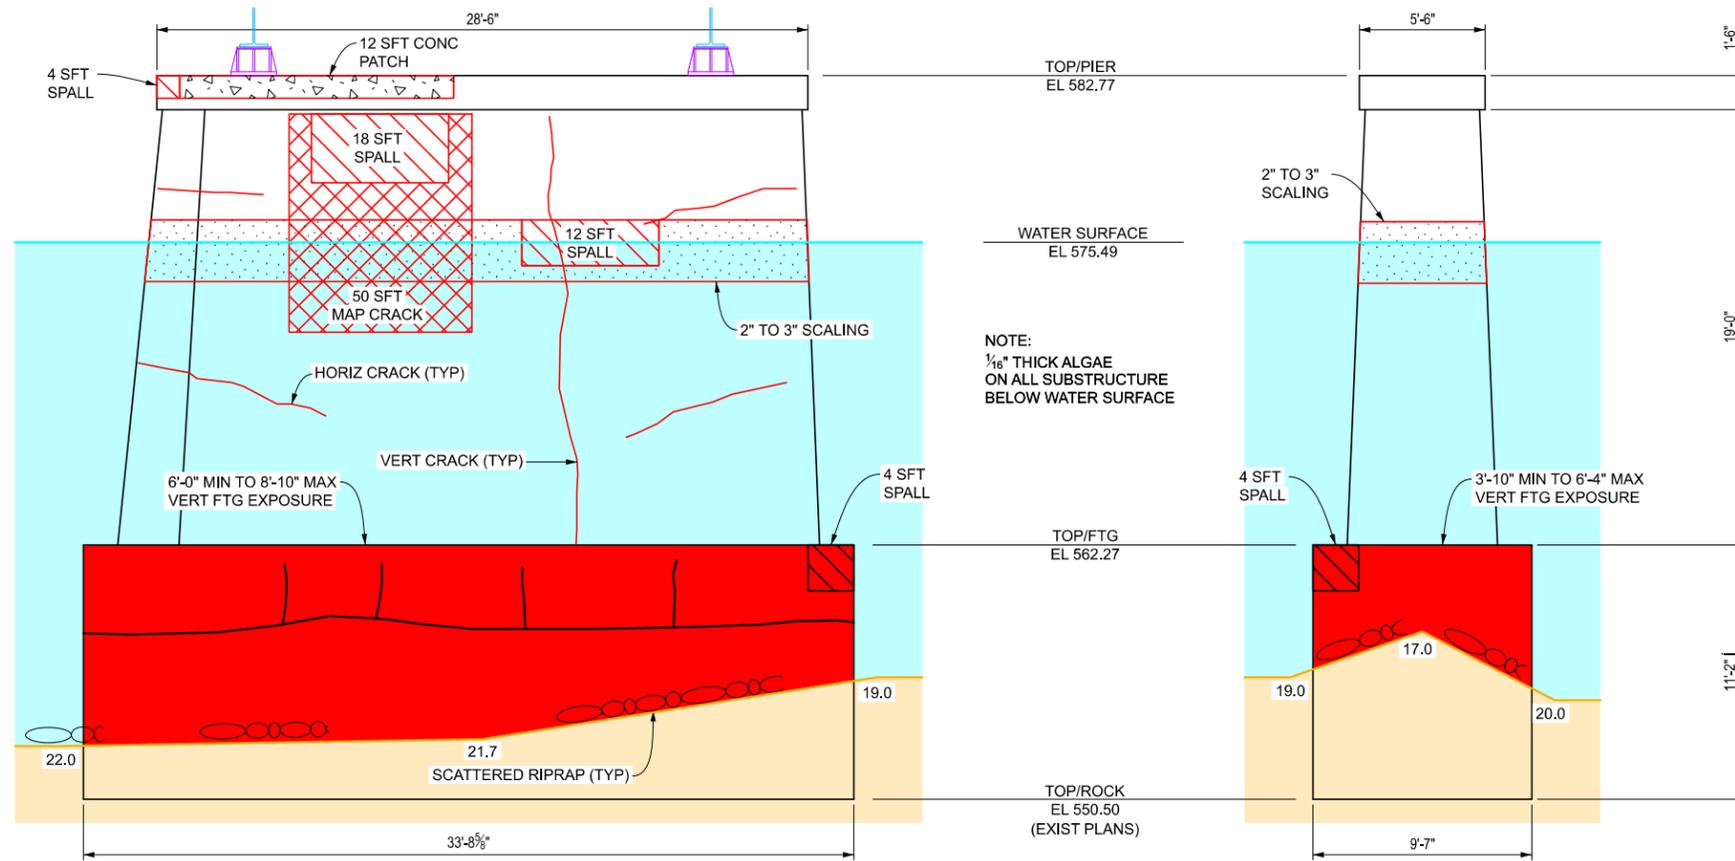
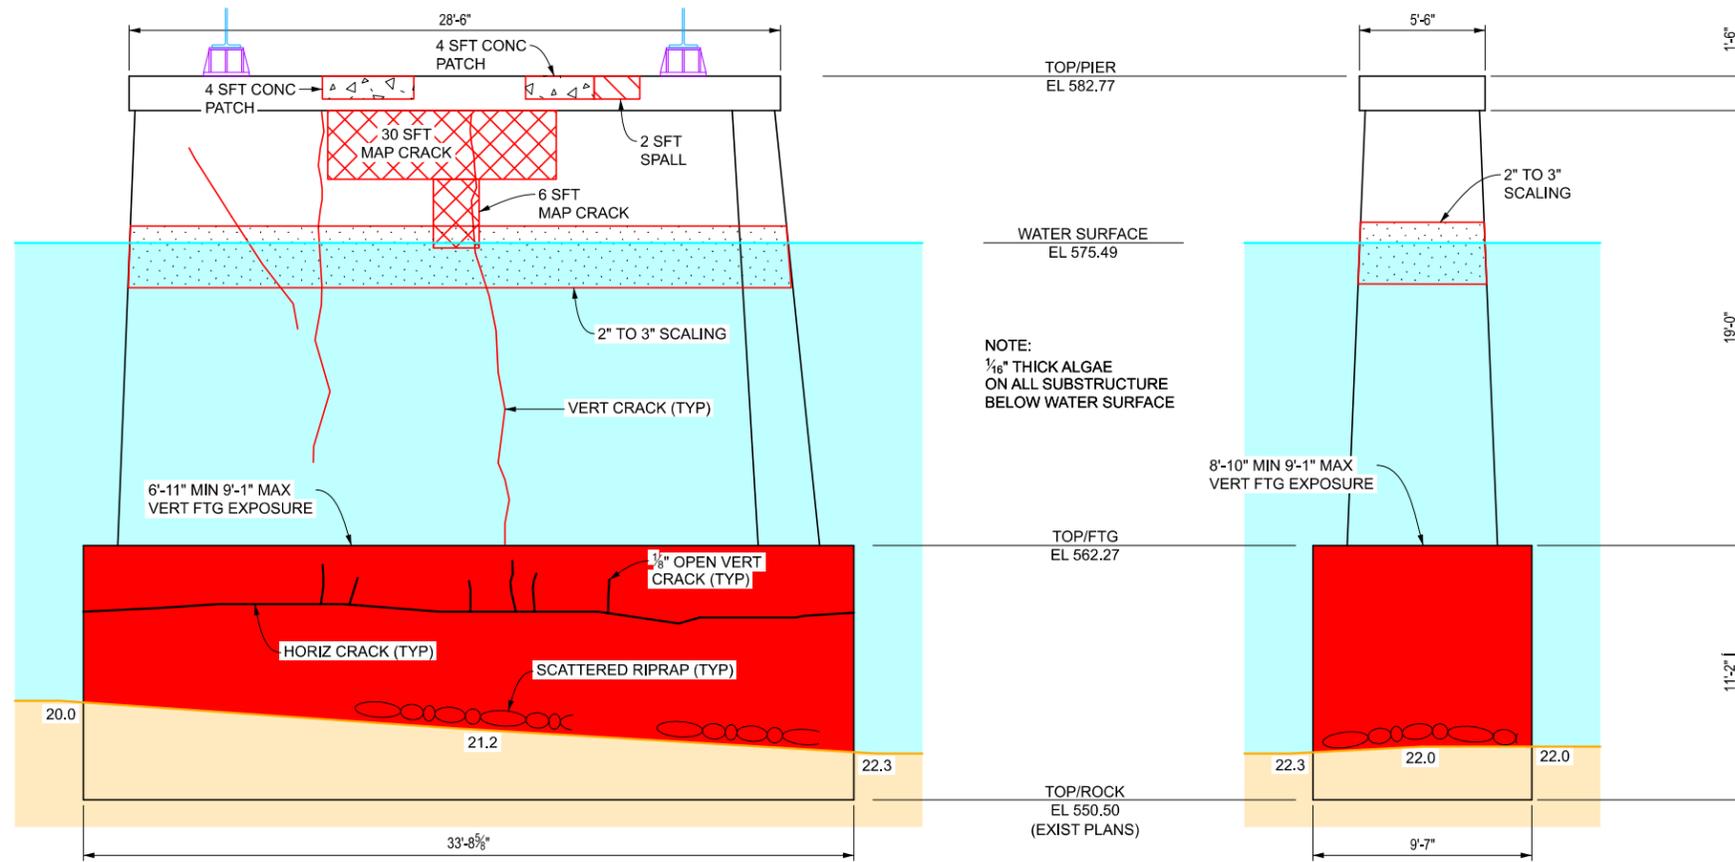
PIER 5W WEST ELEVATION
TRENTON CHANNEL

<p>Pier 5w</p> <p>(Refer to Substructure Elevation Drawings and Soundings Section)</p>	<ul style="list-style-type: none"> • Vertical footing exposure on all sides of pier. Maximum vertical exposure was 9'-1" inches along the west elevation and at north end of pier. • No undermining of footing observed. • 4 sft spall in footing at southwest corner. • 1/8" wide horizontal and vertical cracks in footing along west and east elevations. • 4' tall band of 2" to 3" deep scaling of the concrete below and above waterline. Scaling surrounds perimeter of pier. • Vertical and horizontal cracks in west and east elevations of pier. • 50 sft area of map cracking in west elevation of pier wall extends partially below waterline. • Uniform algae growth on concrete surfaces up to 1" thick. • Channel bottom consists of sand and scattered rocks up to 1' diameter. 	<ul style="list-style-type: none"> • West elevation: 18 sft and 12 sft spalls in pier wall. 50 sft area of map cracking extends partially below waterline. 4 sft spall in bolster area. Concrete patch in bolster area. Vertical and horizontal cracking in pier wall. • East elevation: 2 sft spall in bolster area. 30 sft and 6 sft areas of map cracking in pier wall. Vertical and horizontal cracks in pier face. Concrete patches in bolster area. • 4' tall band of 2" to 3" deep scaling of concrete above and below waterline. Scaling surrounds perimeter of pier.

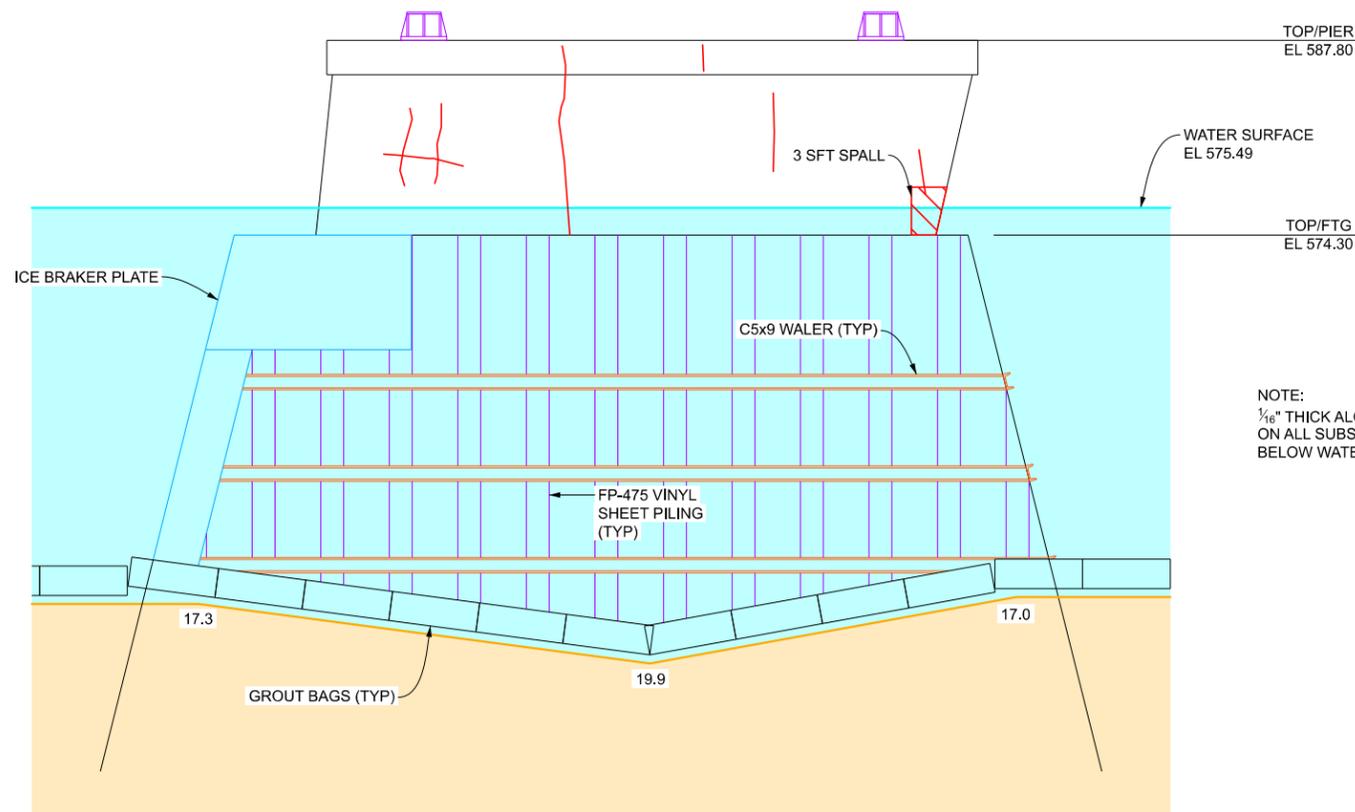
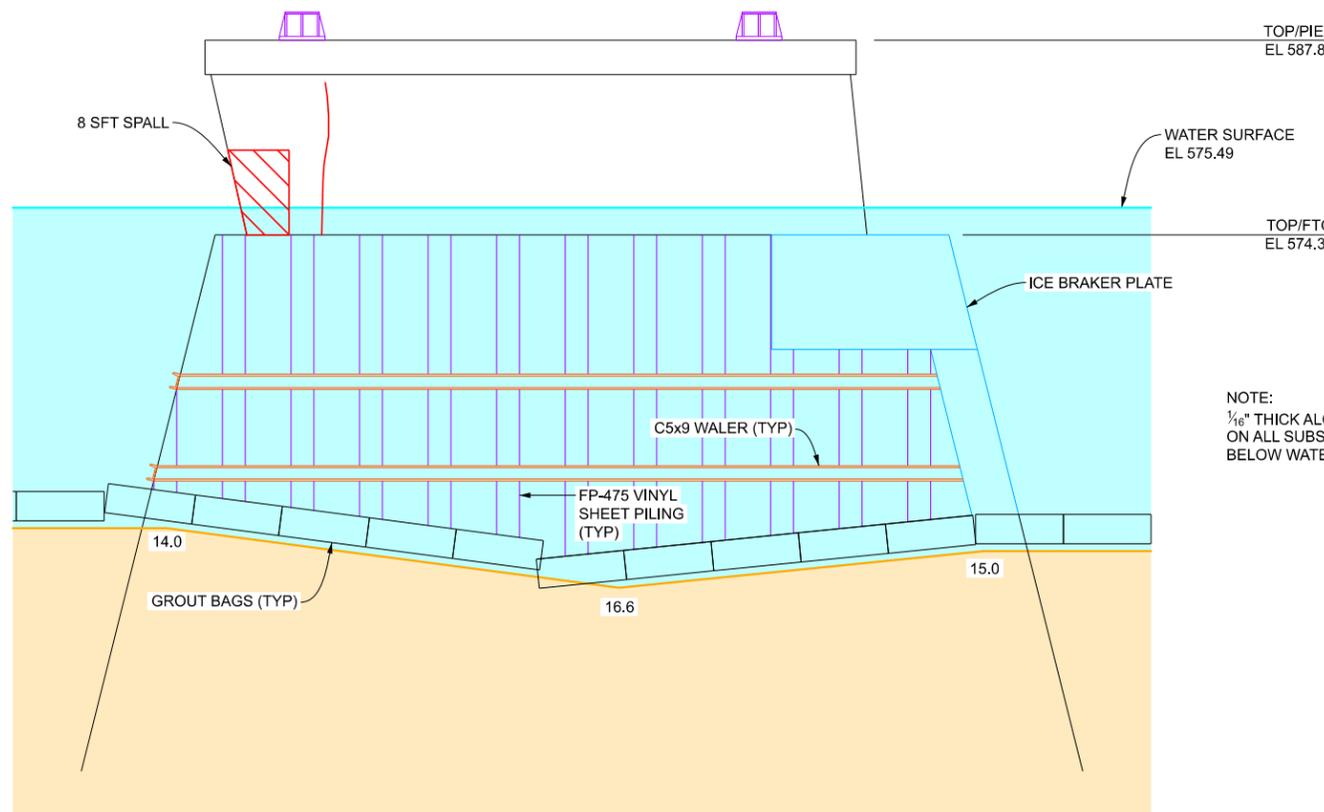
PIER 6W WEST ELEVATION

Substructure Unit	Observations Below the Waterline	Observations Above the Waterline
<p>Pier 6w</p> <p>(Refer to Substructure Elevation Drawings and Soundings Section)</p>	<ul style="list-style-type: none"> • Repairs made to previous timber cribbing deterioration and loss of rock infill. • FP-475 vinyl sheeting surrounds pier (used as stay-in-place formwork). • C5x9 steel walers spaced at 2'-0" vertical spacing securing formwork. • Grout backfill inside vinyl formwork. • Steel ice breaker plate at upstream end, extending 5' below waterline. • Smaller ice steel ice breaker plate extends to channel bottom. • Grout bags along channel bottom. • Areas of spalling on all sides just below waterline. Majority of spalled areas are above waterline. • Uniform algae growth on concrete surfaces up to 1/16" thick. • Channel bottom consists of grout bags, sand and scattered rocks up to 1' diameter. 	<ul style="list-style-type: none"> • South end: 4 sft spall, 50% extends below waterline. • North end: 8 sft spall, 25% extends below waterline. • West elevation: 3 sft spall, 50% extends below waterline. Vertical and horizontal cracking in pier face. • East elevation: 8 sft spall, 30% extends below waterline. Vertical crack in pier face.

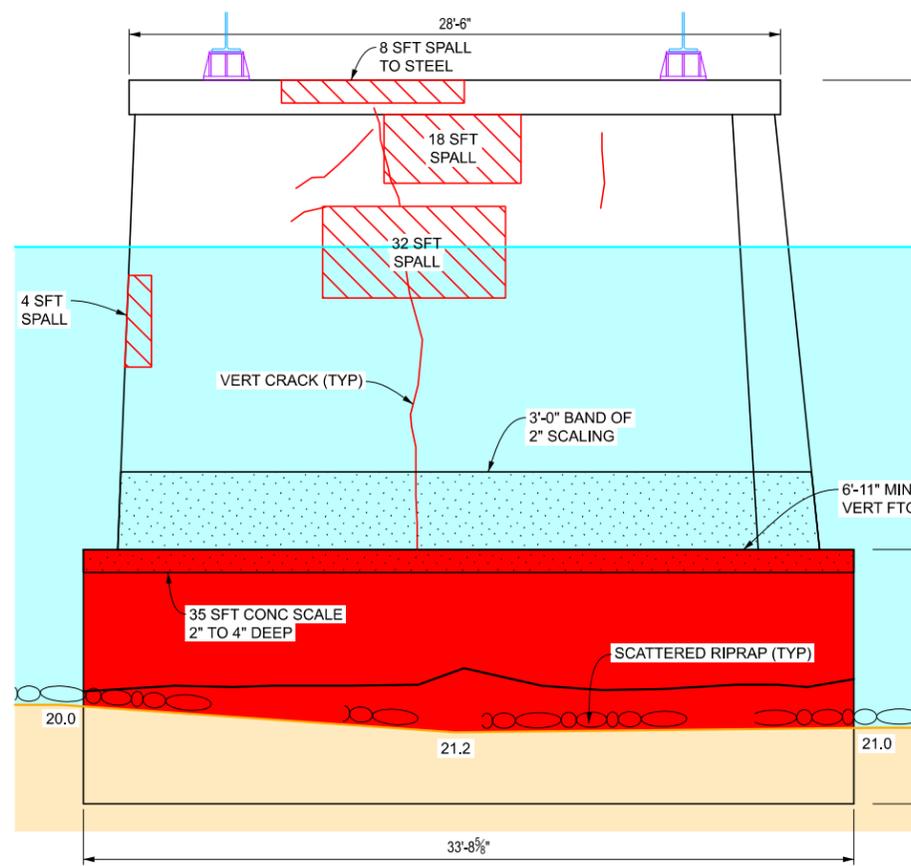
PIER 7W EAST ELEVATION
TRENTON CHANNEL

<p>Pier 7w</p> <p>(Refer to Substructure Elevation Drawings and Soundings Section)</p>	<ul style="list-style-type: none"> • Vertical footing exposure on all sides of pier. Maximum vertical exposure was 8'-10" inches at the north end of pier. • No undermining of footing observed. • 1/8" wide horizontal cracks in footing along west and east elevations. • 4 sft spall in pier wall in east elevation at south end. • 32 sft spall in east elevation extends 50% above waterline. • 1' tall band of 2" to 4" deep scaling on exposed footing. Scaling starts at top of footing and extends down 1'. Scaling surrounds perimeter of pier. • 3' tall band of 2" deep scaling of the concrete in pier wall. Scaling starts at top of footing and extends up 3'. Scaling surrounds perimeter of pier. • Vertical cracks in west and east elevations of pier. • Uniform algae growth on concrete surfaces up to 1" thick. • Channel bottom consists of sand and scattered rocks up to 1' diameter. 	<ul style="list-style-type: none"> • West elevation: 12 sft and 2 sft spalls in bolster area. Vertical and horizontal cracking in pier wall. • East elevation: 8 sft spall in bolster area. 18 sft and 32 sft spalls in pier wall. 32 sft spall extends 50% below waterline. Vertical and horizontal cracks in pier face.

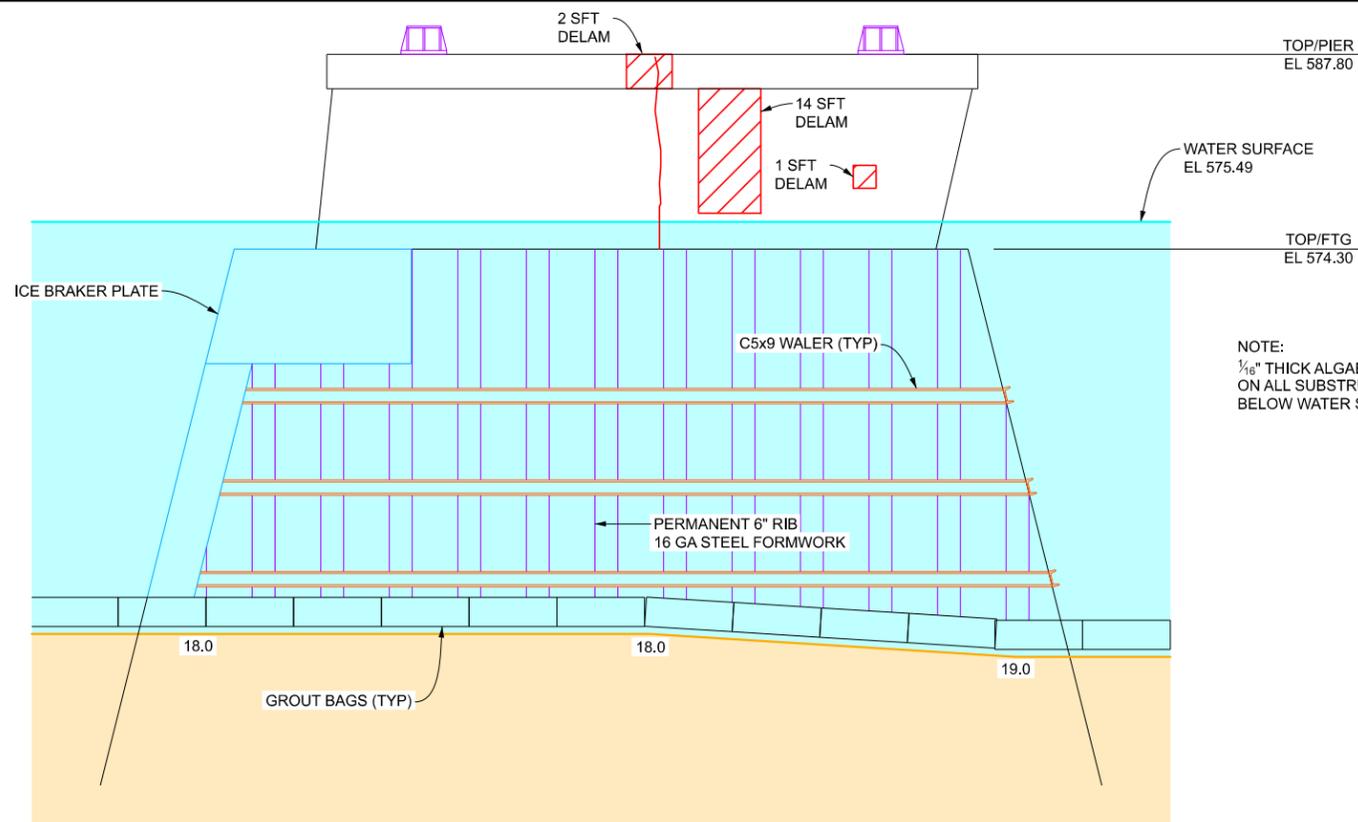
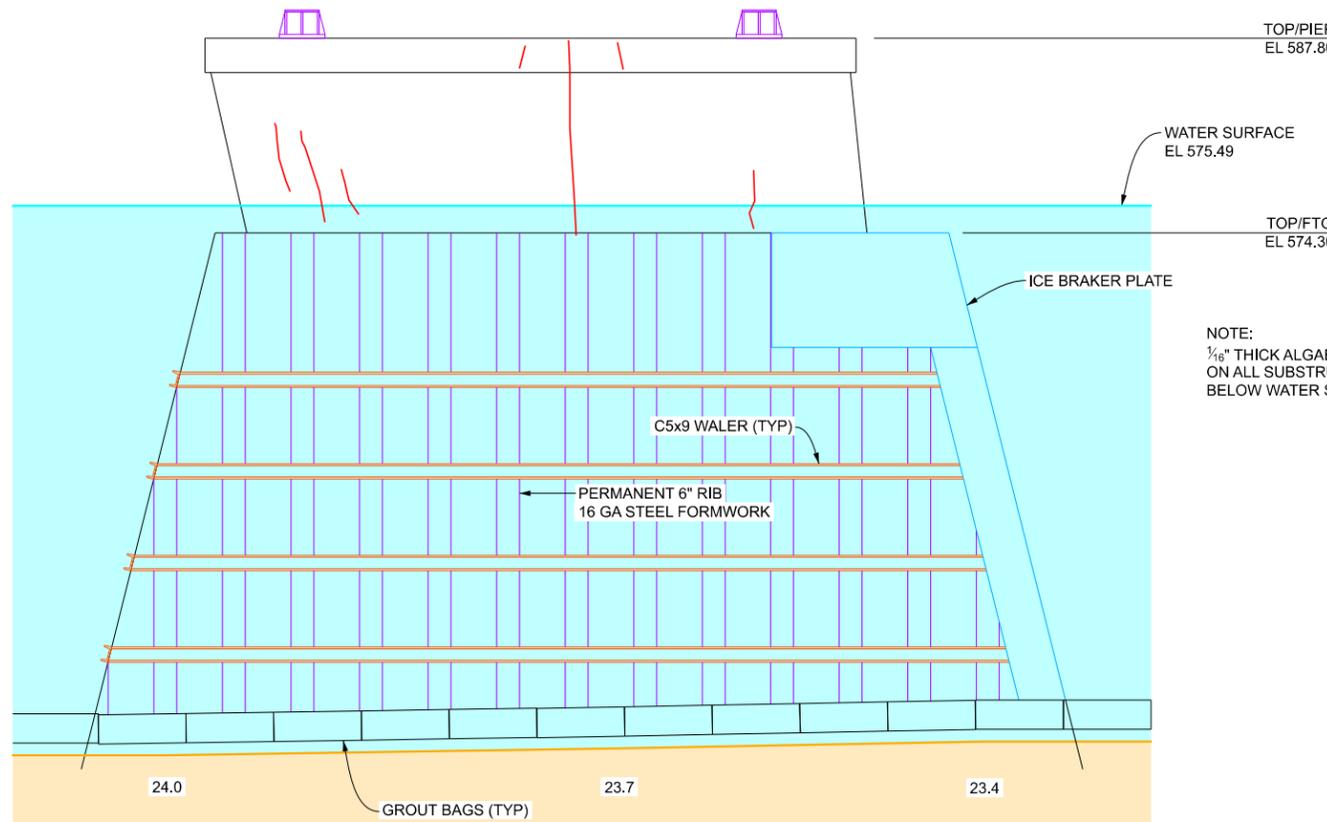
PIER 8W WEST ELEVATION

Substructure Unit	Observations Below the Waterline	Observations Above the Waterline
<p>Pier 8w (Refer to Substructure Elevation Drawings and Soundings Section)</p>	<ul style="list-style-type: none"> • Repairs made to previous timber cribbing deterioration and loss of rock infill. • 6" rib-16 ga. steel sheeting surrounds pier (used as stay-in-place formwork). • C5x9 steel walers spaced at 2'-0" vertical spacing securing formwork. • Grout backfill inside vinyl formwork. • Steel ice breaker plate at upstream end, extending 5' below waterline. • Smaller ice steel ice breaker plate extends to channel bottom. • Grout bags along channel bottom. • Uniform algae growth on concrete surfaces up to 1/16" thick. • Channel bottom consists of grout bags, sand and scattered rocks up to 1' diameter. 	<ul style="list-style-type: none"> • West elevation: 2 sft delamination in bolster area. 14 sft and 1 sft delaminated area in pier wall. Vertical crack in pier wall. • East elevation: Vertical cracks in pier wall and bolster area.
