**UNDERWATER BRIDGE INSPECTION REPORT
GROSSE ILE PARKWAY OVER
TRENTON CHANNEL
STR 12006**

WAYNE COUNTY

NOVEMBER 9, 2021

GLEG FILE No: 1020-2-704

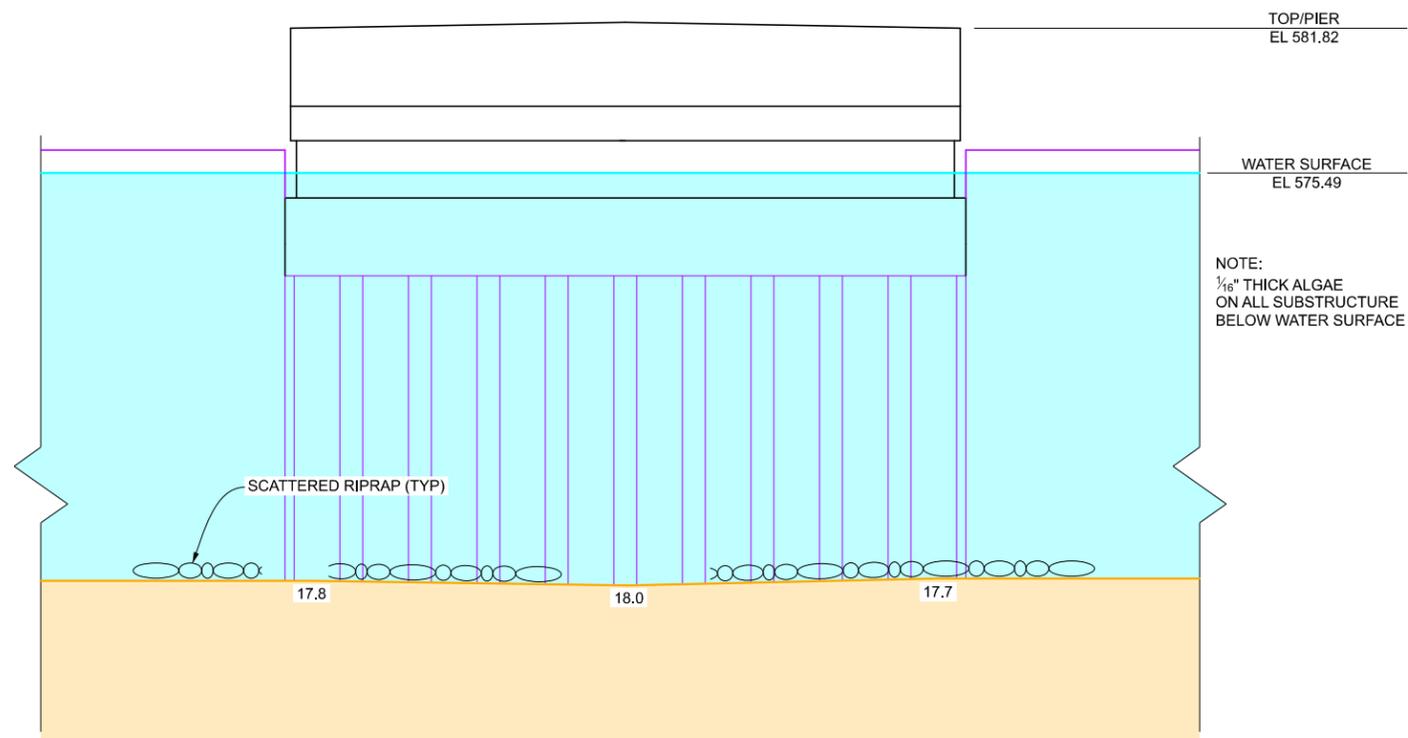
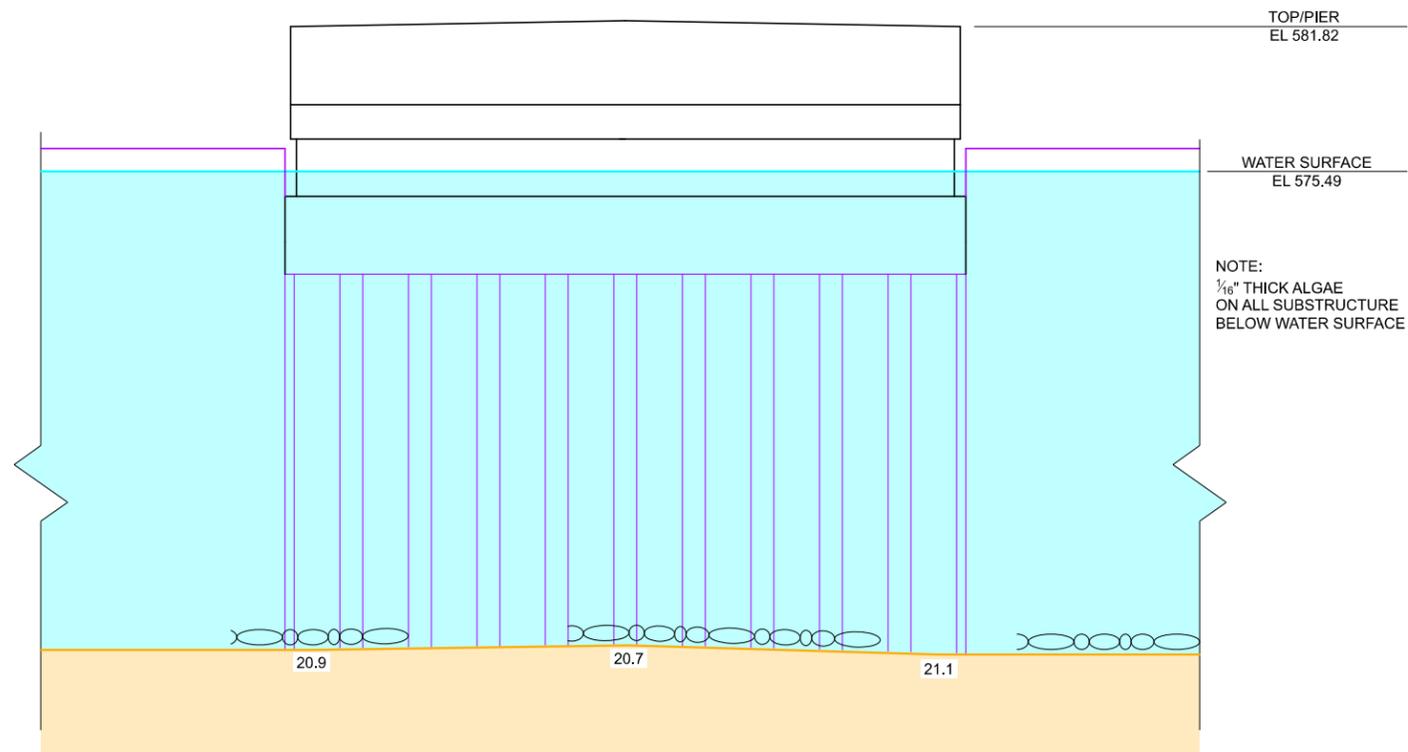
PIER 9W WEST ELEVATION

<p>Pier 9w (Refer to Substructure Elevation Drawings and Soundings Section)</p>	<ul style="list-style-type: none"> • Repairs made to previous timber cribbing, plywood sheeting, grout repair deterioration and loss of rock infill. • 6" rib-16 ga. steel sheeting on west and east elevations of pier (used as stay-in-place formwork). • C5x9 steel walers spaced at 2'-0" vertical spacing securing formwork. • Grout backfill inside steel formwork. • Uniform algae growth on concrete surfaces up to 1/16" thick. • Channel bottom consists of sand and scattered rocks 1' to 4' in diameter. 	<ul style="list-style-type: none"> • Repairs (concrete patches) made to previous spalled and delaminated areas on the pivot portion of the pier.
<p>Pier 9w - Pier Protection System (Refer to Substructure Elevation Drawings and Soundings Section)</p>	<ul style="list-style-type: none"> • Vertical timbers at upstream (north) end of pier have shifted, some have fallen onto channel bottom. • Horizontal timbers in southwest corner of cribbing have come loose and are unstable. • Fluctuations in the channel bottom have created gaps below the exterior plywood along both sides of the pier. The older interior cribbing is visible, but diver was not able to reach. • Deteriorated timbers members with loss of section 30%-70%. • Scattered riprap 1' to 4' in diameter on channel bottom around perimeter 	<ul style="list-style-type: none"> • Settlement of timber cribbing at north side of pier.

Pier 9w is in **fair condition**. The structural portion of pier 9w received the same repairs as the even numbered piers, however steel sheeting was used as the formwork. The swing / pivot portion of pier 9w is in **fair condition**. The previous deterioration of the timber cribbing and loss of rock infill has been repaired with the same procedures detailed in the paragraph above. The previous deterioration above the waterline at pier 9w has been repaired.

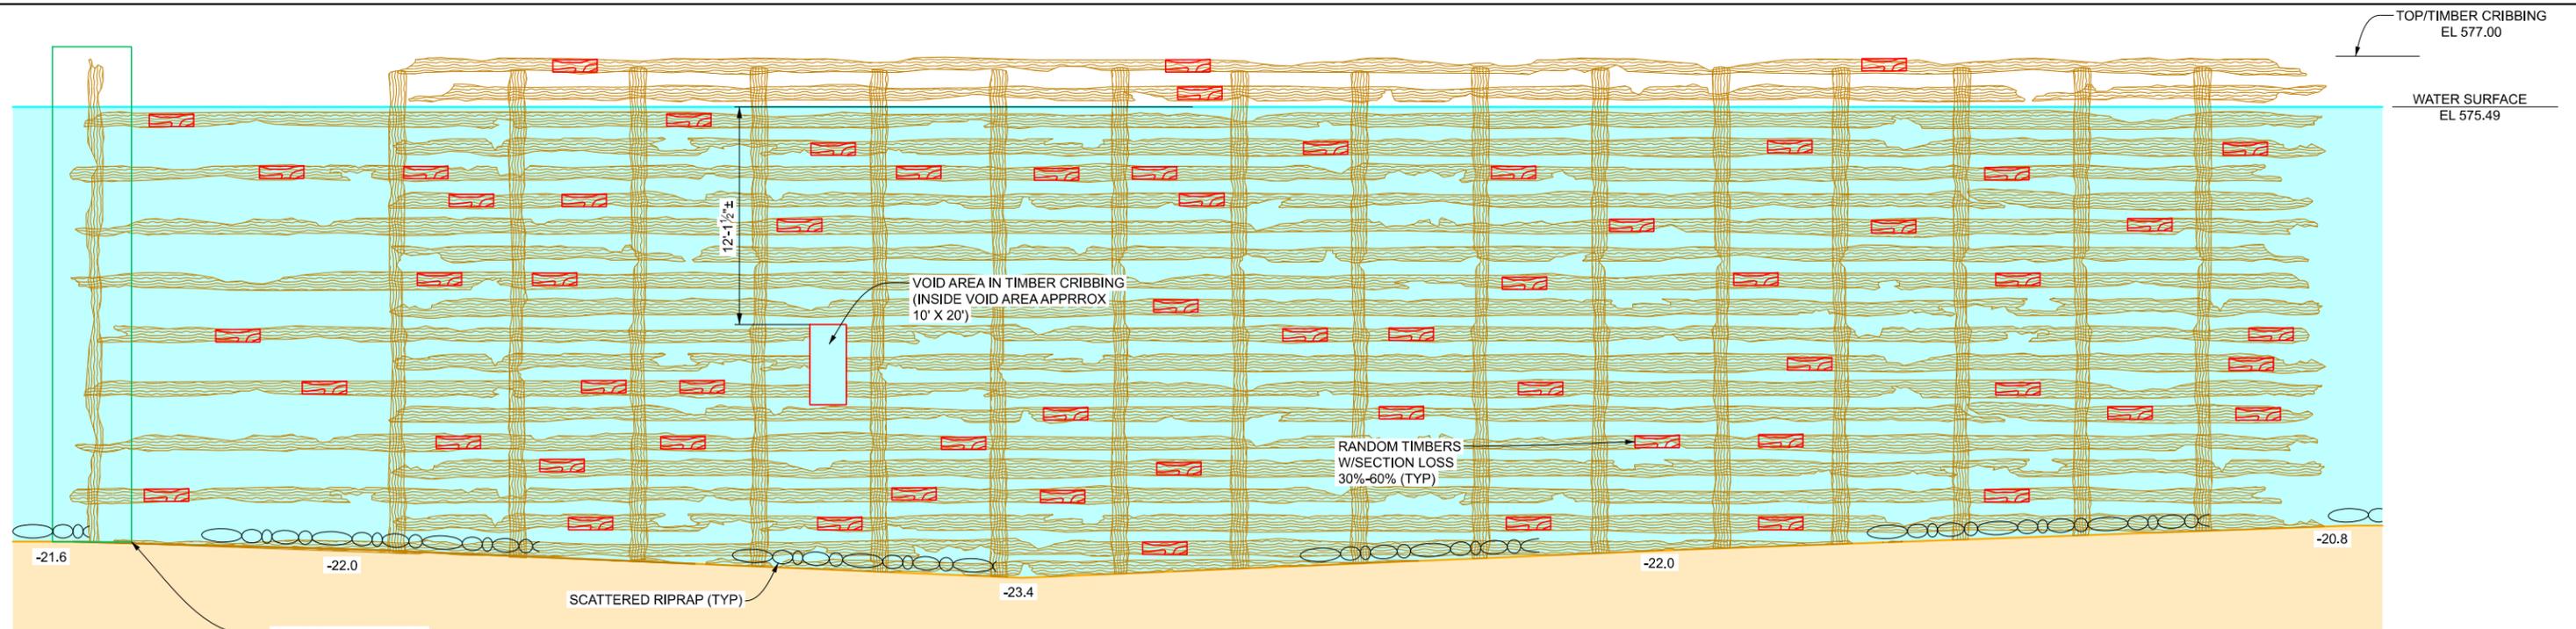
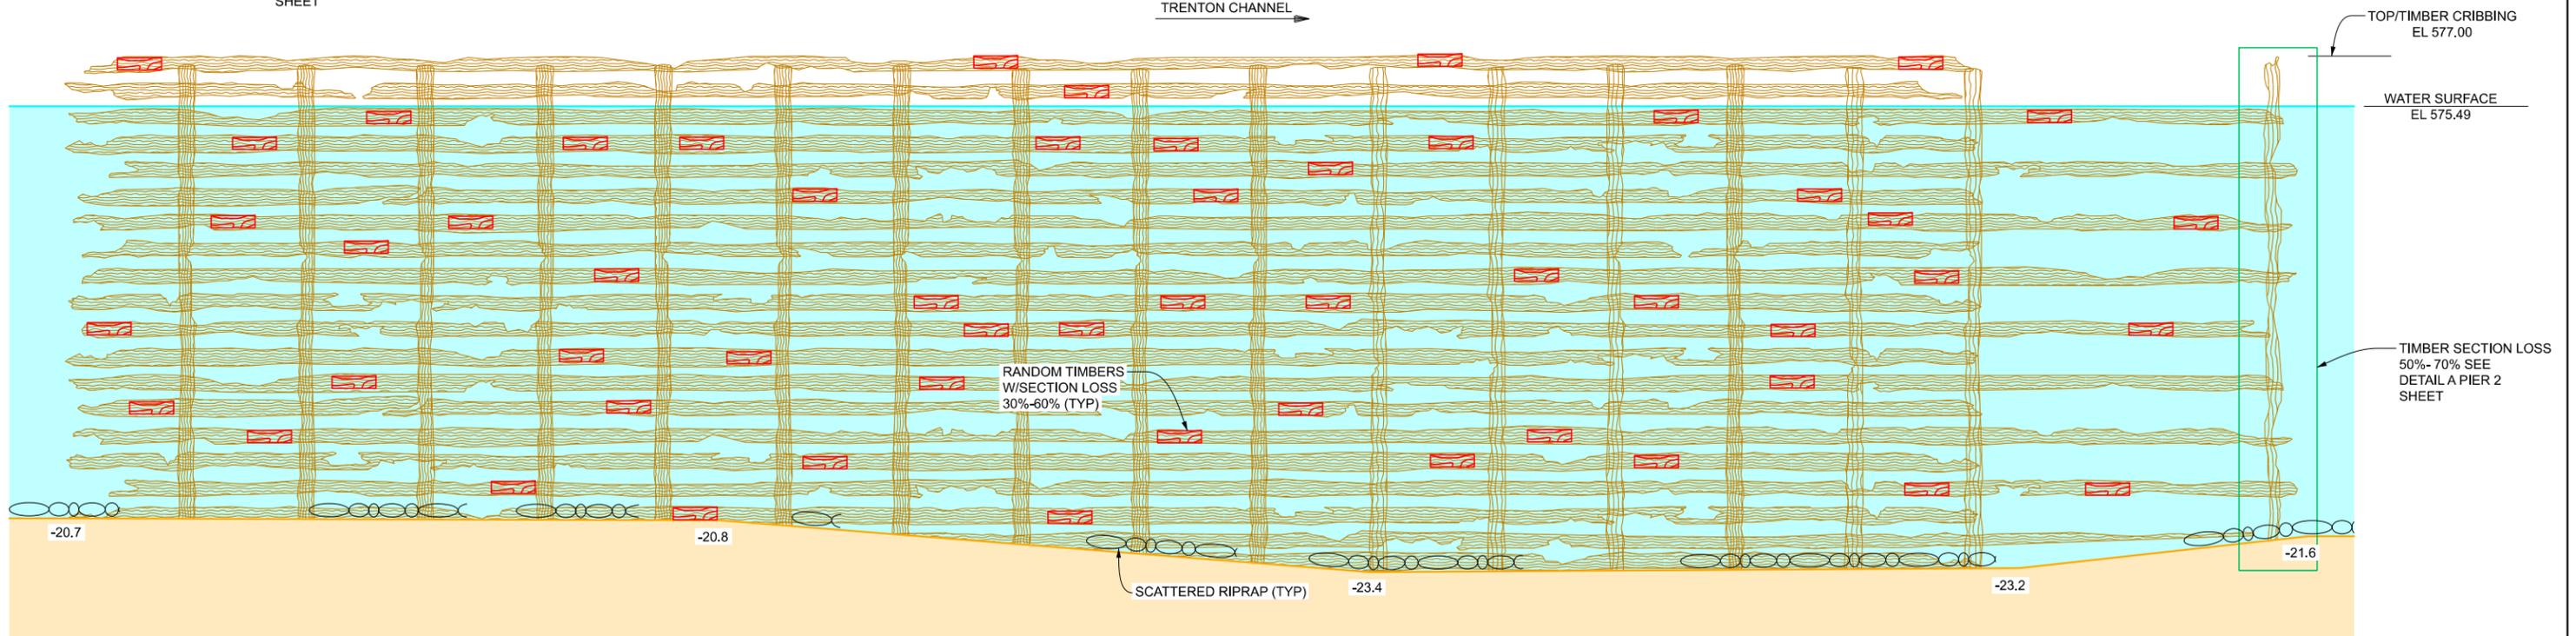
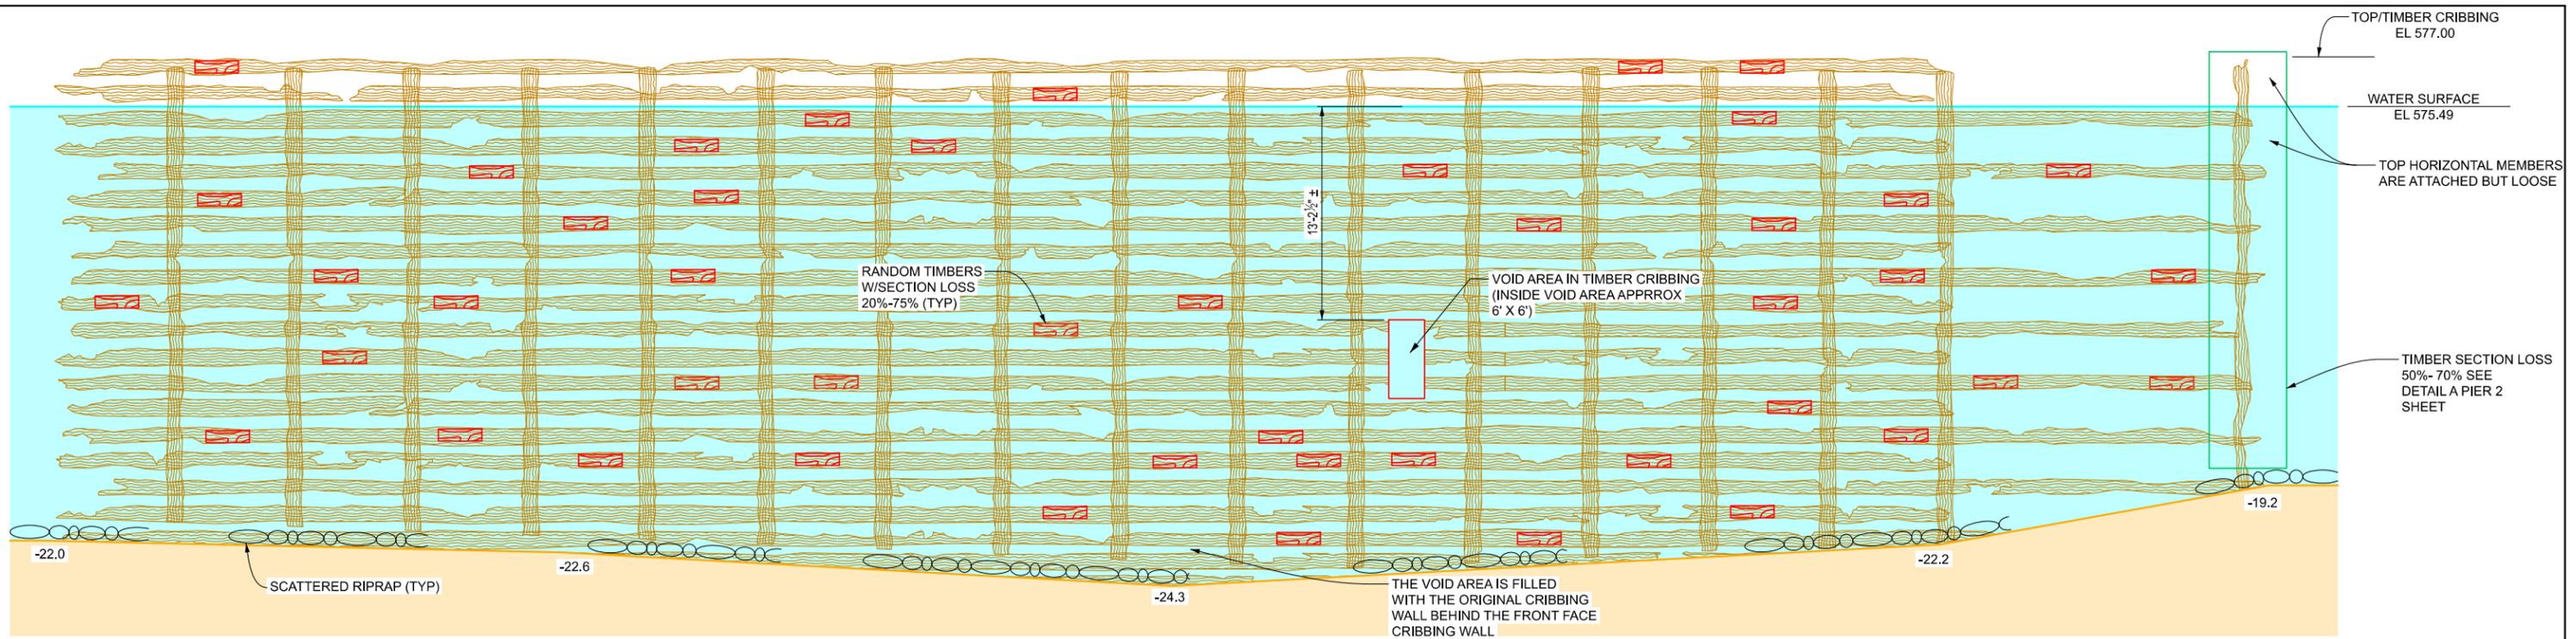
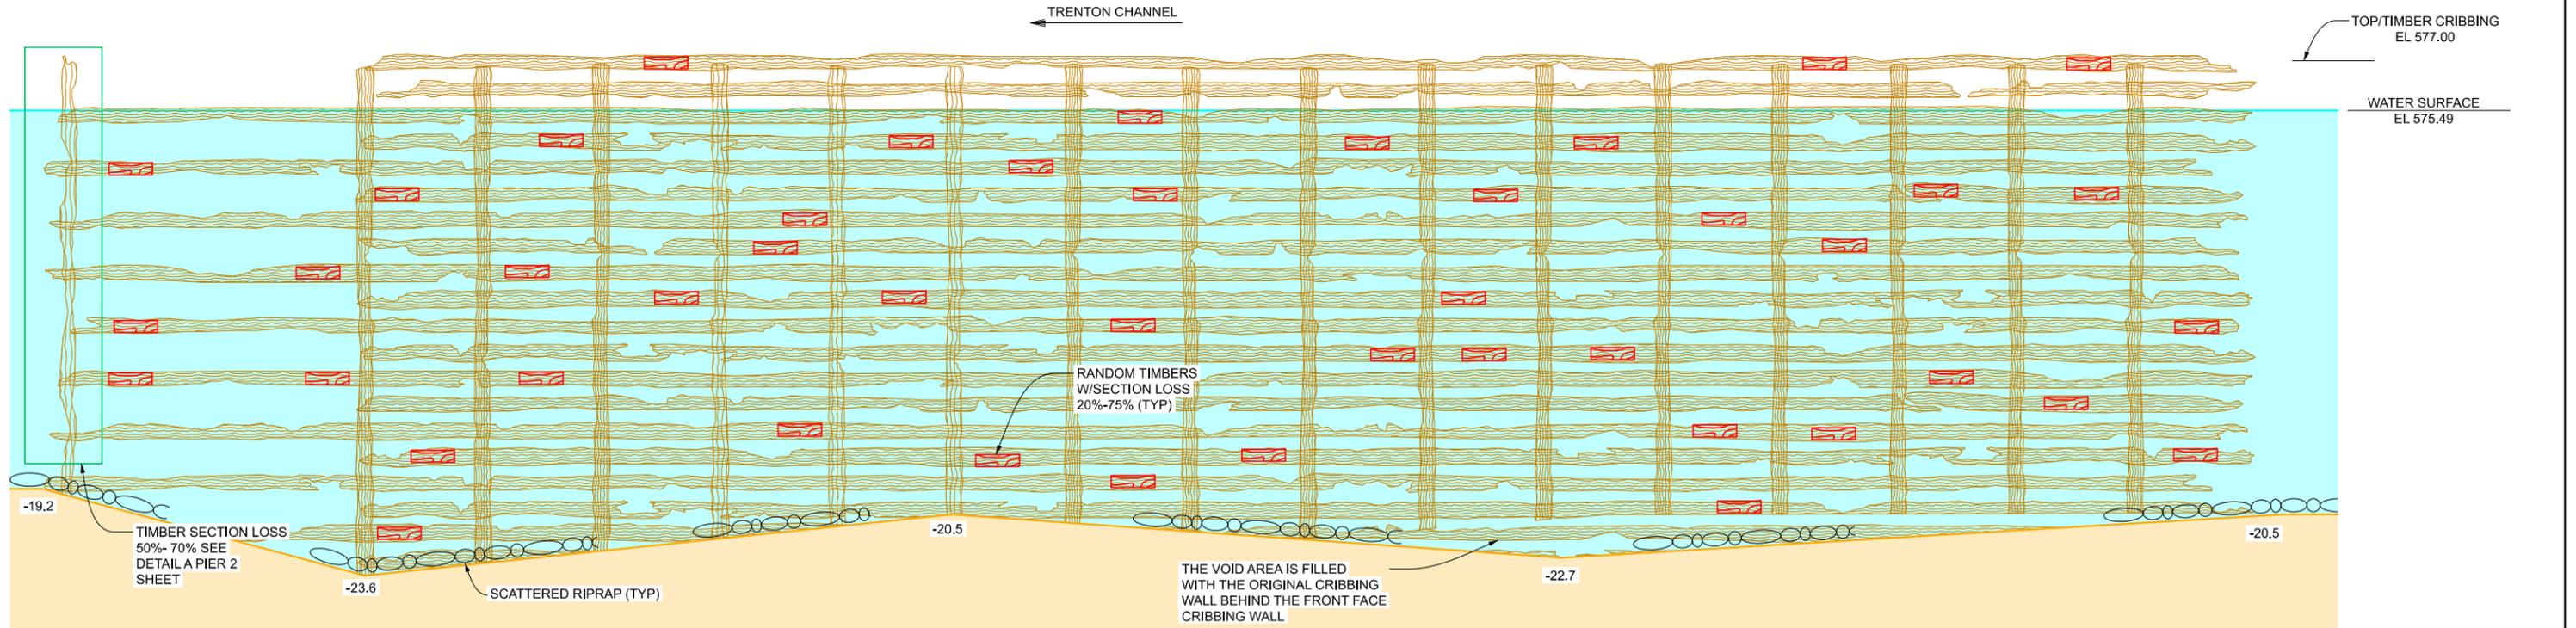
PIEW 9W TIMBER CRIBBING NORTH SIDE WEST ELEVATION

The timber cribbing pier protection system at pier 9w is in **poor condition**. The purpose of the system is to protect the bridge from impacts by vessels and also to identify the navigable channel. The protection system has the visual appearance of sinking, especially at the north end (upstream end). During the 2021, 2020, 2019, and 2017 underwater inspections, water levels have been higher than in older inspections. The high water levels contribute to the sinking appearance, however the extensive deterioration of the pier protection cribbing below water, and failed previous repairs are contributing to the settlement of the pier protection system.

- Adjust underwater inspection frequency to bring 2022 inspection into the months of June, July, August, or September of 2022; then set frequency to 24 months thereafter.
- Continue to survey pier elevations at 4 locations of each pier and monitor by a licensed surveyor or engineer to check for settlement.
- Perform substructure repairs (concrete patching, epoxy injection of cracks) at piers 1w, 2w, 3w, 4w, 5w, 6w, 7w, 8w, 10w, and 11w.
- Replace or retrofit the pier protection system at pier 9w, both the north and south ends.

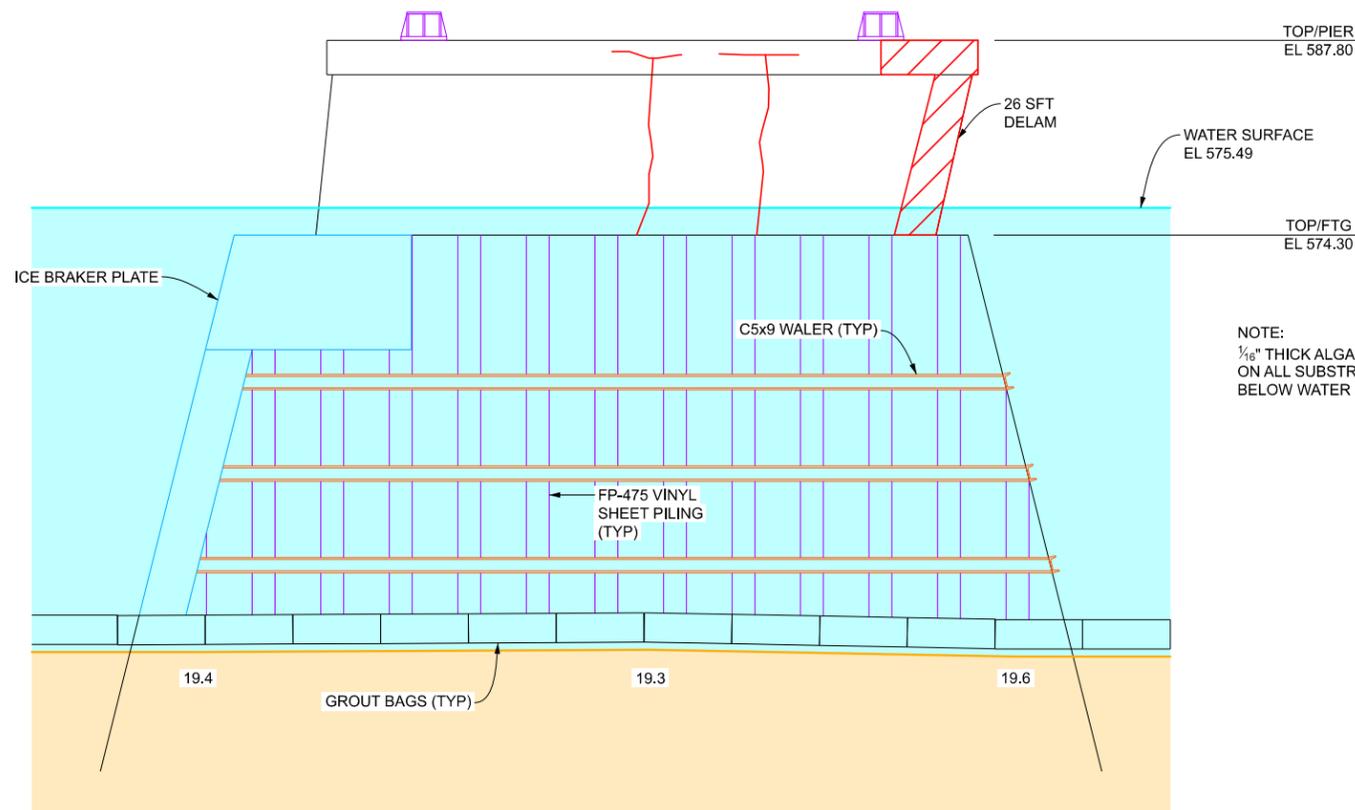
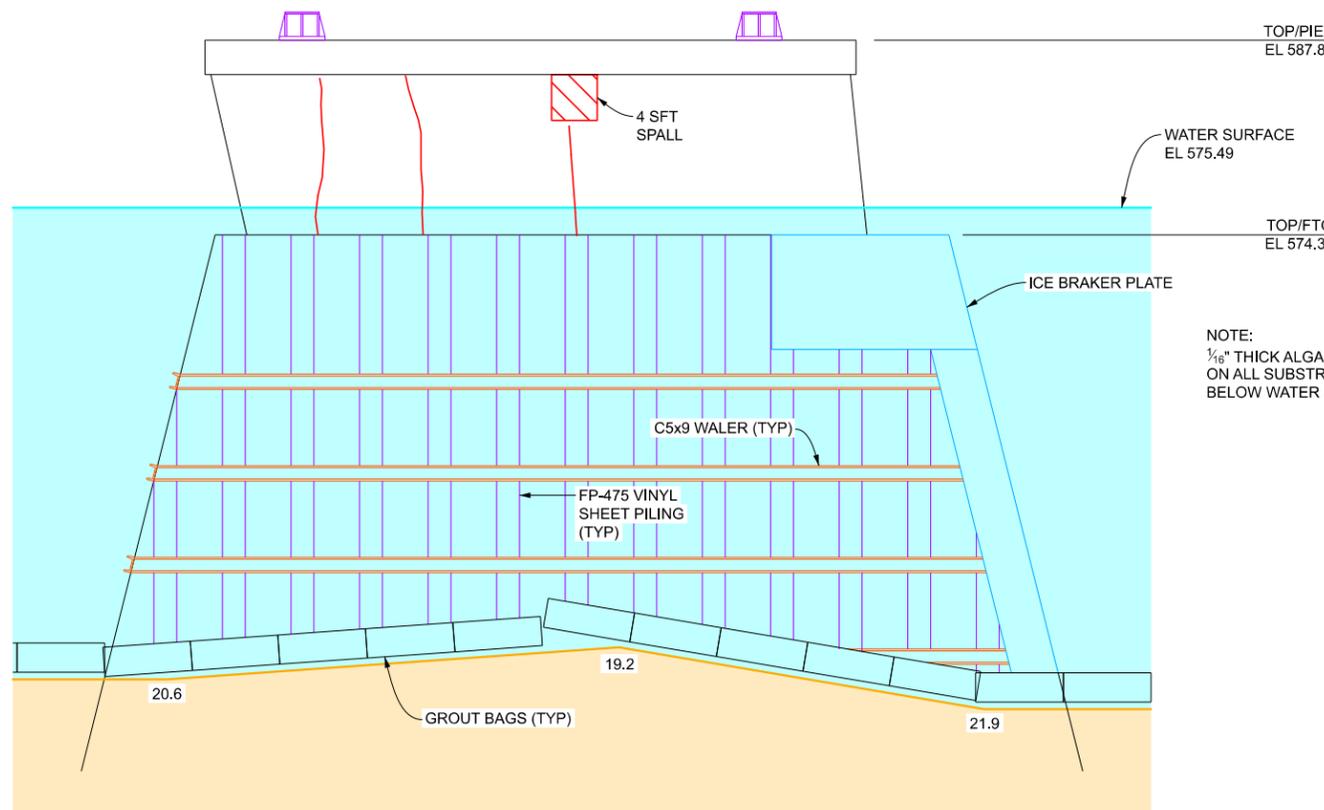
PIER 10W WEST ELEVATION

Substructure Unit	Observations Below the Waterline	Observations Above the Waterline
<p>Pier 10w</p> <p>(Refer to Substructure Elevation Drawings and Soundings Section)</p>	<ul style="list-style-type: none"> • Repairs made to previous timber cribbing deterioration and loss of rock infill. • FP-475 vinyl sheeting surrounds pier (used as stay-in-place formwork). • C5x9 steel walers spaced at 2'-0" vertical spacing securing formwork. • Grout backfill inside steel formwork. • Steel ice breaker plate at upstream end, extending 5' below waterline. • Smaller ice steel ice breaker plate extends to channel bottom. • Grout bags along channel bottom. • 12 sft spall at south end, 75% is above waterline. • 1 sft spall at north end, 50% is above waterline. 10 sft area of 4" deep scaling at north end, 50% is above waterline. • Vertical cracks in west and east elevations extend below waterline to top of footing elevation. • Uniform algae growth on concrete surfaces up to 1/16" thick. • Channel bottom consists of grout bags, sand and scattered rocks up to 1' diameter. 	<ul style="list-style-type: none"> • South end: 12 sft spall, 25% extends below waterline. • North end: 1 sft spall, 50% extends below waterline. 10 sft area of 4" deep scaling, 50% extends below waterline. • West elevation: 26 sft area of delamination in south end of pier wall and bolster area. Vertical and horizontal cracking in pier wall and bolster area. • East elevation: 4 sft spall in pier wall. Vertical cracks in pier wall.

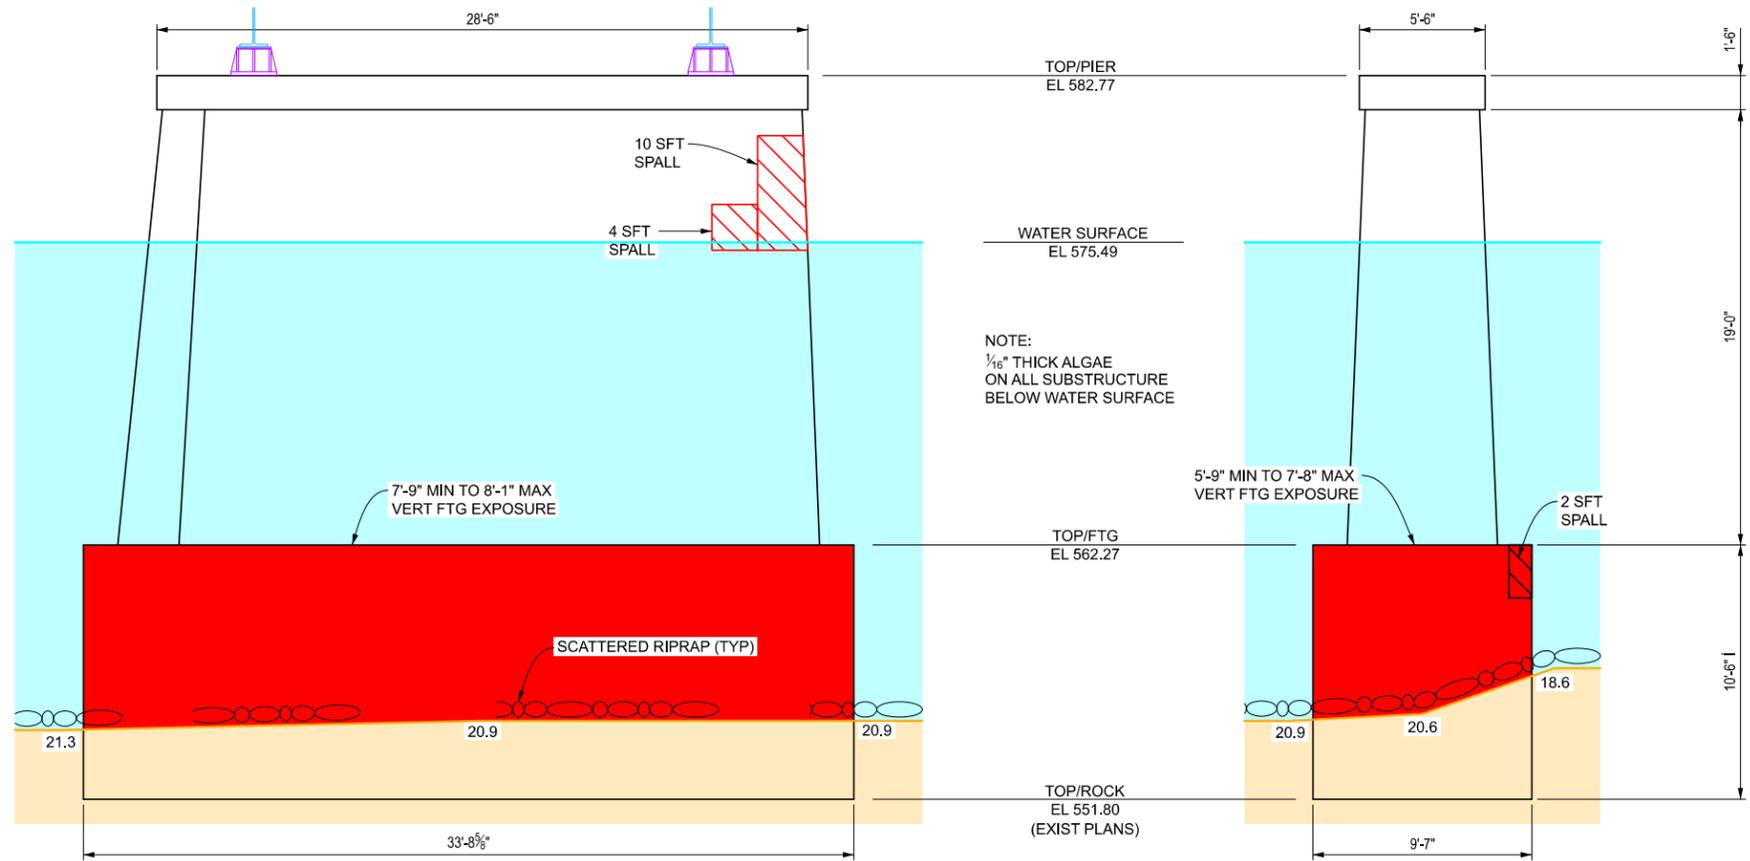
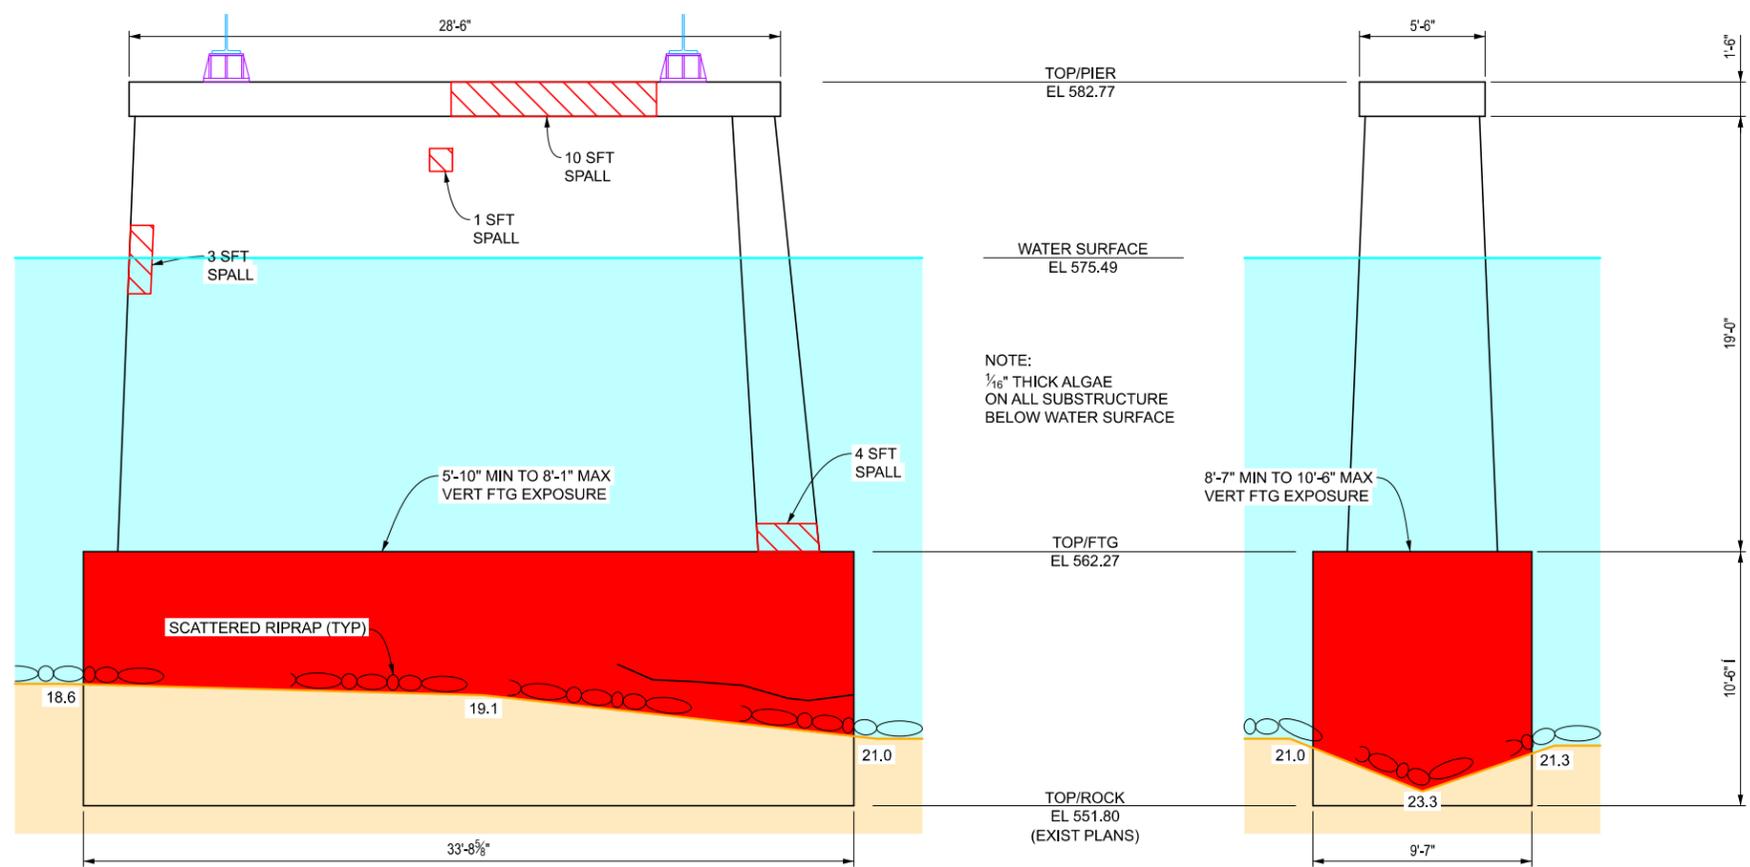
PIER 11W WEST ELEVATION
TRENTON CHANNEL

<p>Pier 11w</p> <p>(Refer to Substructure Elevation Drawings and Soundings Section)</p>	<ul style="list-style-type: none"> • Vertical footing exposure on all sides of pier. Maximum vertical exposure was 10'-6" inches at the north end of the pier. • No undermining of footing observed. • 2 sft spall in footing at southeast corner. • 4 sft spall in nose of pier wall along east elevation, just above top of footing. • 3 sft spall along east elevation extends 50% above waterline. • Uniform algae growth on concrete surfaces up to 1/16" thick. • Channel bottom consists of sand and scattered rocks up to 1' diameter. 	<ul style="list-style-type: none"> • West elevation: 10 sft and 4 sft spalls in pier wall. • East elevation: 10 sft spall in bolster area. 1 sft and 3 sft spalls in pier wall. 3 sft spall extends 50% below waterline.

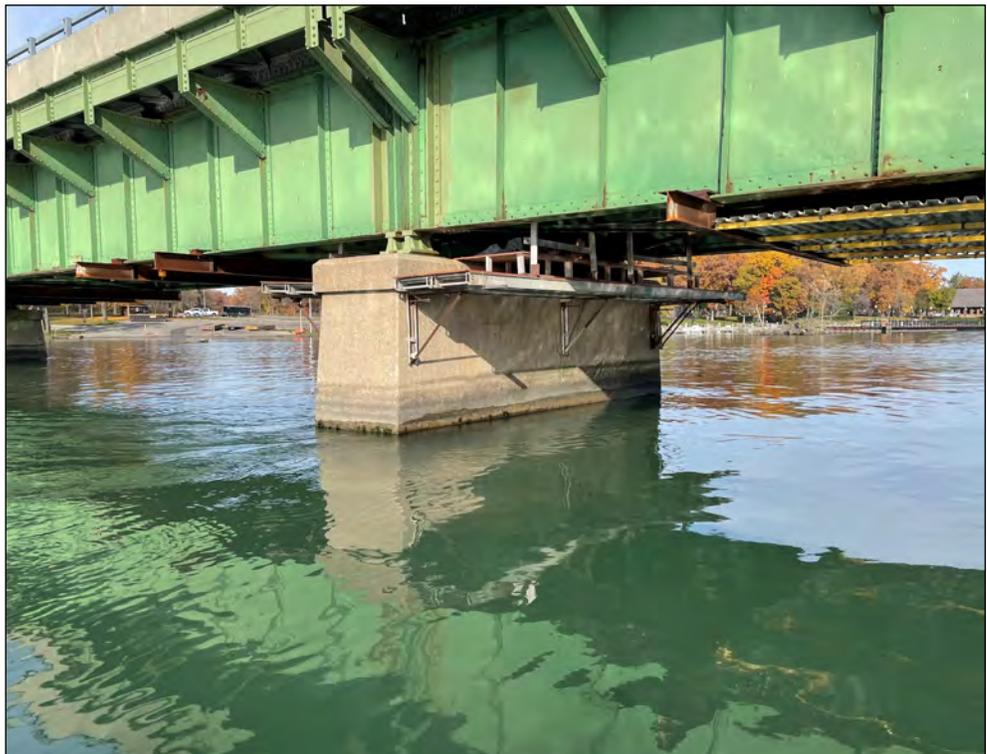
*Pier 3w,
horizontal
crack in
footing, typical
west and east
elevations*

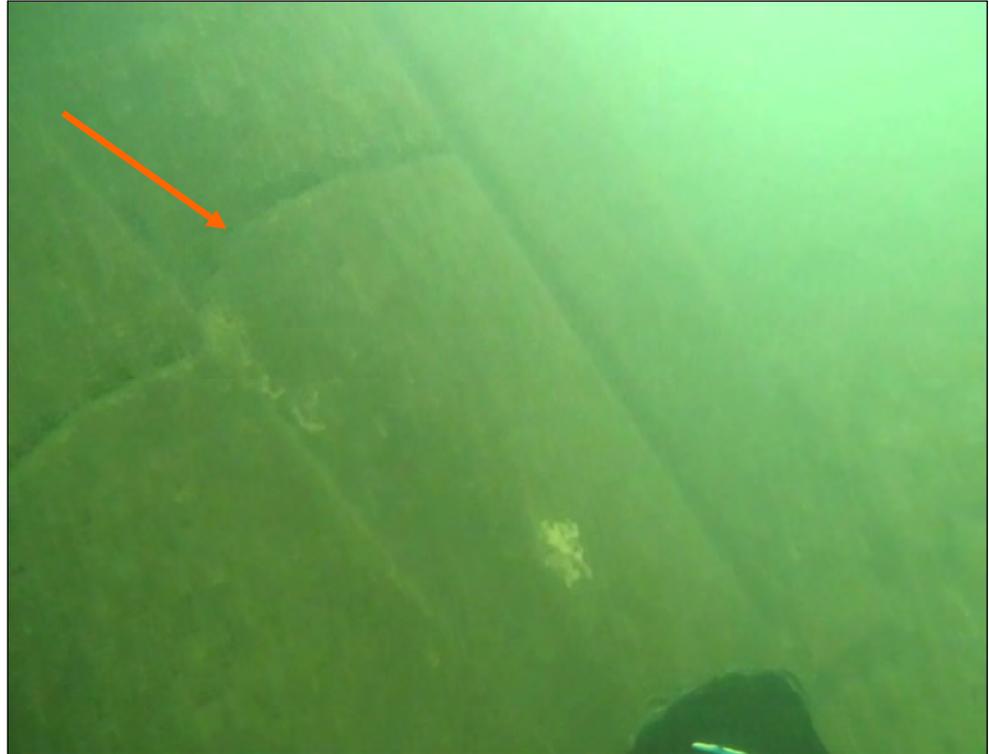
*Pier 3w, typical
condition of
exposed footing*

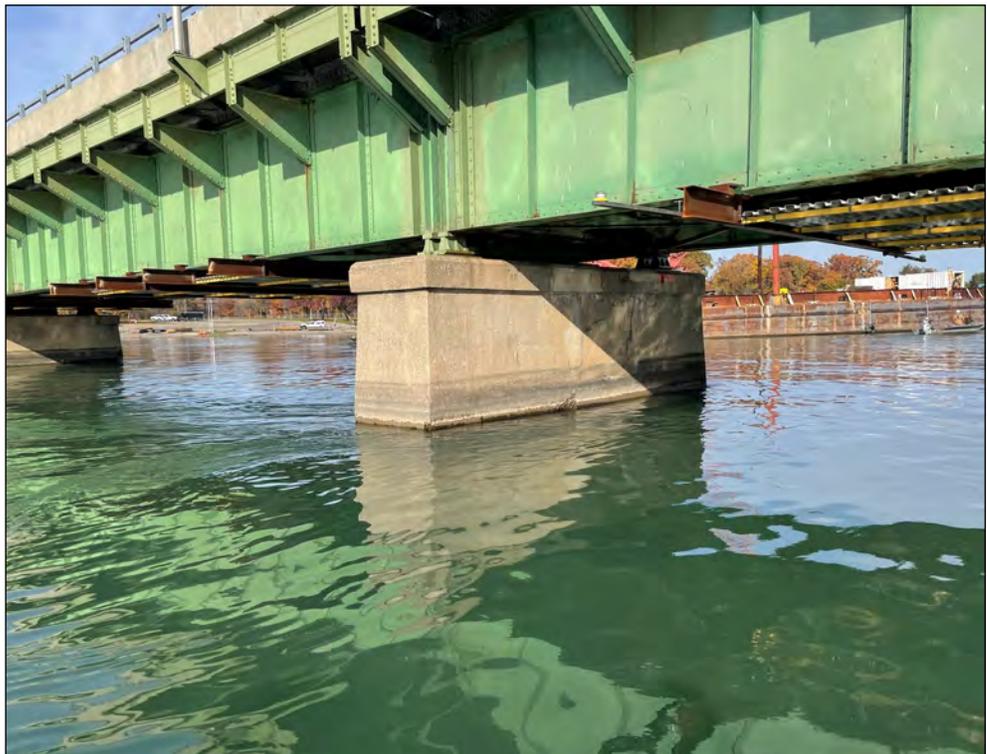
*Pier 5w, open
crack in
footing, typical
west and east
elevations*

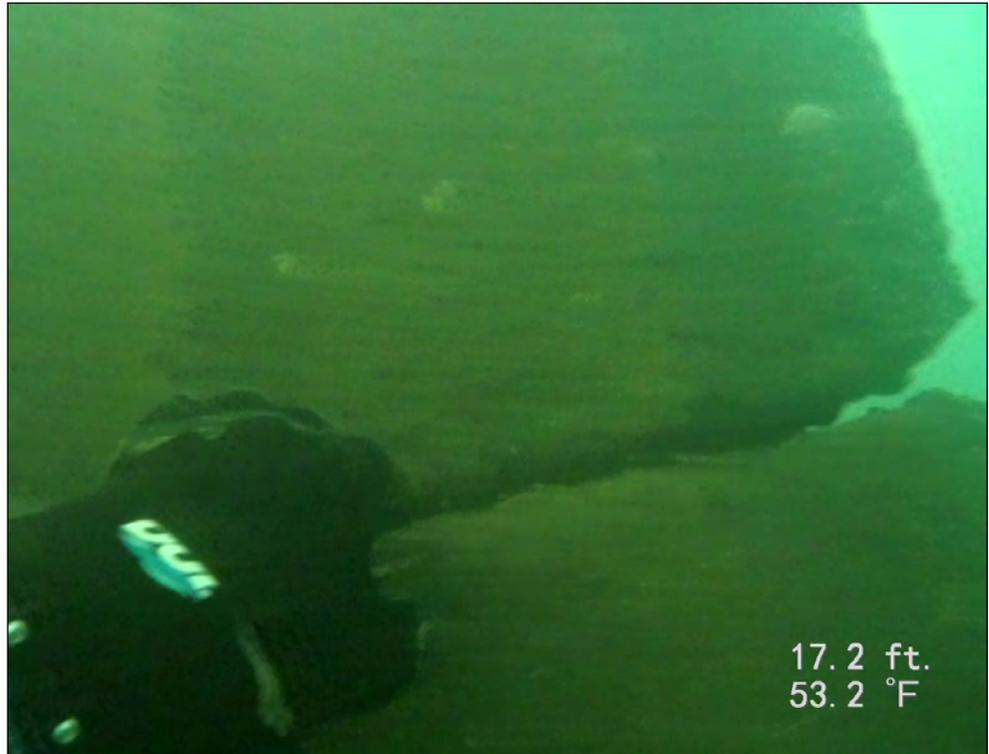
*Pier 5w, open
crack in
footing, typical
west and east
elevations*
