Mr. Homes Inspector - Property Inspection Form

16 March 2020

Property owner	Joe Bloggs
Address	23 Timbuktu Road
Email	House@emailaddy.co.nz
Date	16th March 2020
Time	9:00
Weather at time of inspection	Fine
Agent present	NA
Buyer present	No
Number of bedrooms	4
Purpose	Pre-sale condition report

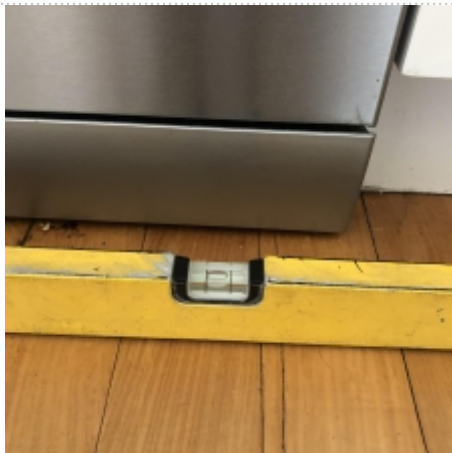
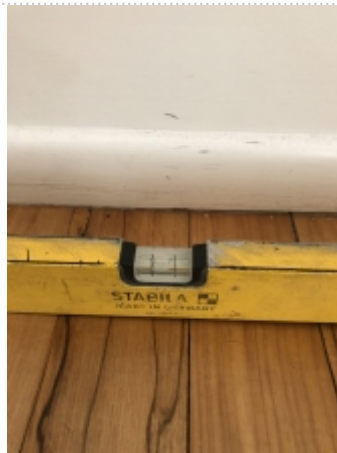
Type	Piles
	Concrete
Description	Concrete pile foundation
Grading	Needs repair
Comment	Needs repair
Photo

Pic 1 & 2: Subsiding piles are evident from levels read in kitchen; Pic 3 & 6
Deterioration of Subfloor perimeter cladding

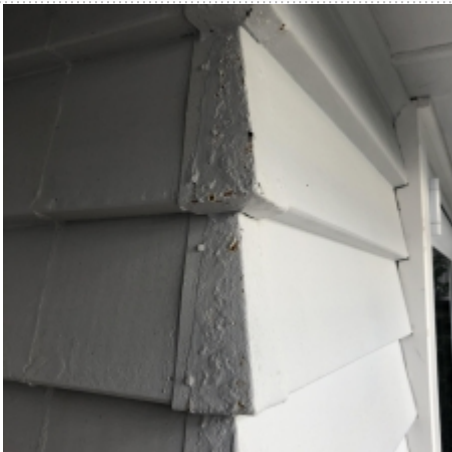
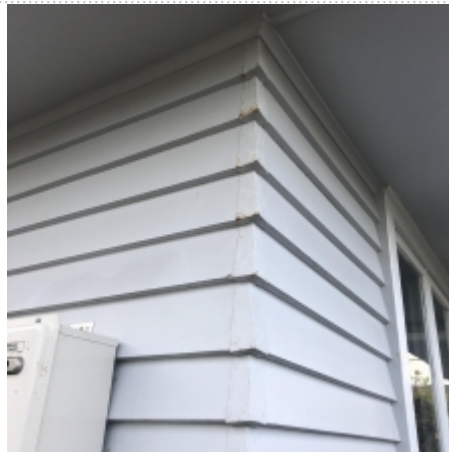
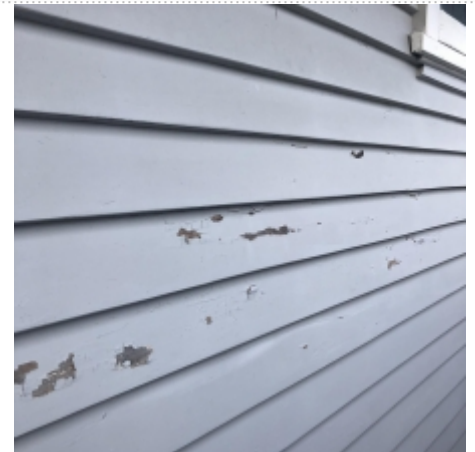
Type	Weatherboard
Description	Bevel back weatherboard, painted
Grading	Average
Comment	Minor damage and deterioration, nothing of major concern
Photo

Pic 1 & 2: Corner soakers showing evidence of decay; Pic 3: Weatherboard
maintenance required

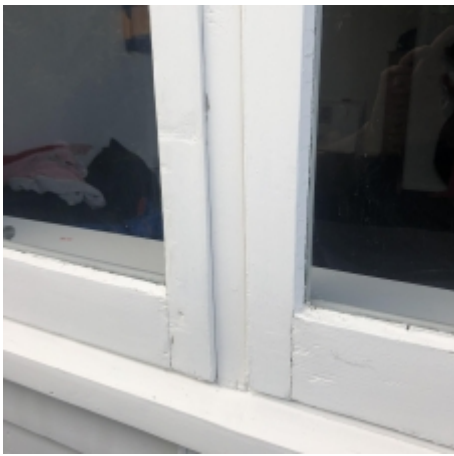
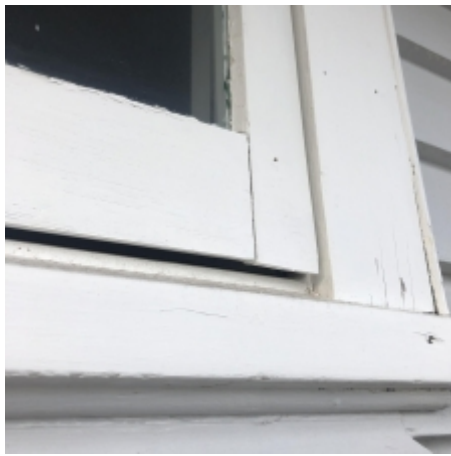
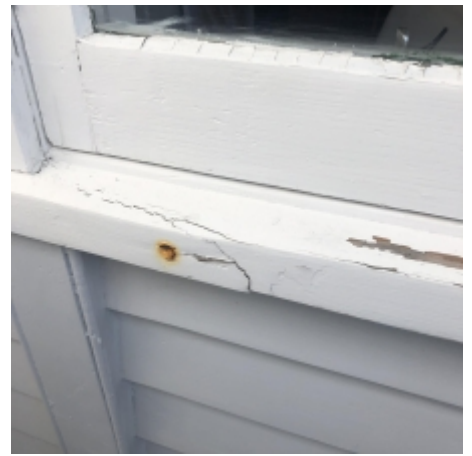
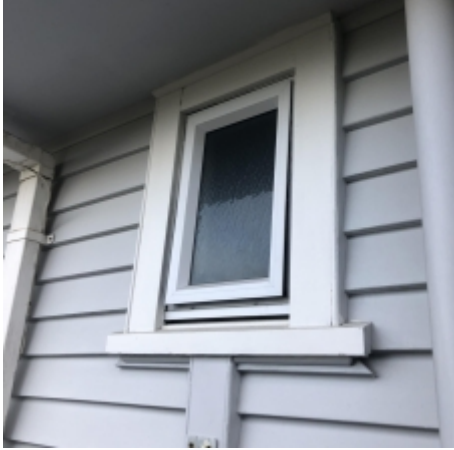
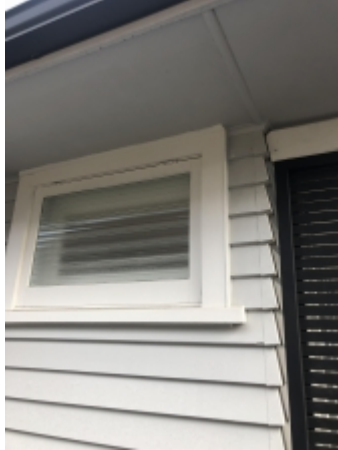
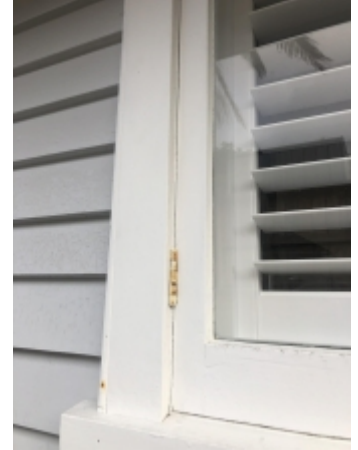
Type	Timber Aluminium
Description	Original timber joinery occupies the majority of the house. 2 double glazed stacker sliders in the lounge and master bedroom.
Grading	Poor
Comment	Poor condition - Original joinery, warping evident in the majority of window sashes Excellent condition - Aluminium joinery Glazing to master bedroom window and kitchen door damaged
Photo

Pic 1-6: Warping to timber joinery and deterioration of joinery hardware
Pic 3: Show evidence of rotting in sill

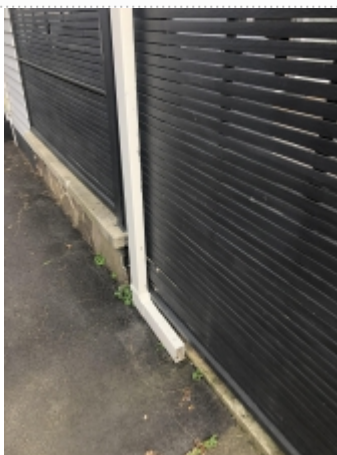
Pic 1: Down pipe run off not connected to gully trap

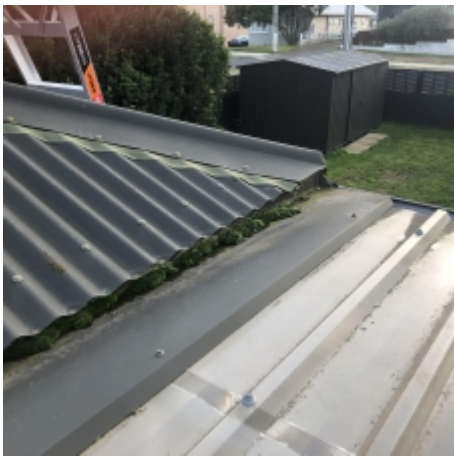
Pic 1: Moss build up on under overhang of roof flashing onto clearlite pergola roof, requires maintenance
 Pic 2: Junction that require sealing
 Pic 3,4&5: Moss build up, flashing requires a minimum up stand of 50mm
 Pic 6: Nail popping, possible water ingress

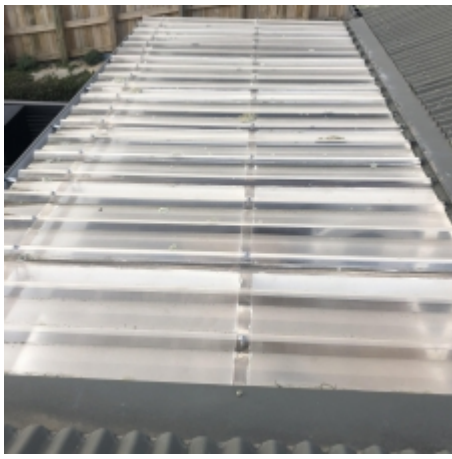
Type	Timber
	Other
Description	Clear lite pergola roof
Grading	Needs repair
Comment	Clear lite pergola roof to front deck appears to not have adequate fall to meet code requirements, minimum fall being 3 degrees. Framing to this roof area requires attention to structural fixings and possible loading of roof
Photo

Pic 1: Minimum fall of 3 degrees, not evident
Pic 2-6: Structural fixings required

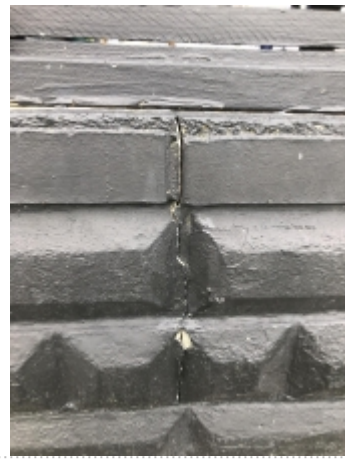
Comment
Retaining wall to front boundary has failed, request for new retaining wall and fence

Pic 2: Retaining wall showing evidence of cracking

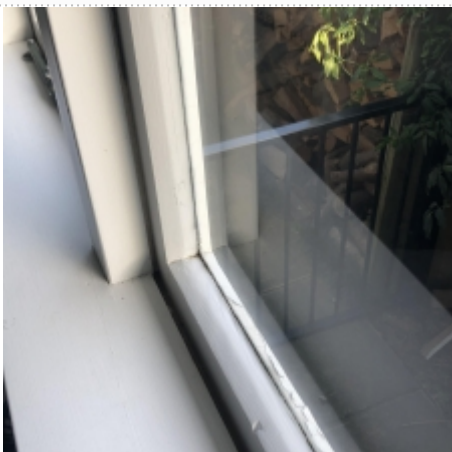
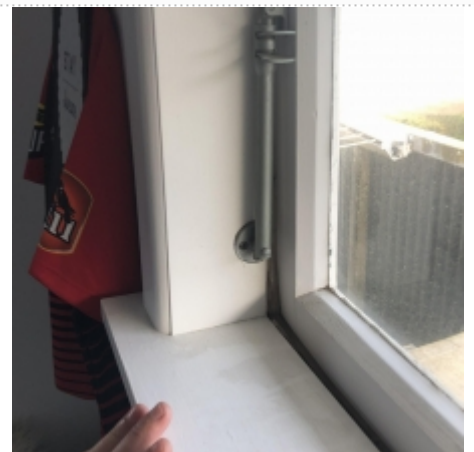
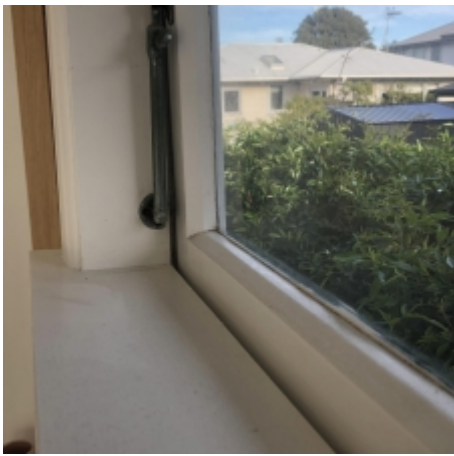
All bedrooms in good condition
HRV system installed to all bedrooms
Good ventilation
Windows: All bedroom timber windows not sealing, need attention
Master bedroom: Window glazing cracked

Pic 1,3&4: Poor seal to window sashes
 Pic 2: Damage to glazing in master bedroom

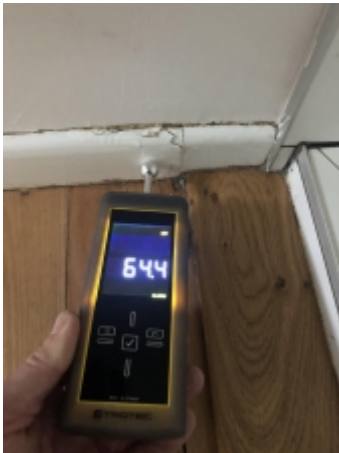
Number	1
Grading	Excellent
Comment	Tiled shower Free standing bath Wall hung vanity Ventilation adequate High moisture reading at base of shower and wall junction (see photos)
Photo

Pic 4: High moisture reading to shower wall junction

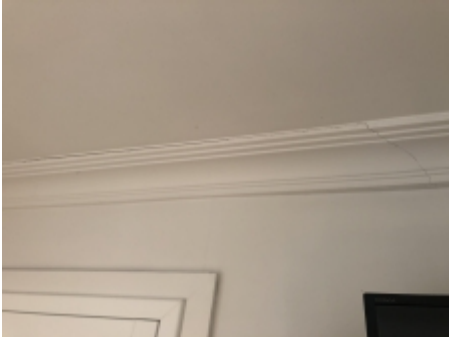
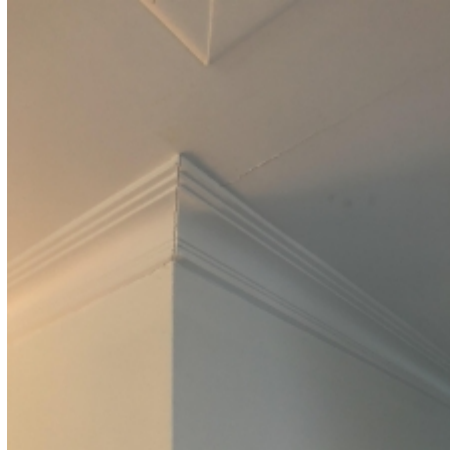
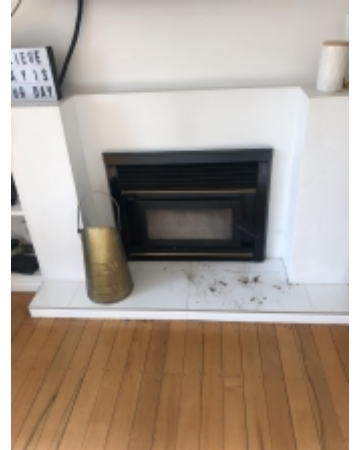
Comment	Minor cracking to coving, sealing and plasterboard. Evidence of possible subsidence of piles
---------	--

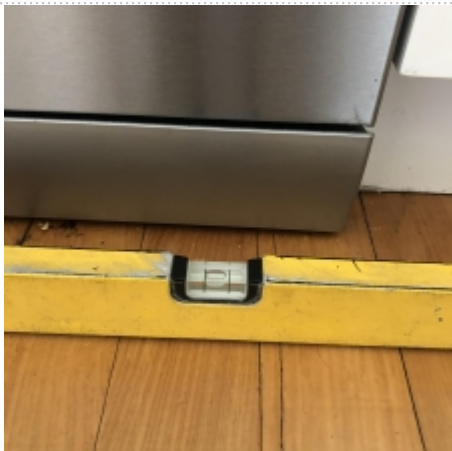
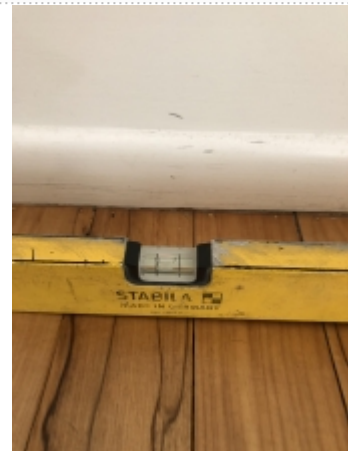
Comment	Levels in dining / kitchen are showing subsiding, cracking in coving and ceiling plaster
---------	--

Photo comment	Pic 1&2: Level showing falls of up to 15mm
---------------	--

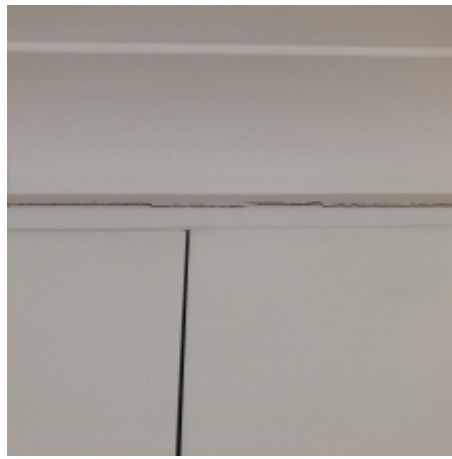
- Pic 1: Rangehood & oven, good working condition
 Pic 2: Cracking to coving above pantry
 Pic 3: Crack in bench top above dishwasher
 Pic 4: Rangehood not fixed back to the wall
 Pic 5: Glazing damage to rear door

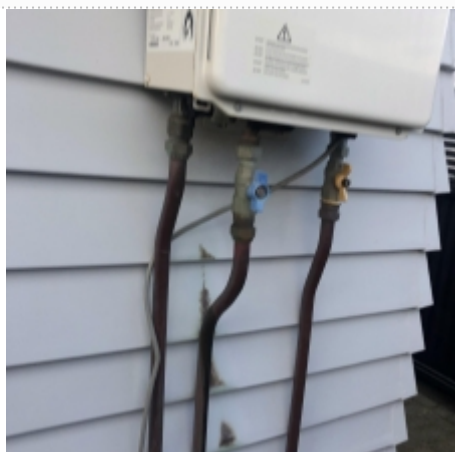
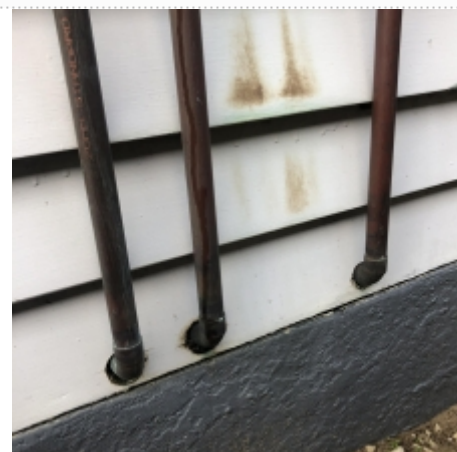
Type	Gas
Grading	Good
Comment	Signs of staining from gas califont to weatherboard, possible maintenance required Gas bottles adequately restrained

Photo comment	Pic 1&3: Shows signs of staining Pic 2: Gas bottles restraints
---------------	---

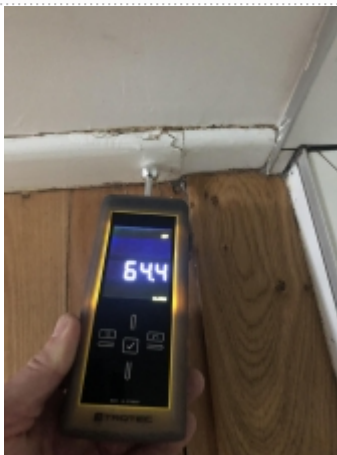
Bathroom - High readings around shower wall junction

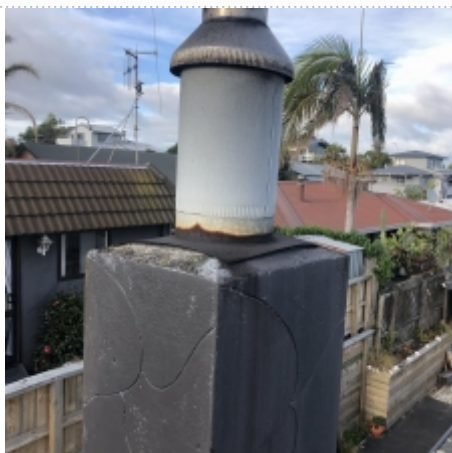
Pic 1: Chimney cowling rusted
