Town of Orleans

Snow Library Current Facility Conditions

Hale Associates, Architects with Mary Braney, Library Consultant
Boston, MA

Executive Summary - Current Facility Conditions Report

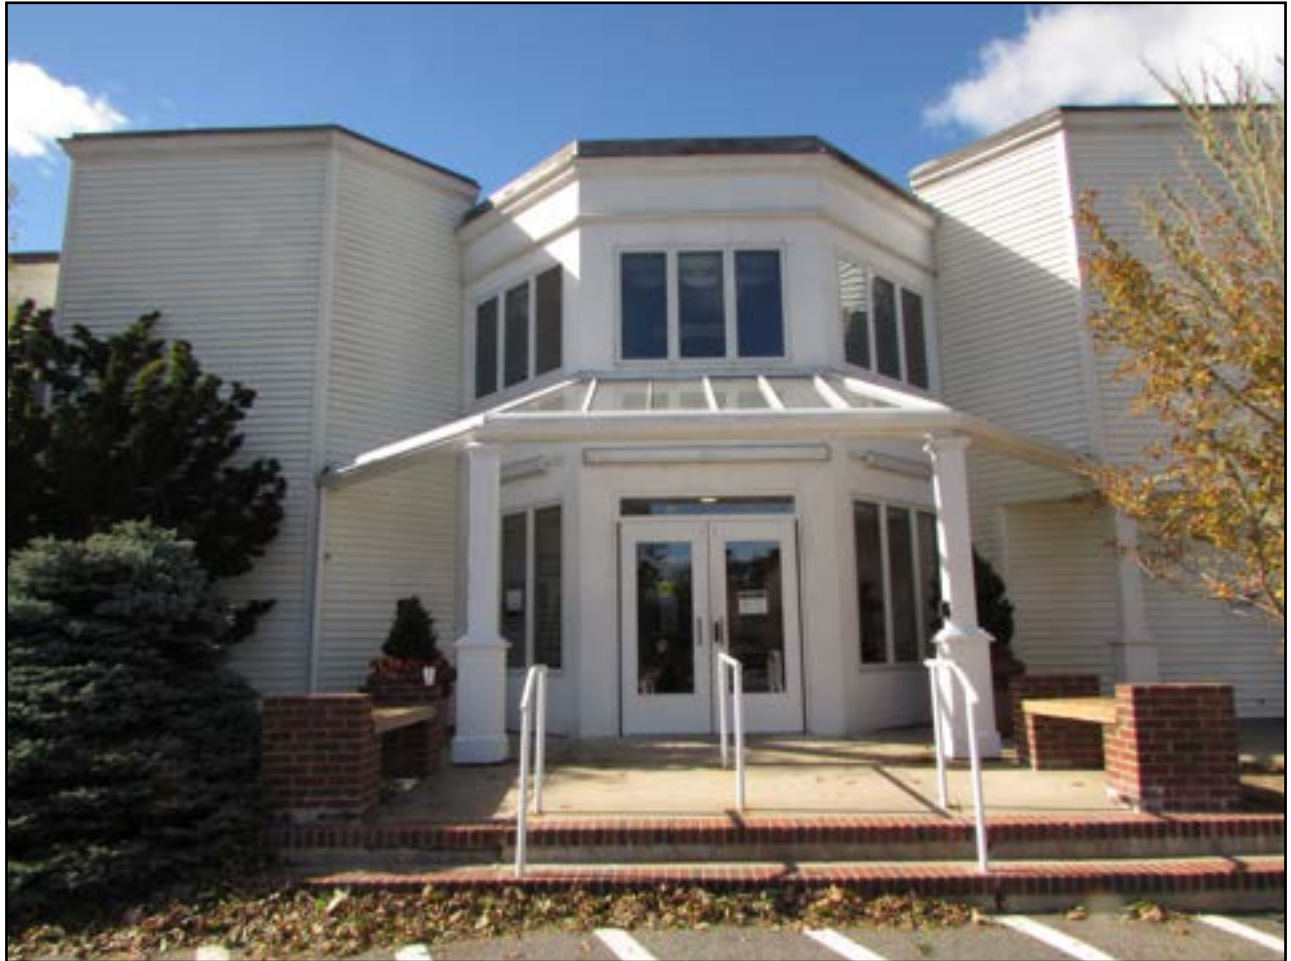
Orleans' Public Library ~ Main Entrance

The Snow Library has a clumped-together, closed architectural character which isn't welcoming with its out-of-date architectural image. This 'clumping' arrangement contributes to confusion about where program areas are located within the building, resulting in overall library service inefficiencies.

In general, the character-defining elements of the exterior (sloping glass canopy entrance, EIFS wall cladding, vinyl siding clapboards and residential style windows) are intact and have served adequately. These cladding components remaining life span is approximately 5-10 years. Some elements of the exterior construction will require updating and replacement in the very near future. Some of the major elements could be upgraded in the context of a major capital public project (a complete 'gut' rehabilitation and large new addition).

Obsolete and incompatible building system components should be removed when all building systems are updated (utility boxes on concrete pads, vestigial lighting, irrelevant signage, inadequately sized utilities, waste and potable water services, etc) .

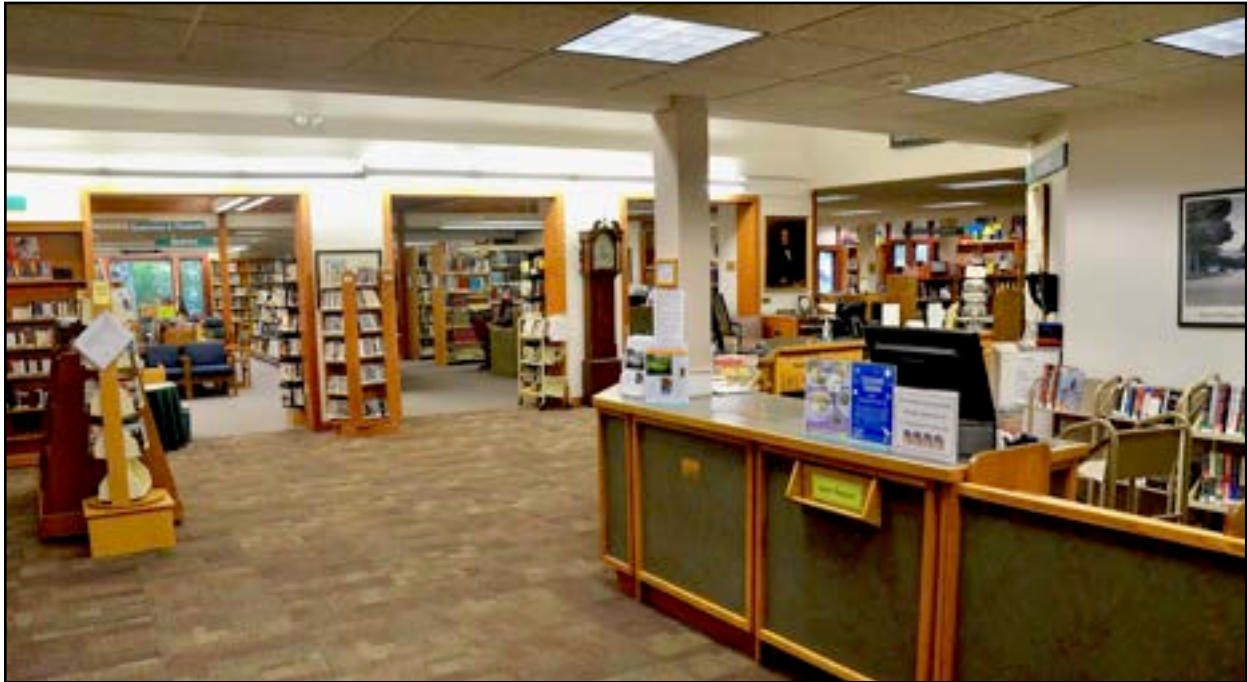
Main Floor Level

The **Circulation Desk** wraps around a corner of the Main level. The Circulation desk is built as a basic wooden frame box, faced with a plastic laminate desk front and plastic laminate top surface. (Over thirty linear feet of service counter, including a three-foot wide section at wheel-chair height faces the new materials area and the business collection alcove.).

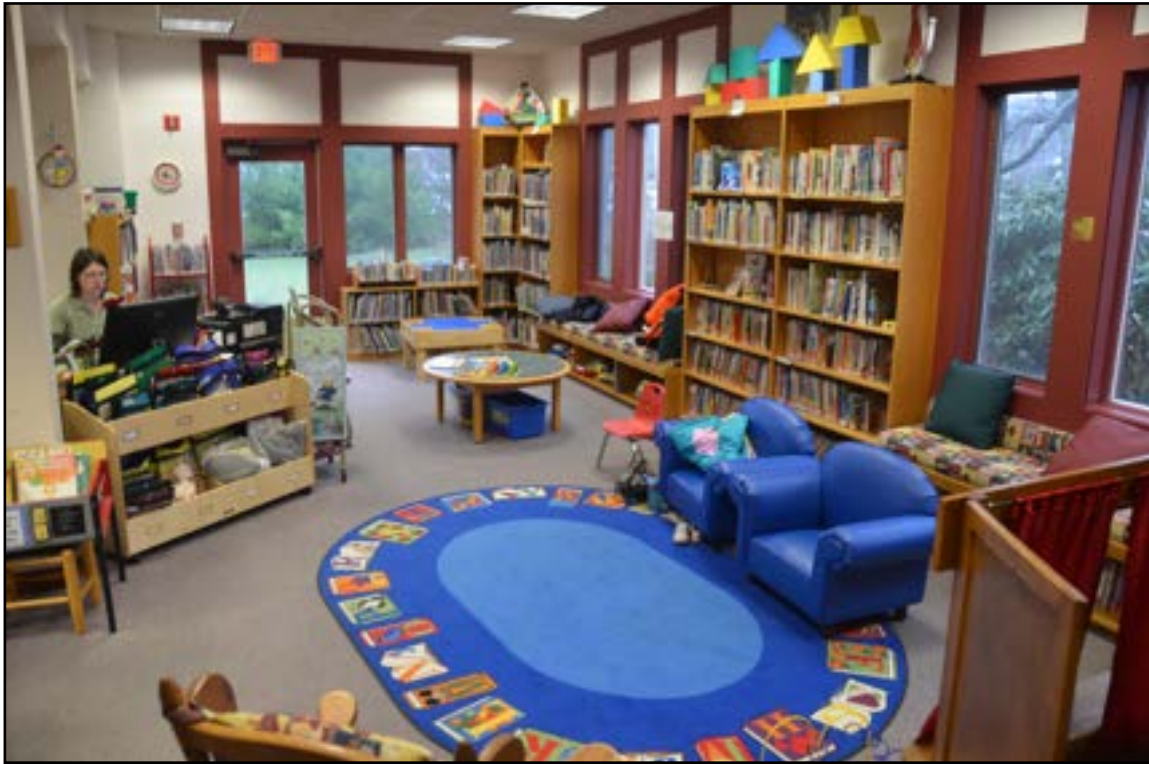
Main Floor Level

‘The **Children’s Area**, containing materials for preschoolers and school-age children is charming, small and cluttered. On one side cozy window seats, child-sized lounge chairs, a colorful rug, a puppet theater and a play table attract preschoolers. Picture books are arranged at the children’s eye level.’

The interior design finish is gyp board walls and ceilings with a thin, adhered carpet. It is acoustically, ‘normally quiet’ except when there are large surges of children. Windows are residential quality with double glazed units that are trimmed with painted low-end soft woods .

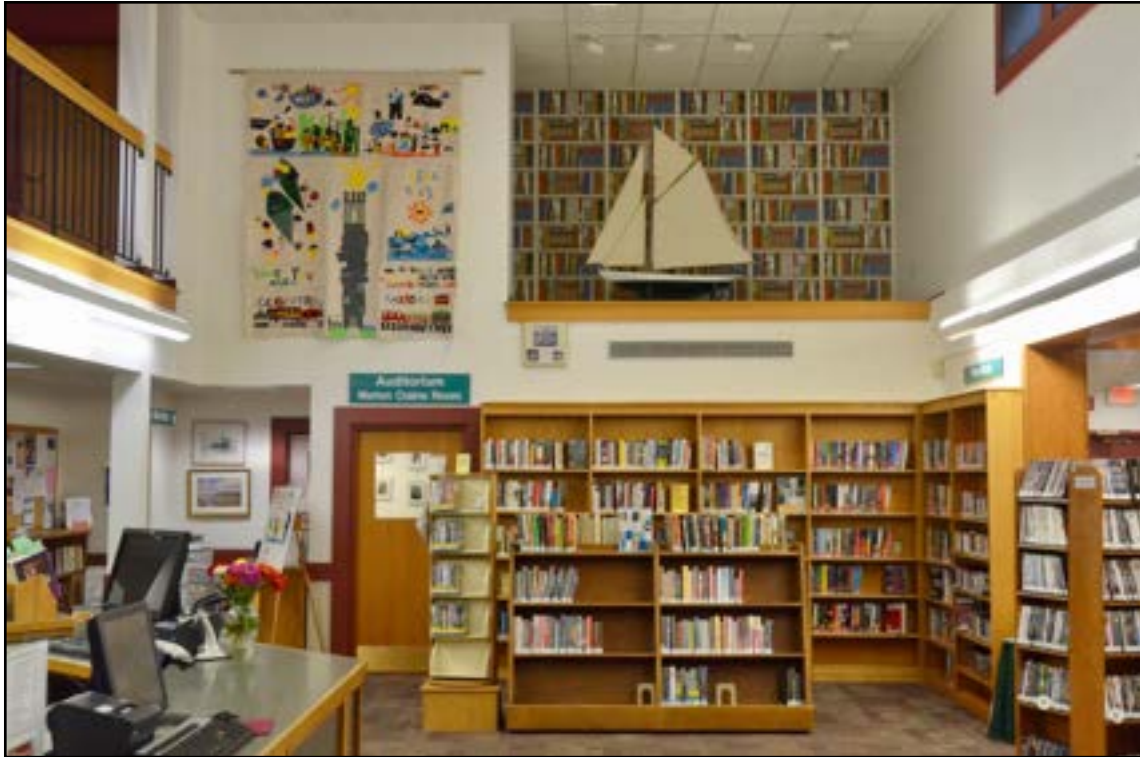
Main Floor Level

New Materials and Acquisitions, open areas. Portions of the non-fiction collection are convenient to the Reference and Circulation Desks. The **Periodicals** and **Reading Areas** flank the Circulation area and the Children's Area and present a haven for casual readers. Unfortunately the Children's area next-door is open to this space, making it noisy with exuberant young patrons so close by ! The YA area on the upper level is open directly to the primary adult transaction space below it. At busy times, both areas affect each other with distracting cross chatter.

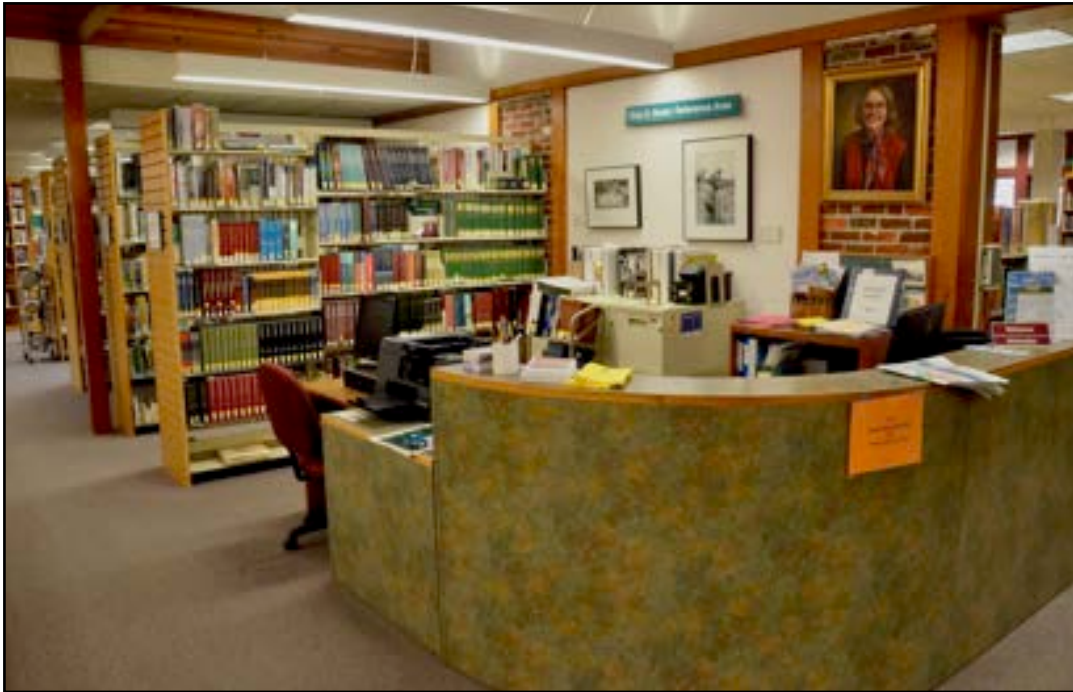
Main Floor Level

‘ The **Reference Desk Area** is behind a desk wall topped by a narrow shelf. The wall is a barrier to interaction with patrons requesting assistance both physically (either librarian or patron has to stand and bend to see the computer or a document) and acoustically (all conversations can be overheard). ‘ The Reference desk is built with the same basic wooden frame box, faced with a plastic laminate front panel and p-lam top surface, as the Main Circulation Desk.

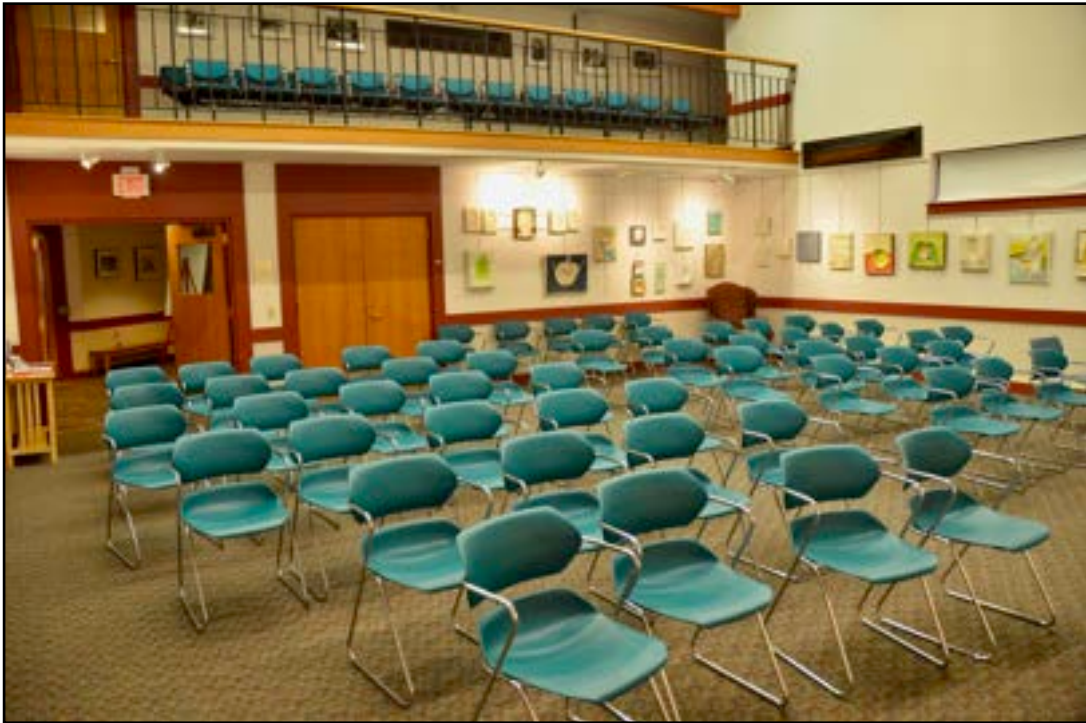
Main Floor Level

'The **'Marion Craine' Meeting Room** provides both library event programs, town meetings for the General public and incidental Art Gallery wall space. Well-attended programs occur daily. Sometimes several in each day. The Meeting Room gallery exhibits change monthly with local Cape and invited artists. If programs require different arrangements, furniture can easily be moved. About (80) individuals can be comfortably accommodated in loose, auditorium-style seating.' Acoustically, the space is modestly adequate. The floor is sound absorptive with a thin, wall-to-wall carpet. This absorption is assisted by a steeply sloped ceiling. Wall/ceiling finishes are gypsum board which has poor sound benefit. There is no wall absorbcency material covering the rear wall (opposite the speaker) to prevent flutter echo. Storage for this busy room is minimal and forces the library to limit its equipment and furnishings, storing tables and chairs in the hallway.

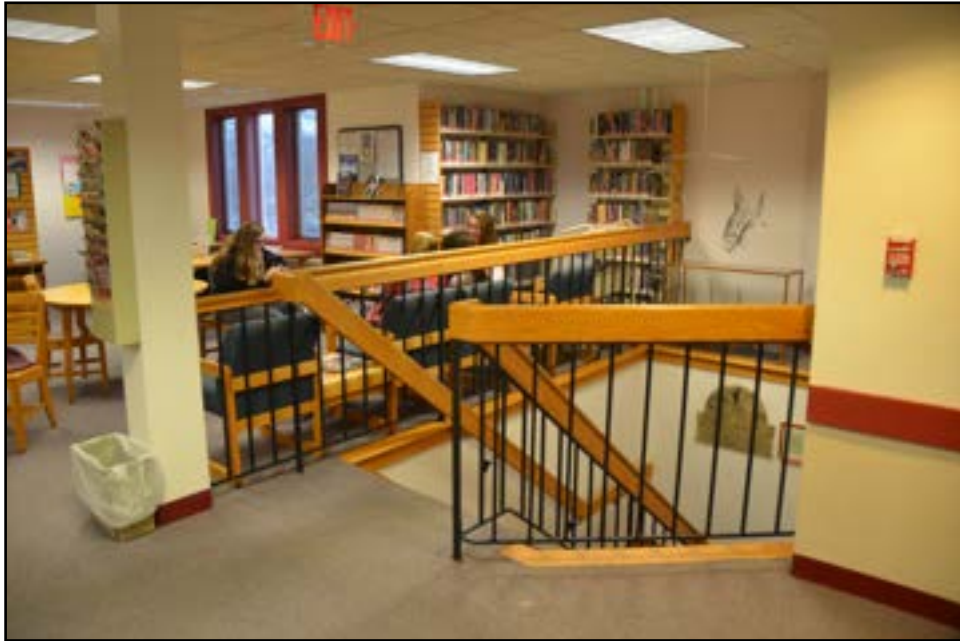
Upper Floor Level

The **Young Adult** area contains the young adult collection for research and recreational reading and provides comfortable work and social space for middle school students and high school students. It has the architectural feeling of a 'loft' space. This means that it is an open space with no walls or barriers and is not acoustically separate from the Main Circulation desk below, which can be busy and quite noisy. Occasionally adults looking for large table space drift up to this **YA** area. The space is woefully inadequate for young adults who can spill out over the space after school. In addition, structural problems in the floor framing have been discovered and addressed (see Structural Report in Appendix).

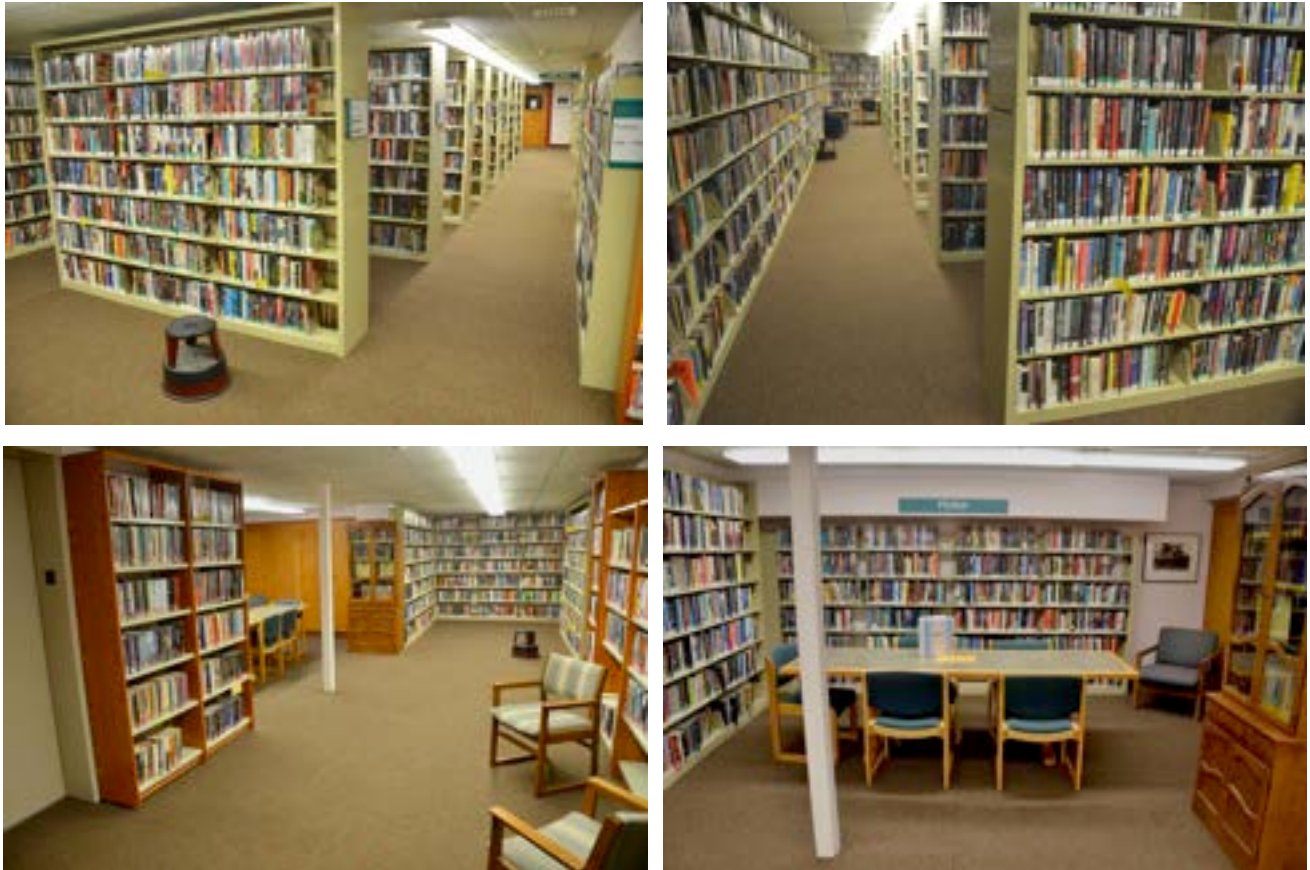
Lower level Adult steel stacks

The Adult shelving layout, including fiction and non-fiction, is packed into the Lower level of the library. Aesthetically the Snow's basement stack area meets minimal standards for a traditional steel, 7-shelf, budget stack area. The steel (7) shelf units are 90" tall with top ties and the basement's rough floor-to-ceiling dimension is 96". Calculating carpeting, space for hidden electrical wiring and an acoustical ceilings tile system, the steel stacks are a tight fit ! There is no room for a Building Code described automatic sprinkler system. This is a crucial code non-compliance in this Assembly class structure that serves the general public .

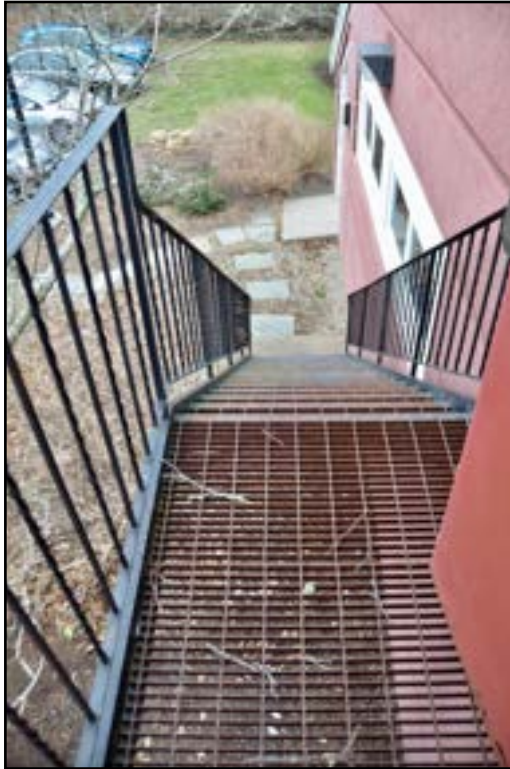
Meeting Room Mezzanine exit stairs.

Inaccessible Meeting Room and Adult Stack Area egress landings (and stair systems) are not in conformance with ADA and/or Massachusetts Architectural Board (MAAB). The book return slot handle is much too high to meet ADA/MAAB standards.

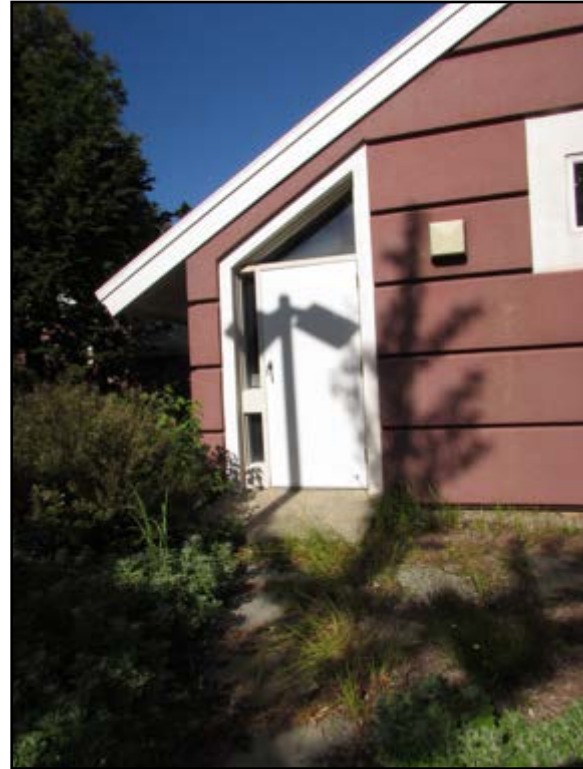
Meeting Room emergency egress door. Note sloping landing.

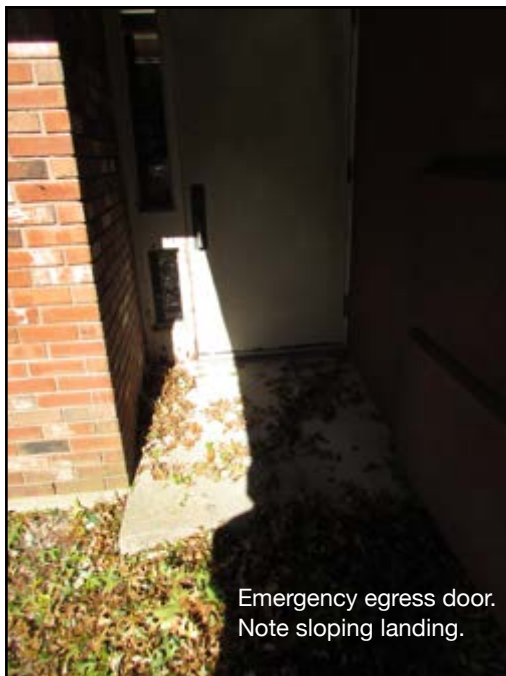
Emergency egress door.
Note sloping landing.

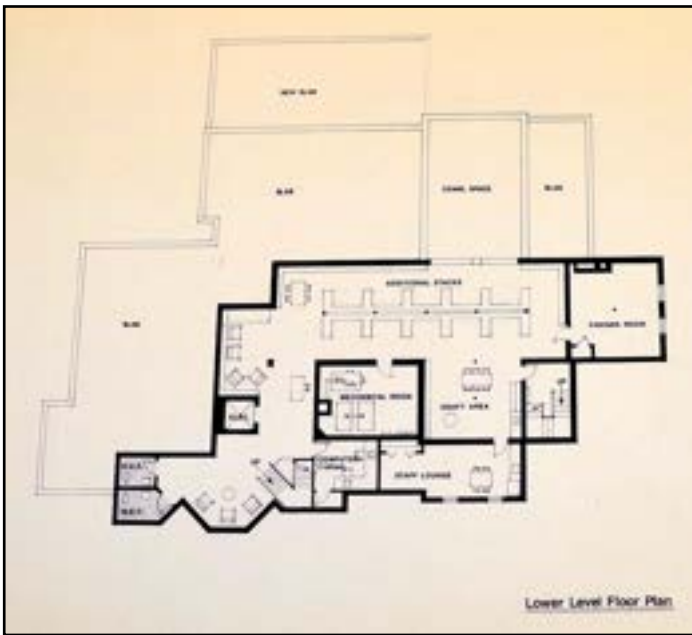
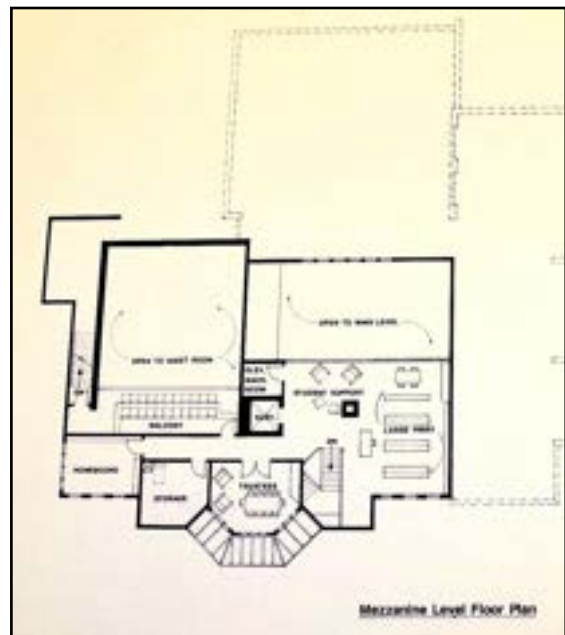
Emergency fire escape.

Both **Lower and Mezzanine** floor levels do not have (2) legal means of (fire-escape) egress. The Building Code requires (2) enclosed, fire-rated stairwells at each floor level. (The elevator does not count as a means.) The Lower level has only one stairwell that is enclosed; the Mezzanine level is through an open Balcony. For both levels, the 2nd means of egress is by way of the central communicating stairway which is convenient but not enclosed and therefore does not meet this Code requirement.

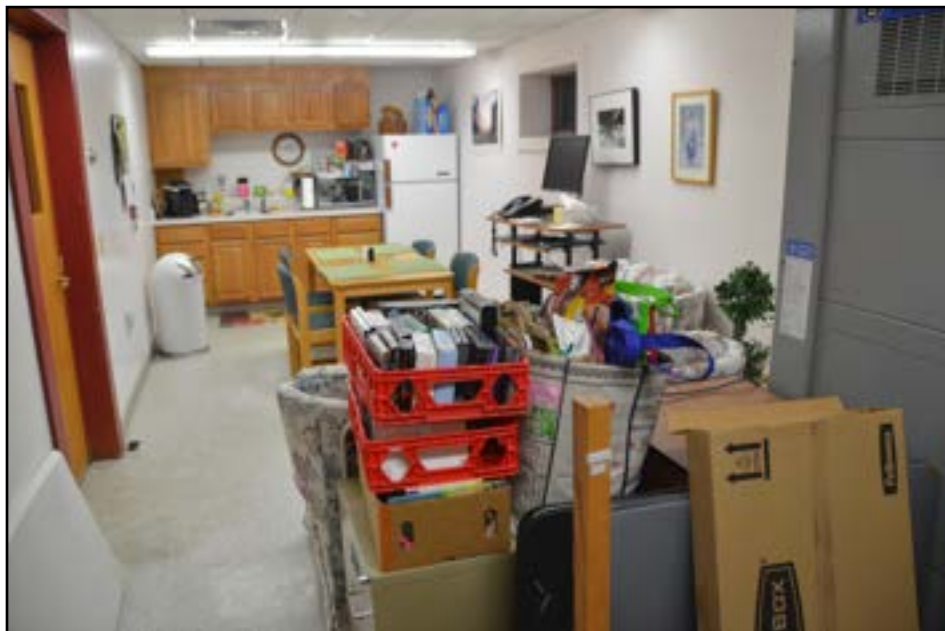
The lower level **Staff Room** kitchen cabinets, plumbing fixtures and furniture are not in conformance with ADA and/or Massachusetts Architectural Board (MAAB) standards.

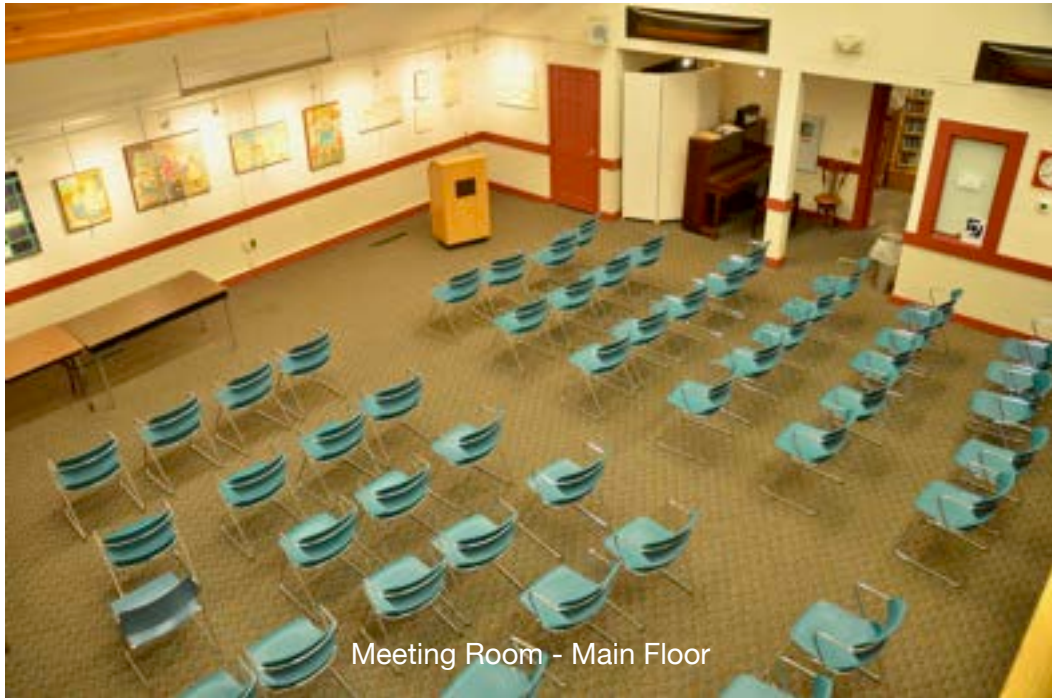
Meeting Room - Main Floor

The Craine Meeting Room is very popular and in constant demand. Today's functioning capacity is approximately 80 persons, the future library programming calls for 200. It is heavily booked by the library and outside groups looking for adequate space - anywhere in town. Tables, chairs and equipment storage is teensy for a meeting room of this size that is expected to serve a wide variety of program furnishing configurations. The original architectural layout did not intend this room to be used as a meeting room.

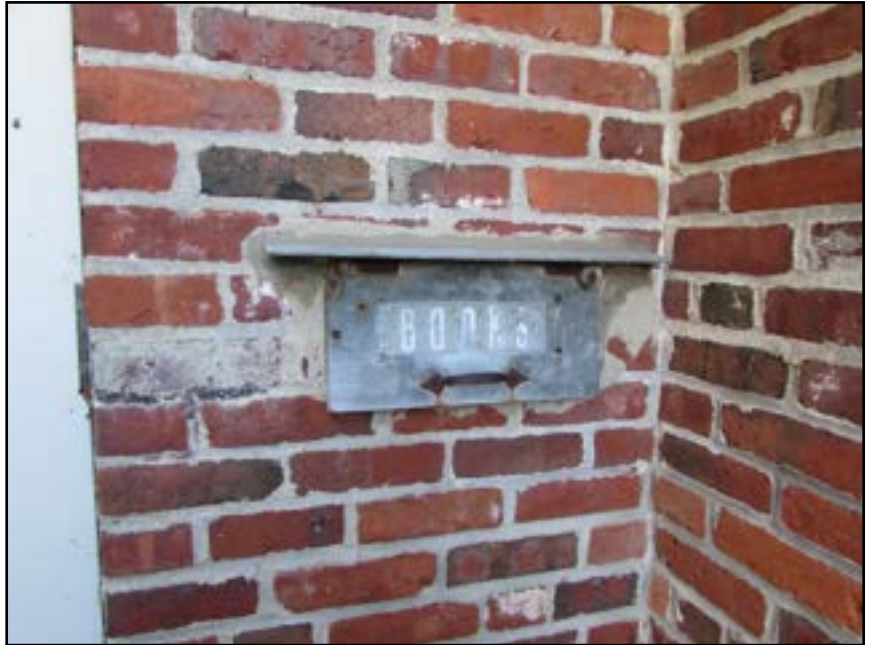
1950's original
Book Return Slot. (defunct)

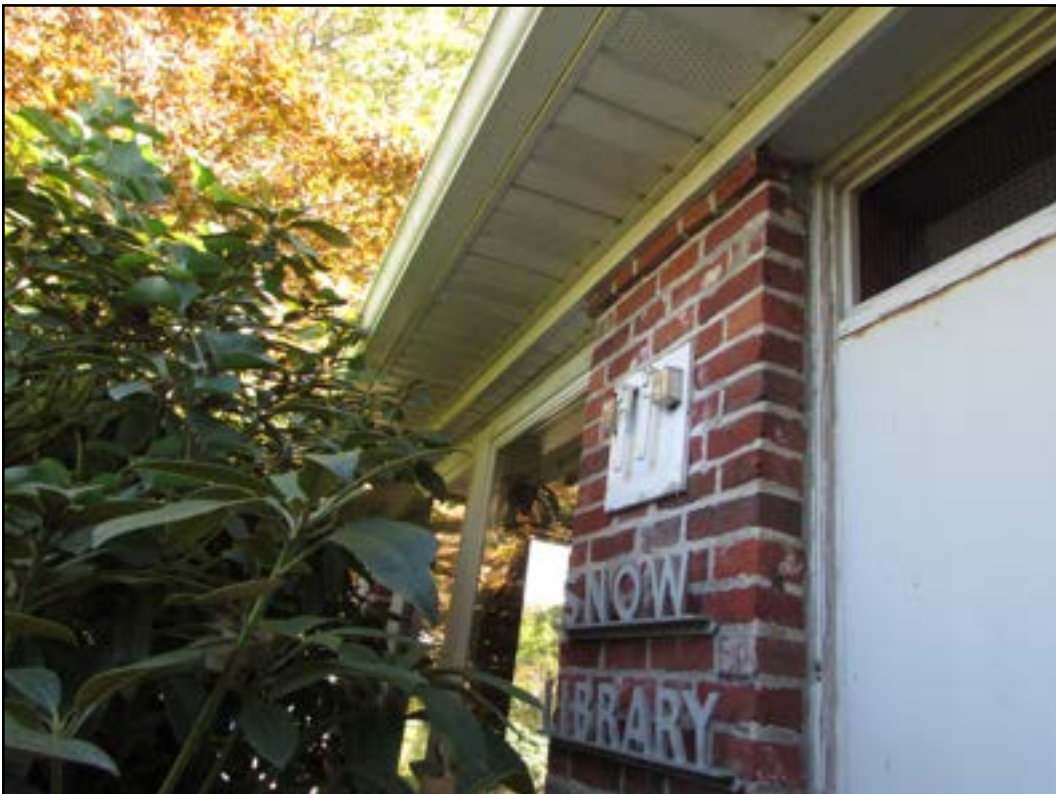
Original
Library
Sign and
Light Fixture
Location.
(defunct)

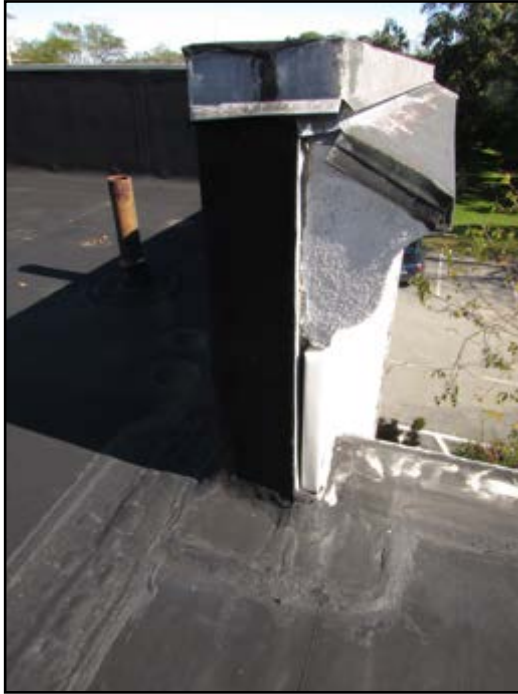
The Main library roof is primarily a flat membrane roof. Generally in good condition; the parapet wall cladding shows considerable de~lamination and deterioration. The membrane appears to be a relatively new installation.

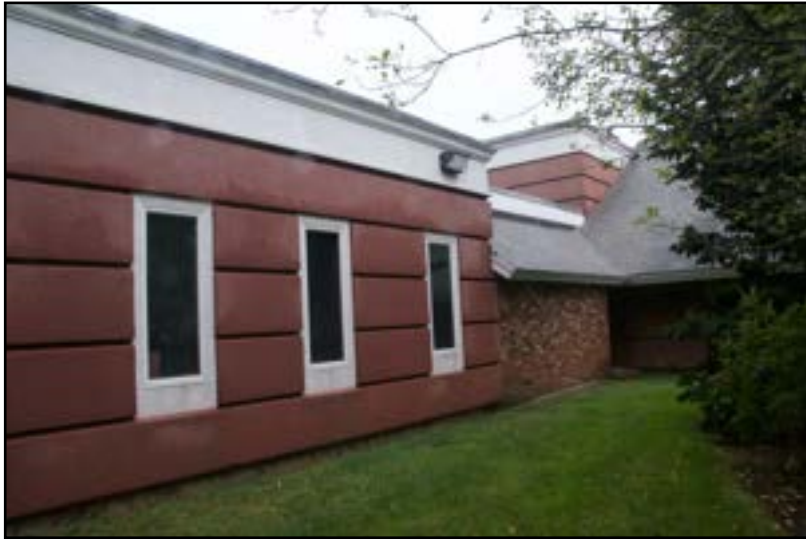
The 'Stucco' Exterior Insulation System used on the North, West and South exterior walls was specified for being inexpensive and for its thermal efficiency; but has been problematic to achieve water tightness, repair and maintain in the past.

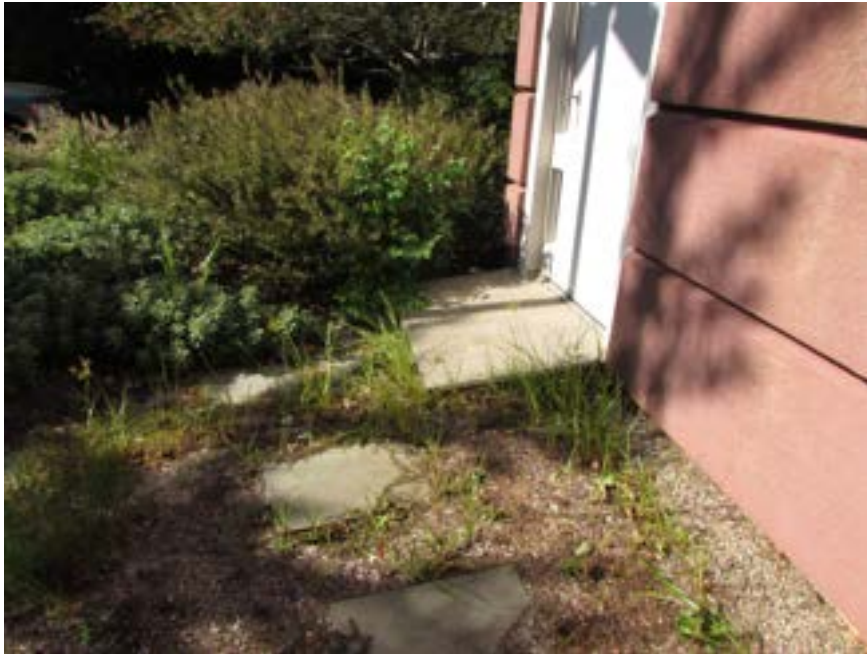
The exterior envelope shows weathering typical for a structure that has been exposed to nearby Cape Cod salt air and humidity over a span of 27 years. All ferrous metals show considerable rusting.

Exterior insulation wall cladding is dull but in average condition. Light colored trim details show built-up stains and embedded soil and grime.

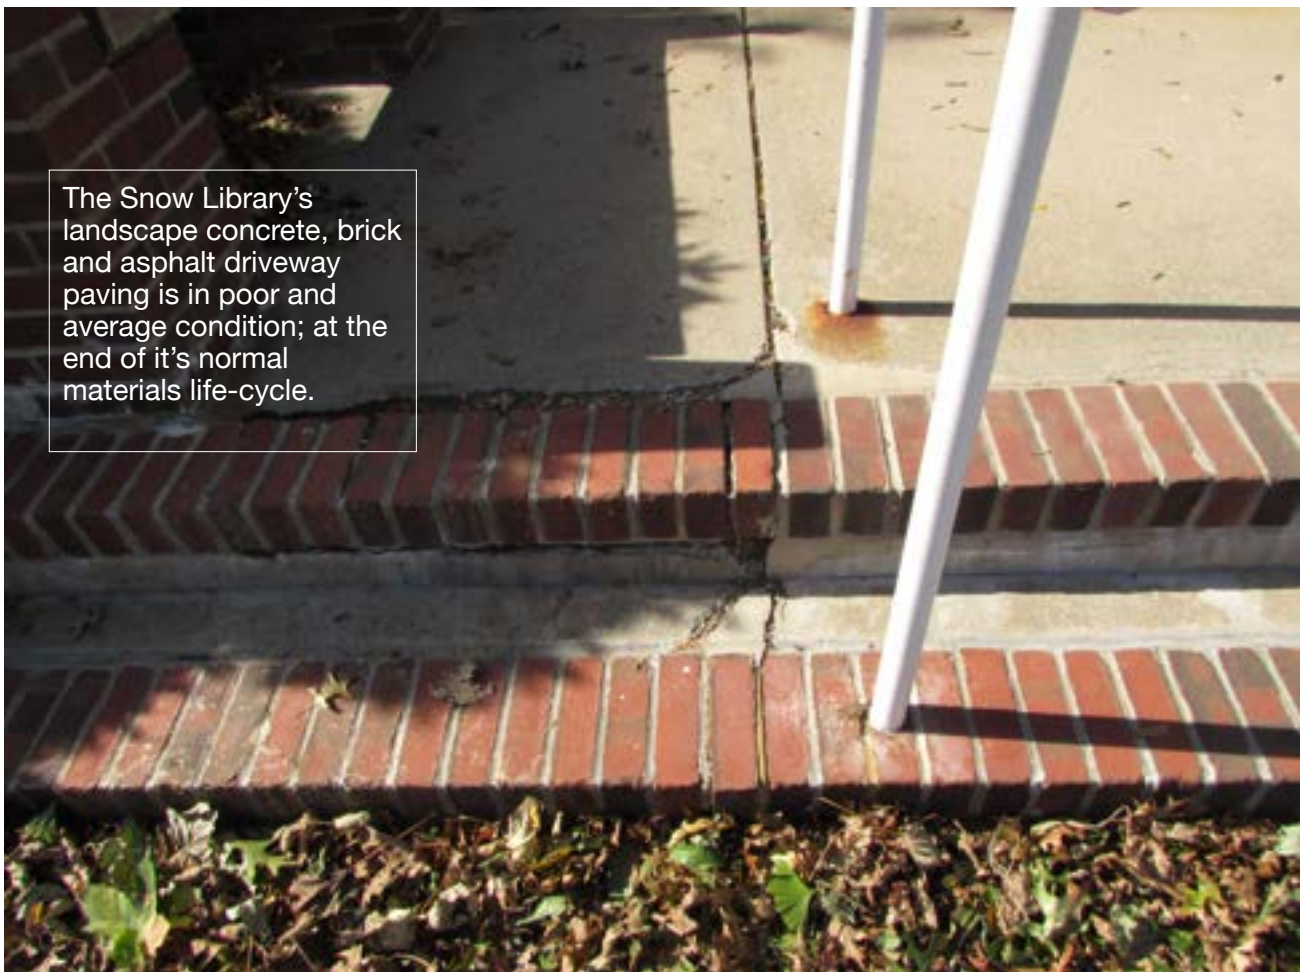
The Snow Library's landscape concrete, brick and asphalt driveway paving is in poor and average condition; at the end of its normal materials life-cycle.
