Audit Report for December 30, 2021
Sewer Collapse and Wastewater Spill in the City of Carson

Los Angeles County Sanitation Districts

4 May 2022

On December 30, 2021, the Districts' 216th Street Relocation Trunk Sewer experienced a critical failure in the City of Carson causing a Sanitary Sewer Overflow (SSO) event that impacted local residents on 212th Street and caused closure of some local beaches.

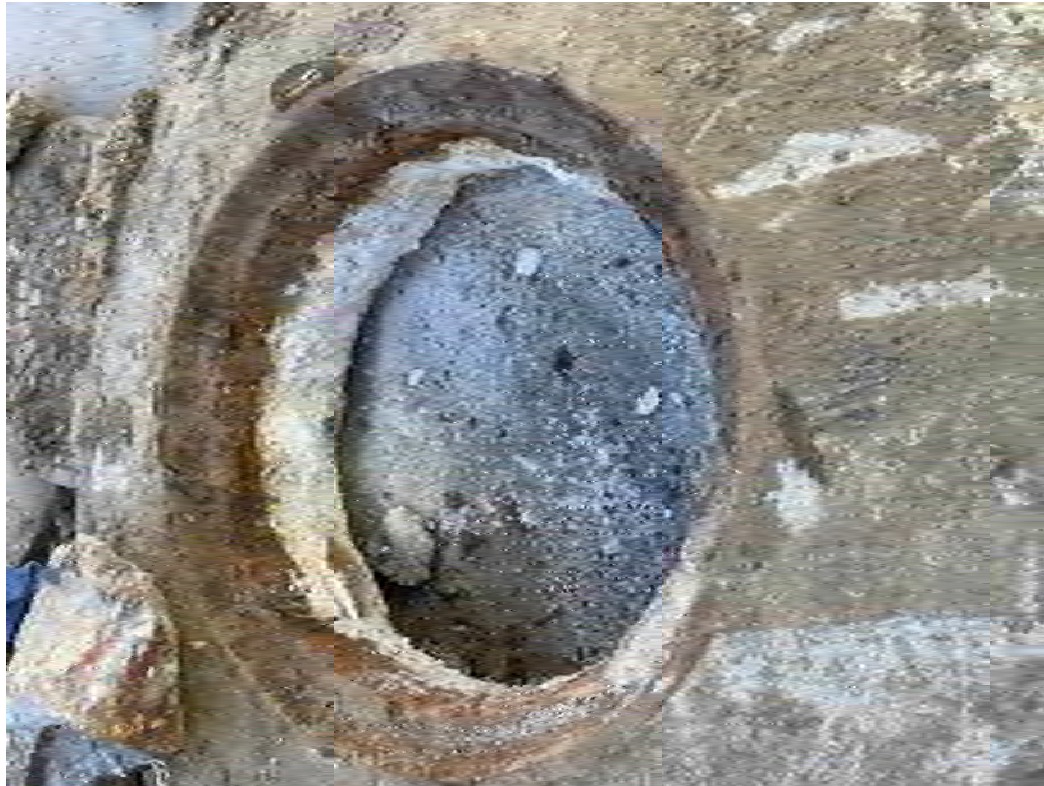
Photo 3-12 Manhole Ring and Cover Debris

As shown in **Photo 3-12**, the manhole ring and cover along with the cast in place collar were included in the debris. The concrete and grout located below the ring and cover was highly friable, indicating that it has been weakened by corrosive gasses often found in sanitary sewers.

There was no apparent material from the manhole shafting, brick or precast among the debris collected and transported to the Compton Yard. This could indicate that the material broke into very small sections and washed downstream.

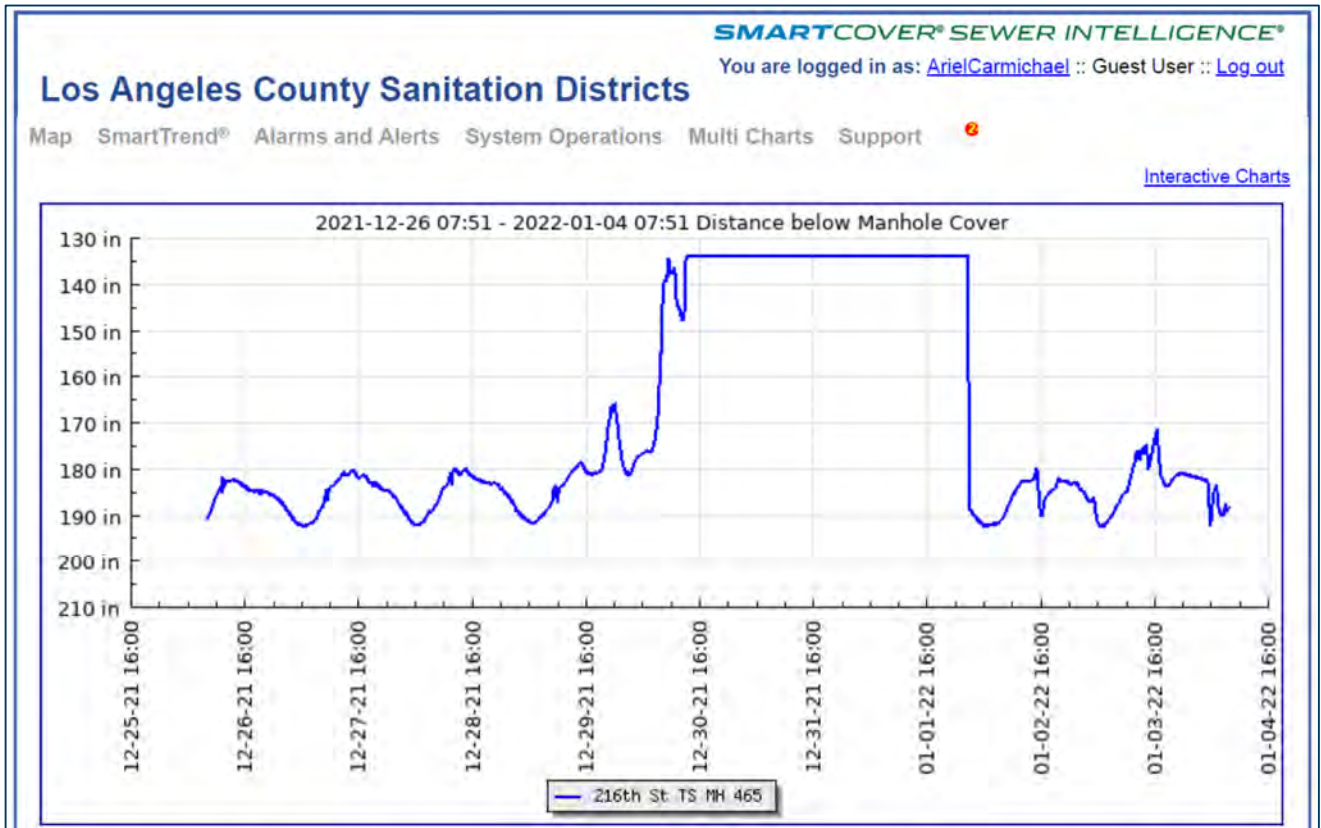
Figure 3-4 Distance from the Manhole Cover to the Water Level in Manhole 465 Between December 26, 2021 and January 4, 2022

Although not directly a measurement of flow, another source of data for sewer behavior on December 30, 2021 is a Smart Cover installed in manhole 465 in Figueroa Boulevard, roughly half-way between the Main Street Pumping Plant and the failure location. A Smart Cover is an electronic device installed in a manhole that measures water level at adjustable time intervals. This water level data is viewable remotely and alarms may be set at various levels. The graph in **Figure 3-4** shows the distance from the manhole cover at ground level to the water level in the manhole 465 in approximately 10-minute intervals between December 26, 2021 and January 4, 2022. The typical distance ranges from 180 inches to 190 inches. The pipe invert is 202 inches below ground level and the crown of the 36-inch pipe is 166 inches below the ground level. At about 09:25 on December 30, 2021, the depth to the water surface decreased to about 134.3 inches. The distance then gradually increased to about 148 inches at 12:50 but then rapidly decreased back to 133.9 inches at 13:17. It remained at this level until the bypass pumping system was able drain the system on January 2, 2022 at about 01:00.
