Stapleton Rowhome Association
Hail Damage Evaluation
10045 Martin Luther King Boulevard
Denver, CO 80238
Farmers File: 5010168593
Haag File: 1121000002-128

Re: Stapleton Rowhome Association
Hail Damage Evaluation
10045 Martin Luther King Boulevard
Denver, CO 80238
Farmers File: 5010168593
Haag File: 1121000002-128

In accordance with your request, we inspected the Stapleton Rowhome Association buildings to determine the extent of hail-caused damage to the building exteriors and when the damage occurred. We inspected the sites on February 1, 2, and 3, 2021.

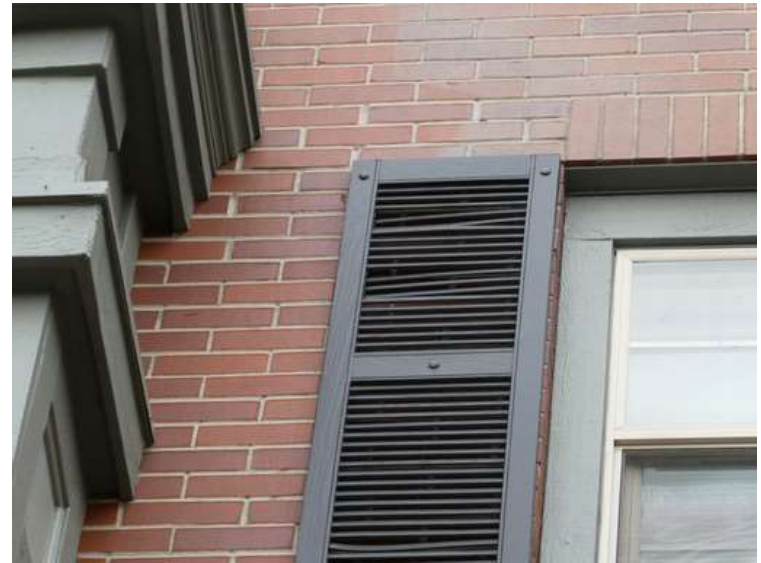
4. Building 01. Fractures in a plastic shutter.

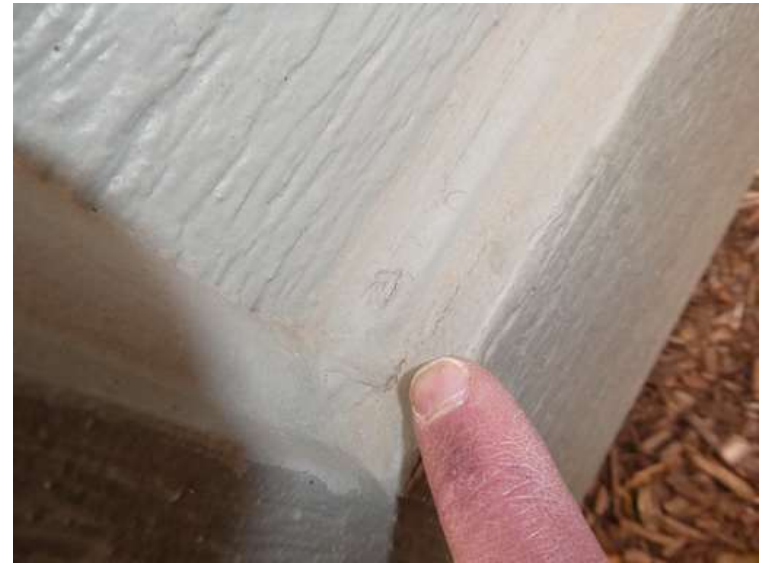
36. Building 02. Chips in paint from hail.

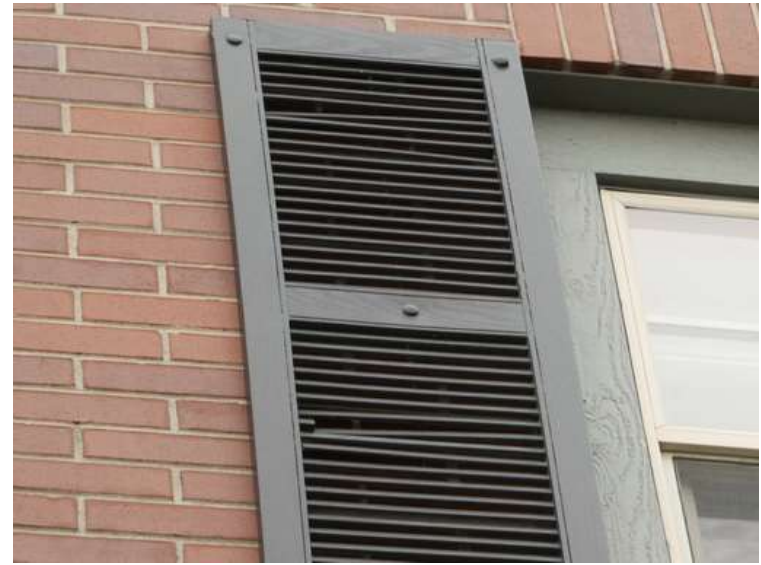
46. Building 02. Fractures in a shutter.

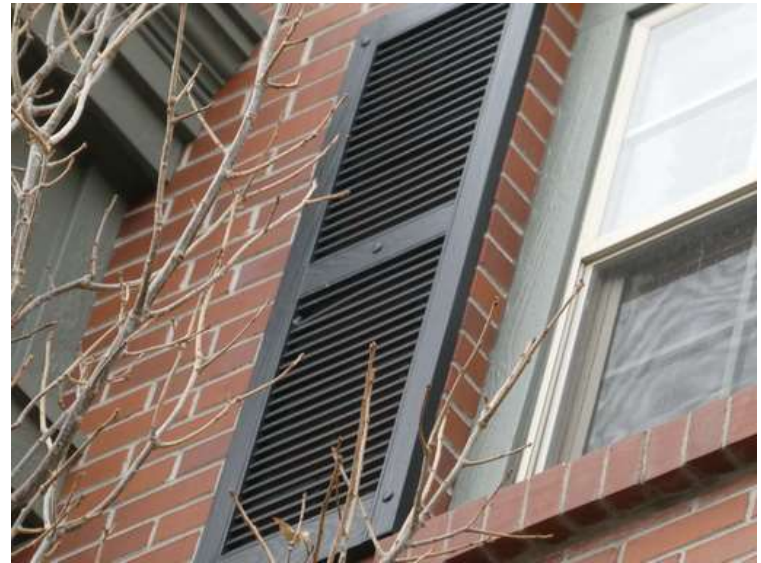
64. Building 03. Fractured shutter.

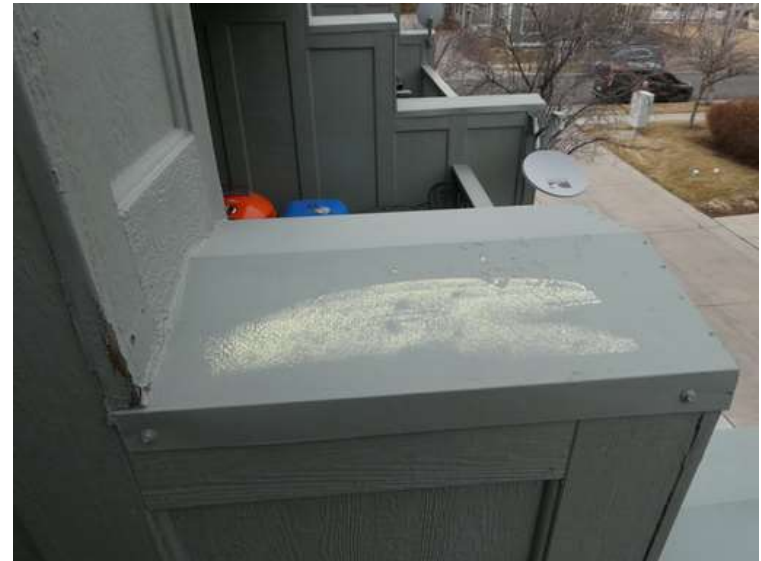
72. Building 03. Dents in a painted steel cap from hail.

Hail dented various metal appurtenances including steel coping, exhaust vents, flue caps, attic vents, gutters, downspout extensions, and steel flashings and caps on ledges and bay windows. The metal items will continue to perform as intended despite the dents. Addressing the dents would require replacing the metal.

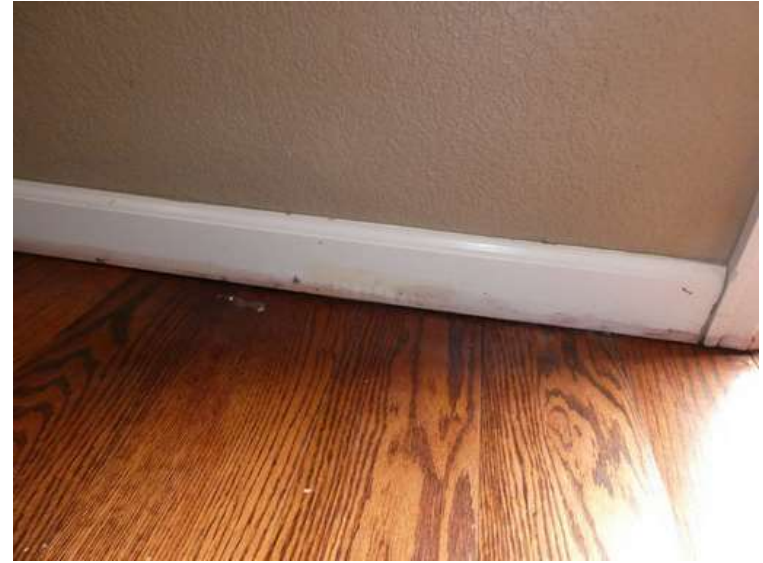
82. Building 03. Stained base board.

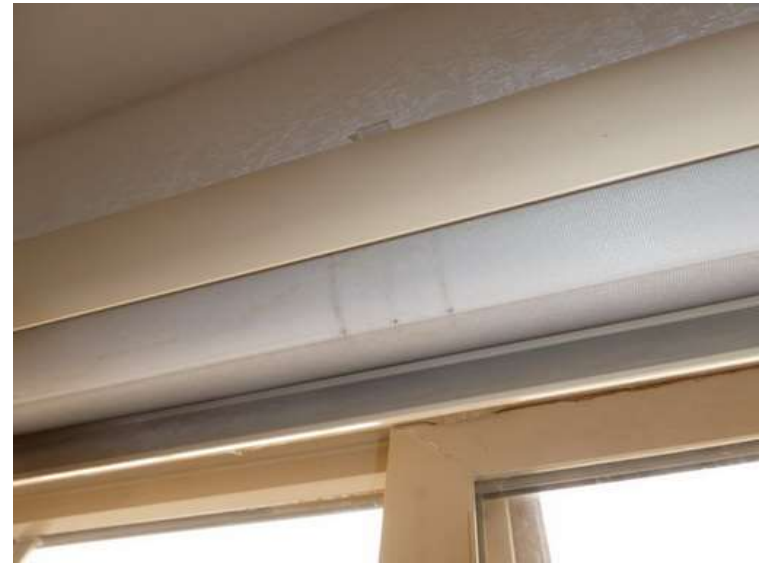
84. Building 03. Water stains.

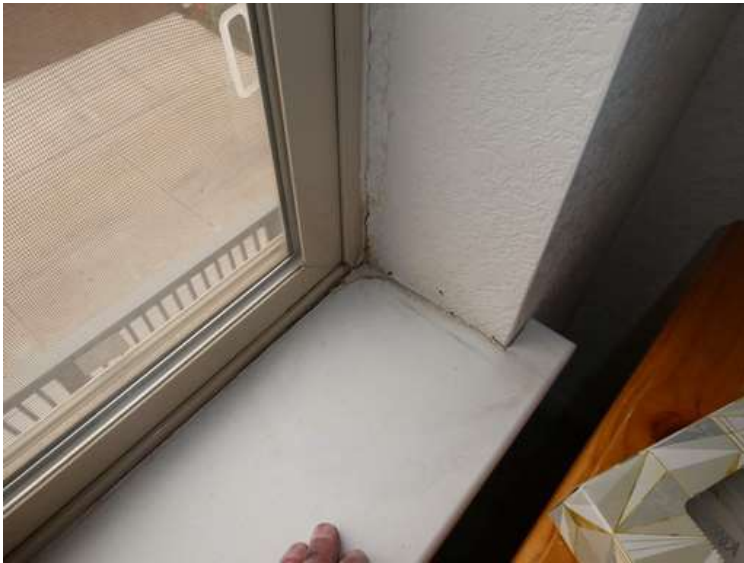
85. Building 03. Water stains.

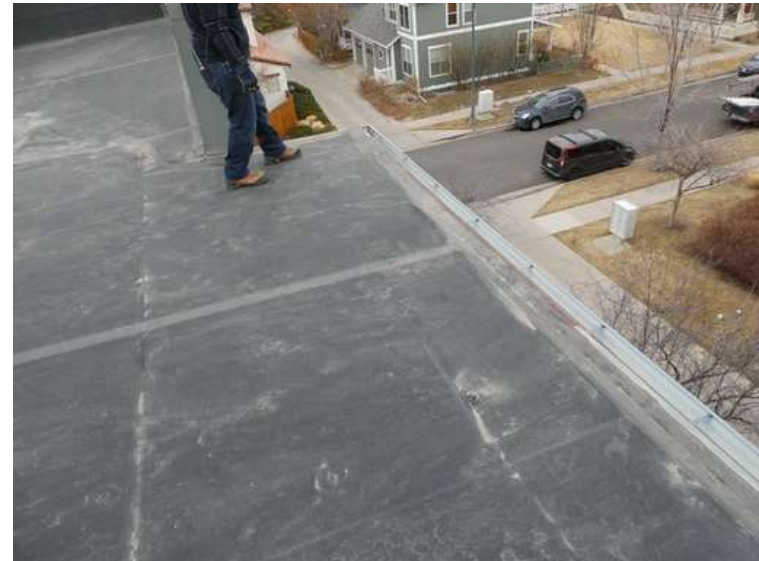
89. Building 03. Joint in edge metal. Edge metal was rusted where water pooled at the perimeter of the roof.

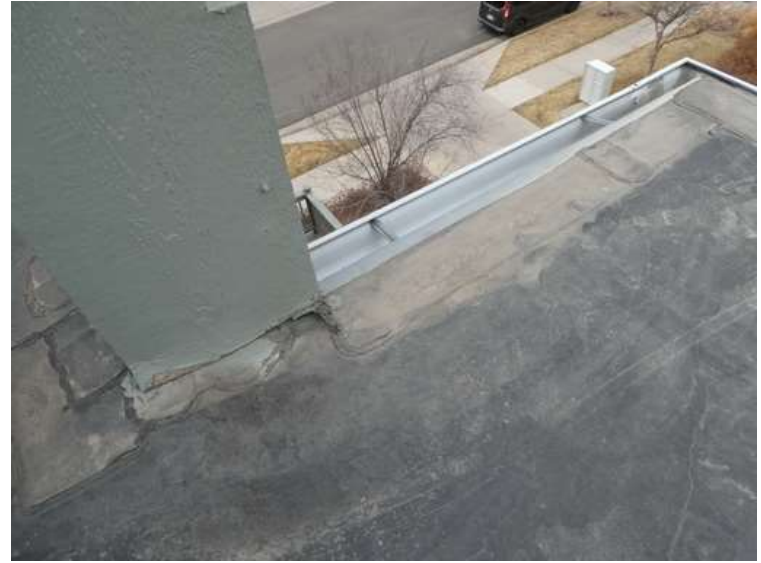
91. Building 03. Opening where water could leak past the roof.

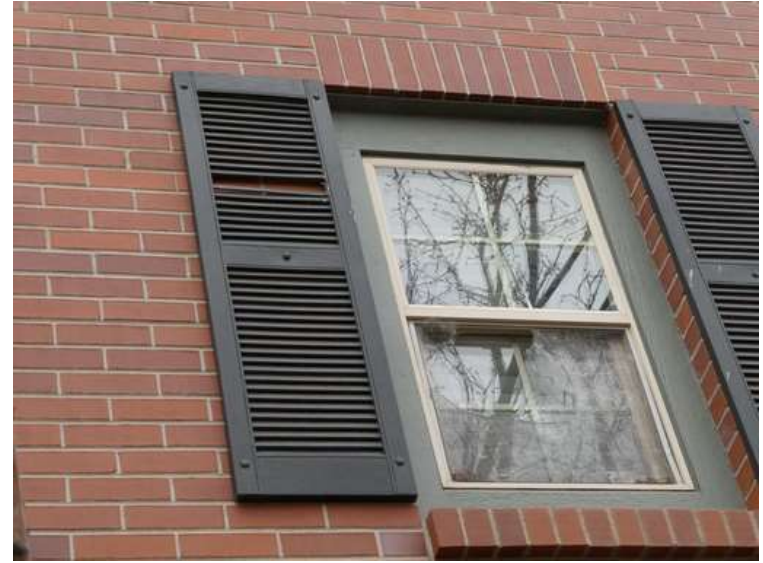
102. Building 04. Shutter fractured by hail.

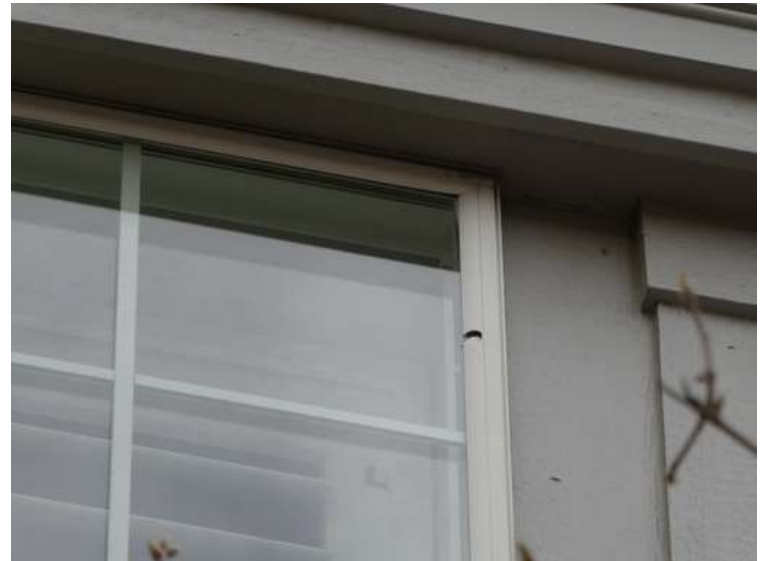
124. Building 05. Fracture in vinyl glazing bead.

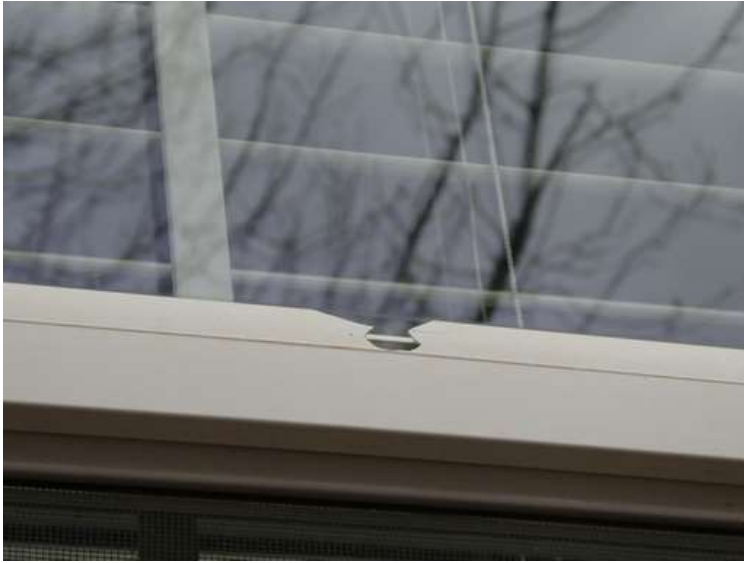
141. Building 06. Beading fractured by hail.

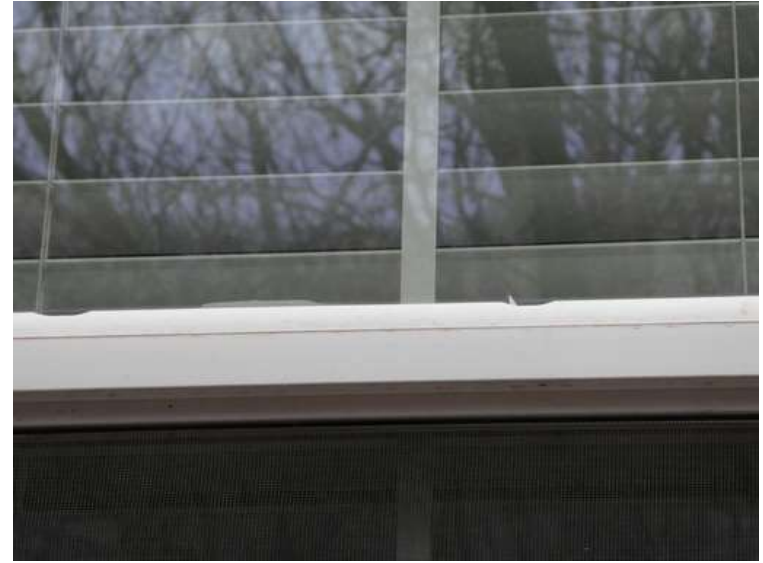
142. Building 06. Beading fractured by hail.

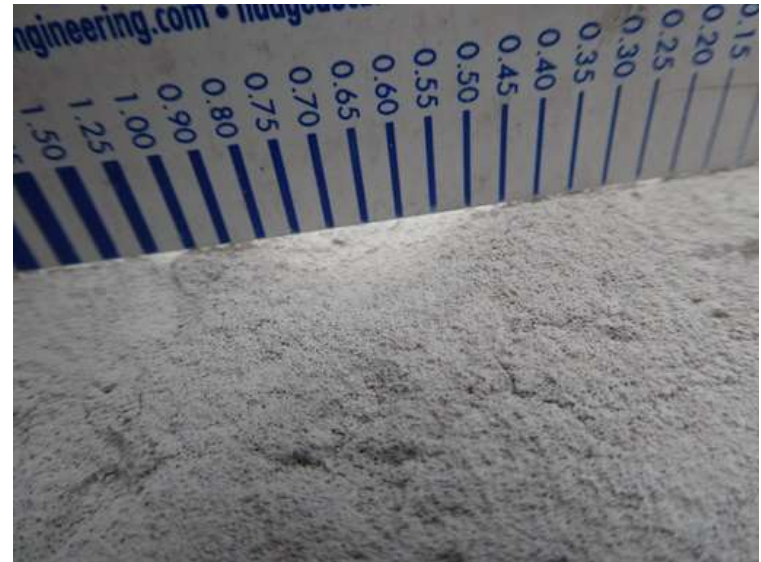
156. Building 06. Straight edge over a dent.

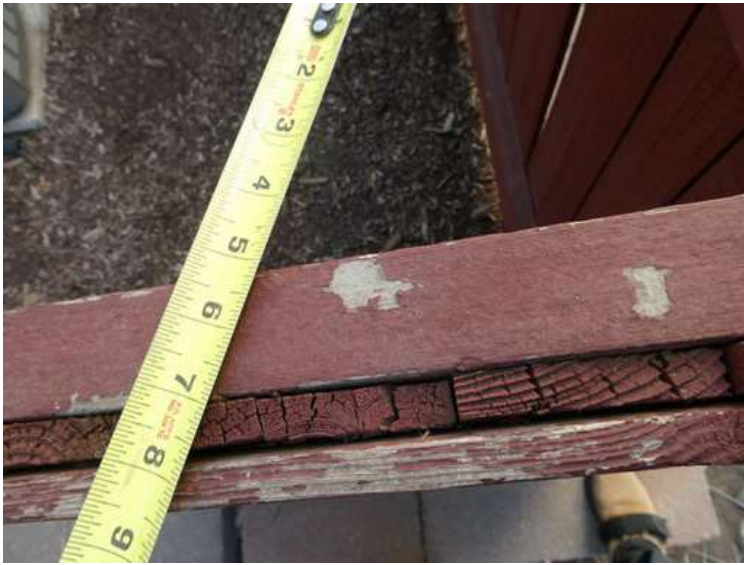
169. Building 07. Chip in stain on a wood fence.

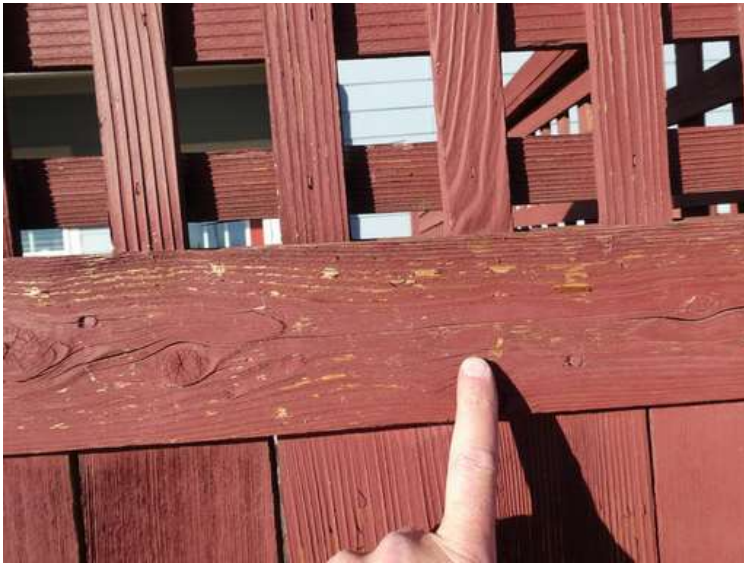
171. Building 07. Scuffs in stain from hail.

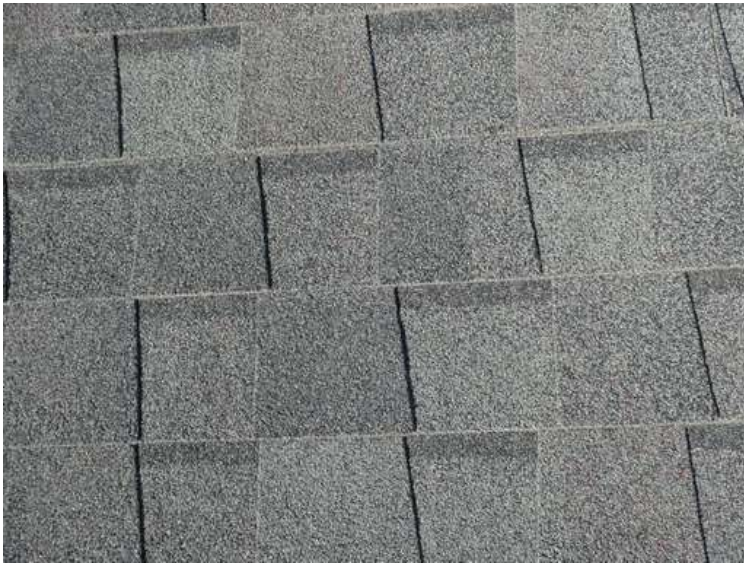
183. Building 07. Shingles were in like-new condition.

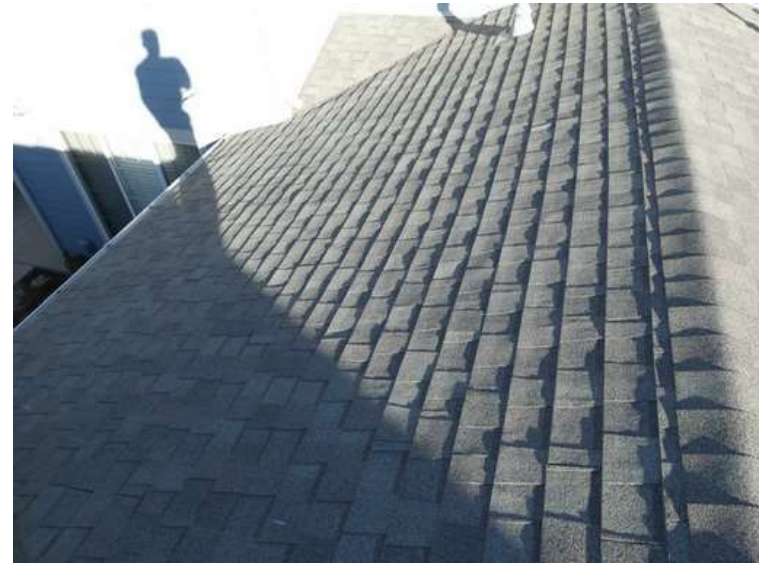
184. Building 07. North test area. No shingles within the test area were bruised by hail.

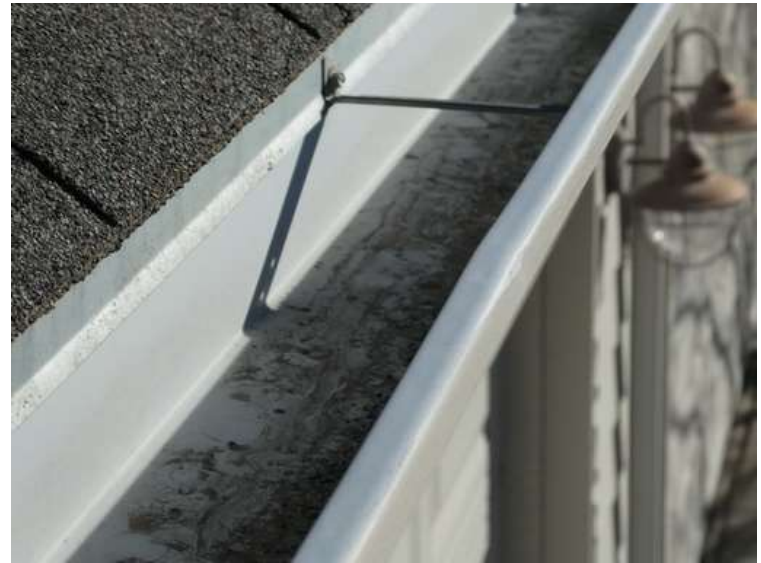
196. Building 08. Dent in a gutter.

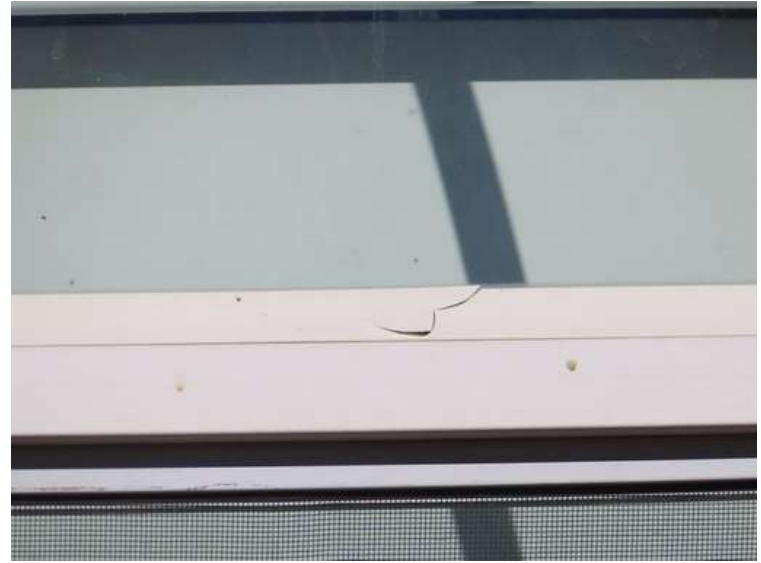
262. Building 11. Fracture in glazing bead from hail.

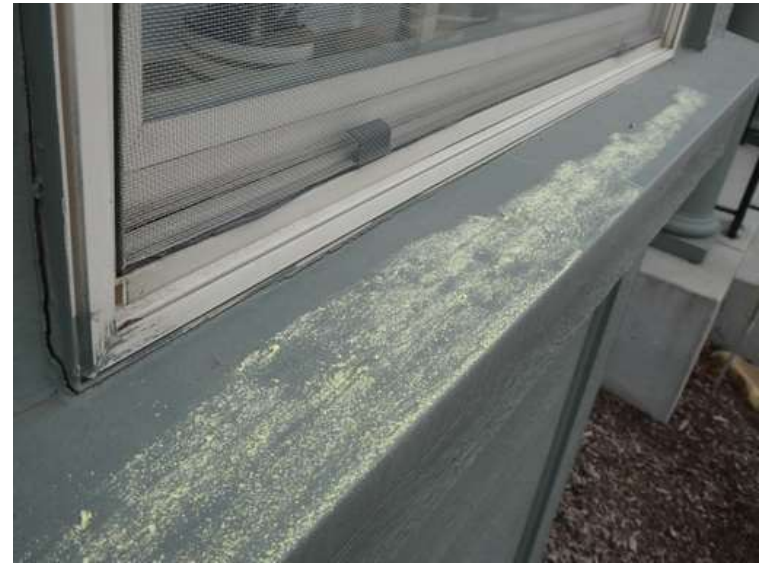
308. Building 14. Dents in metal wall flashing.

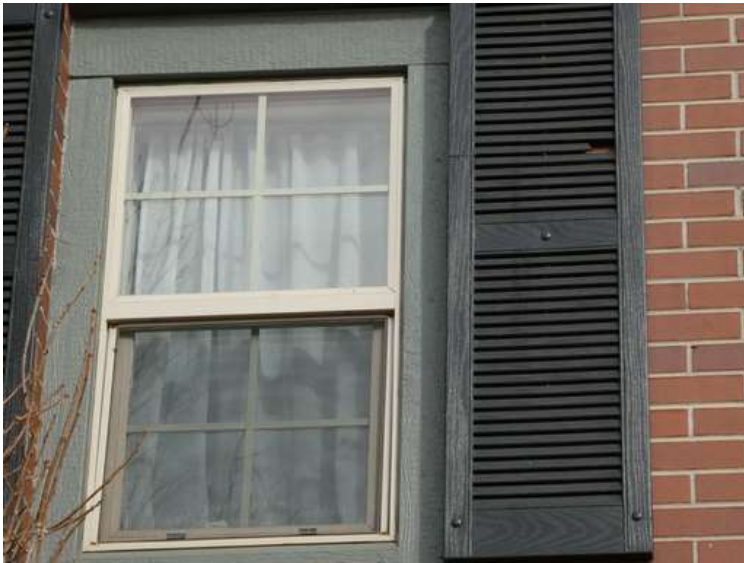
315. Building 14. Fractures in a shutter from hail.

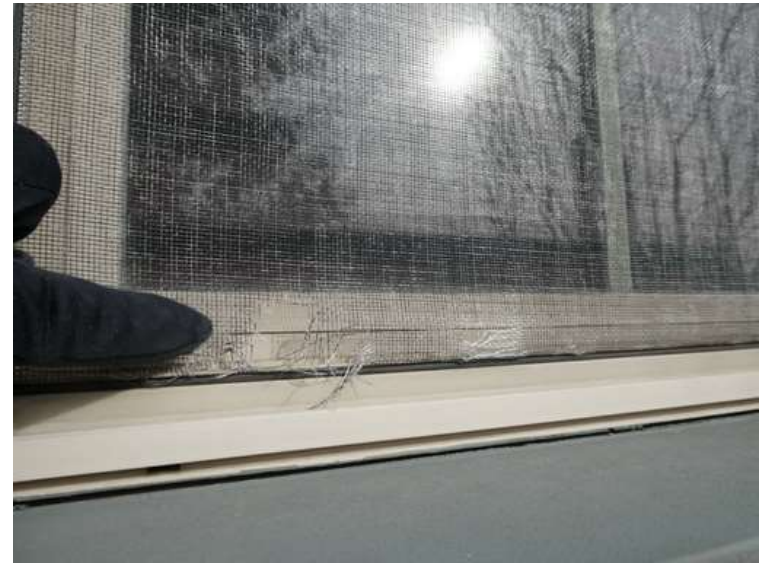
316. Building 14. Tears in a screen.

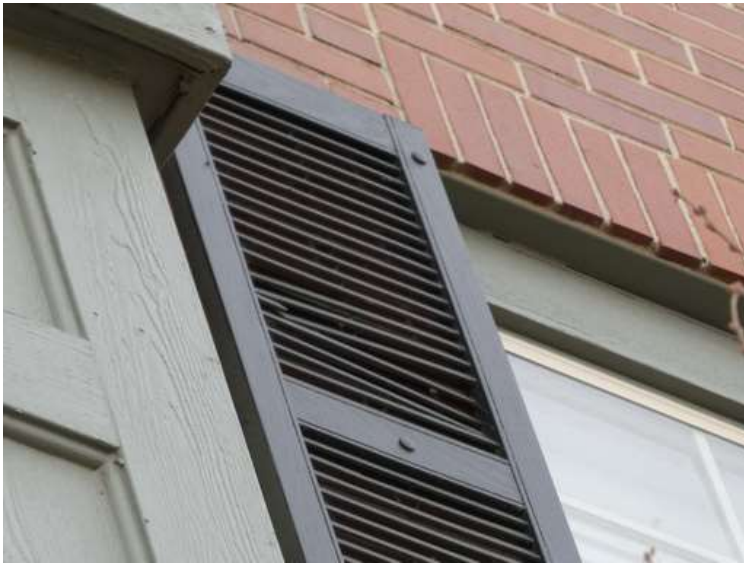
339. Building 15. Fractures in a shutter.

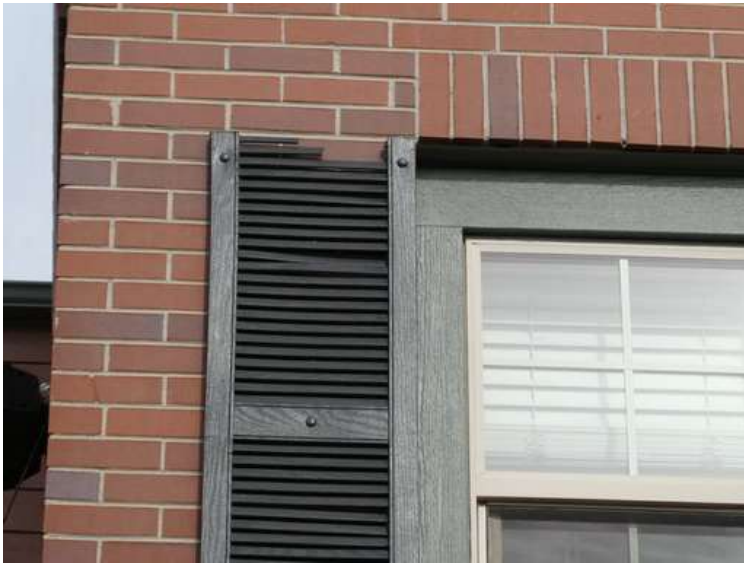
349. Building 15. Fractures in a plastic shutter.

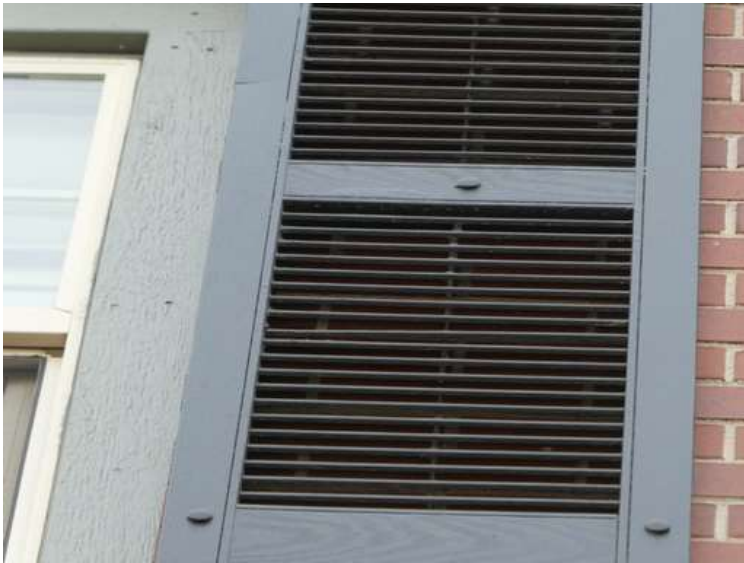
367. Building 16. Fracture in a shutter.

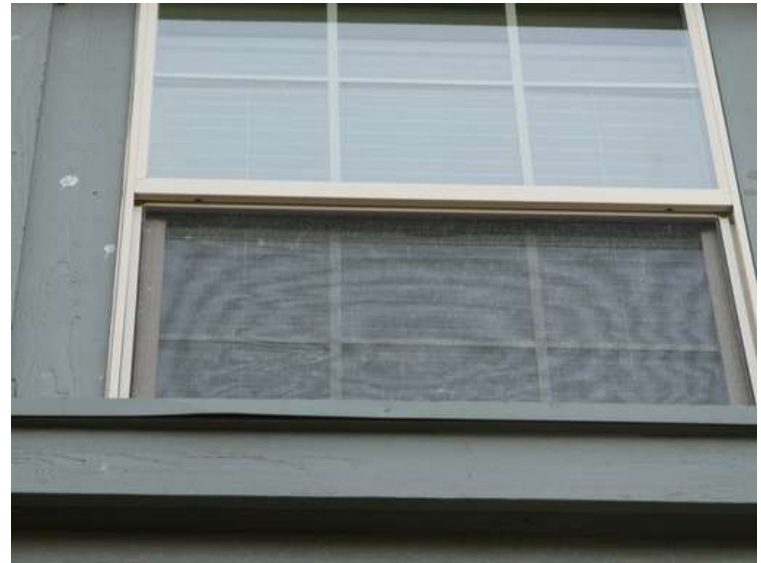
368. Building 16. Tears in a screen from hail.

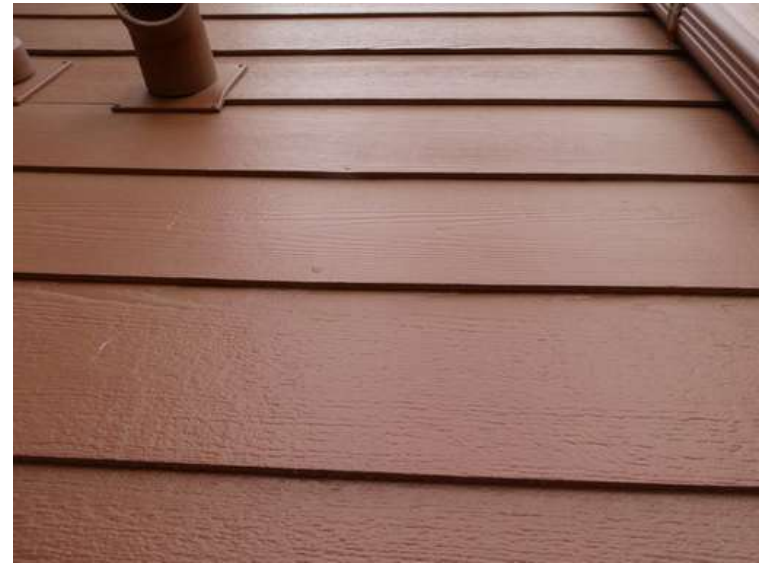
372. Building 16. Paint finishes on fiber cement siding was not fractured by hail.

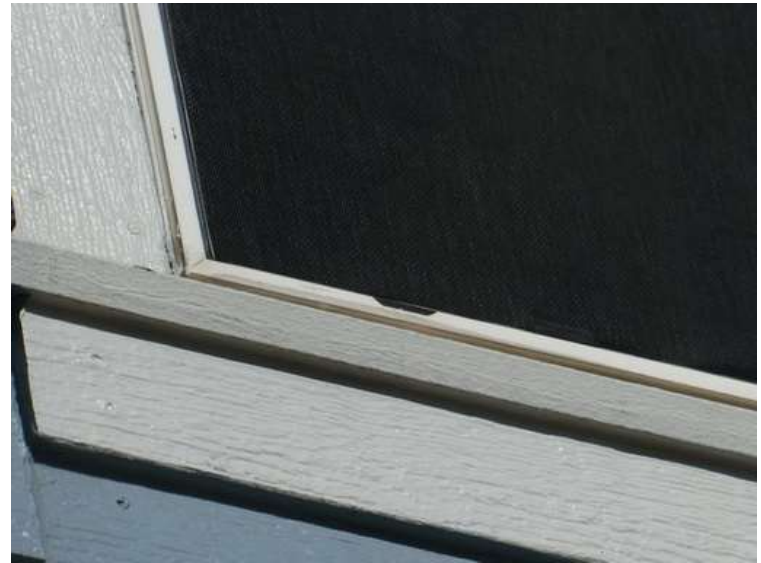
420. Building 19. Fractured window frame.

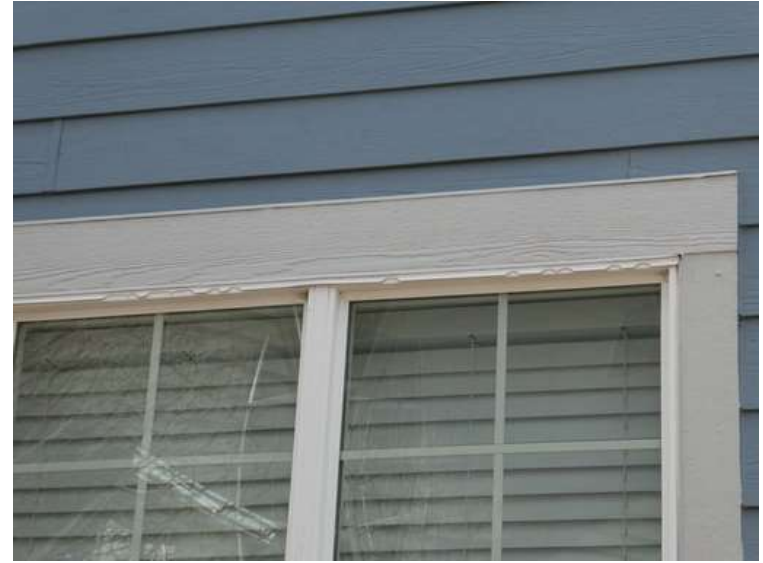
422. Building 19. Fractures in vinyl above the window.

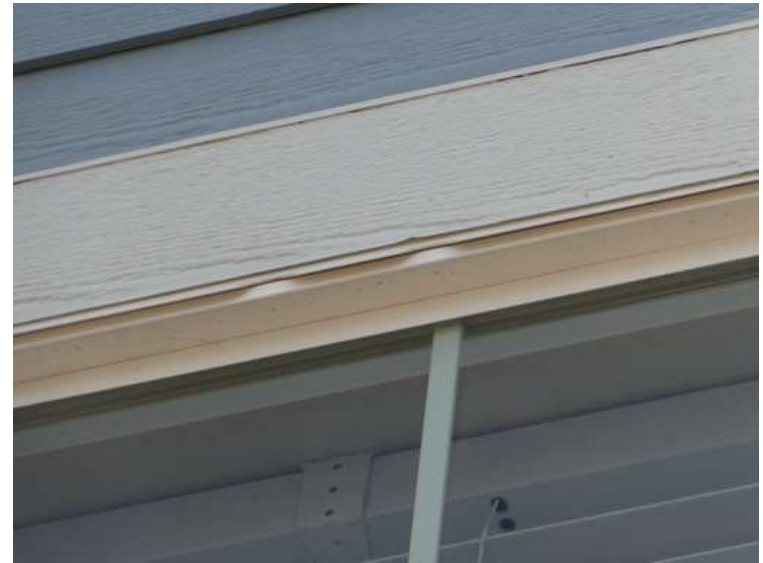
424. Building 19. Fractures in vinyl above the window.

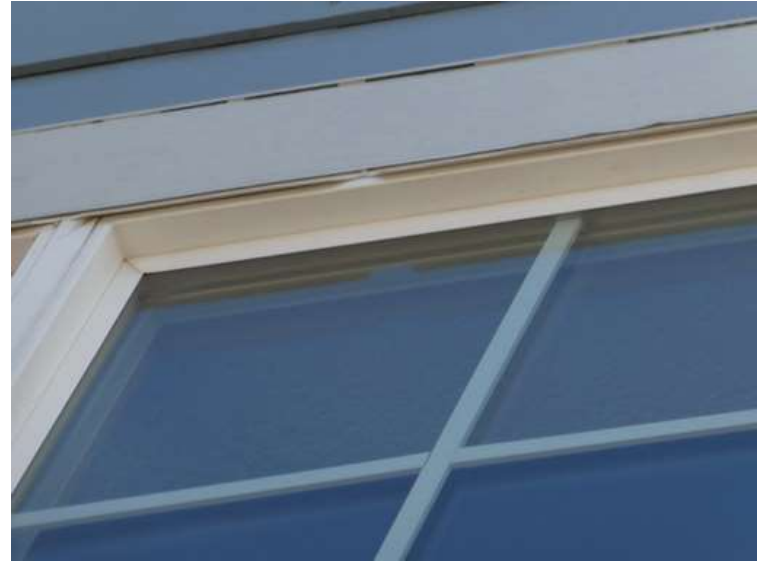
426. Building 19. Fractures in a vinyl window frame.

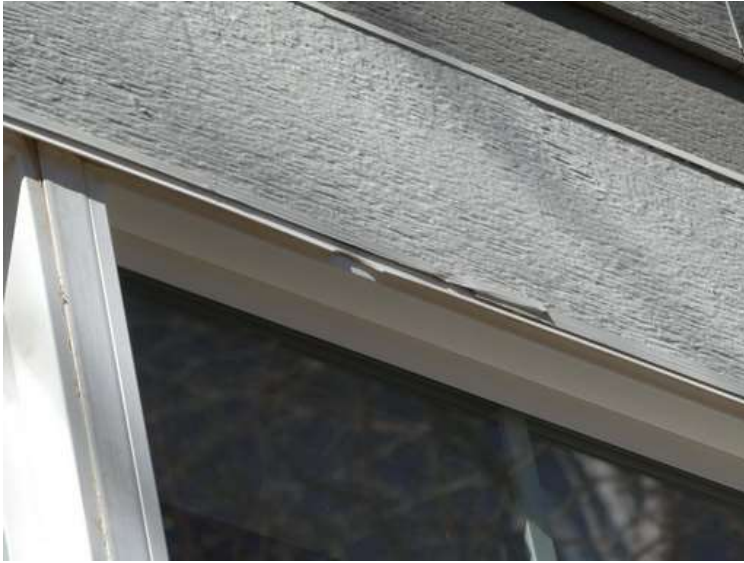
449. Building 20. Fracture in a vinyl window frame.

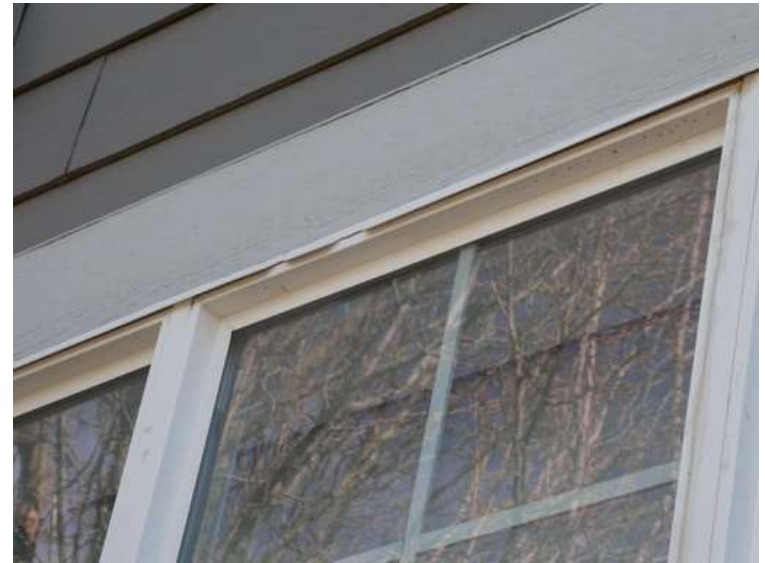
452. Building 20. Fractures in a vinyl window frame.

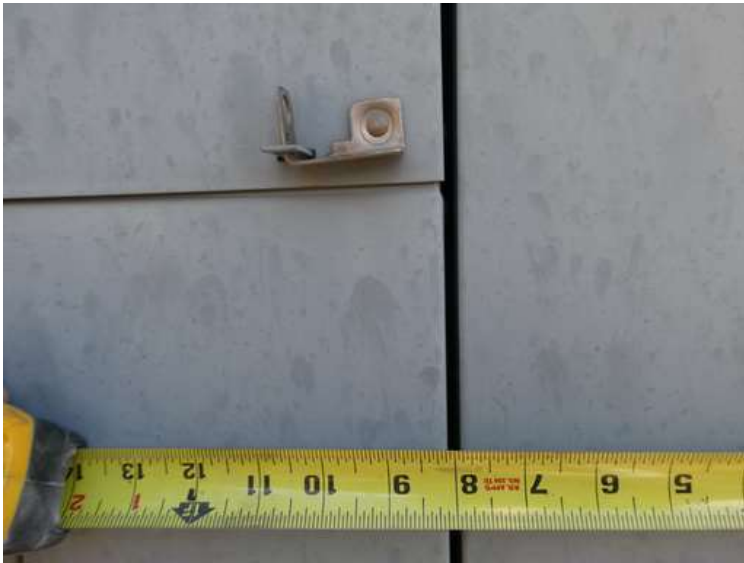
453. Building 20. Spatter marks on an electrical box.

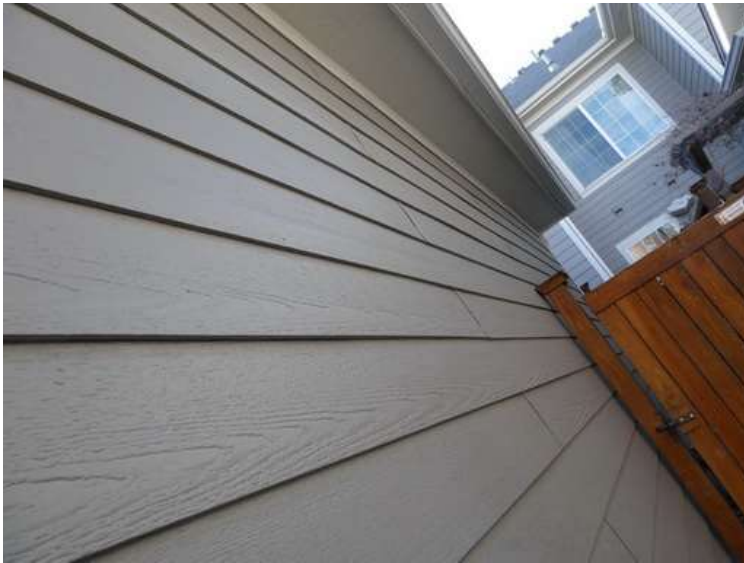
455. Building 20. Paint finishes on fiber cement siding were not fractured by hail.

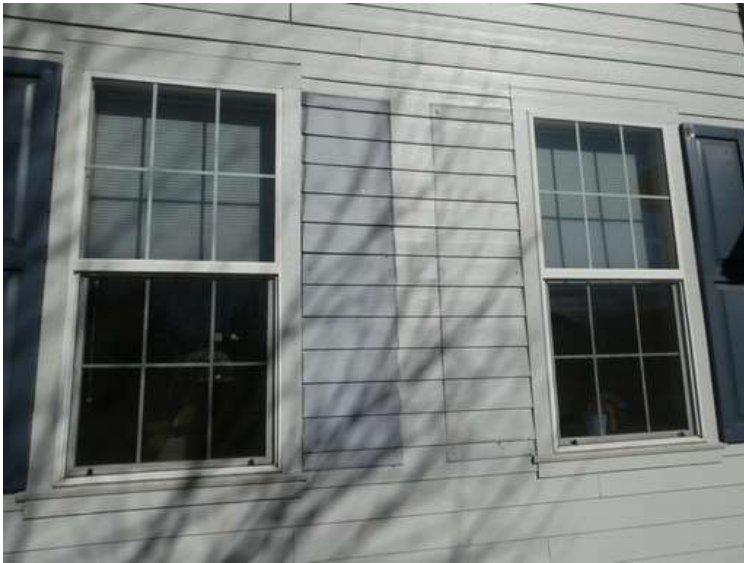
471. Building 21. Windows missing shutters.

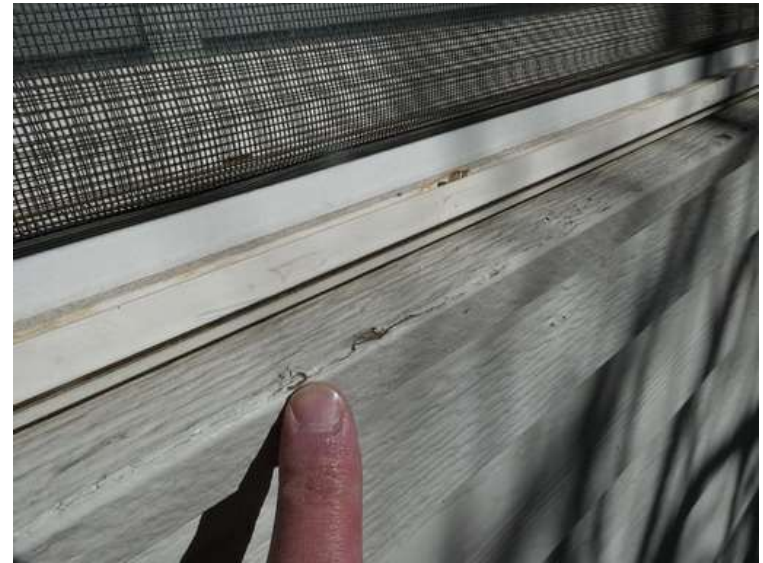
472. Building 21. Chips in paint on a sill from hail.

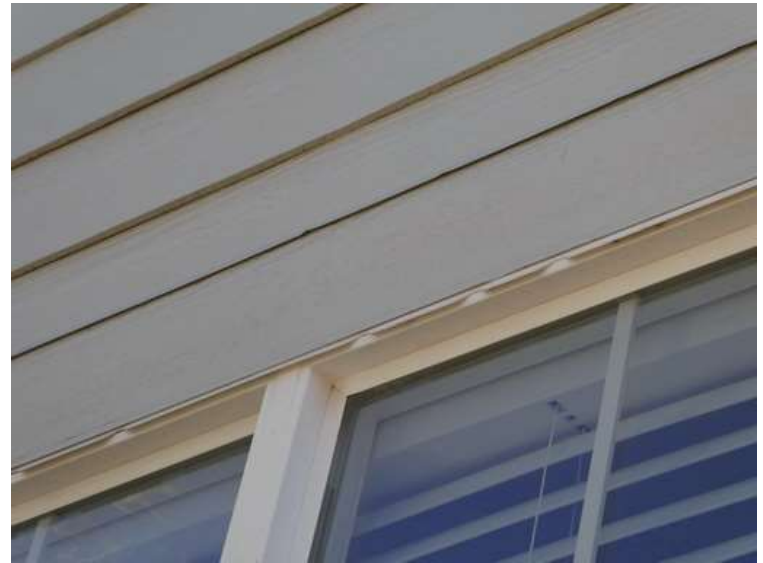
476. Building 21. Fractures in a vinyl window frame from hail.

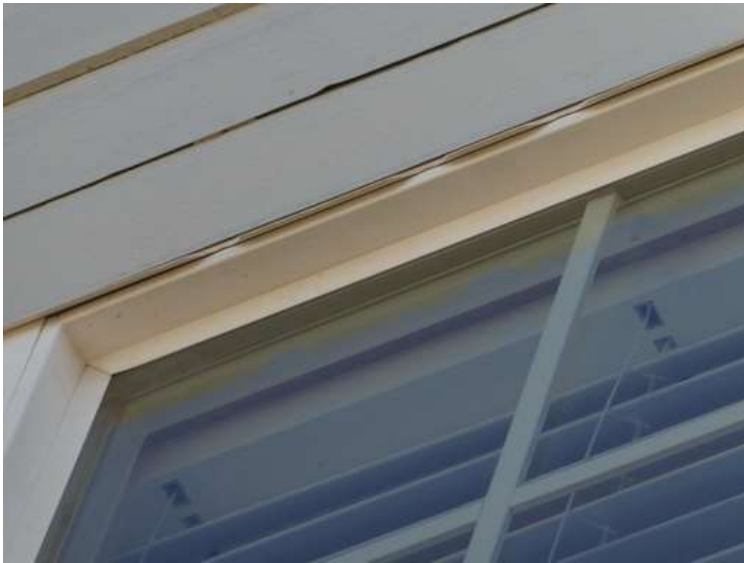
477. Building 21. Fractures in another vinyl window frame.

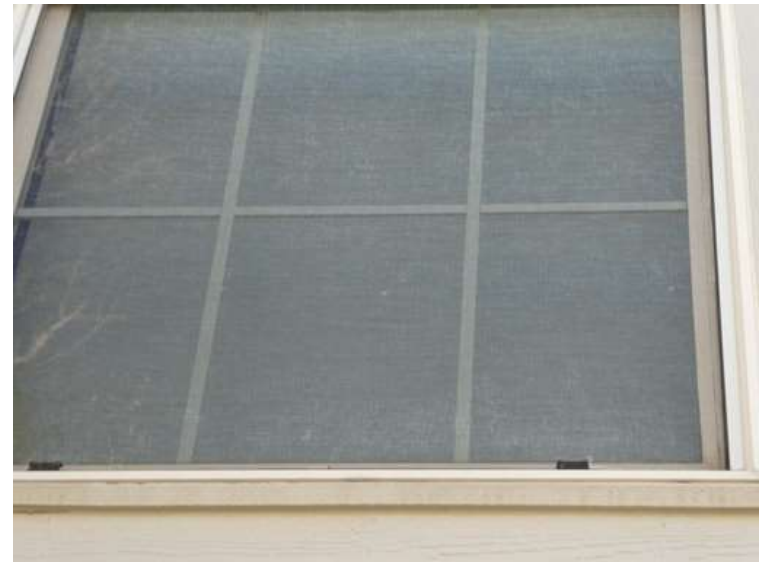
480. Building 21. Tears in a screen.

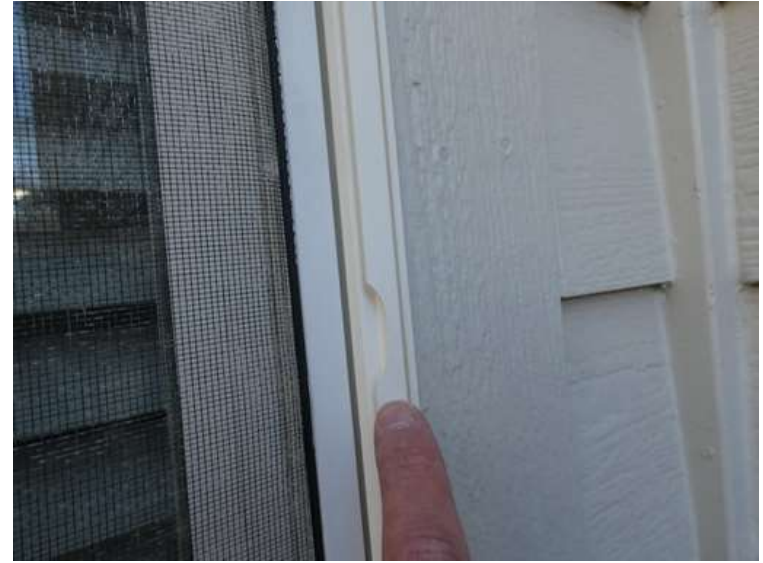
482. Building 21. Fracture in the frame from hail.

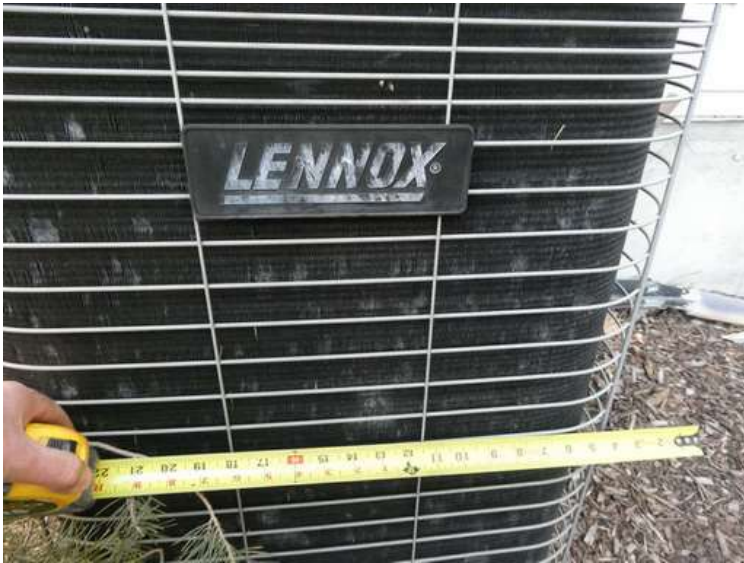
483. Building 21. Dents in condenser fins from hail.

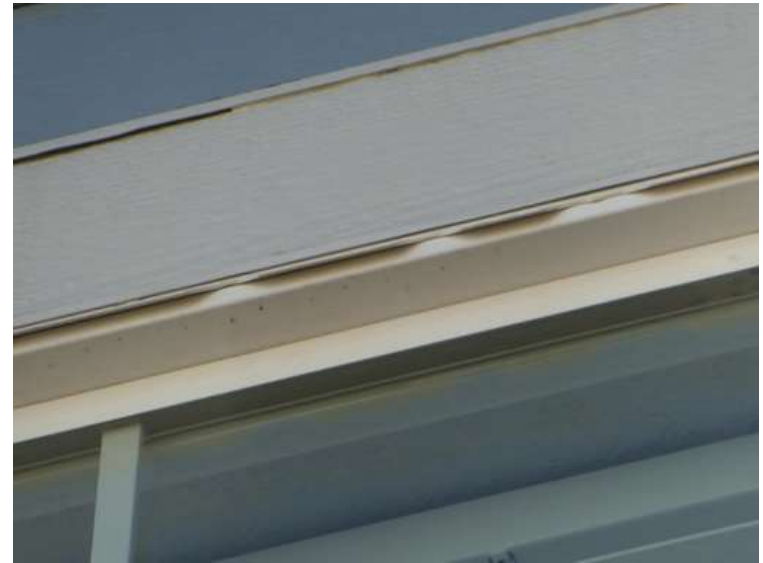
516. Building 22. Fractures in another window frame from hail.

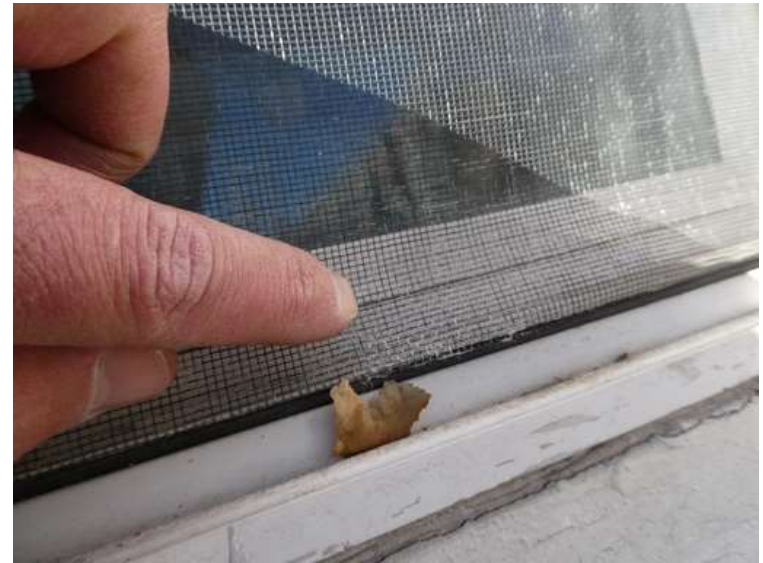
572. Building 24. Tear in a screen.

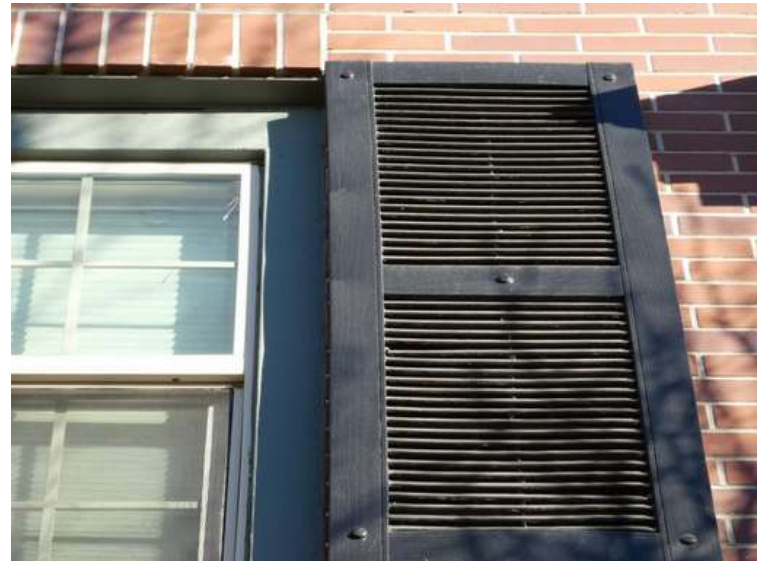
604. Building 25. Fractured shutter.

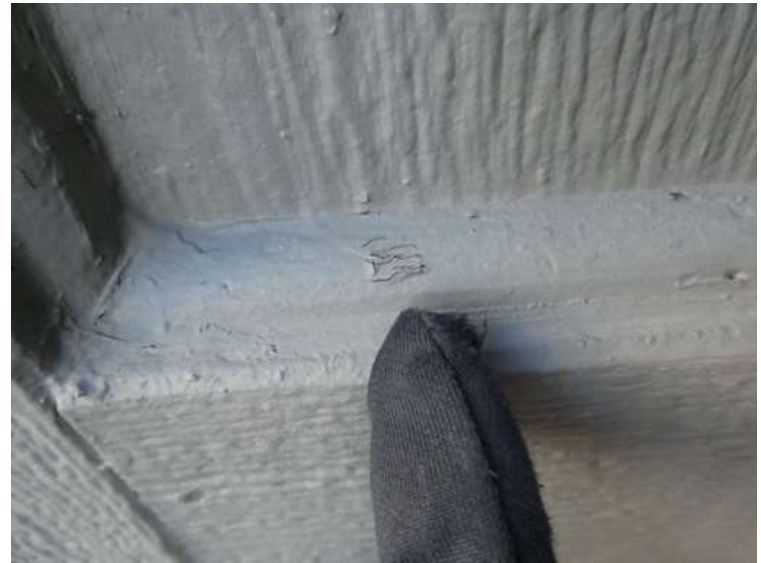
612. Building 25. Chip in paint on a west elevation.

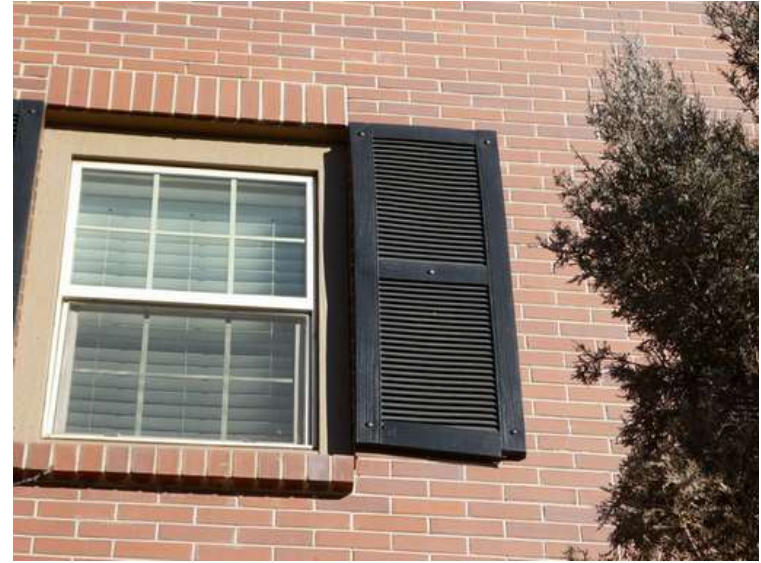
630. Building 26. Fractured shutter.
