# Illinois River and Tributaries: Streambank Erosion Sites and Analysis 2020 Report

Prepared by Natural State Streams LLC for The Illinois River Watershed Partnership, September 2021

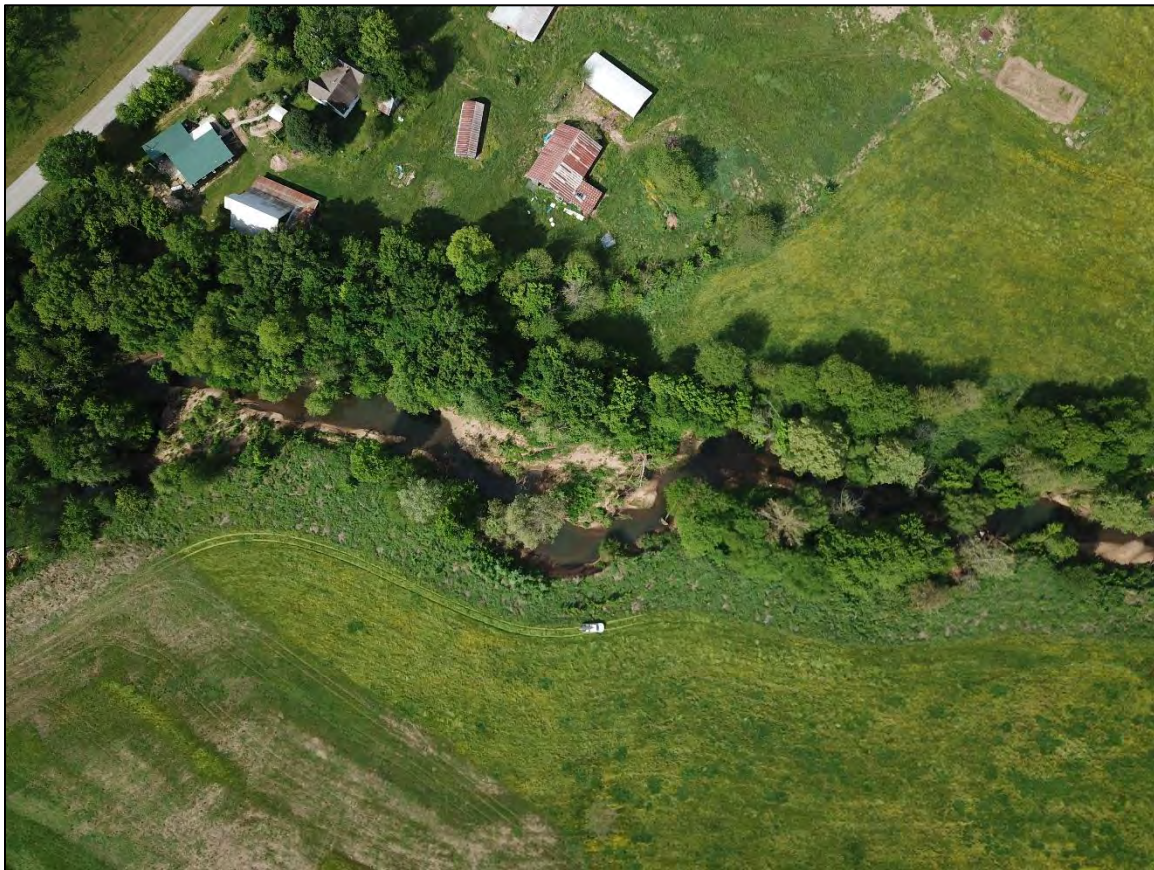
A small logjam just upstream from the survey site has been contributing to mid-channel and transverse bar development for years and creating a condition of elevated Near-Bank Shear Stress (NBSS). After all of the data analysis, a more thorough BEHI and NBSS investigation (2020), and utilizing the erosion prediction curves developed for the Illinois River Watershed, we have estimated that this bank will continue to erode at a rate of around 3.75 feet per year on average.

We are seeing evidence of the greatest amount of erosion migrating gradually downstream as this is a natural process described as down valley meander migration. As the area of greatest stress erodes a bit with each flood, the eroding bank slowly moves in an upstream to downstream direction. We observed areas on the most upstream portion of this cut bank to be fairly stable and starting to recolonize with vegetation, while the most active areas of erosion are on the downstream 1/3 of the study bank.

*Muddy Fork 1 FID 228. Aerial shot captured by drone during our most recent annual survey, 05/07/2020.*

This site would be a good candidate for restoration activities. Although it is not one of the most actively eroding banks in the study, there is significant bank loss occurring and the stream appears overall in relatively poor health. Expanding the riparian corridor here with a 100 ft buffer of native hardwoods would help slow down erosion long-term, help protect water quality, and provide a corridor of shade and cover for wildlife.

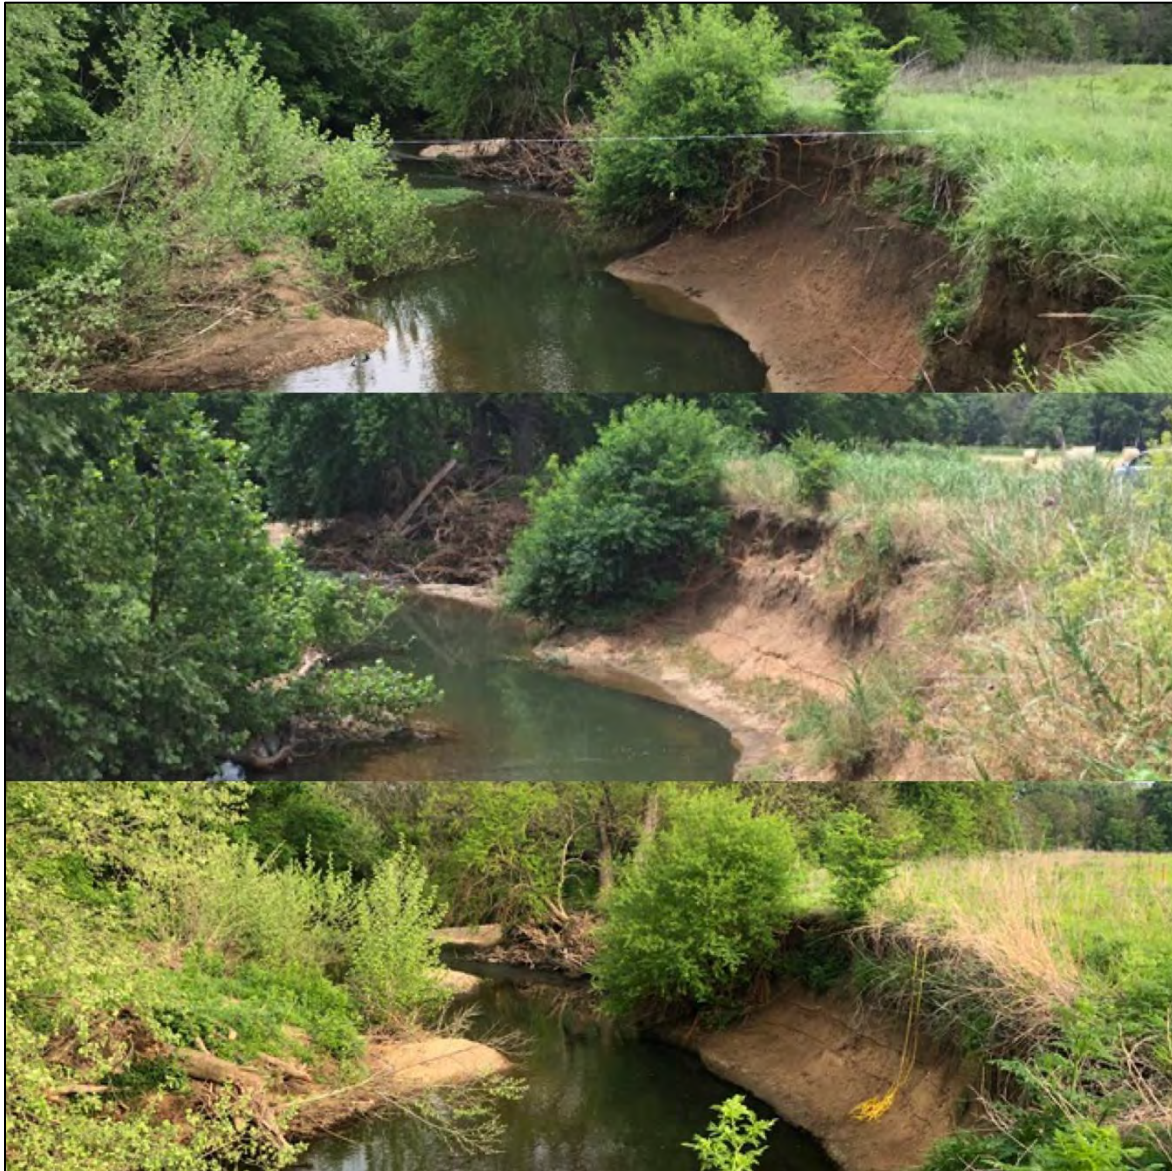
Muddy Fork 1 FID 228. 2017 (top) vs 2018 (middle) vs 2019 (bottom) Looking downstream.

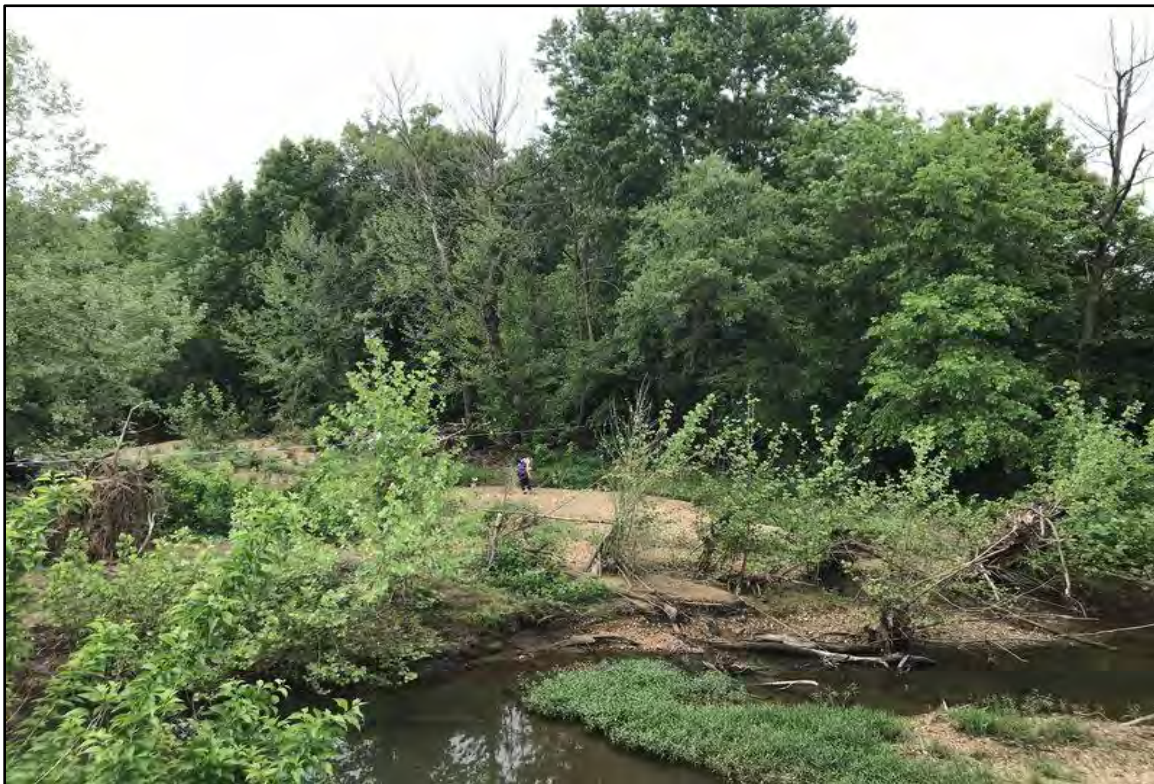
*Muddy Fork 1 FID 228, (2018) mid-channel bar.*

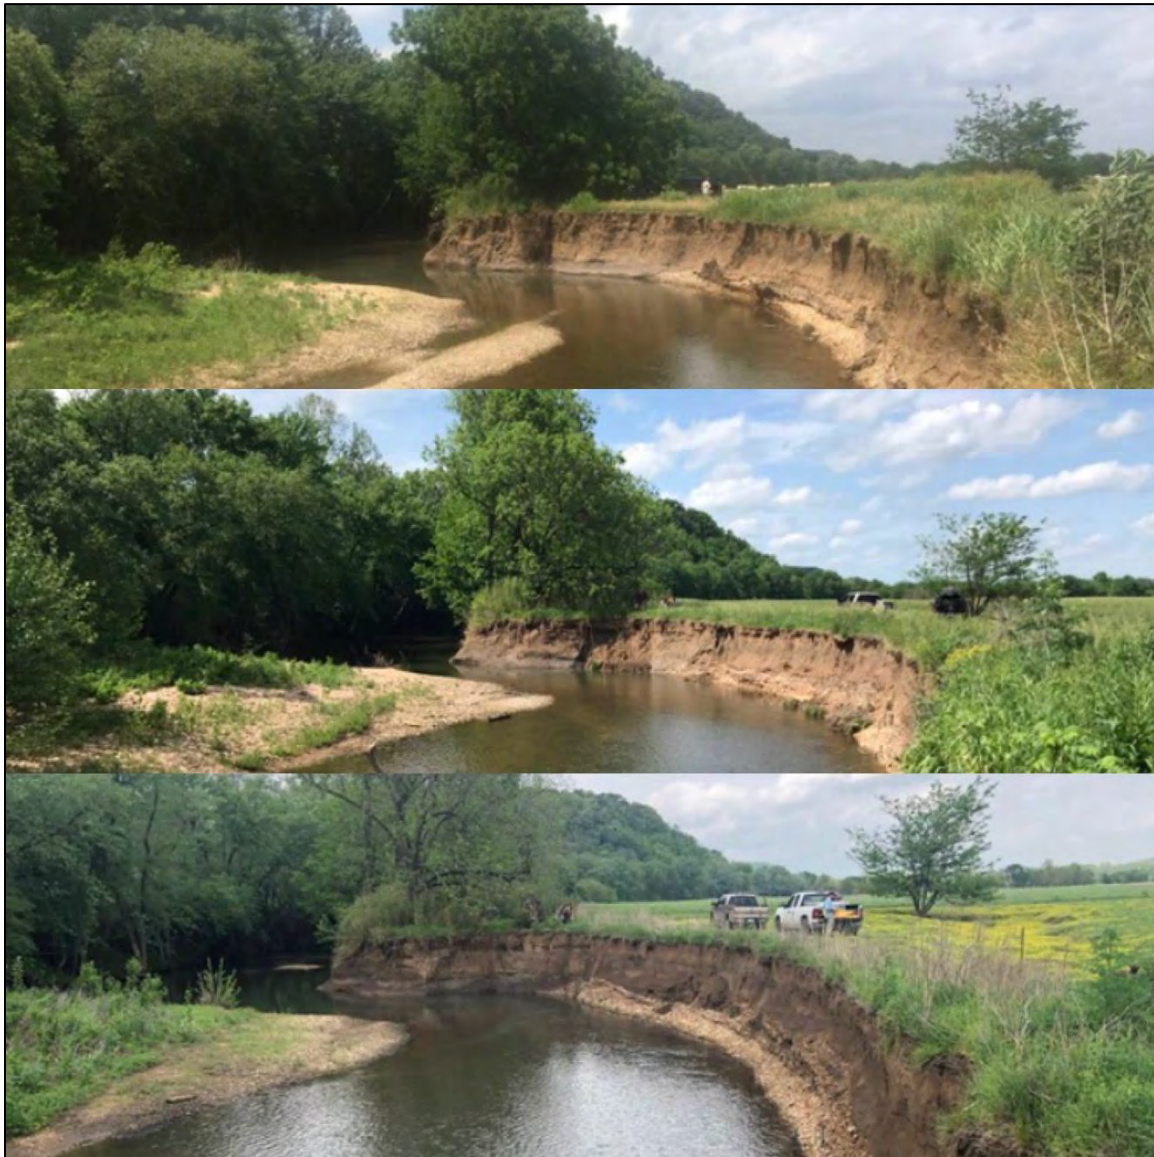
*Muddy Fork 2, FID 67. 2017 (top) vs 2018 (middle) vs 2019(bottom), Looking Downstream.*

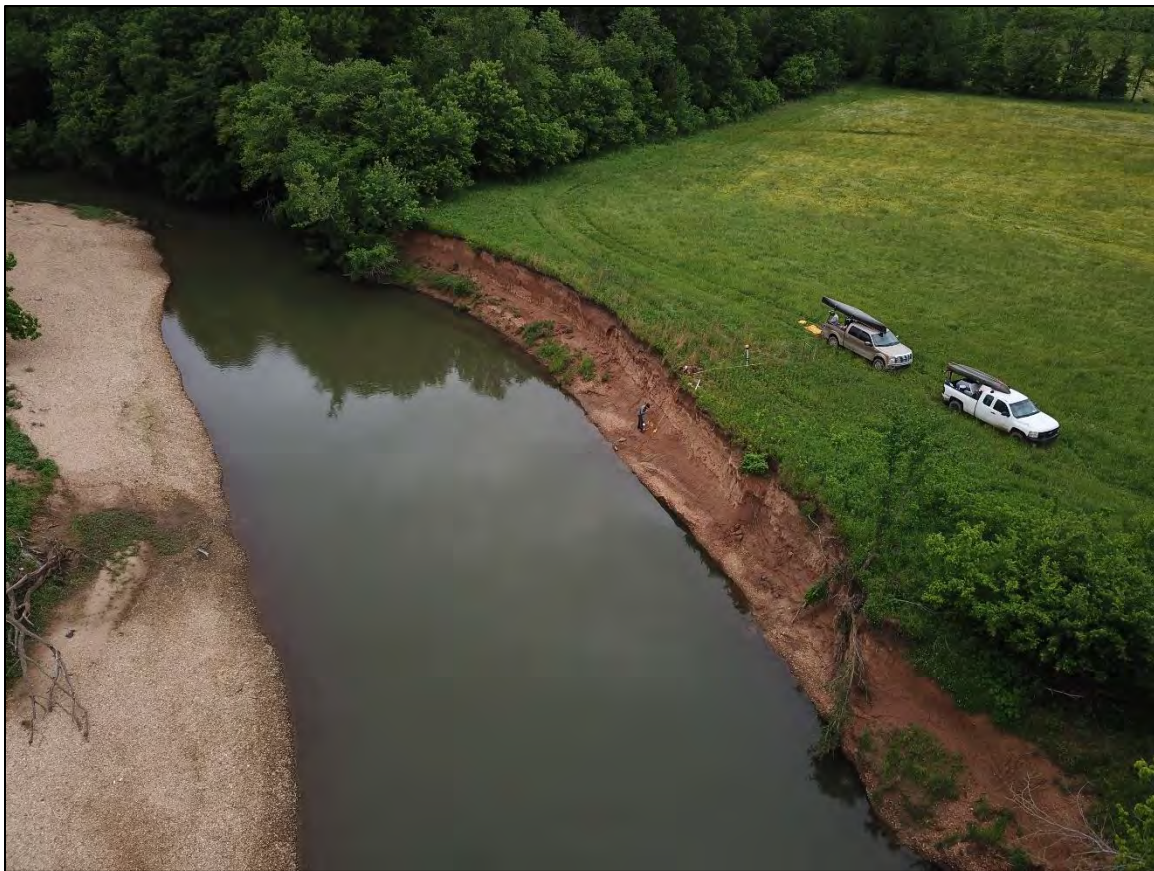
*Illinois River 1 FID 25. Aerial shot captured by drone during our most recent annual survey, 05/14/2020.*

This bank is so tall that even a relatively low erosion rate of around a foot a year quickly adds up to a large volume. Even so, we do not feel like this site would be an ideal location for a large-scale streambank stabilization or restoration project at this time. The cost would be great and would likely outweigh any realized benefits. Alternatively, it would be helpful to establish around a 75 ft or wider corridor of deep-rooted trees along the top of bank at this location that may eventually provide shade and rooting density to benefit the river and help hold soil in place.

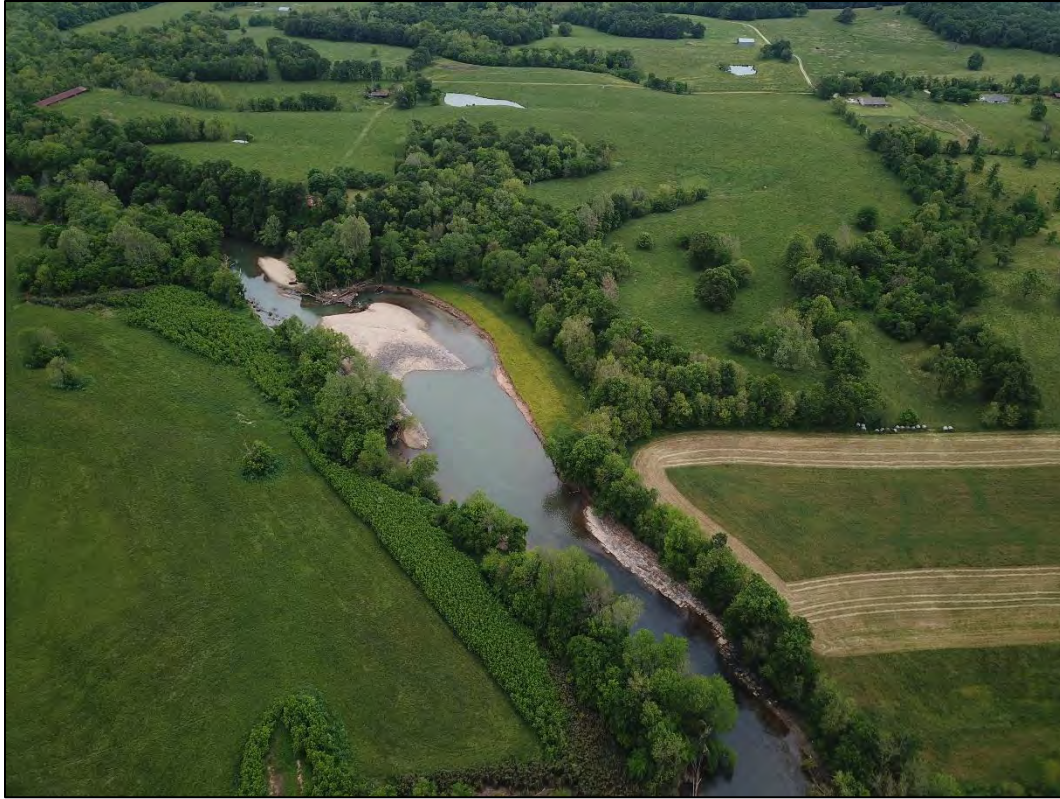
Through natural erosive and depositional processes, a large quantity of loose shale once accumulated in the bed of the river at this location, just downstream of a large natural bedrock outcropping of relatively flaky shale in the Illinois River. Over some period of time, this shale had been transported some 200 feet downstream of the outcropping and had built up in layers and formed an unusual but relatively stable riffle that spanned the riverbed approximately 60 feet upstream of the current cross section location. This shale layering can be observed as a stable channel feature on Google Earth from the earliest aerial in 1994 all the way up to around 2009 when it appears that a mid-channel gravel bar had begun to form on top of the riffle, extending downstream for some ways directly in the center of the river channel.

Mid-channel bars are notorious for altering flows, and this bar can be witnessed splitting flow in two separate directions, directly towards either side of the channel causing elevated Near Bank Shear Stress (NBSS) on both the left and right bank. By interpreting the Google Earth aeriels it is apparent that, sometime after 2009 and before 2012, bank erosion started occurring immediately upstream and downstream of where the shale riffle met the right bank. This erosion is associated with very high NBSS caused by the formation of the small mid-channel bar that had begun to form around 2009. Only a very narrow riparian corridor was present at this location, as most of the land here was and still is maintained primarily as a hay field. By 2014 the shale riffle had become destabilized. It had migrated downstream approximately 30 feet from its previous location, and an extensive mid-channel gravel bar had formed extending for some ways downstream.

*Illinois River 2 FID 2. Aerial shot looking downstream at the site, 05/13/2020.*

Regardless of the outcome of any further discussions regarding bats, we recommend immediate action. It is truly unknown how great and long-term of an effect this large-scale disturbance could have without professional intervention. A plan should be developed as soon as possible to restore this reach of river to a state of stability and equilibrium. This will not be an easy fix, but there really are countless benefits to undertaking an endeavor like this. We could spend the next 5 years restoring every eroding bank in this study and still not come close to realizing the potential sediment and nutrient reduction impact of this one project.

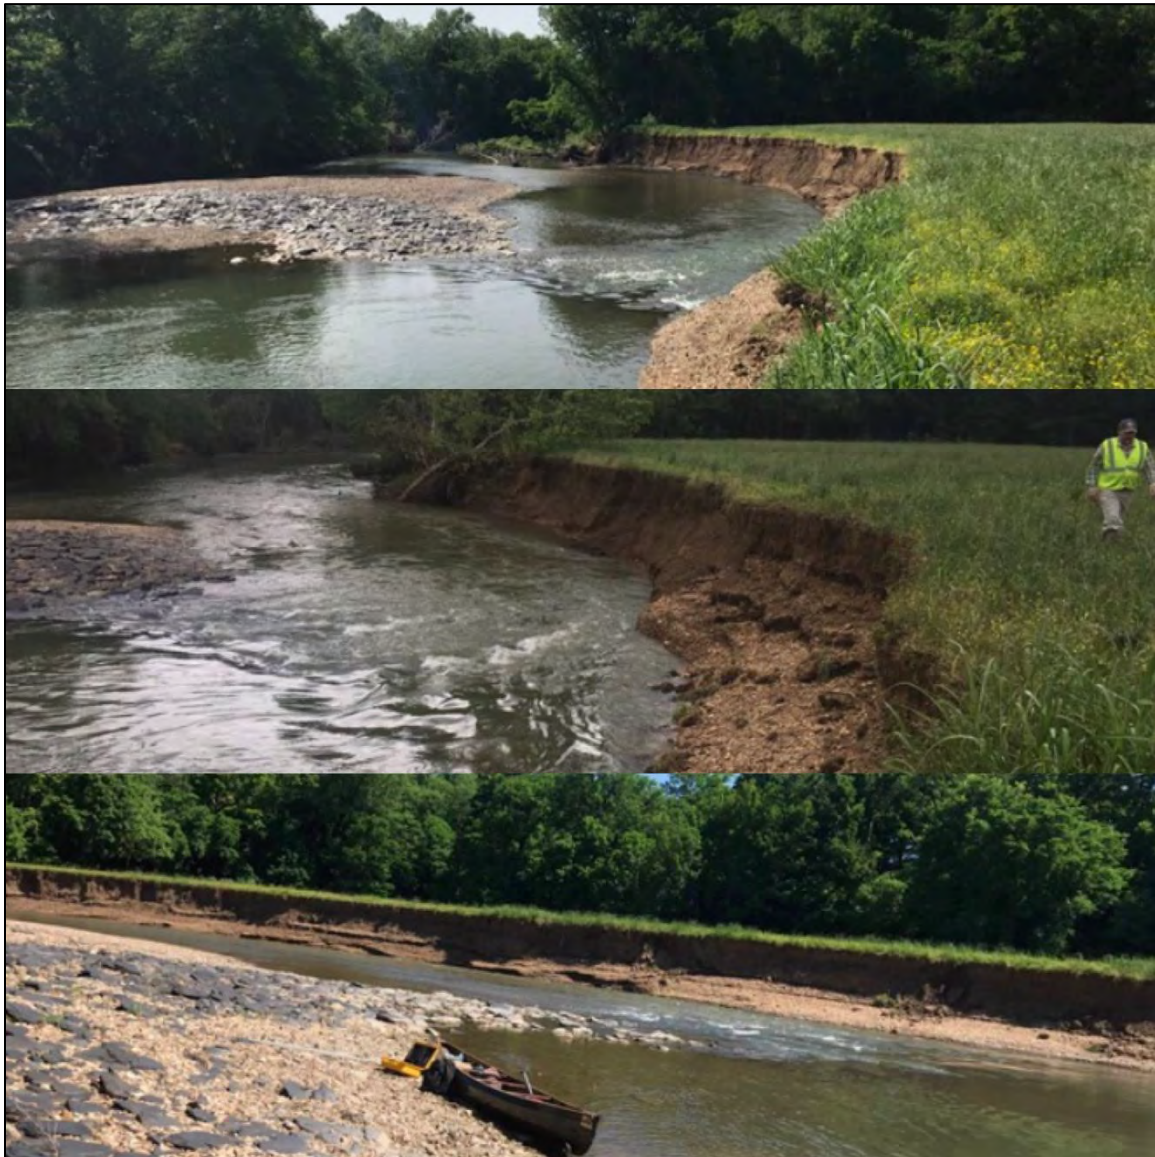
*Illinois River 2 FID 2, 2017 (top) vs 2018 (middle) vs 2019 (bottom), Looking Downstream.*

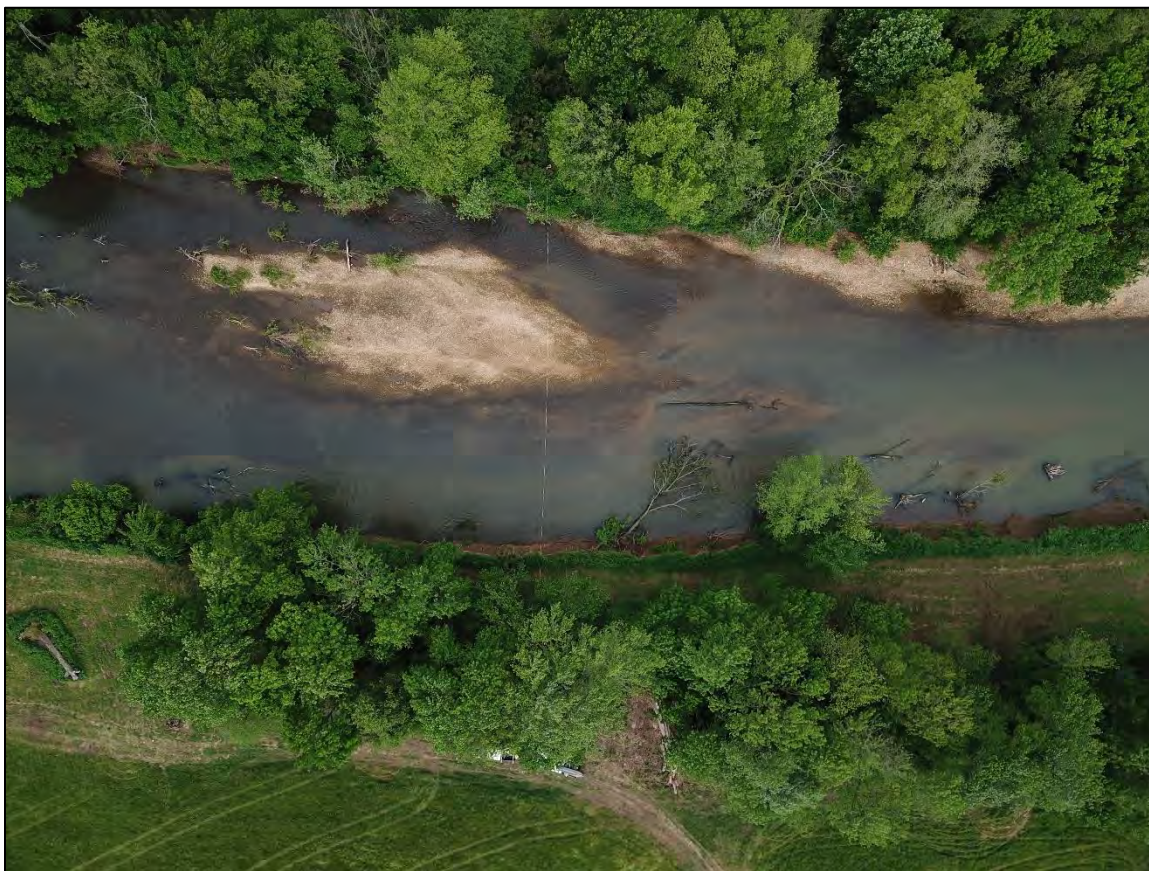
*Illinois River 2 FID 75. Overview of the cross section survey, 05/14/2020.*

Based on the latest data and modeling, predict that the bank at this site will continue to erode at an average rate of 1.78 feet laterally per year. That estimate would put this site in the top half of study sites in regards to predicted erosion potential (ft/year). Our recommendation is to keep an eye on this site over the coming years and be aware that any significant growth or migration of the mid-channel gravel bar would indicate a corresponding increase in NBSS. Any efforts to maintain and enhance the riparian corridor onsite would also be helpful. There are several small riverside hay fields that could be taken out of hay production and a now-mow regimen introduced (while maintaining river access) to encourage forest re-growth and help ensure the long-term sustainability of this beautiful spot.

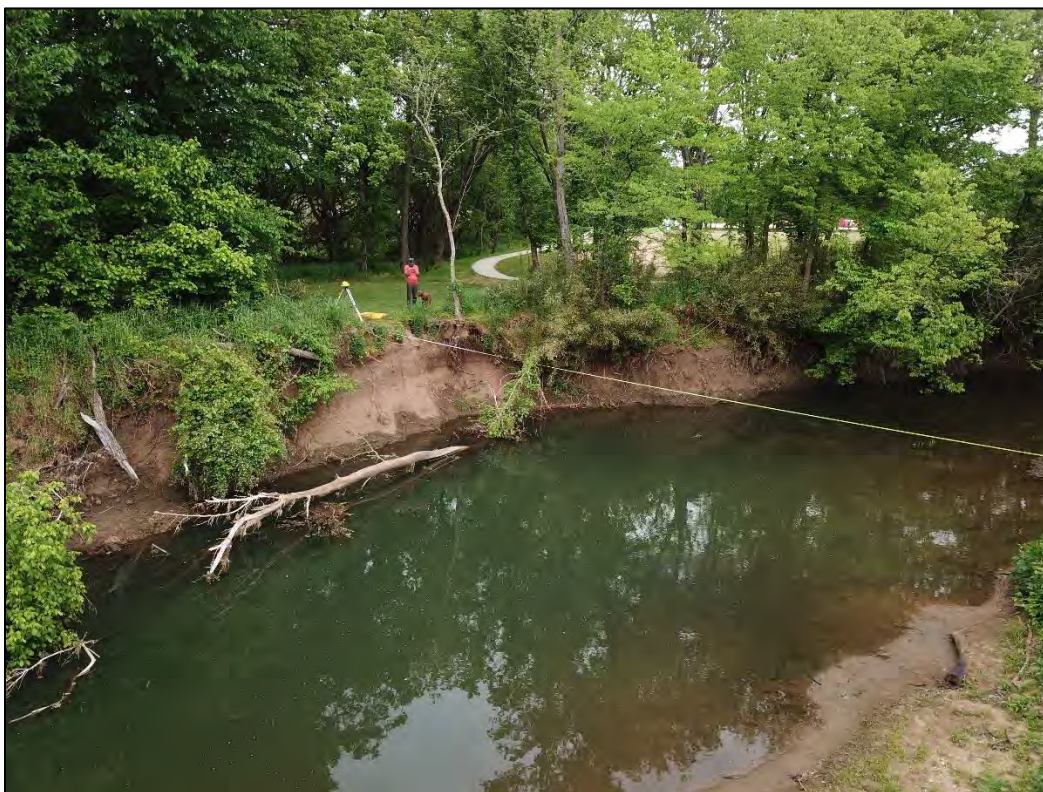
Based on modeling completed in 2020, it is estimated that the cut bank at this site will continue to erode at an average rate of only 0.33 feet laterally per year. This is one of the lowest measured and predicted erosion rates for any of the 15 sites in the study. Initially it may appear that there would be more erosion occurring at this site, given that the bank is nearly vertical, quite tall and has relatively little direct protection from roots and other vegetation. It is really the bank material here that is the key to those low observed and predicted erosion rates that we are reporting. This bank is comprised almost entirely of clay. Clay is generally resistant to erosion, and therefore a bank comprised of clay (unless it has layers of sand or gravel) will generally experience low rates of erosion.

*Muddy Fork 1, FID 172 (5/06/2020) Note nearly vertical bank comprised primarily of clay.*

The only recommendation that we have for this site is to potentially engage with Prairie Grove Parks staff to ensure that the riparian corridor along Muddy Fork is preserved as this place continues to develop into a popular park. In addition, developers appear to be encroaching very close to the floodplain from the East of this location. There is a large tract of relatively wild land on the West side of the creek that appears to be active floodplain. From the historical aerial photos, you can see that this area was once maybe a hay or sod farm, but it appears to have laid fallow for some time now. Ensuring that low-lying properties like this do not get filled or unsustainably developed is important for preventing long-term channel instability and is also great for natural flood retention and mitigation downstream.

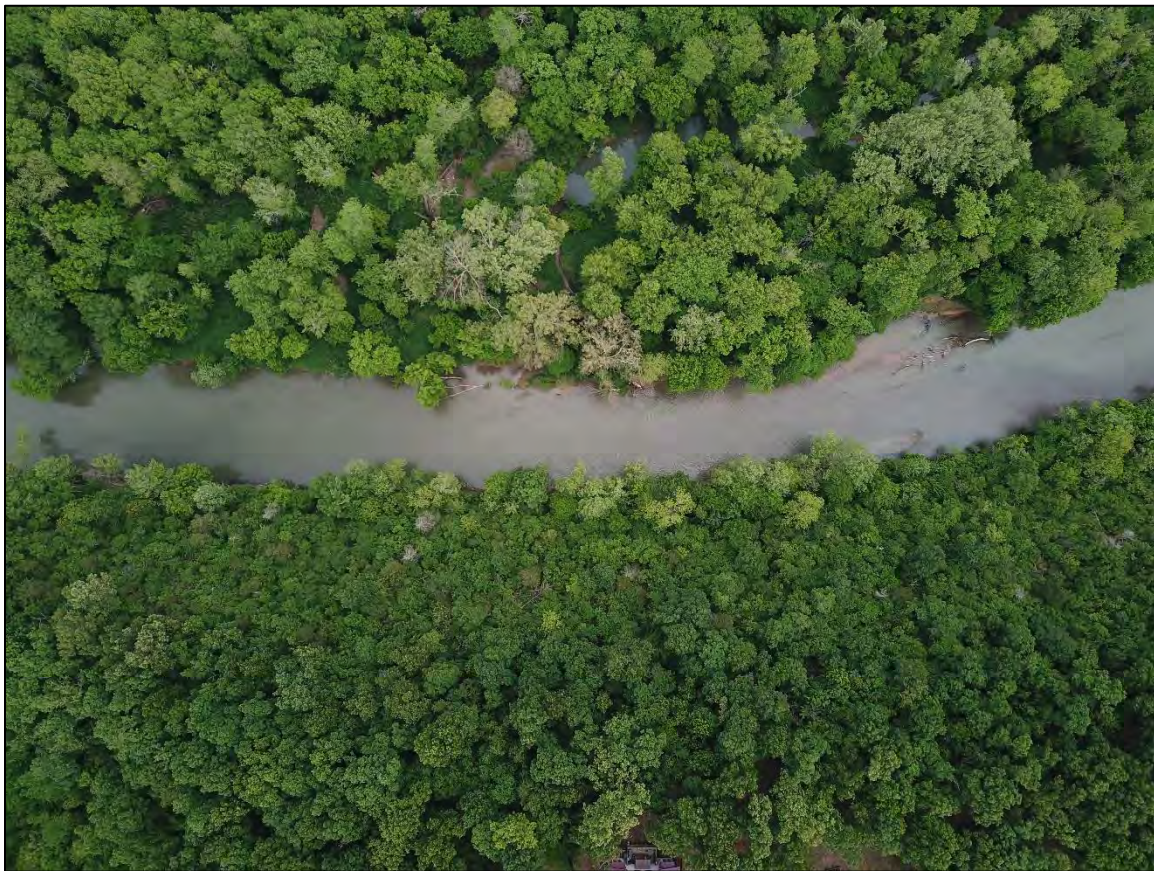
The latest modeling based on 2020 data estimates that this site will continue to erode at an average rate of 0.26 feet laterally per year, which makes this site one of the areas with the lowest both measured and predicted erosion rates included in the study. Based on these results, we conclude that Site 7 is actually very stable in terms of being able to withstand large flood events while displaying little to no change in bank and channel shape. This site is beautiful and uniquely protected, being bound on one side by a wooded, rocky hillside and on the other by a riparian zone that consists of over 500 feet of mature bottomland hardwood forested floodplain with hydrologically interconnected side channels and wetlands. Continued protection of this resource is the key to its long-term resilience and sustainability.

*Illinois River 2, FID 16 Aerial View of the Cross Section location at the time of the 2020 annual survey (5/13/2020).*

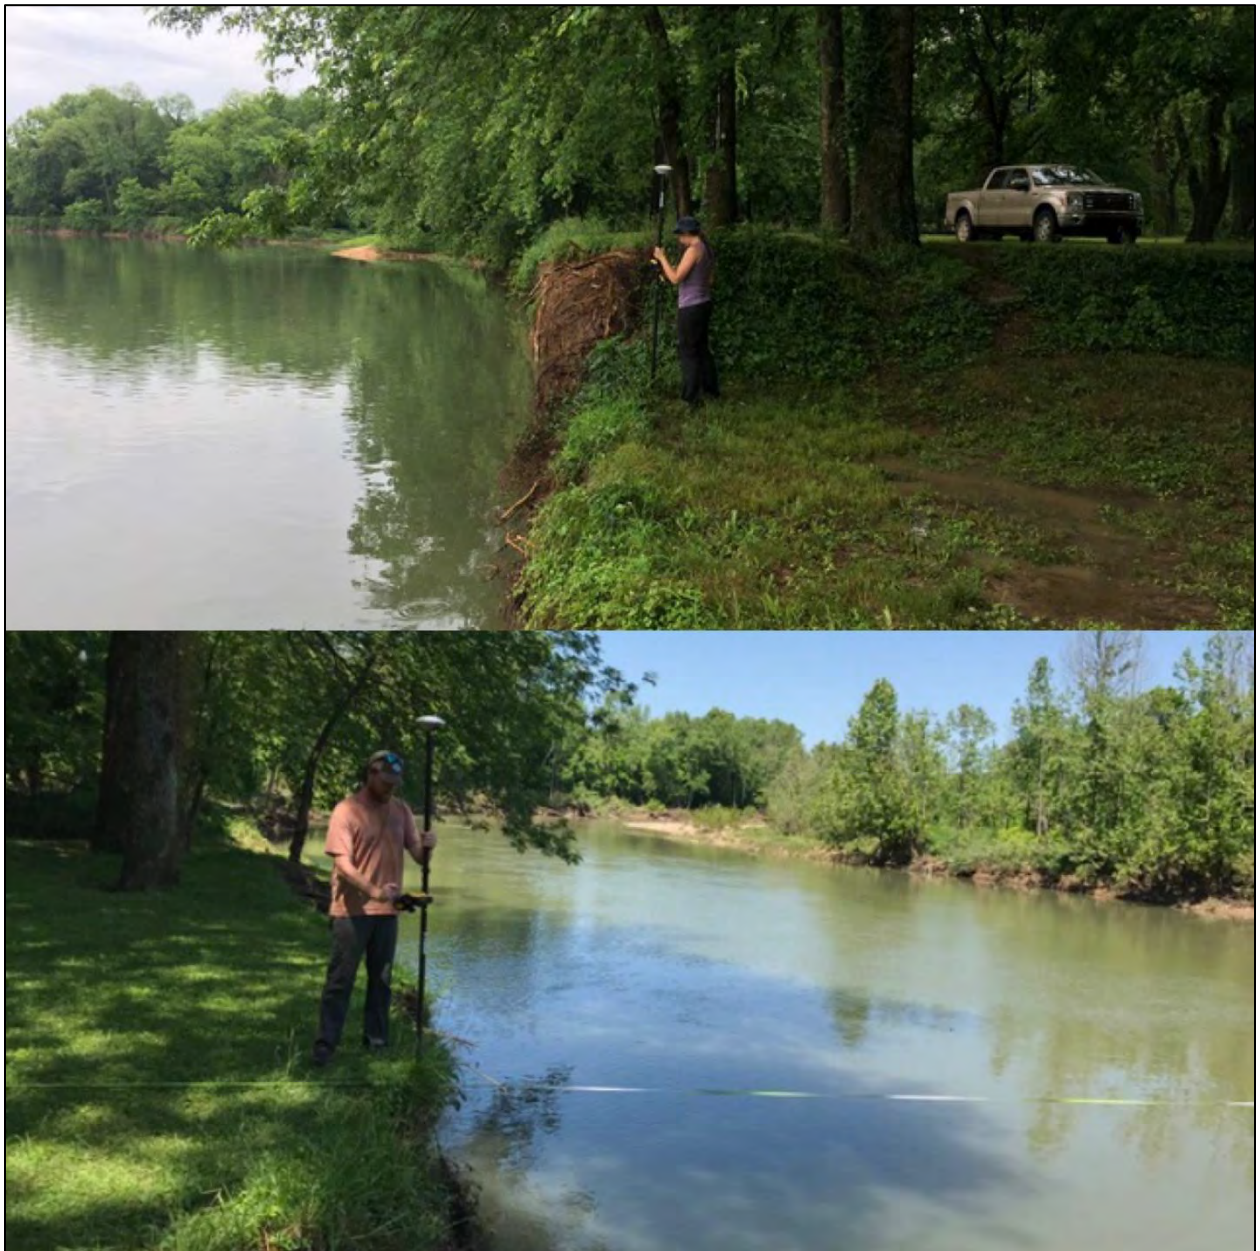
*Illinois River 3, FID 46, 2018 (top) & 2019 (bottom), GPS marking of current top of bank position.*

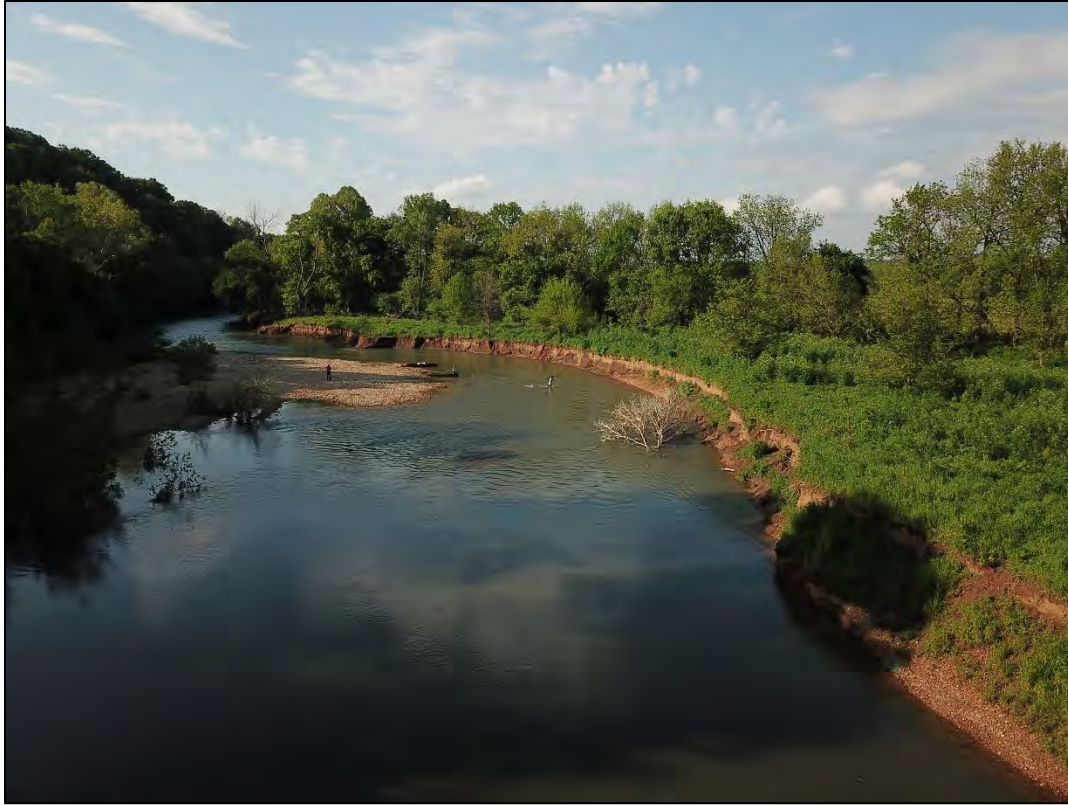
Gaining an understanding of the underlying causes of instability at a restoration site is critical to developing a plan that is likely to lead to successful outcomes. Looking at the reach of river immediately upstream and downstream of the project site, there appears to be a pattern of side-channel bar development. This pattern includes this site as well as two banks within a mile upstream of this site and may even include study Site 5 (Illinois River 2 to 412 FID 75) not far downstream of this location as well.

*Illinois River 2 FID 69 (5/13/2020) Looking downstream towards the site.*

Through a quick reconnaissance utilizing Google Earth, we have identified a relatively small tributary that feeds into the Illinois River from the East approximately  $\frac{3}{4}$  of a mile upstream of Site 9 which may be dumping vast amounts of gravel into the river. A large gravel bar or delta forms at the mouth of this tributary where it flows into the Illinois River. It appears that extensive bank erosion and, likely, channel incision are actively occurring for several miles along this small stream. A field reconnaissance to assess the current condition of this creek, gauge its role in gravel contribution to the river, and potentially recommend actions that could reduce the volume gravel would be a recommended action which could go hand in hand with a more direct restoration approach and plan that would need to be developed to stabilize, restore, and revegetate the cut bank at Site 9 on the Illinois.

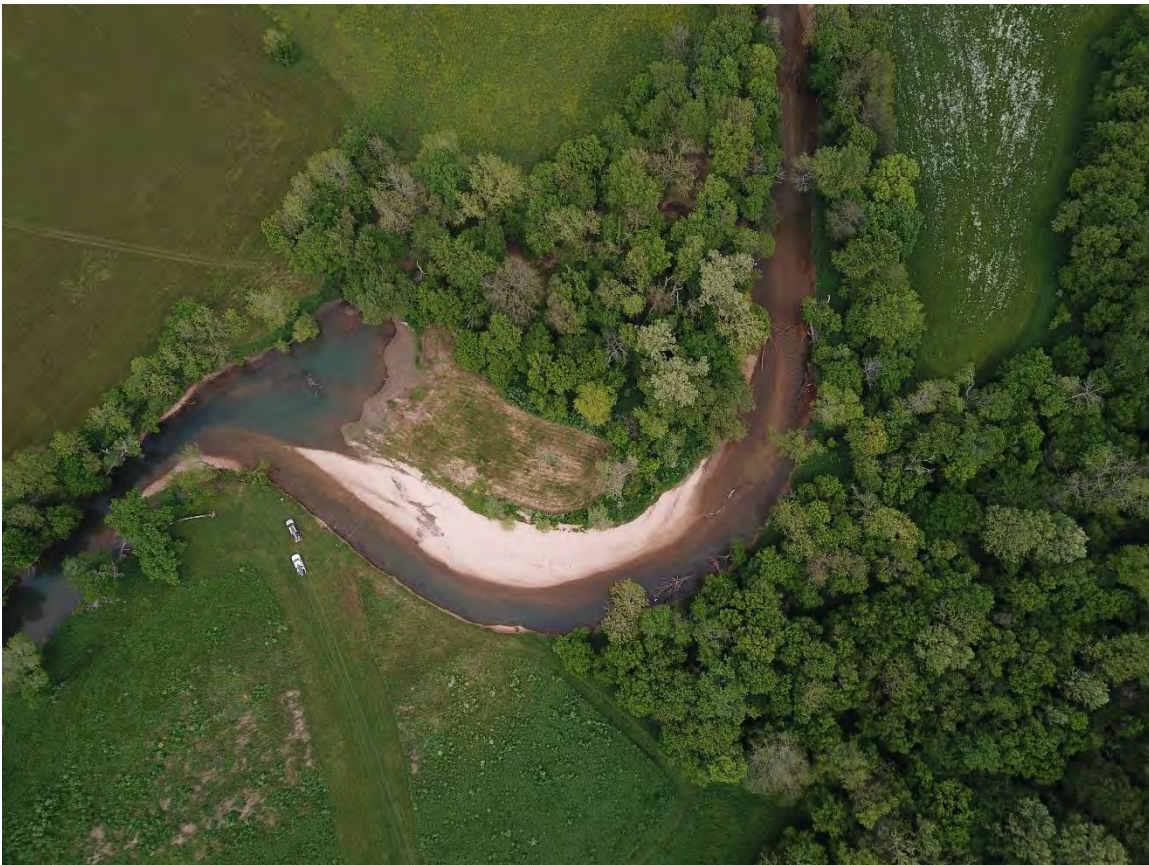
*Clear Creek FID 8, (5/11/2020) Aerial view.*

Any serious restoration plan for this site is going to recommend hardening the toe of the bank with a combination of wood and/or rock as well as sloping, matting and replanting the bank with native vegetation. This is a site that is going to continue to experience very high stresses, so the restoration approach needs to be very resilient to that. Changes in both the hydrologic regime due to the headwaters encompassing large parts of the city of Fayetteville as well as the sediment regime due to all of the extensive bank erosion occurring along the creek make this a unique challenge. This could be a great demonstration project, however, with a high likelihood of success. The approaches utilized here could be replicated elsewhere along Clear Creek, serving as a demonstration site which also addresses a bank that is known to have been contributing a very large volume of sediment and nutrients downstream and eventually into the Illinois River.

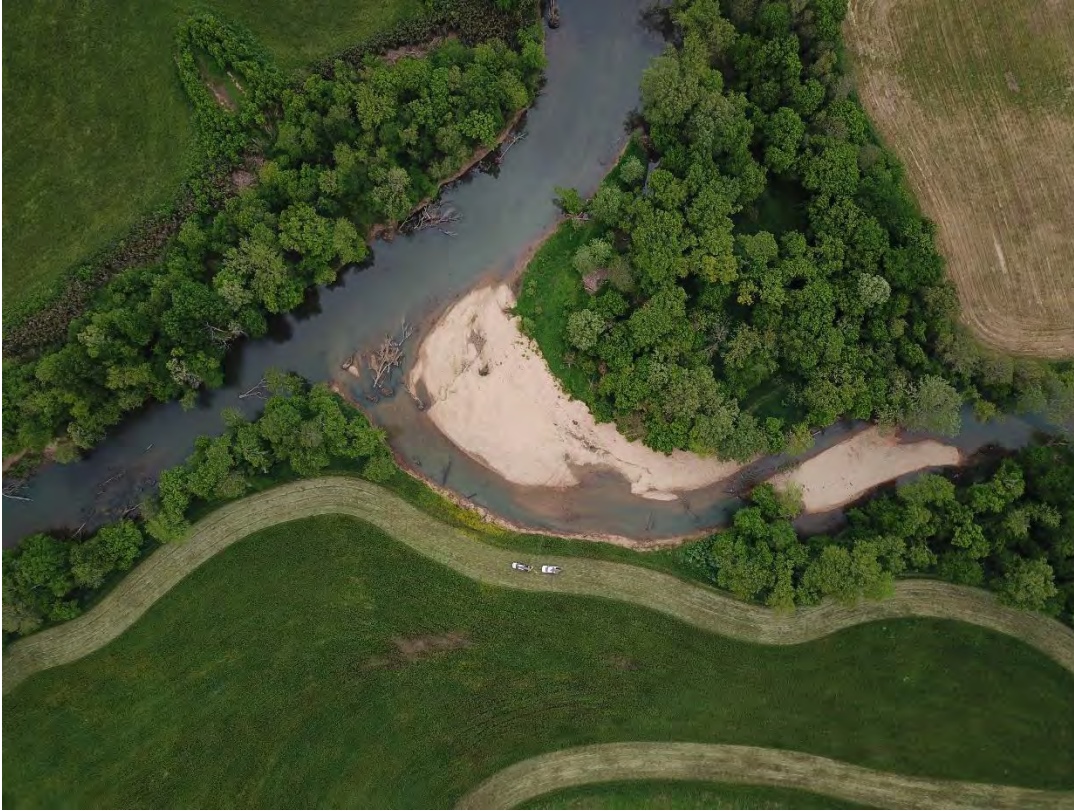
Utilizing detailed site data and updated bank erosion rate modeling, we can now confidently estimate that this site will continue to erode at an average rate of 8.75 feet laterally per year. The measured and predicted erosion rates for this site are among the highest recorded in this study. The only site included in this study with higher observed erosion rates just happens to be located around 1,000 ft downstream of this site along the Illinois River (Site 4 – Illinois River 2 FID 2).

After 4 years of study in this watershed, we are gaining a better understanding of how interconnected these stream systems truly are. Clear Creek is currently experiencing some of the most dramatic erosion in the watershed, and the two sites on Clear Creek included in this study are clearly no exception to this statement. In fact, two of the four most actively eroding sites included in the 15-site study are located on Clear Creek. Development in the headwaters, construction of multiple dams on the creek, along with extensive riparian degradation and incompatible land use practices have ultimately led to a system in flux.

*Clear Creek, FID 40 (05/11/2020) Aerial View.*

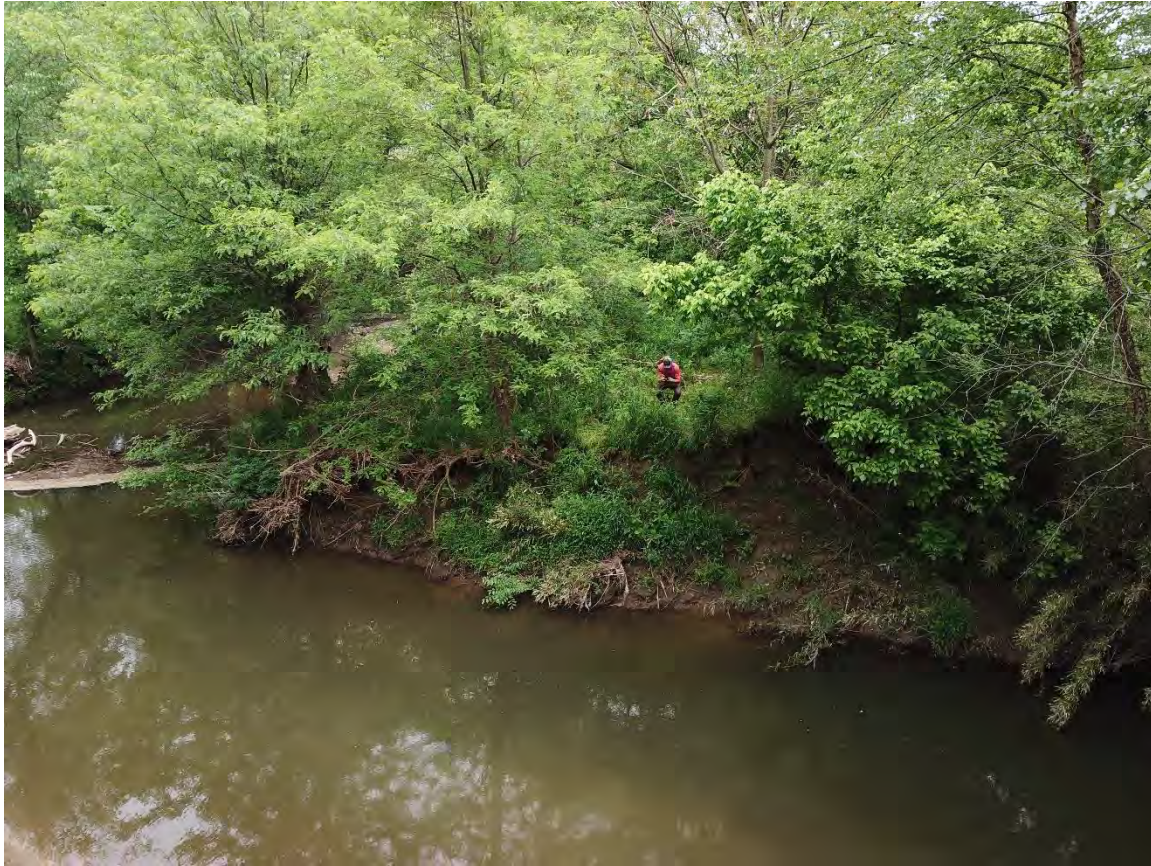
measured and predicted erosion rates out of any of the 15 sites included in this study. With that understanding, we have determined that this may be a good location to collect reference reach geomorphic data at some point in the future. If our observations are correct, it is likely that a long reach of Moore's Creek, including several meanders upstream to Site 13 are very stable and could yield valuable information about the dimension, pattern and profile of the natural stable form. This information can be utilized as a template for the development of Natural Channel Design- based restoration approaches on projects within the Illinois River Watershed.

*Moore's Creek 3 FID 43 (2019) Cross Section View looking back at the very stable study bank.*

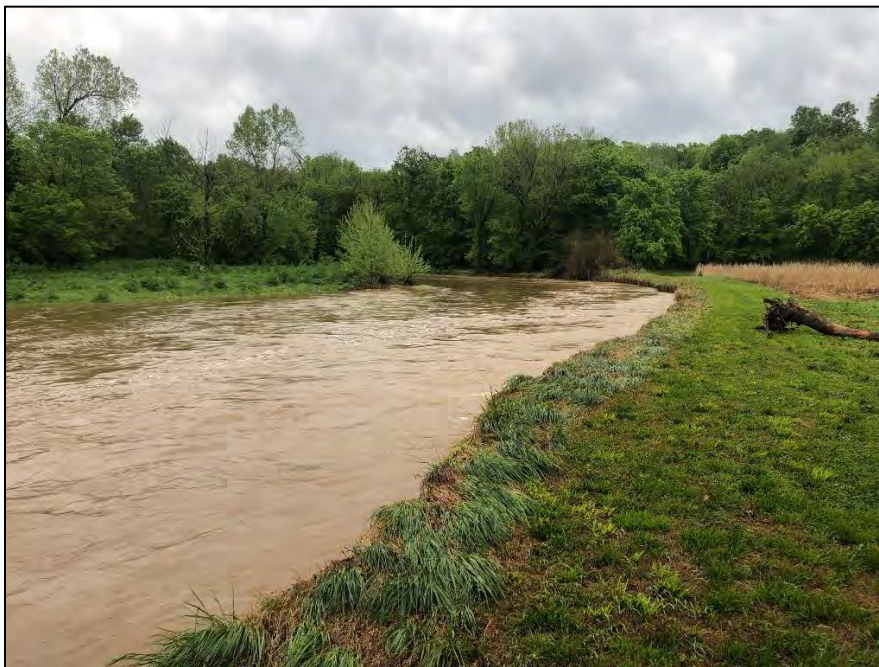
*Bankfull flow conditions observed at Site 10 (Clear Creek FID 8) on May 1, 2019.*

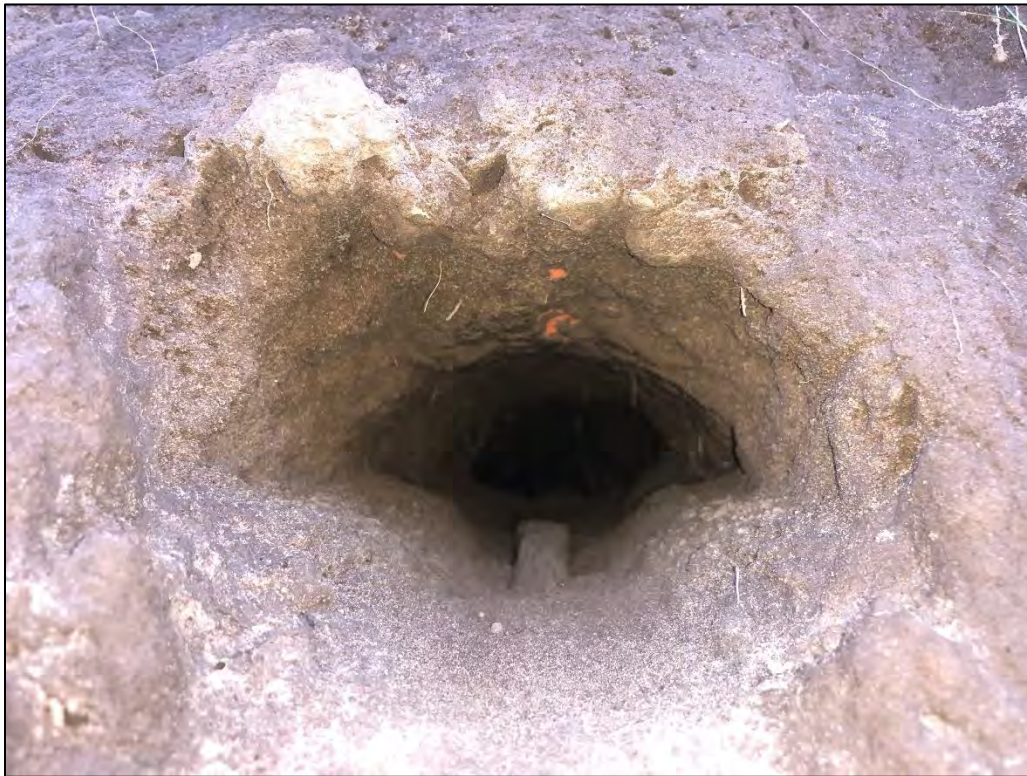
*Bank swallow burrow observed in relatively stable streambank at Site 3 (Illinois River 1 FID 25) on May 14, 2020.*
