June 23, 2016  
G5056

SUBJECT: **Geotechnical Hazard Assessment**  
RE: Pillar Point Bluffs and California Coastal Trail  
County of San Mateo, California

**Geotechnical Hazard Map**  
**Pillar Point**  
 San Mateo County, CALIFORNIA

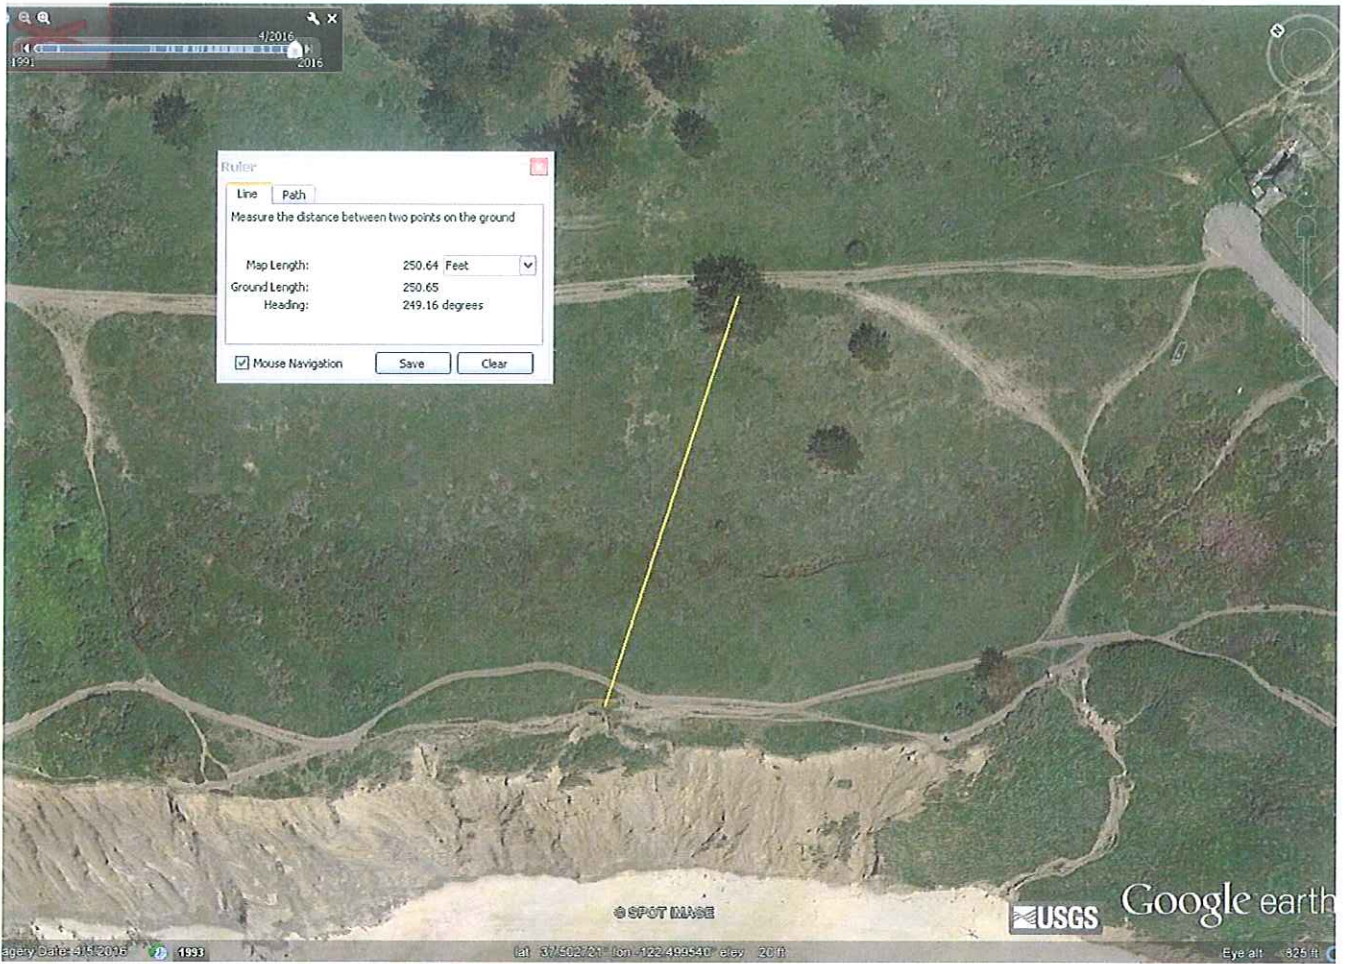
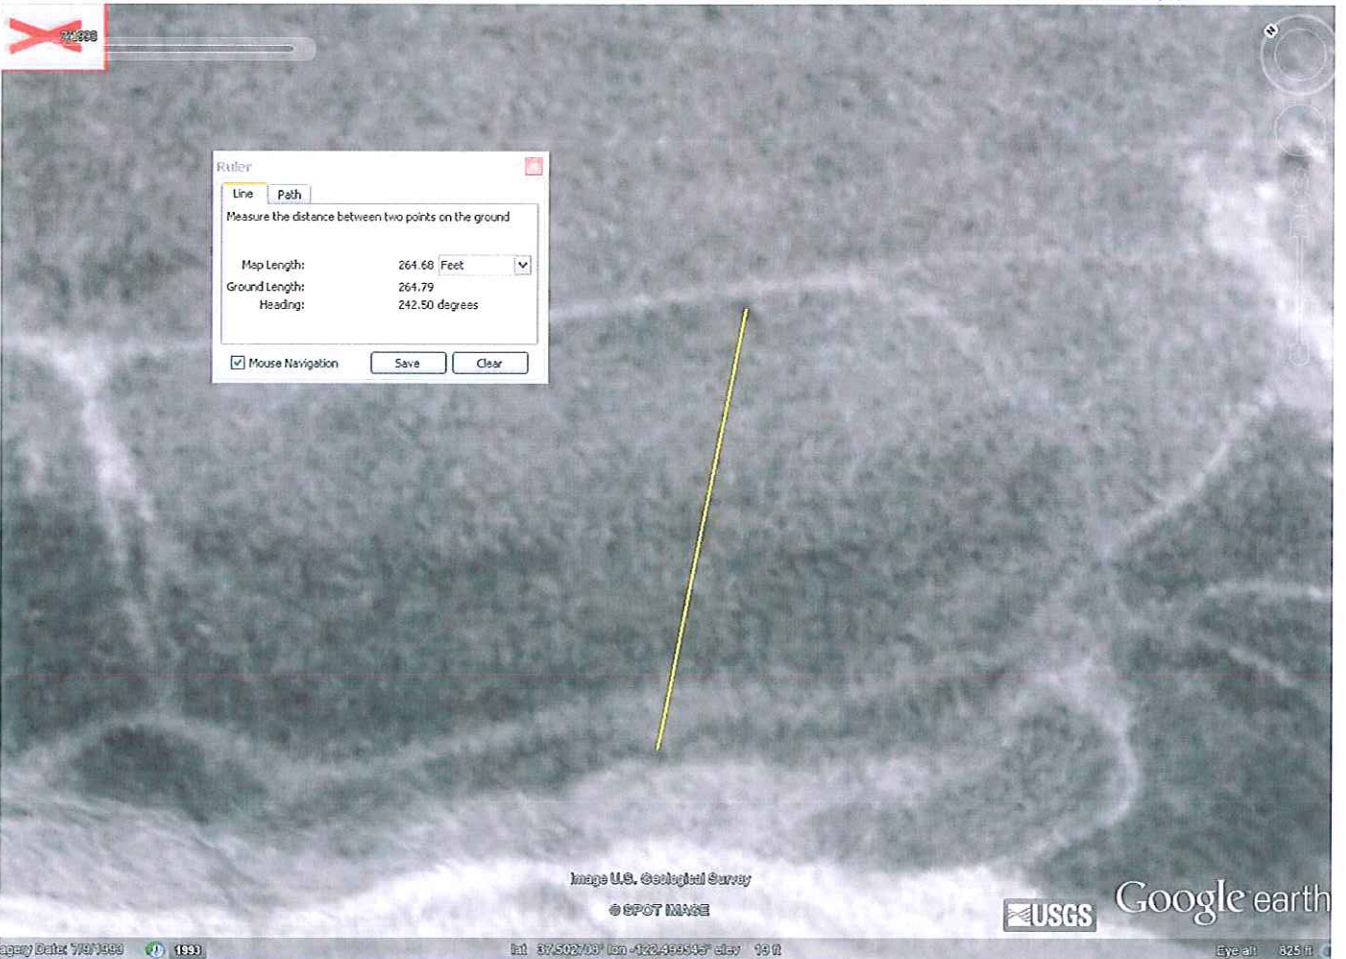
SOUTH

As allowed by identifiable site trees that have persisted from 1993 to present, we have measured bluff retreat rates from aerial photographs at 3 representative locations along the existing bluff trail over the last 23 years. Along the northern trail segment, we obtained an average rate of 0.5 feet/year, over the middle trail area an average rate of 1.3 feet/year, and over the southern portion of the trail 0.6 feet/year (source data is included in Appendix A). As a comparison to other local bluff retreat rates, we understand that coastal bluffs from Bernal Avenue to San Lucas Avenues have an average retreat rates of 0.4 feet/year from 1910-1971 and specific bluffs at Moss Beach have an average retreat rate of 1.6 feet/year (1866-1972).

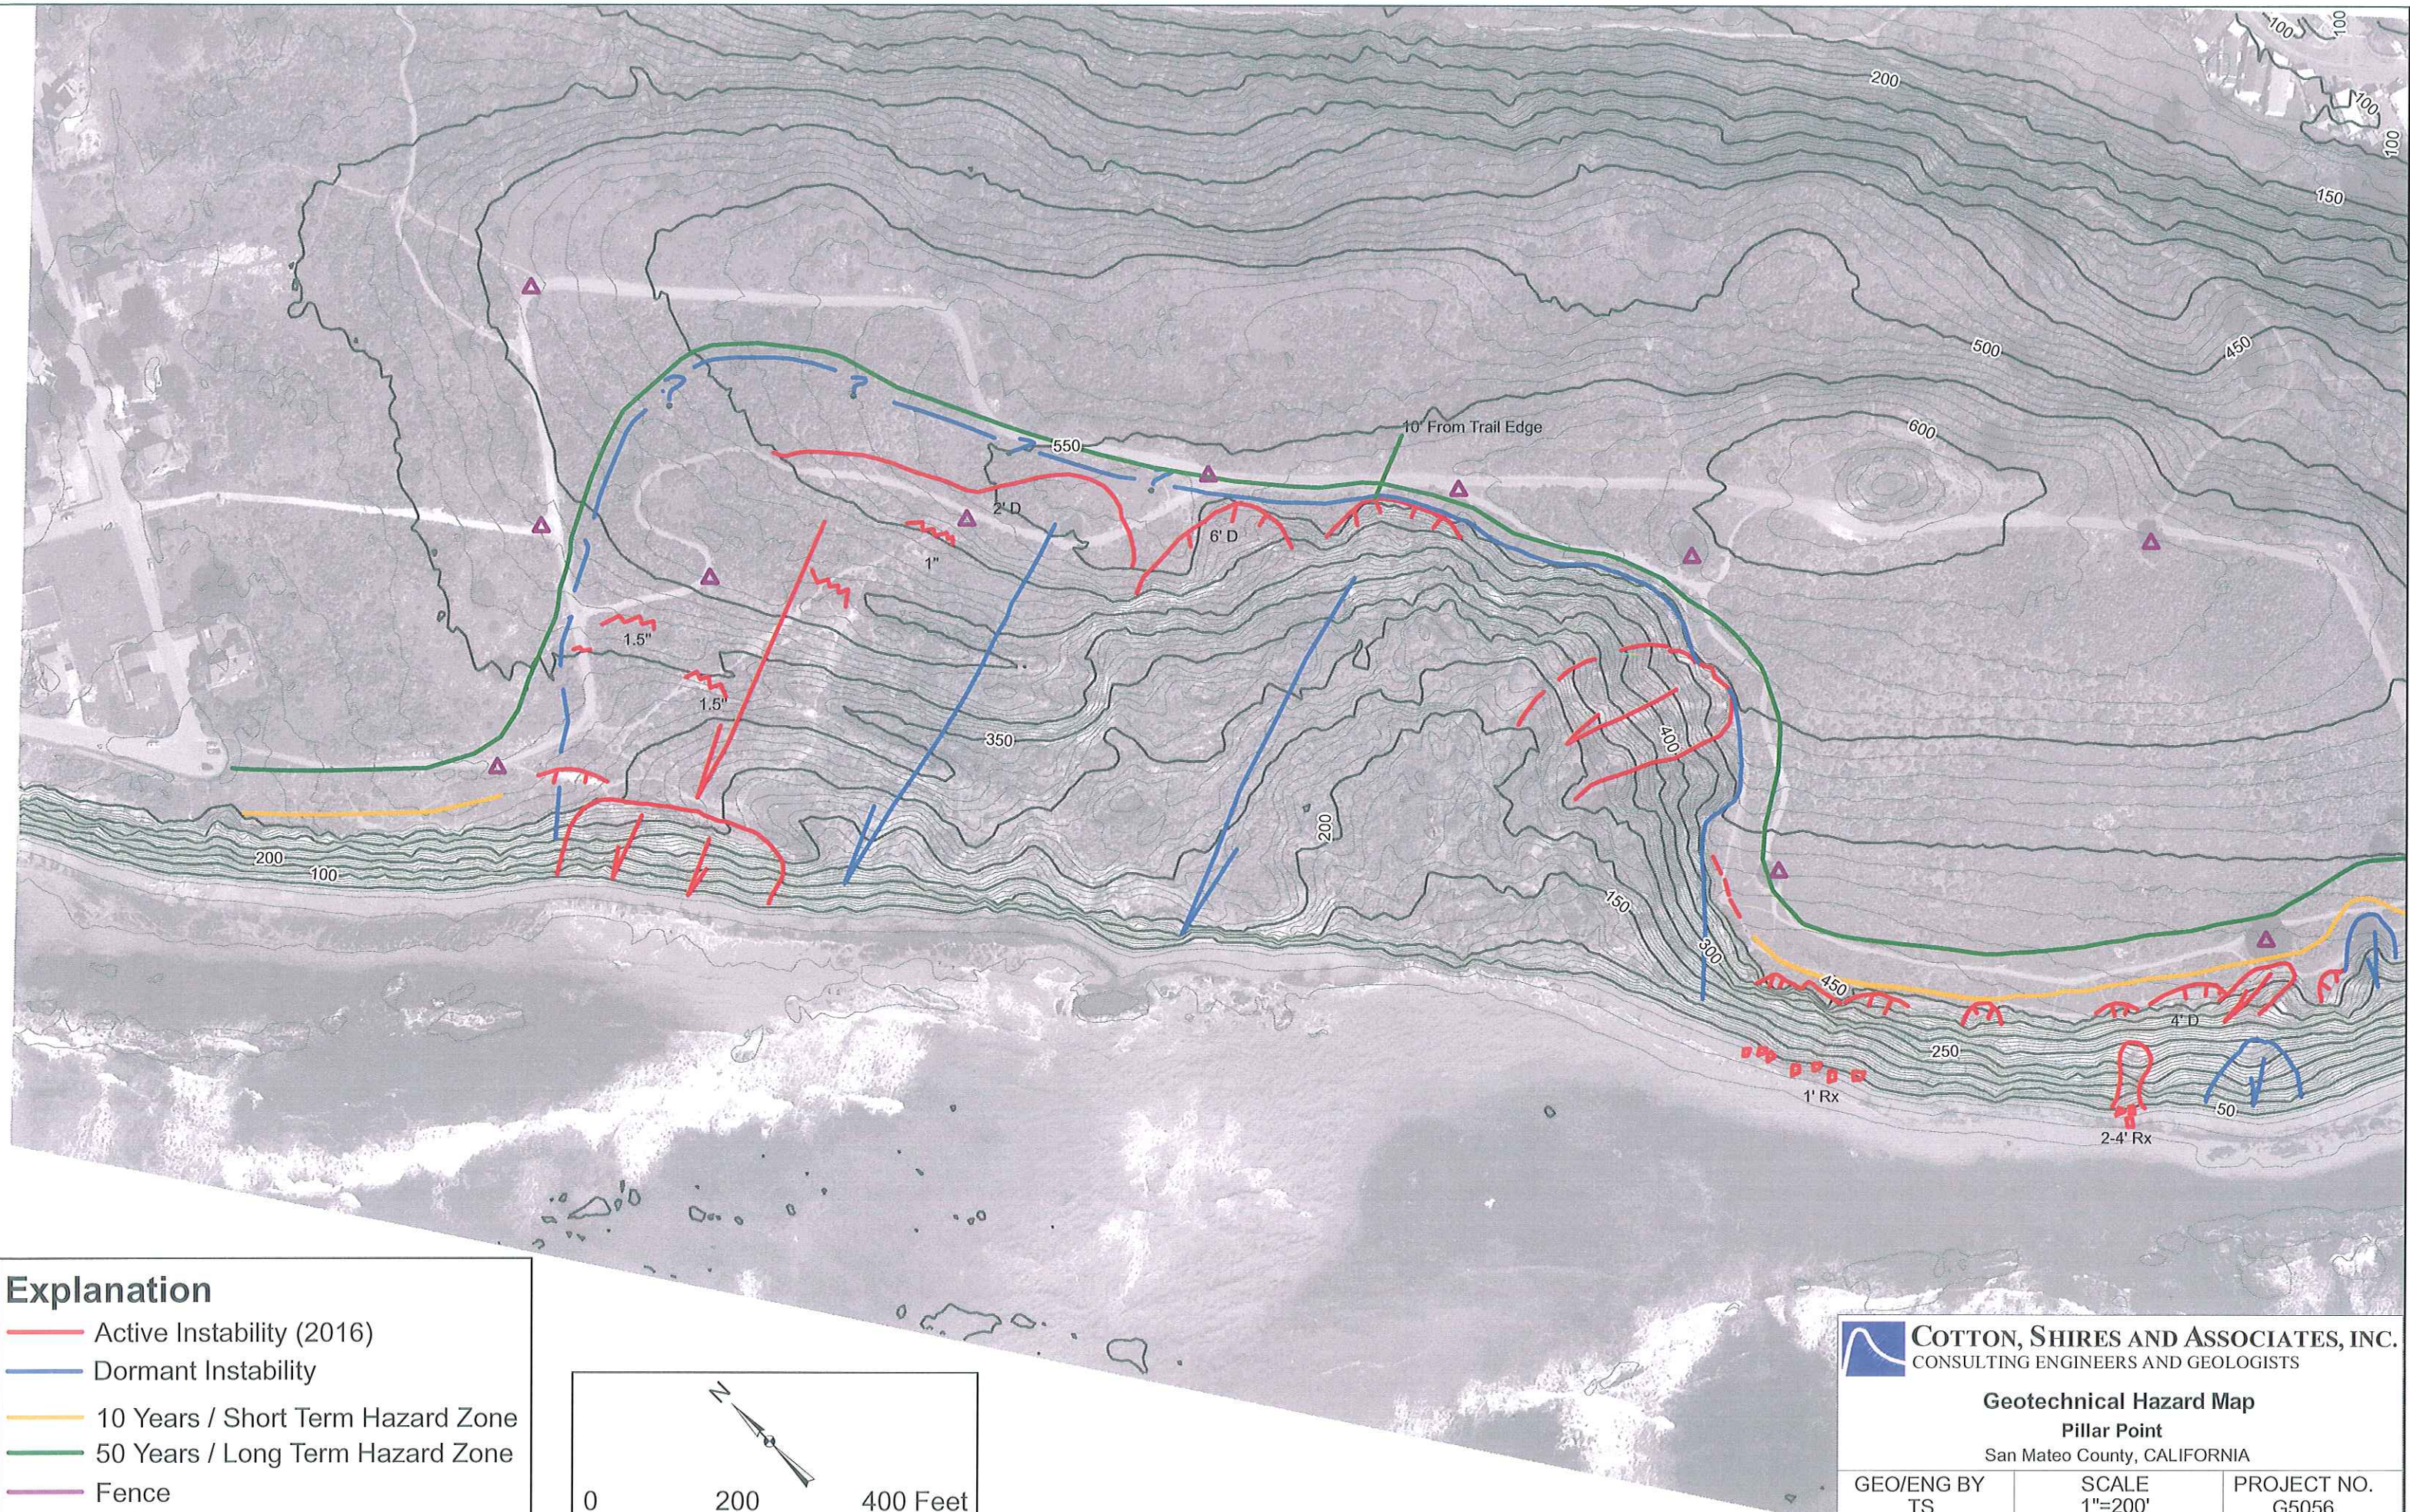
GEO/ENG BY TS	SCALE 1"=200'	PROJECT NO. G5056
APPROVED BY DTS	DATE June 2016	Plate 1

Observed top of bluff tension cracks and fissures, often combined with vertical displacements ranging from 0.5 inch to 2.5 feet, are an indication of incipient landsliding whereby blocks of ground will ultimately become fully detached and fail towards the beach. Existing paths which extend to the west of prominent tension cracks or fissures should be deemed hazardous and unsuitable for continued public access. Plates 1 and 2 present the results of our reconnaissance geologic mapping and indicate where fresh active margins of ground displacement were observed (red). The mapping of features in blue indicate where dormant (previous to 2016) landslides were observed.

Portions of the existing trail system along the top of the Pillar Point bluff have a high risk of being undermined by landsliding associated with bluff retreat. The 2015-2016 winter conditions have triggered significant bluff retreat, and areas that are now partially undermined will likely experience further instability and possible catastrophic failure in the upcoming months or following winter seasons. Other portions of the trail/path system located very close to the bluff may currently appear stable but are in fact next in line for slope failure. Given average potential long term top of bluff retreat on the order of 1.5 feet/year, we recommend consideration of closing off and abandoning various existing bluff trails/paths. The general locations of trail segments for consideration to be abandoned are those paths within the Short Term Hazard Zone (yellow) delineated on Plates 1 and 2. We suggest that specific trail segments to be closed be identified in the field with supplemental geotechnical input regarding the highest risk areas. There is a complex bluff top network of trails and casual paths that are difficult to accurately depict or recognize on the utilized base map resulting in the need for field identification of specific closures.

To replace trail segments that are to be closed, we recommend consideration of establishing new trails or utilizing existing alternative trails that are located east of the Short Term Hazard Zone (based on a 10-year life span). For the permanent California Coastal Trail (life span of 50 years or more), we recommend that the Long Term Hazard Zone (green) be observed. As a basic trail layout strategy for the top of the Pillar Point bluff vicinity, we recommend consideration of constructing observation points that are spurs off of a trunk trail with outlooks that observe at least the Short Term Hazard Zone. Observation points would ideally be surrounded on the west side by appropriate safety barriers (possibly a wood rail fence). It should be understood that spur trails to overlooks may require shortening and maintenance in the future as additional bluff retreat occurs. We recommend that geotechnical consultation be provided as a revised trail layout plan is prepared to verify that favorable observation points are selected.

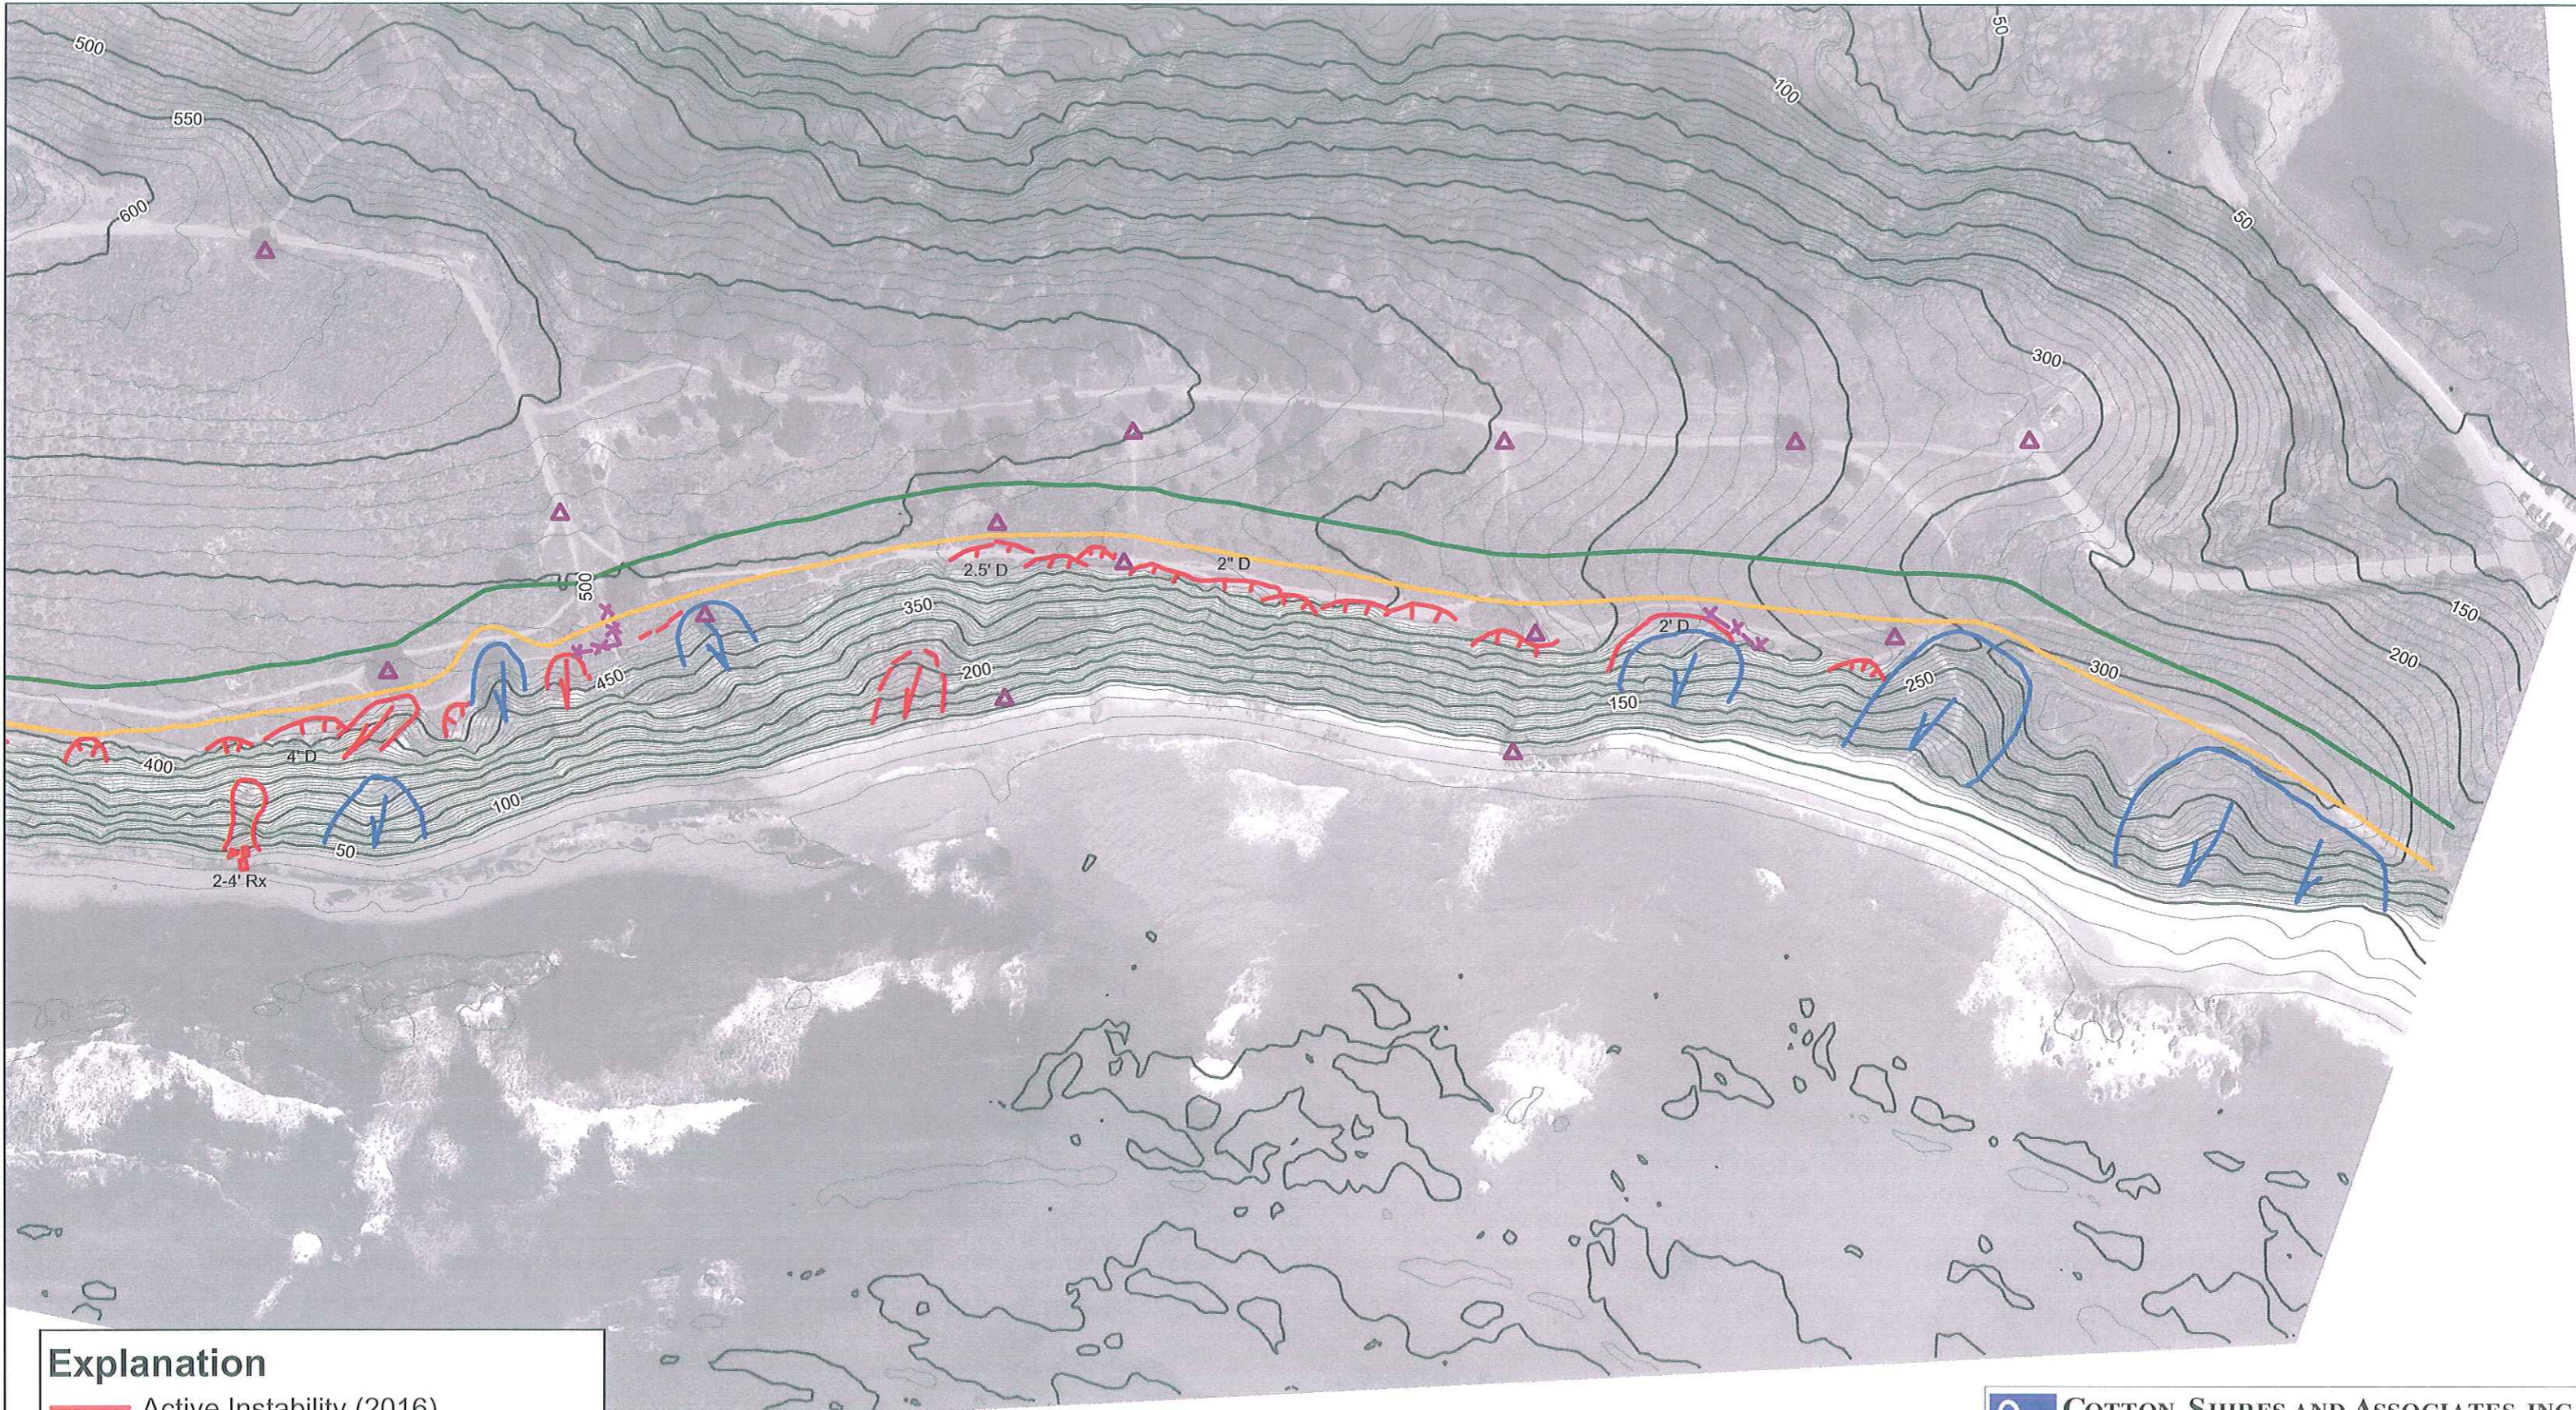
<b>Geotechnical Hazard Map</b>		
<b>Pillar Point</b>		
San Mateo County, CALIFORNIA		
GEO/ENG BY TS	SCALE 1"=200'	PROJECT NO. G5056
APPROVED BY DTS	DATE June 2016	Plate 2

We also observed signs of past dormant and active deep-seated landsliding in the vicinity of Jean Lauer Trail and adjoining bluffs to the southwest. This trail system essentially encompasses a very large and old landslide complex that has partially reactivated during the 2015-16 winter season. We observed open ground fissures along prominent graben features within the northern half of the landslide complex. Active landsliding has occurred along the southeastern edge of this landslide undermining a portion of an adjacent trail. Another portion of the landslide complex (northwestern corner) displays active deep-seated displacement of ground over an area of approximately 30,000 square feet. Active basal shear surfaces were observed at beach level in this vicinity.

Based primarily on local topography and observed signs of active displacement, we have delineated the apparent margin of this landslide complex on Plate 2. From observation of historic aerial photographs, we estimated that the eastern edge of this landslide is enlarging at a relatively slow average rate of 0.1 feet/year or 5 feet over a period of 50 years. Due to the imprecision in defining an accurate boundary around the entire landslide feature, we are recommending a 20 foot wide Long Term Hazard Zone adjacent to the apparent eastern margin of this feature.
