**SHORELINE PROTECTION
FEASIBILITY STUDY
FOR
PRINCETON, PILLAR POINT
HALF MOON BAY, CALIFORNIA**

**SAN MATEO COUNTY HARBOR DISTRICT
1 Johnson Pier
El Granada, CA 94018**

**MOFFATT & NICHOL ENGINEERS
3000 Citrus Circle, Suite 230
Walnut Creek, CA 94598**

September 2001
M&N FILE NO. 4852

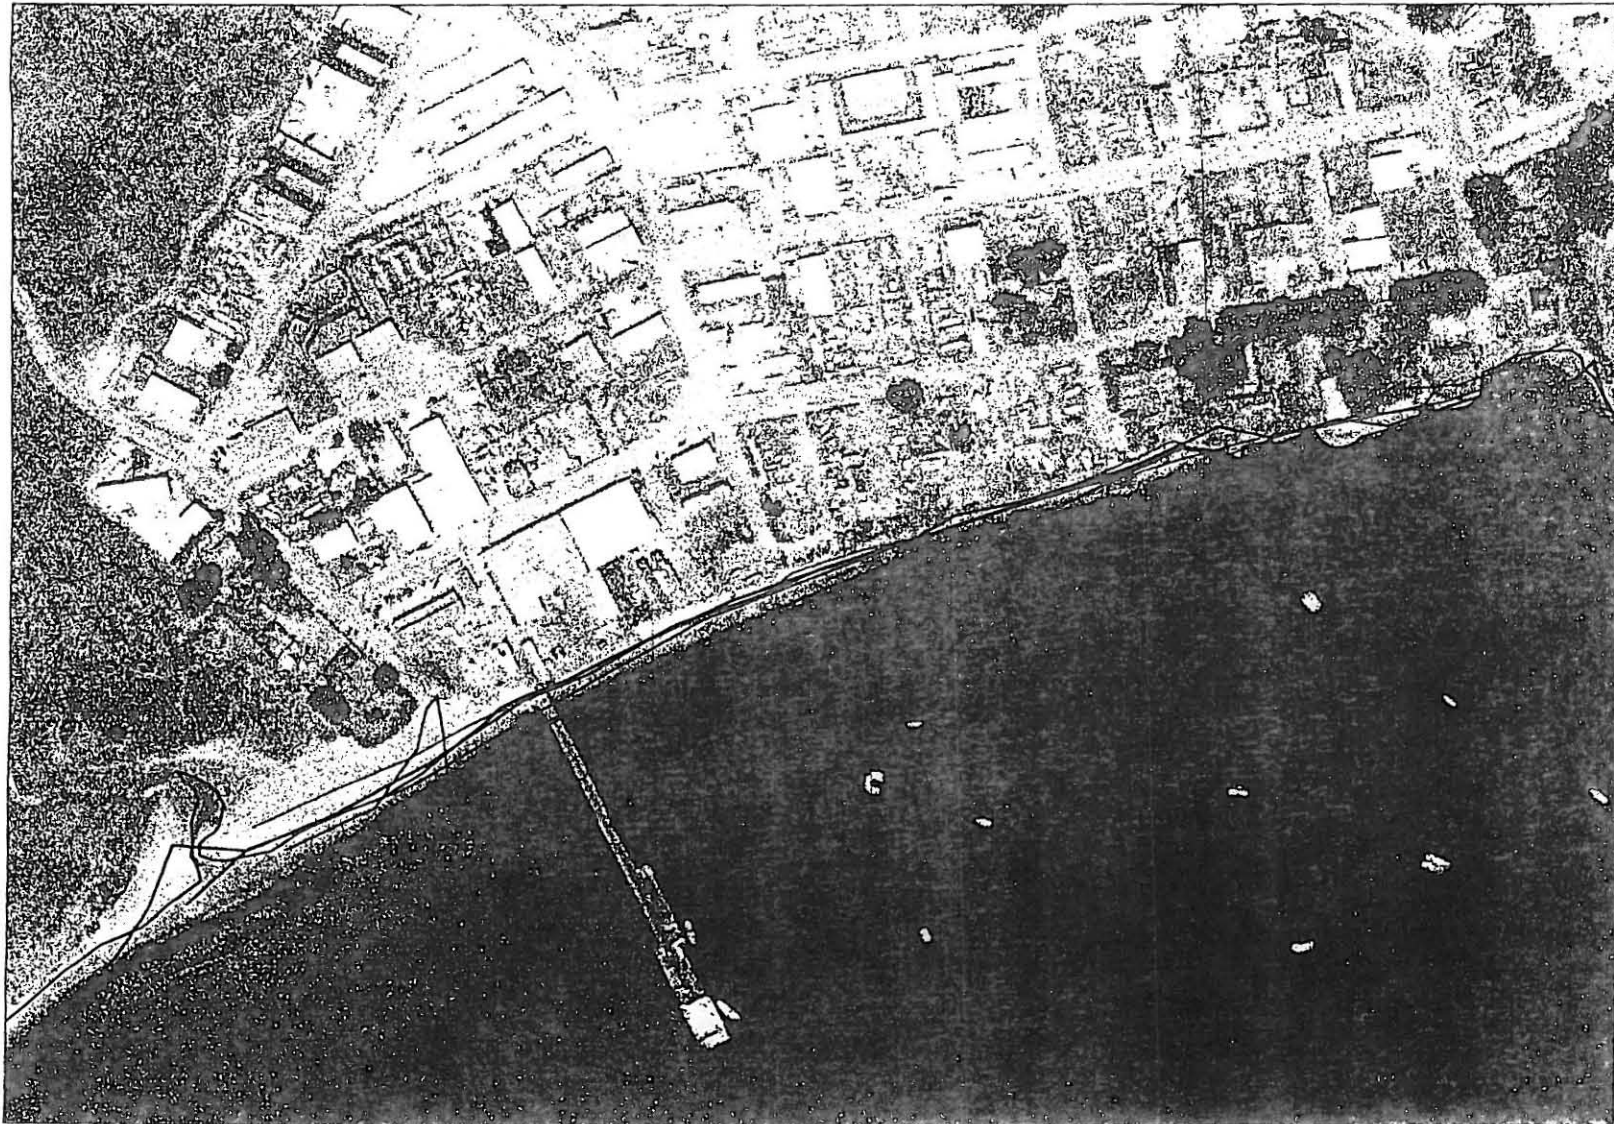
FIGURE 9

The various shorelines are shown on Figure 9, and the top of bank for each year is shown on Figure 10. The data, although approximate, indicate that erosion of up to 15 to 17 inches/year occurred in the area between Romeo and Vassar. The reach between Vassar and Columbia eroded at about 1 foot/year. Near Columbia, little to no beach exists. Observed erosion rates were about 7 inches/yr. The reach between Columbia and Broadway had eroded at about 45 inches/yr between circa 1968 and circa 1983 (Griggs and Savoy, 1985). The shoreline was anchored in the late 1980's by rip-rap, and is approximately at the same location since then except at the segment where rip-rap was used to build out the shoreline west of the Conference Center.

**HISTORIC SHORELINES ANALYSIS USING AERIAL PHOTOGRAPHS
(SCALE: 1" = 300')**

NOTE: LINES INDICATE WETTED BOUND (APPROXIMATELY MEAN HIGH WATER LINE) FOR EACH YEAR

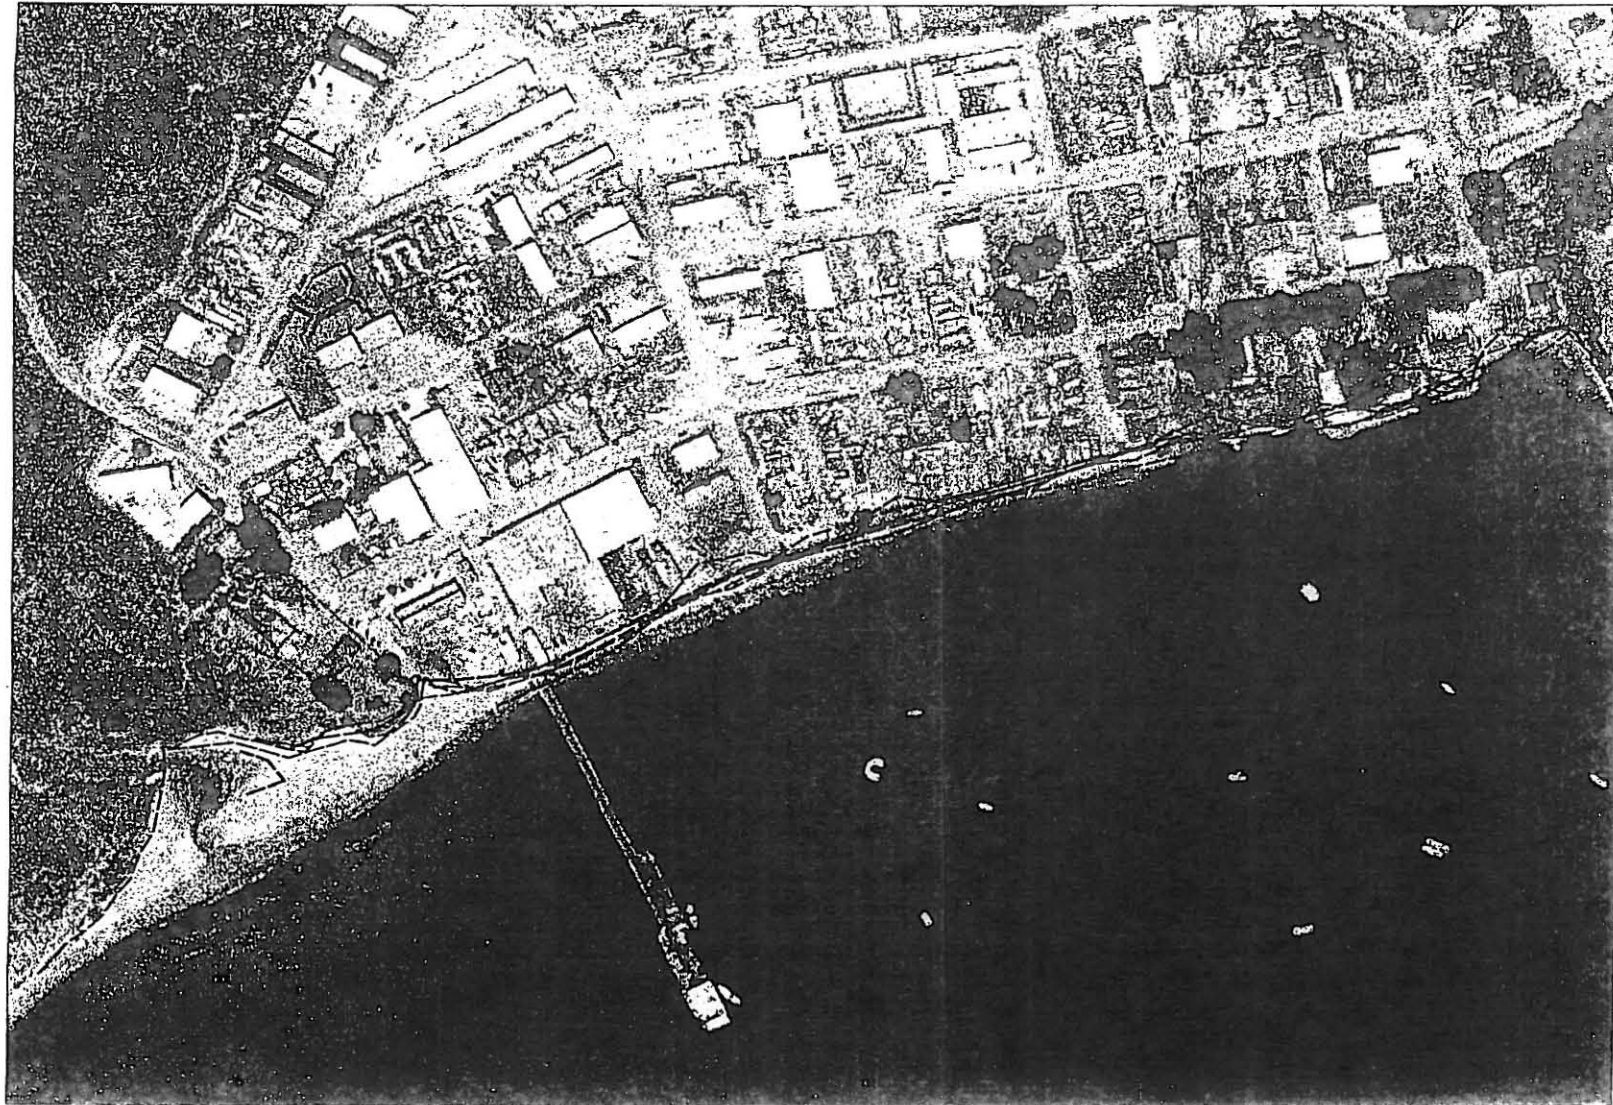
FIGURE 10

**HISTORIC BANK RETREAT ANALYSIS USING AERIAL PHOTOGRAPHS
(SCALE: 1" = 300')**

NOTE: LINES INDICATE VEGETATION LIMITS ALONG TOP OF BANK FOR EACH YEAR

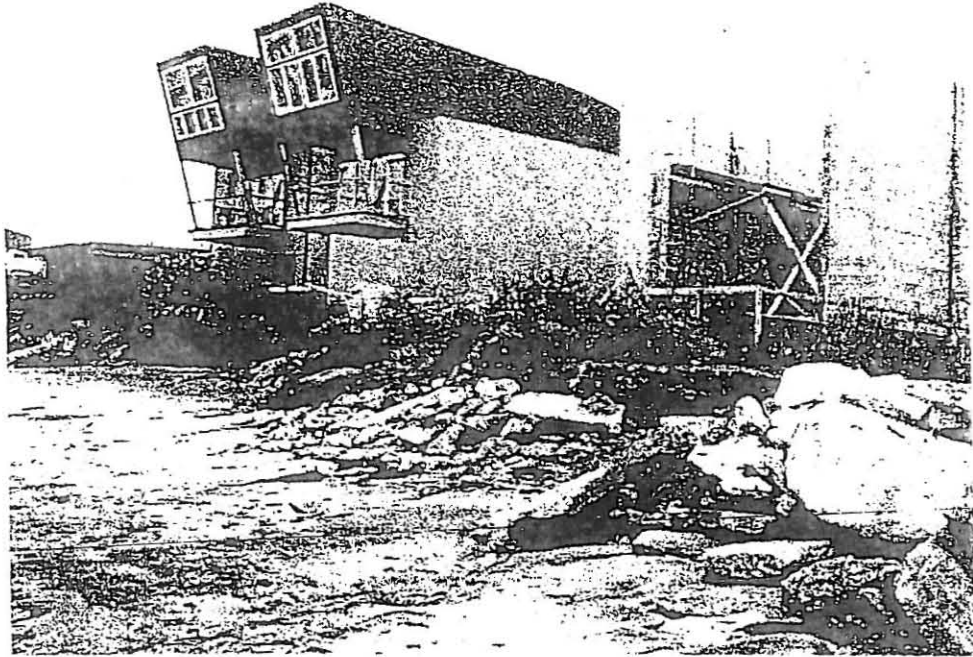
Between West Point and Vassar Avenues, approximately 350 linear feet of the 500 foot long reach of shoreline has been armored with a concrete seawall and concrete rubble. Pictures of this reach are presented in Plates A1 through A3 in Appendix A. The beach exposed at high tide is narrow (about 10 feet wide, see Plate A1). Romeo Pier is located approximately 100 feet east of West Point. The reach just west of Vassar has an unprotected segment of shoreline where the beach is wider and erosion is ongoing (see Plate A2).

Approx. 200' West of Vassar

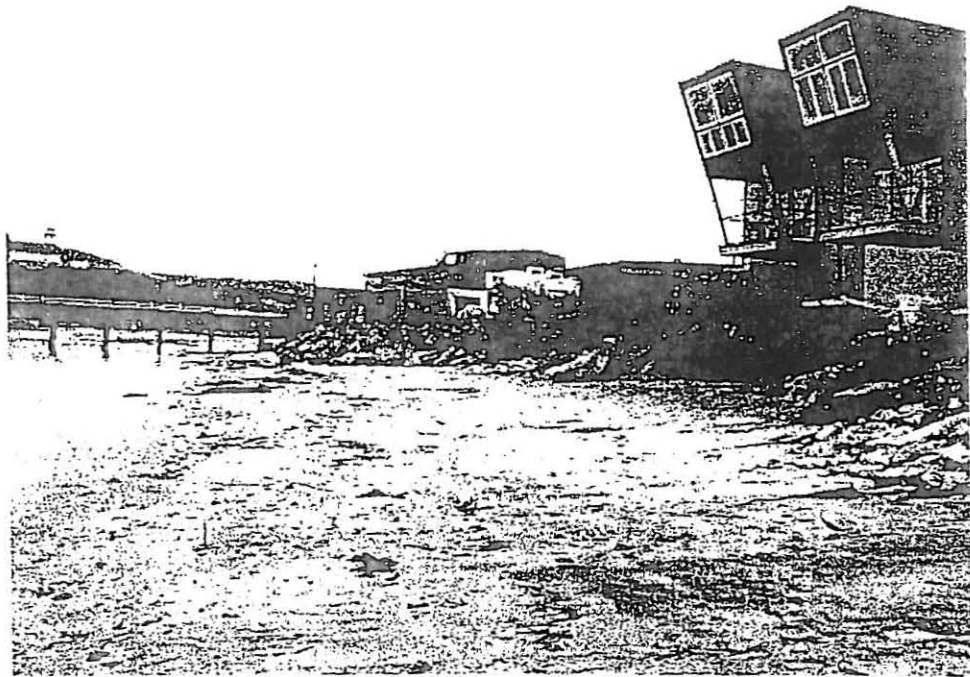
Approx. 200' West of Vassar

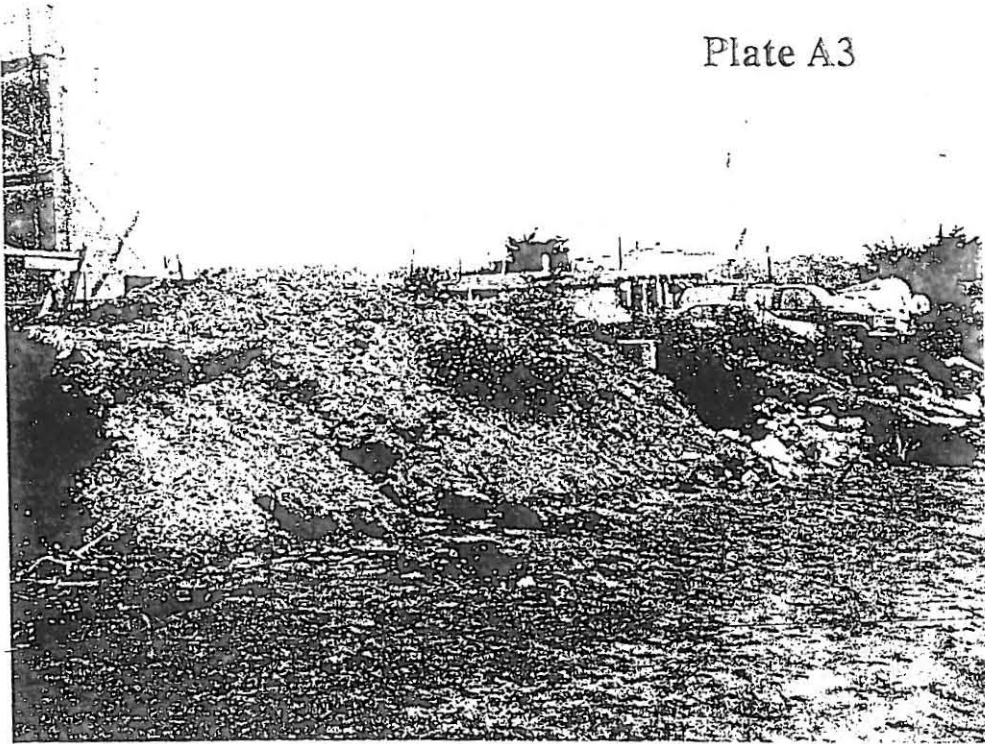
Exposed Bank (approx. 200' west of Vassar)

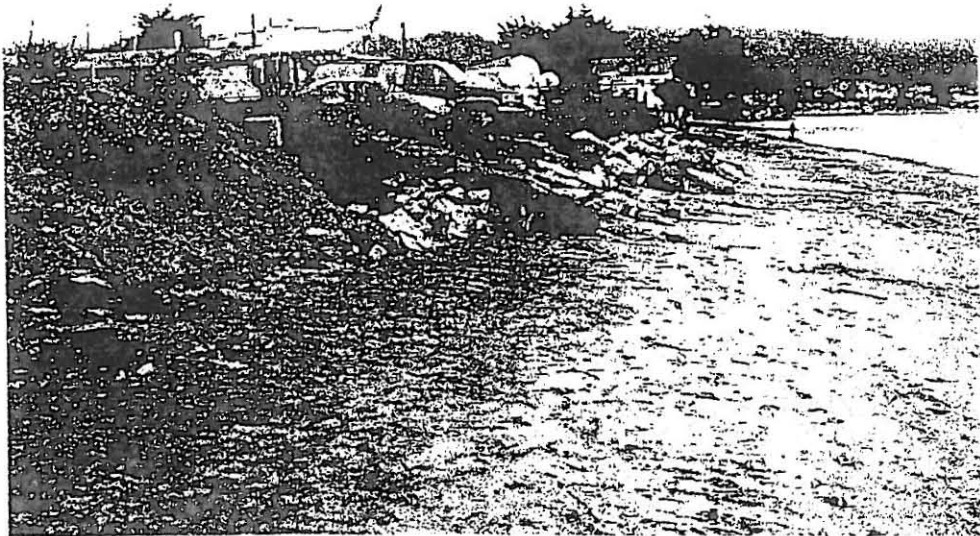
Plate A4

Rubble at end of Vassar

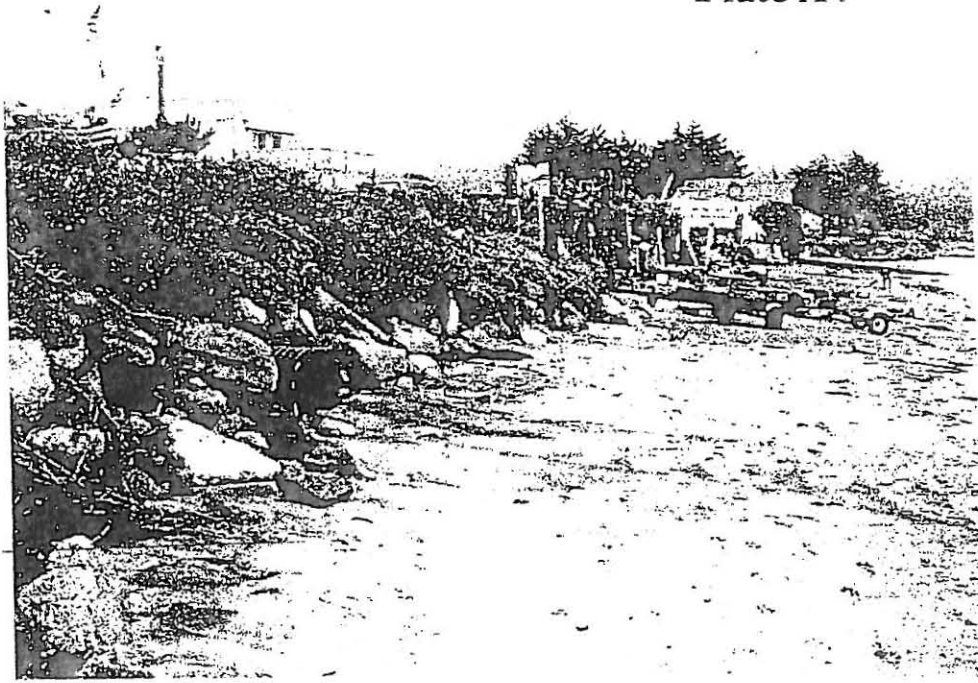
Between Vassar and Columbia Avenues, the shoreline fronting the Yacht Club and the boat yard, is mostly armored as seen on Plates A4 through A8. The beach width transitions from a narrow beach at high tide near Vassar (see Plate A4) to almost none near Columbia (see Plate A7). The shoreline treatment varies from concrete rubble randomly placed, to a concrete seawall at the boat yard. Two parcels have constructed access ramps/stairs to the beach. Approximately 200 feet west of Columbia, a set of marine railways for a small boat repair yard extends into the water from the shore. A storm drain outlet has been installed near Vassar.

Storm Drain Outlet at Vassar

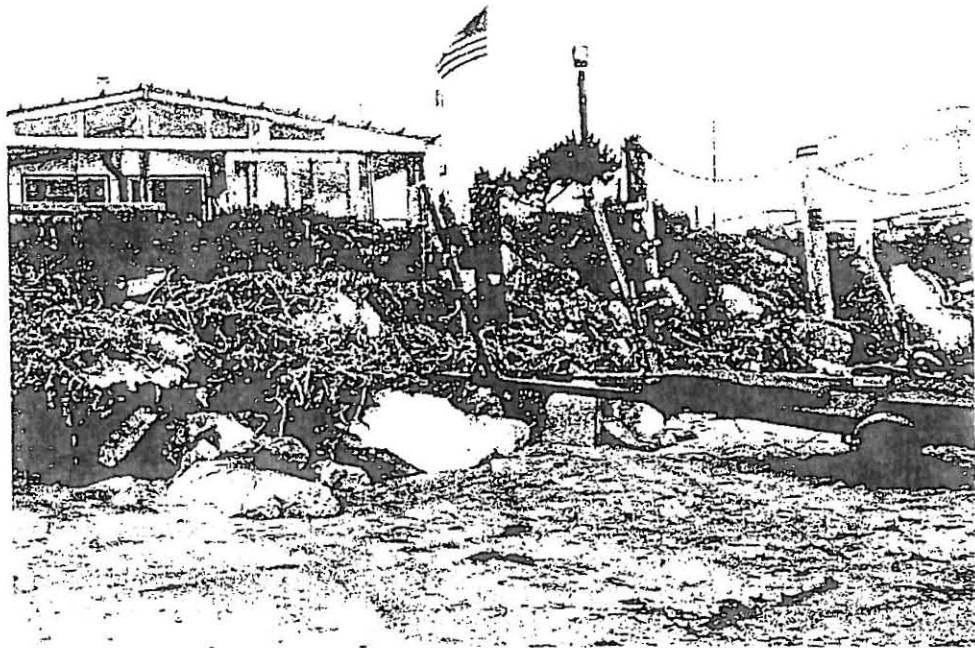
Plate A5

Near Yacht Club

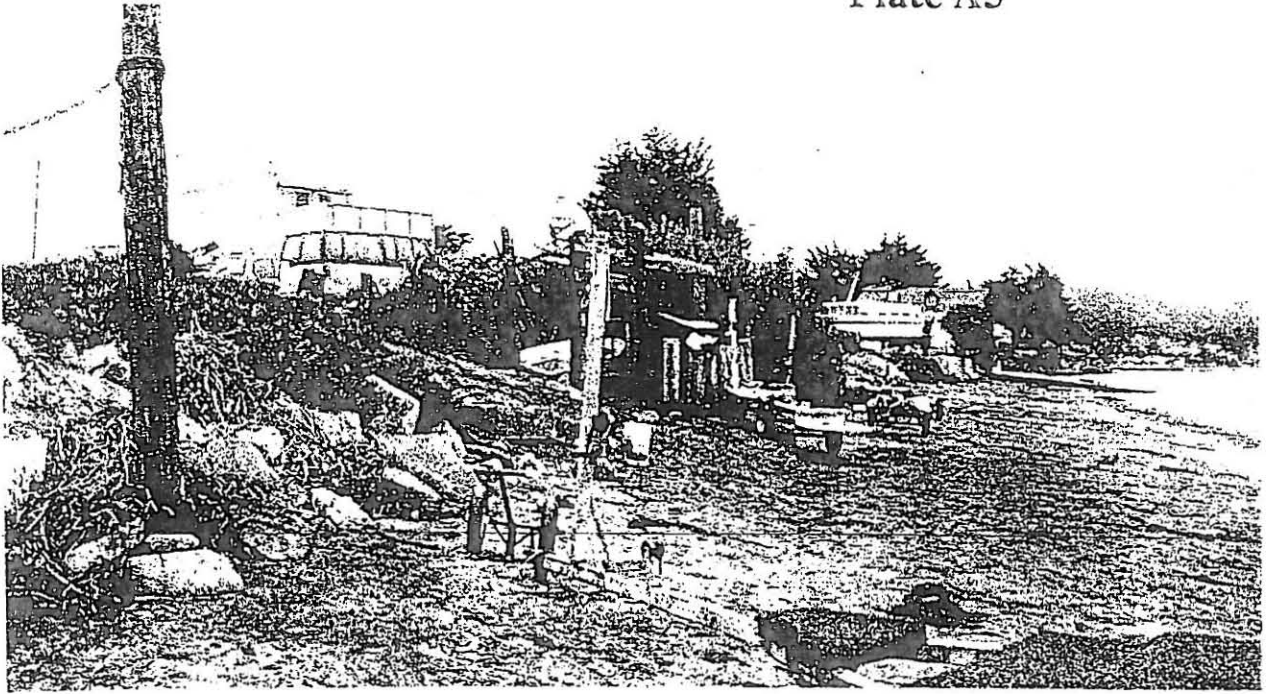
Near Yacht Club, East of Vassar

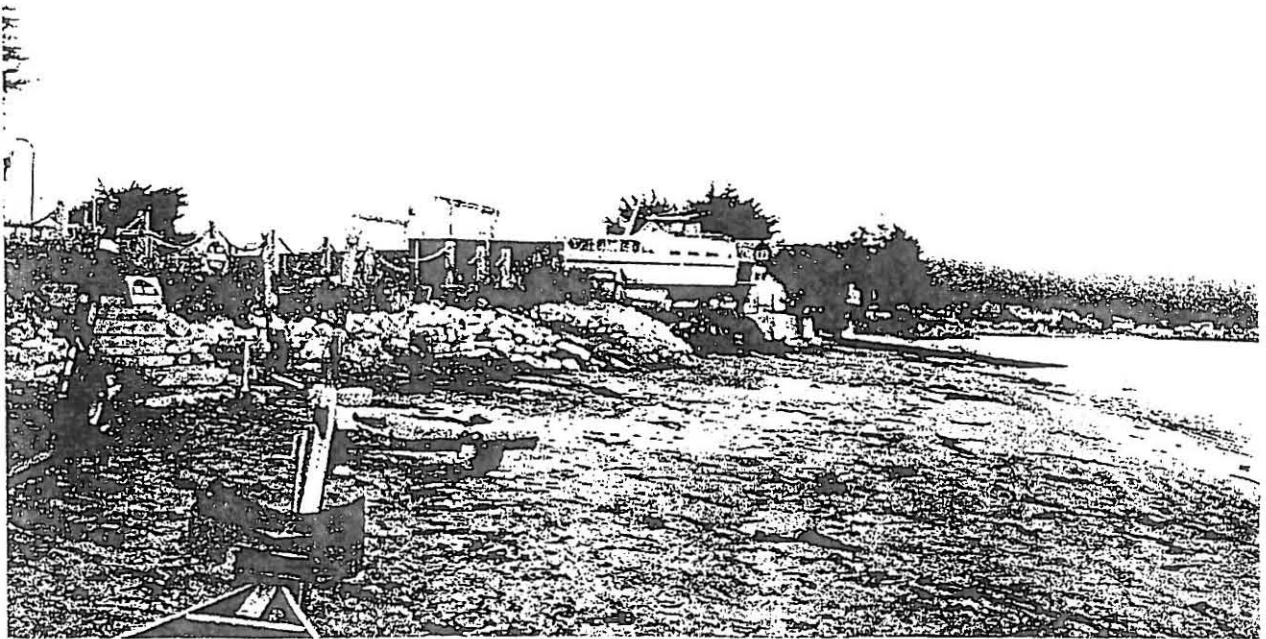
East of Boat Yard

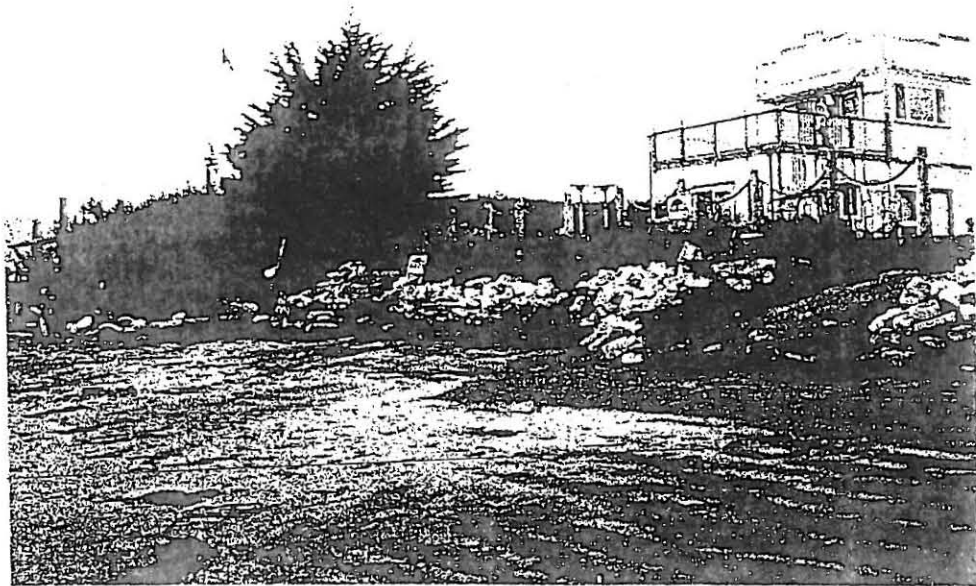
West of Boat Yard

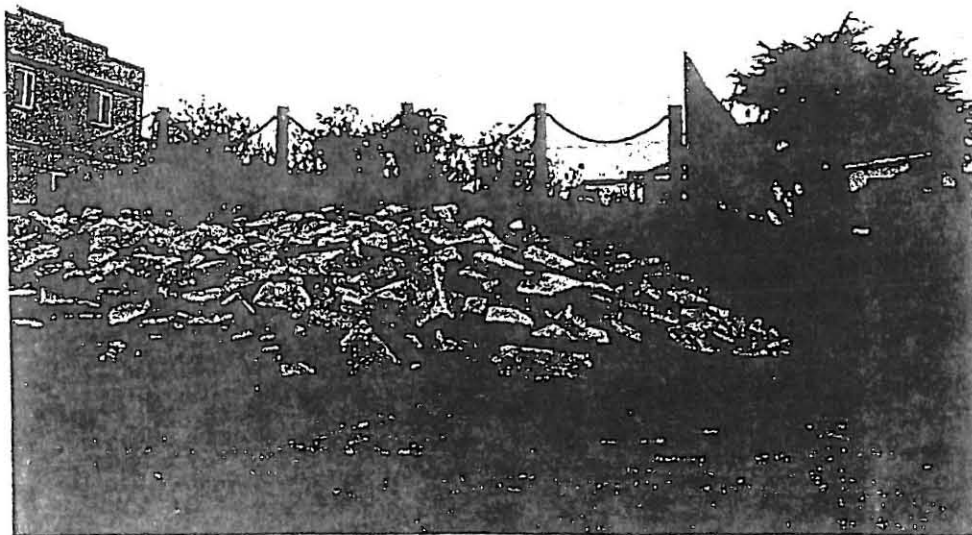
West of Boat Yard

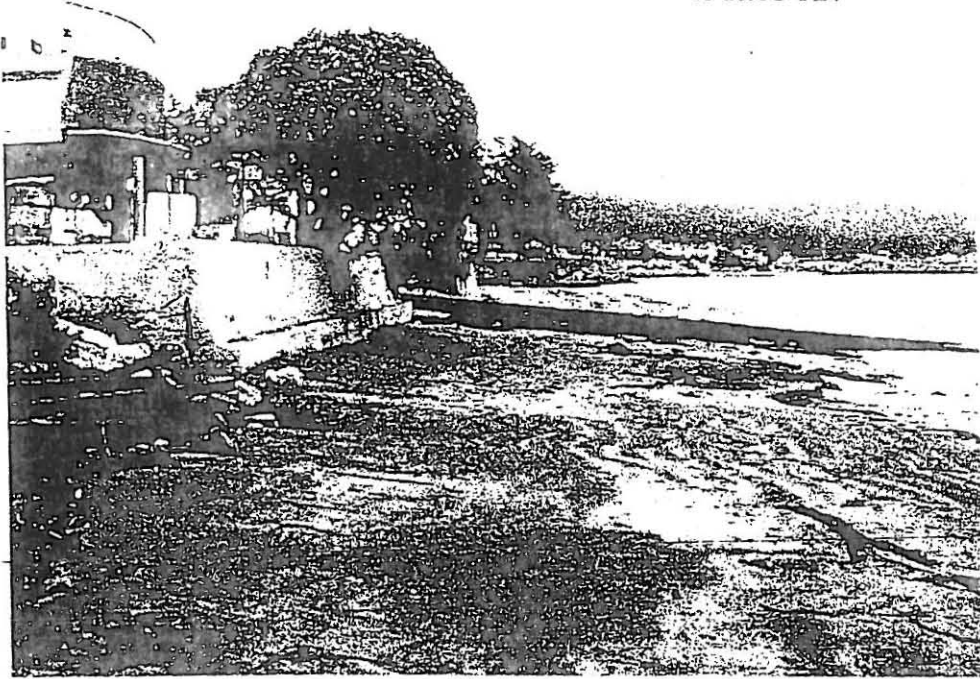
Wall in front of boat yard

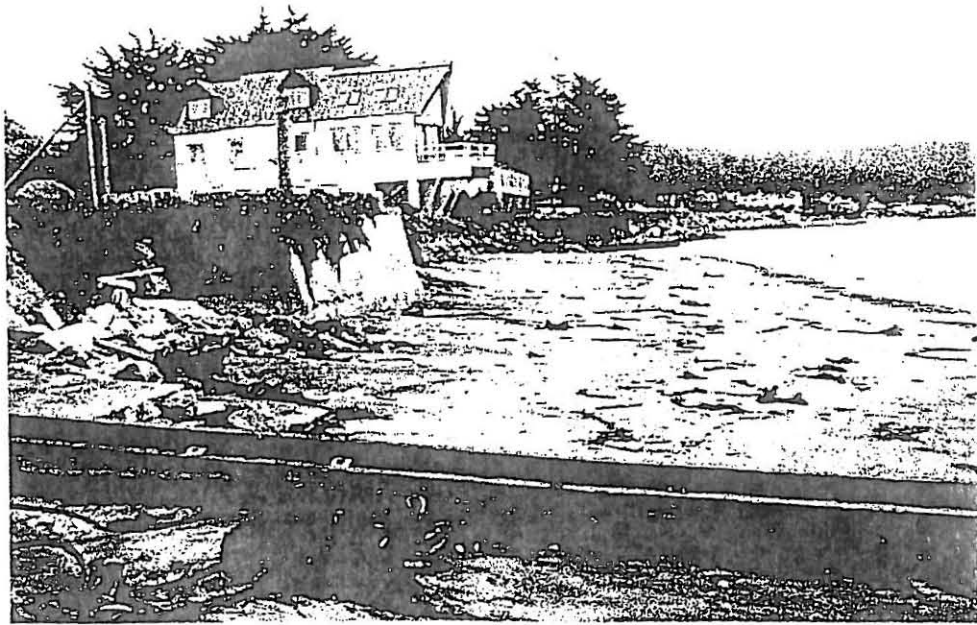
Marine railway for boat yard

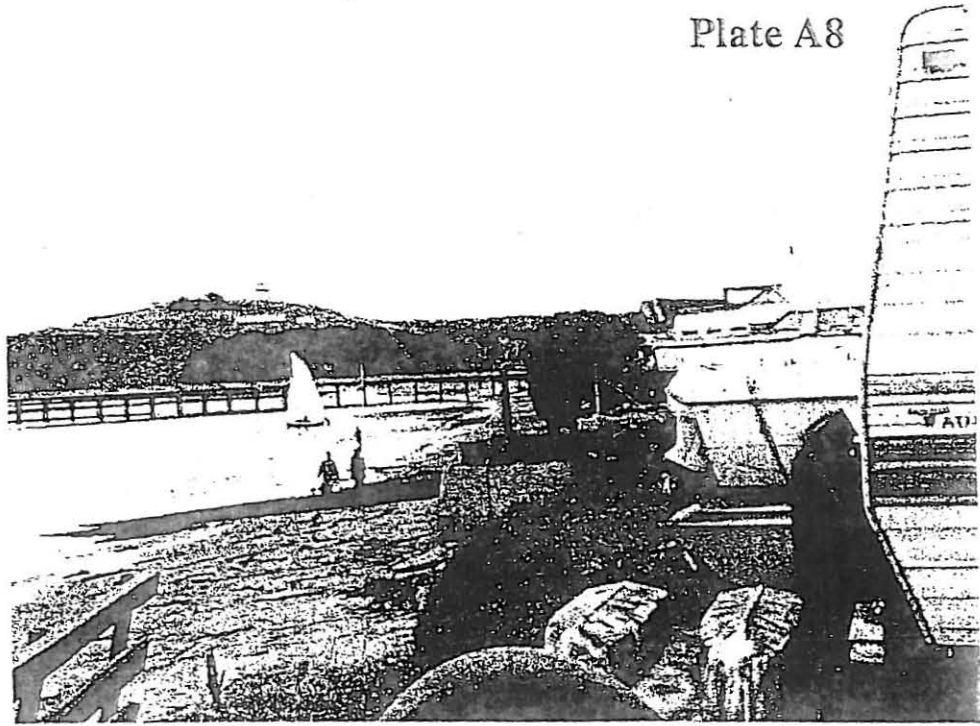
From atop dune at end of Broadway.
Marine railways visible in background

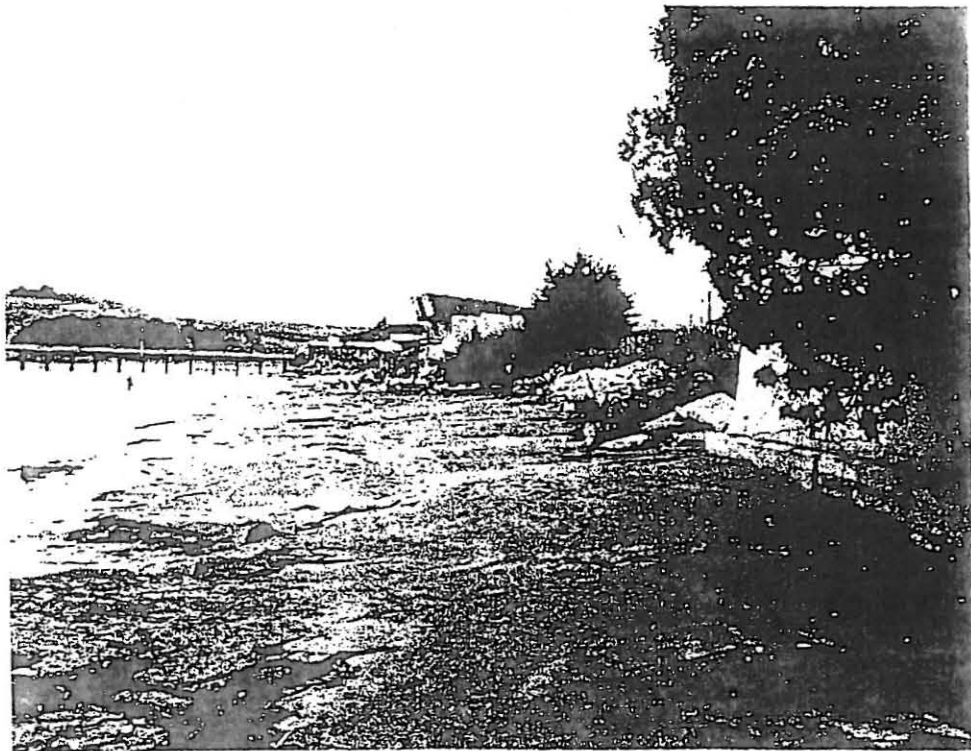
Looking west from marine railway

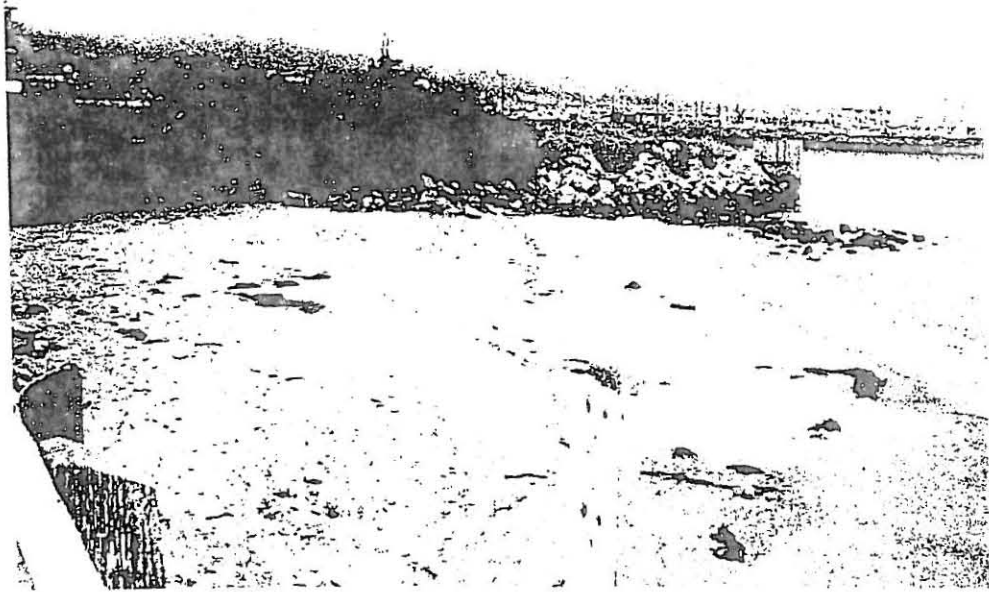
At Broadway, looking east

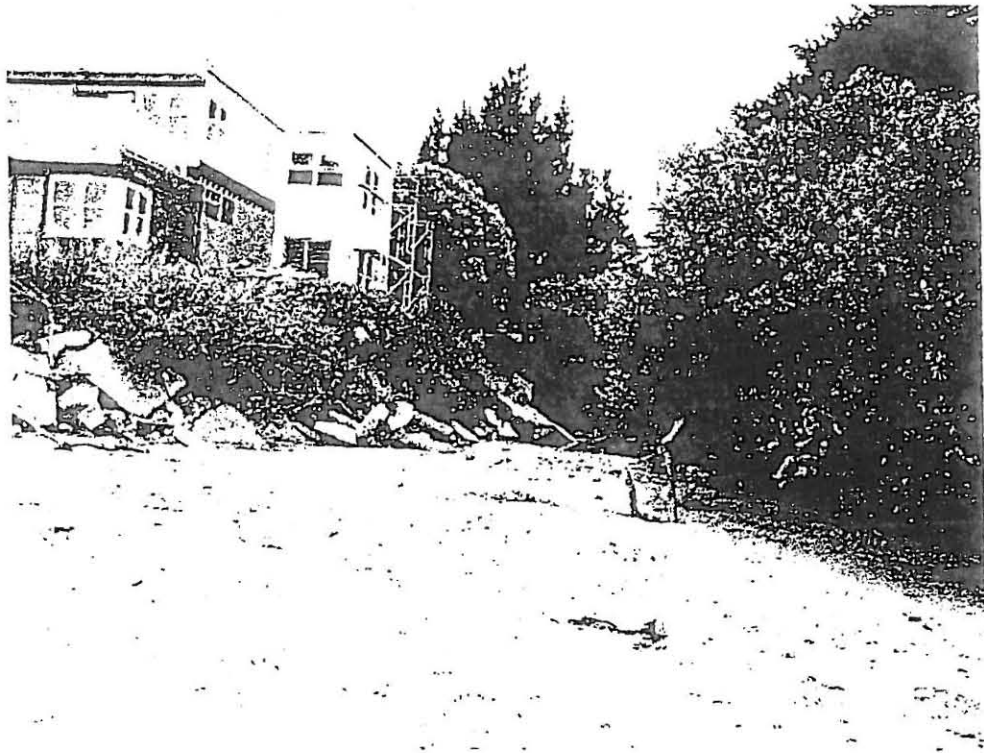
Denniston Creek, looking upstream

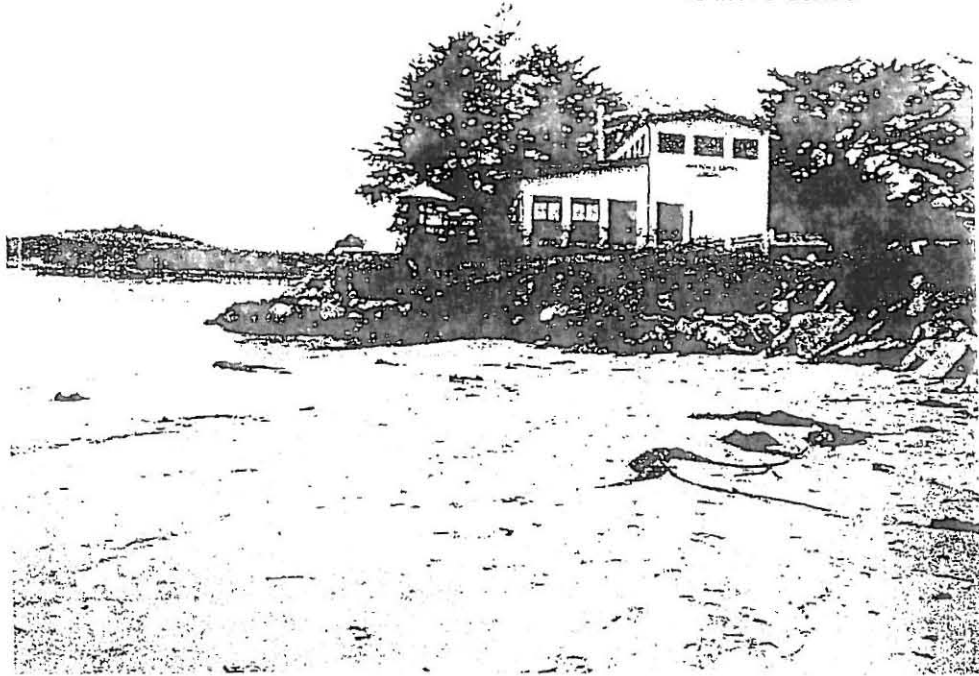
At Broadway, looking west.
Conference Center visible

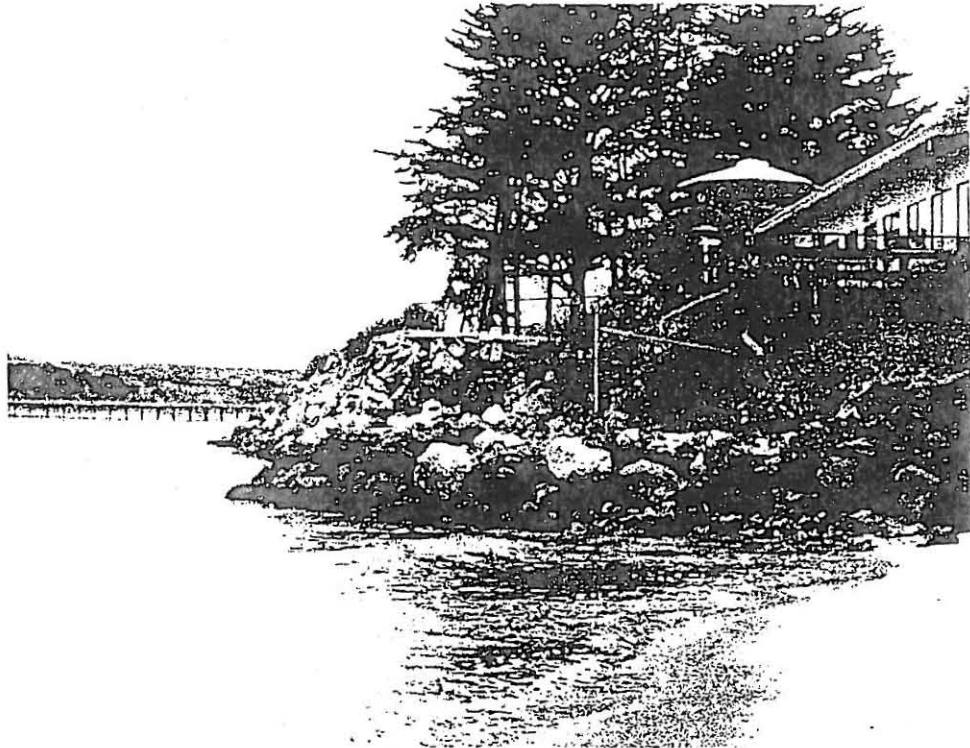
At Broadway, view of slope protection
in front of conference center.
