**Planning & Zoning
Committee of the
MidCoast
Community Council**
PO Box 64, Moss Beach
CA 94038
Serving 12,000 residents

re: PLN2003-00375: application to remove 5 Monterey cypress trees at 741 Edison St. in Montara.

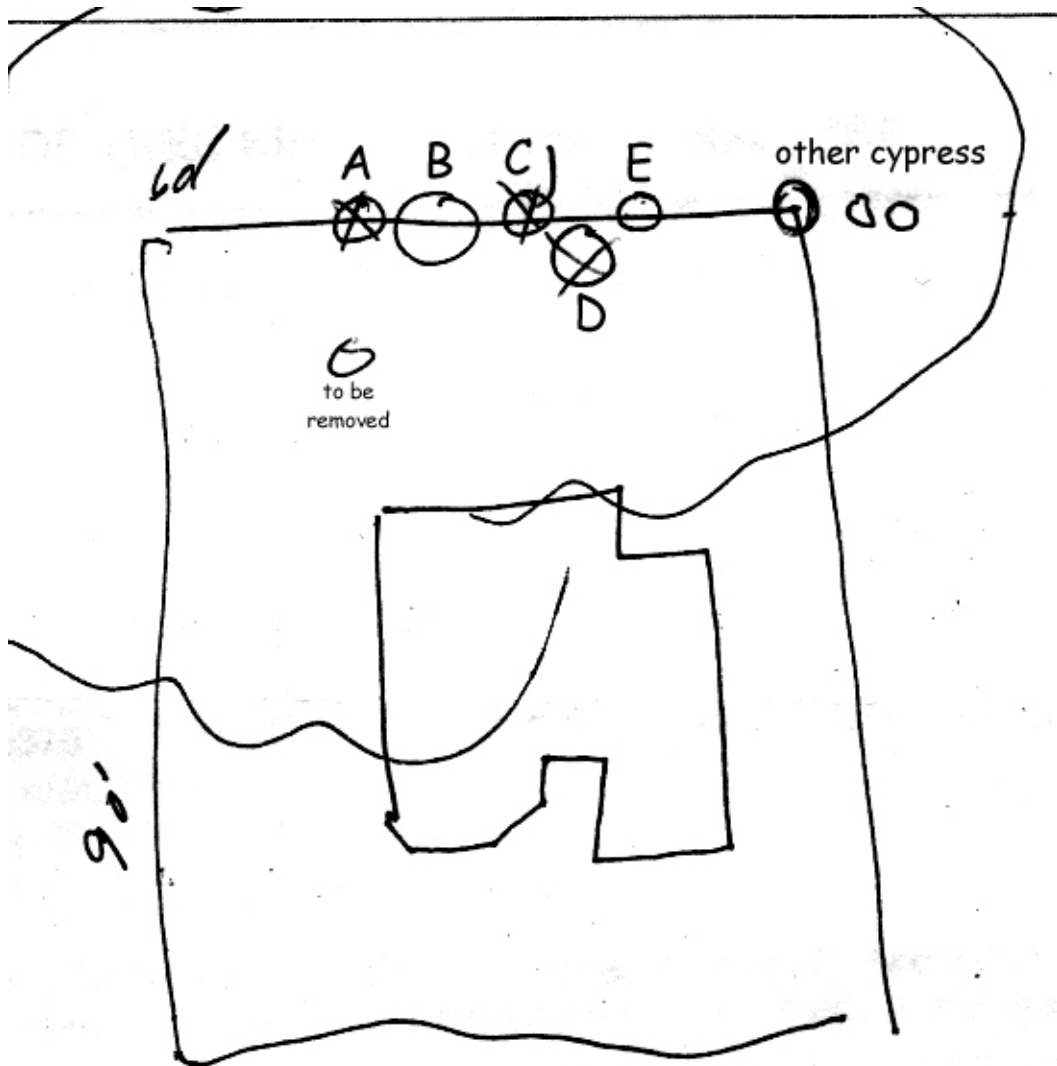
I examined the trees in question for this permit, and have the following comments, For clarity, I am including a diagram at the end of this letter based on the application to indicate which tree is which. The trees are designated A thru E. Another 20" cypress is located approx. 10' in front (south) of tree A. This tree appears to be destined for removal as part of the approved residence (PLN2003-00225). Three other cypress sit to the left (east) of the property, approx. 12' from tree E.

3. Tree A has a bad lean to the west and to the north, toward the street and toward to the neighboring structure. It was "topped" at some point in it's life, and has not been subsequently maintained. Almost all growth is to the west side of the tree, and the trunk shows signs of weakening from stress.

4. Tree B has a slight lean to the south, but appears structurally sound and may be retainable with decent pruning.
5. Tree C also has been topped and not maintained, and leans and has branched unbalanced to the north. Like A, it shows sign of stress weakening.

6. Trees D and E may be co-leading trunks of the same tree, or else are growing very tightly together. D has very pronounced lean to the south and appears weakened – E appears structurally sound and retainable with proper care.

- A. the Planning Department consider whether this is the proper procedure in regards to its relationship with the Design Review application and process,
- B. that a qualified arborist report assess the health and structural integrity of the trees and their ability to be retained,
- C. that impacts to potential damage to surrounding trees, and potential impacts to drainage, flooding and erosion for any removal be properly assessed and addressed
- D. that suitable replacement trees, in terms of their benefits and contributions to the urban coastal tree resource, be designated for any removed.
