Report for **San Mateo County Harbor District**
Pillar Point Harbor
DRAFT Condition Survey for West Trail

June 2012

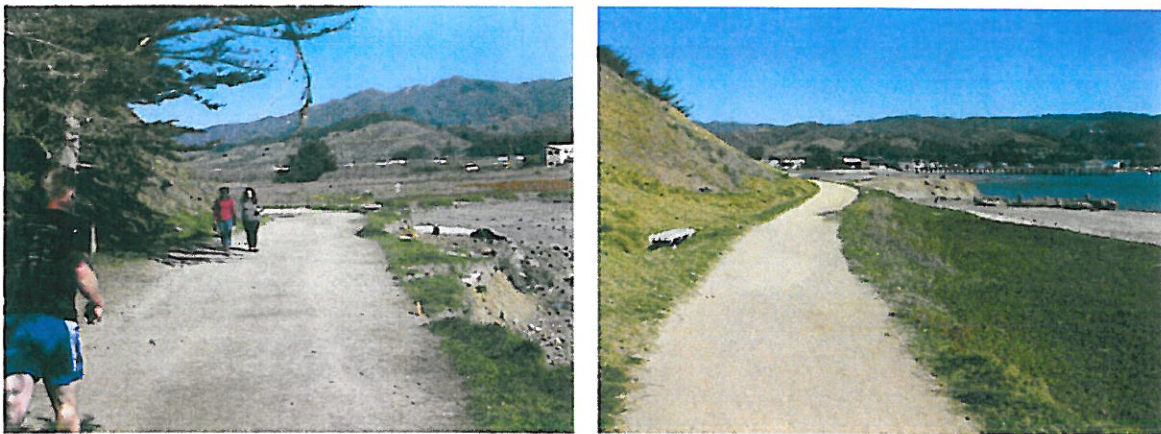
Photos 1 & 2 – West Trail, typical conditions

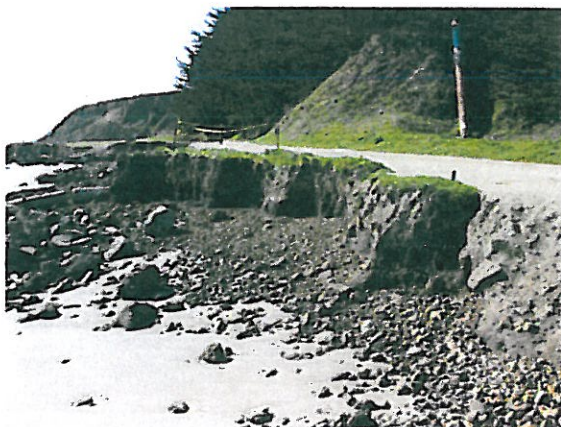
The harbor-side of the northern portion trail is seeing erosion from wave action. In several areas, the erosion has resulted in an approximately 6-foot high near-vertical slope that is within a few feet of the trail edge. Below this 6-foot high drop-off are areas of natural rocks of various size, and assorted pieces of concrete rubble. At Mean Higher High Water, the water comes up close to the bottom of this drop-off. In a few areas, the erosion has begun to encroach directly onto the trail. Photos 3 through 6 show eroded portions of the edge of the trail. At Station 8+00, a 30-foot section of 14" outer diameter pipe is exposed in the eroded portion of the drop-off (Photo 5). The harbor-side erosion can be assumed to be on-going. No unstable areas of imminent additional failure were observed.

Photo 3 – Looking South, showing eroded areas encroaching into path, Sta 5+50 to 6+00

Riprap can be placed along the embankment from Sta 5+35 to Sta 8+25 to minimize future erosion from wave action (Figure 1). We recommend placing the rip rap at a slope of 1.5H:1.0V (Figure 2). The rip-rap size, as determined by the 100-year significant wave height of 2.5 feet as listed in the Coastal Engineering Analysis, should be 3.5 feet diameter placed over smaller stones and grouted in place.

The riprap should be placed along the embankment from Sta 5+35 to Sta 8+25. This is the portion of the path affected by wave action erosion. The average embankment height is approximately 6.5 feet along this expanse. The beach is currently sloping at approximately 12% away from the bottom of the existing embankment. Therefore, if the new riprap is placed at a slope of 1.5H:1.0V, the new riprap would extend approximately 12-feet horizontally from the top of the embankment. The total volume covered by riprap would be approximately 420 cubic yards.

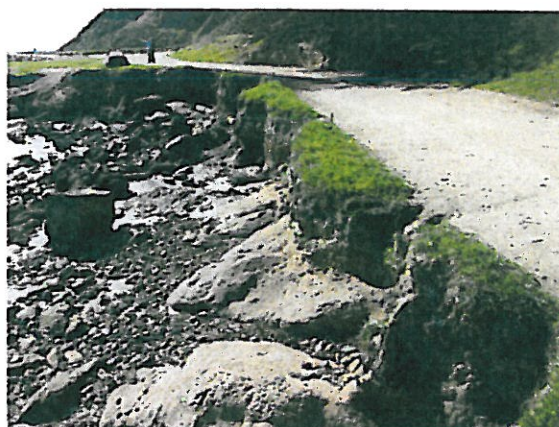
Photo 4 – Looking South, showing eroded areas encroaching into path, Sta 7+00 to 8+00

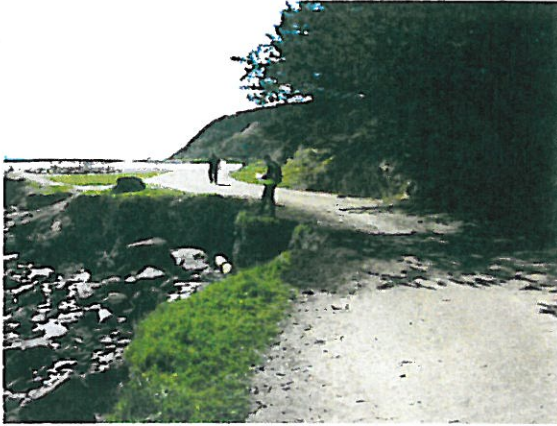
Photo 5 – Looking South, showing eroded areas encroaching into path, Sta 7+50 to 8+00

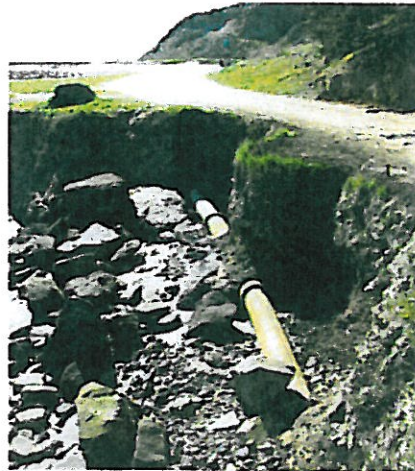
Photo 6 – Pipe exposed at Sta 8+00

The existing pipe that runs parallel to the trail that is exposed at the toe of the existing embankment at Sta 8+00 (the function of this pipe is unknown) would be buried by the riprap.

The wall would either be pile-driven or vibrated into place, depending on geotechnical and environmental concerns. Attention would have to be paid to the existing pipe that is exposed at Sta 8+00. The wall could be consistently installed on the outboard side of this pipe (Figures 3 and 4, similar). Or, if it is determined that this pipe is not functioning, the pipe could be partially removed if its location conflicted with the proposed sheet pile wall.

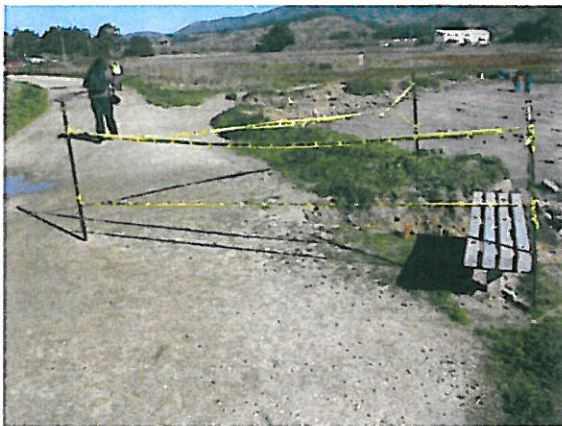
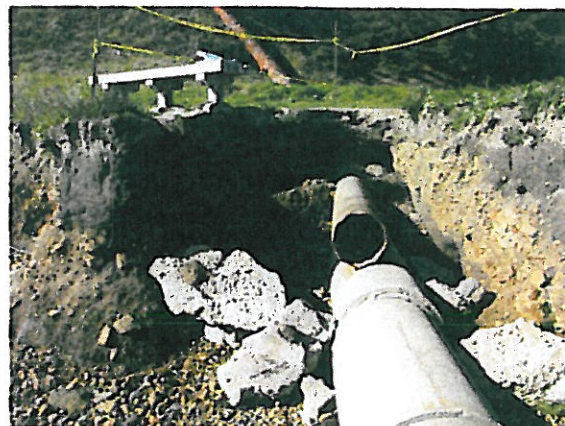
Erosion at two existing stacked culverts near Sta 6+00 has created the most severe encroachment into the pathway along the project site. The void missing from the trail is 3' wide, with a 3.5' drop-off (to the bottom of the top culvert). The upper culvert is a 12" Corrugated Metal Pipe (CMP). The lower culver is an 18" inner diameter, 23" outer diameter concrete pipe that is broken into many segments. Both culverts are clogged with debris, and it can be assumed that they are not functioning. This location was taped off with yellow "CAUTION" tape on the day of the visual condition survey. The bench at this location is undermined, and is unsafe.

Photos 7 & 8 – Sta 6+00, showing severe erosion at stacked non-functioning culverts.

Both of the two culverts at Sta 6+00 appeared to be clogged and we assume that they are non-functioning. We did not observe an inlet that led to these culverts, so we do not know what area they are meant to drain. The 24" corrugated metal pipe (CMP) on the hill-side of the path, which is fed from a concrete swale, does not appear to connect to either of the culverts, although it might be expected that these culverts would be used to convey water from the 24" pipe to the harbor. We assume that the discharge from the 24" pipe currently ponds on the hill-side of the path and sheet-flows towards the harbor. This discharge is most likely causing the erosion on the water-side of the path at the culverts. The 24" pipe most likely drains a large portion of the hill-side above the path, and we should assume that it is at capacity under the most severe rainfall events.

We recommend coordinating with the Harbor District to investigate the design intent of the existing culverts. If they were installed to convey water from the 24" pipe, why are they no longer functioning? Is it desirable that they are repaired? Why are there two stacked culverts, whose combined capacity is still less than that of the 24" pipe? This coordination and investigation will help determine what repair is appropriate. The following repair alternatives are available. Regardless of the repair, coordinate this work with the repairs for the harbor-side erosion at the north portion of the path.

This alternative recommends a direct underground connection from the 24" pipe to the culverts. A box structure (for example, a junction structure topped by a catch basin or a manhole) would be constructed on the hill-side of the path. The 24" pipe would discharge directly into this structure and the existing culverts would convey the flow under the path to the Bay. This alternative would be the most sound, as it would deliver all stormwater flows to the harbor without the risk of flows over the existing trail.

We would need to investigate and ensure that the existing culverts are structurally sound if they are to be retained, and connected to the new junction structure. If they are to be retained, remove existing debris, and investigate upstream structural integrity. The pipes would need to be extended towards the waterline to ensure proper outflow.

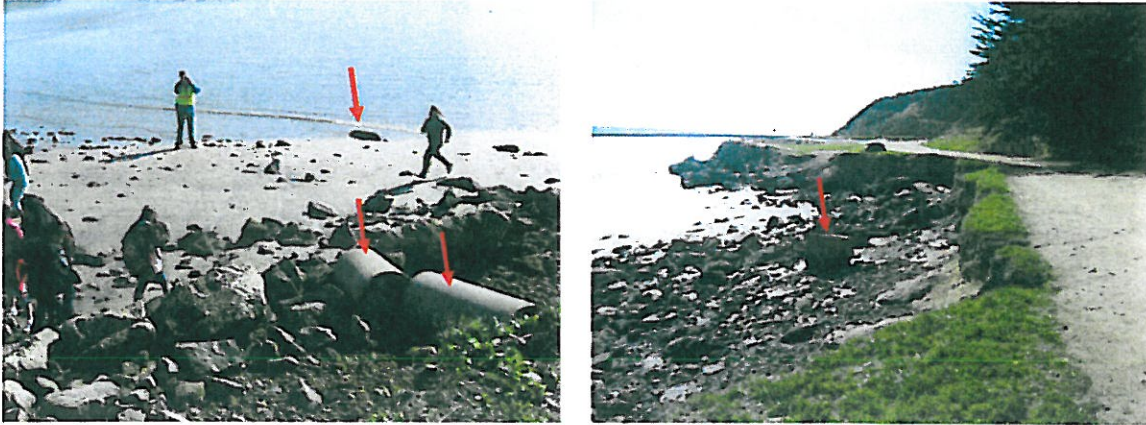
There are several large pieces of concrete rubble mixed in with the rocky material at the water's edge. The area from Sta 7+50 to 8+50 appeared to have the most rubble. Additionally, pieces of the broken concrete culvert at Sta 6+00 are strewn along the beach, including a piece that was only visible during low tide.

Photo 9 – Concrete rubble on beach, Sta 6+00

Photo 10 - Concrete rubble on beach, Sta 8+00. There are several other pieces of smaller rubble in addition to the large piece indicated.

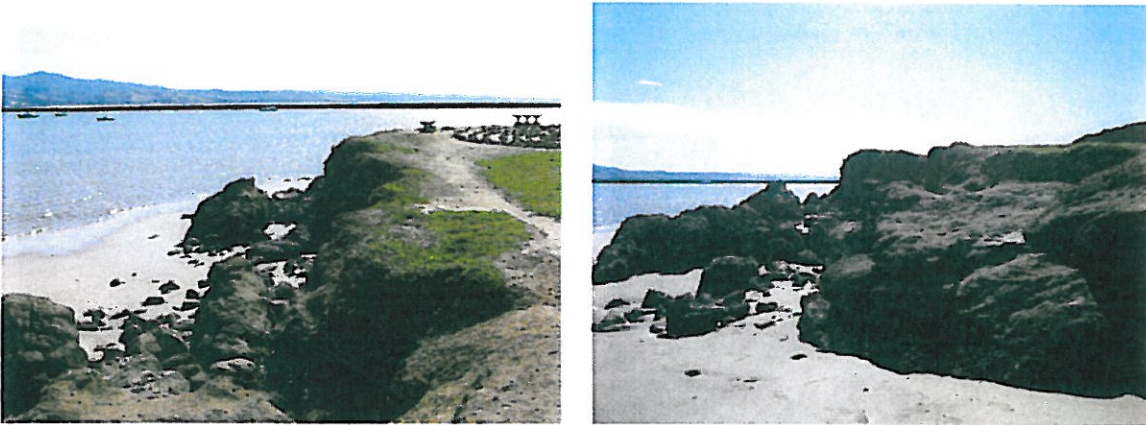
From Station 8+50 to 9+50, there is a bulb-out between the pathway and the water's edge. Generally this area is about 10 feet higher than the beach below. There are large rocks on the beach. The edge of this bulb-out appears to be eroding in a similar manner to the edge of the pathway from Sta 5+50 to 8+00, but this is less of a concern because the pathway does not pass directly adjacent to the bluffs.

Photos 11 & 12 – Bulb-out, seen from pathway and from the beach.

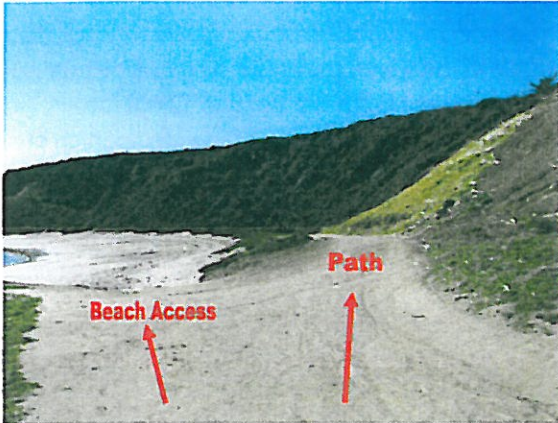
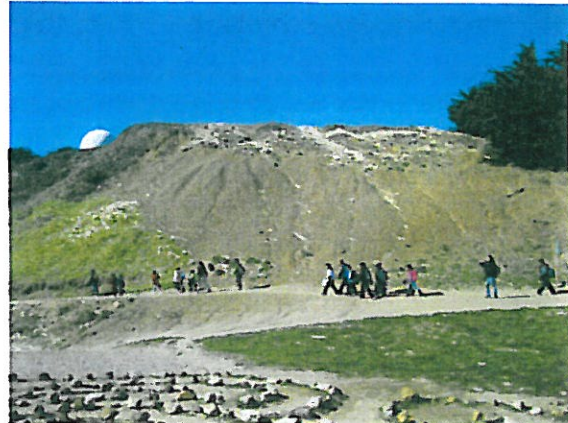
Beginning at Sta 9+25, an off-shoot of the trail forks down to the beach. Several people were observed using this off-shoot as beach access.

Photos 13 & 14 – Beach access point.

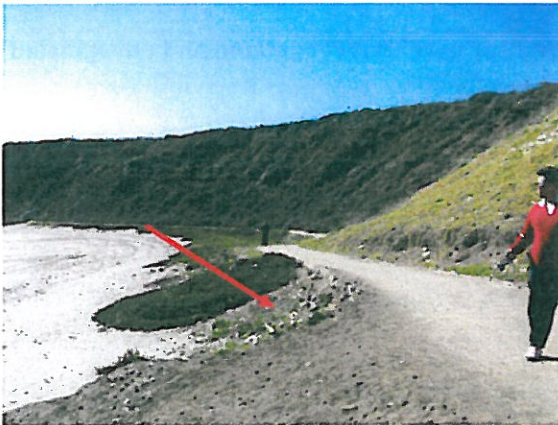
From Sta 10+00 to 12+00, the path is generally separated from the water line by a band of vegetation. There are a few narrow “desire paths” through the vegetation that people have used to walk through the vegetation and access the beach. No erosion is seen, except for a 25-foot section from Sta 10+00 to 10+25, which is shown in Photo 15.

Photo 15 – Southern portion of path, taken from Sta 9+75. Eroded area indicated.

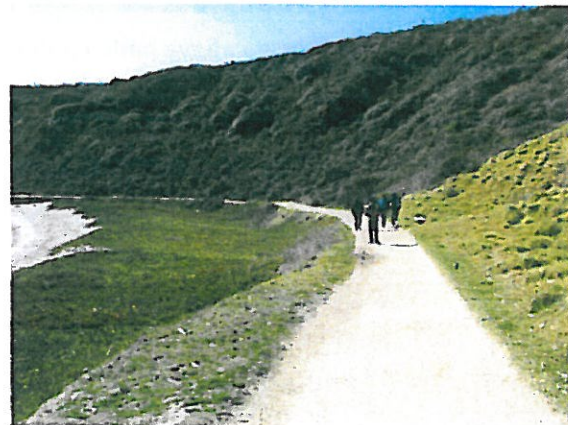
Photo 16 – Southern portion of path, taken from Sta 11+25

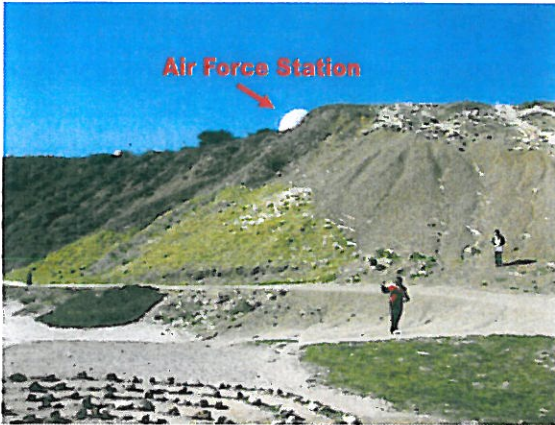
The hillside above the pathway generally appears to be stable in the vegetated areas. The hillside from Sta 5+00 to Sta 8+50 is heavily covered with cypress trees and brush. From Sta 9+75 to 12+00 the hillside was covered in newly sprouted grasses. We have been informed that the unvegetated portion of the slope (from Sta 8+00 to 9+75), has been eroding on to the pathway. This portion of the hillside is sloped at approximately 1.5H:1V. The Pillar Point Air Force Station is located on the top of the hillside. Storm water run-off from that site, combined with the lack of vegetation and underlying geotechnical conditions, may be contributing the erosion of the hillside.

Photo 17 – Erosion of hillside above path, centered on Sta 10+00. Both vegetated and unvegetated portions of the hillside are shown.

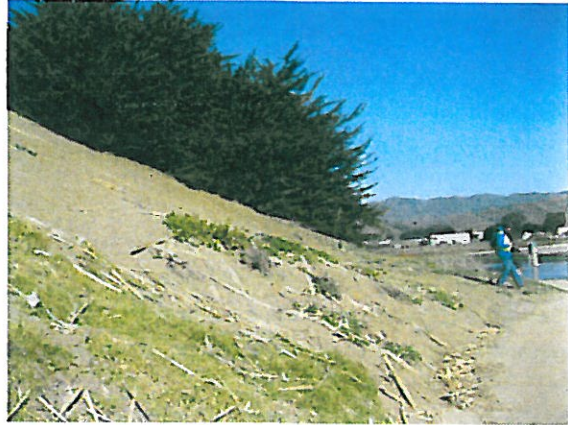
Photo 18: Hillside erosion, looking North from Sta 10+00
