# Fitzgerald Marine Reserve (FMR)

A Review of Infrastructure Projects and Natural Resource Protection Issues

MCC presentation February 13, 2013 by Lisa Ketcham

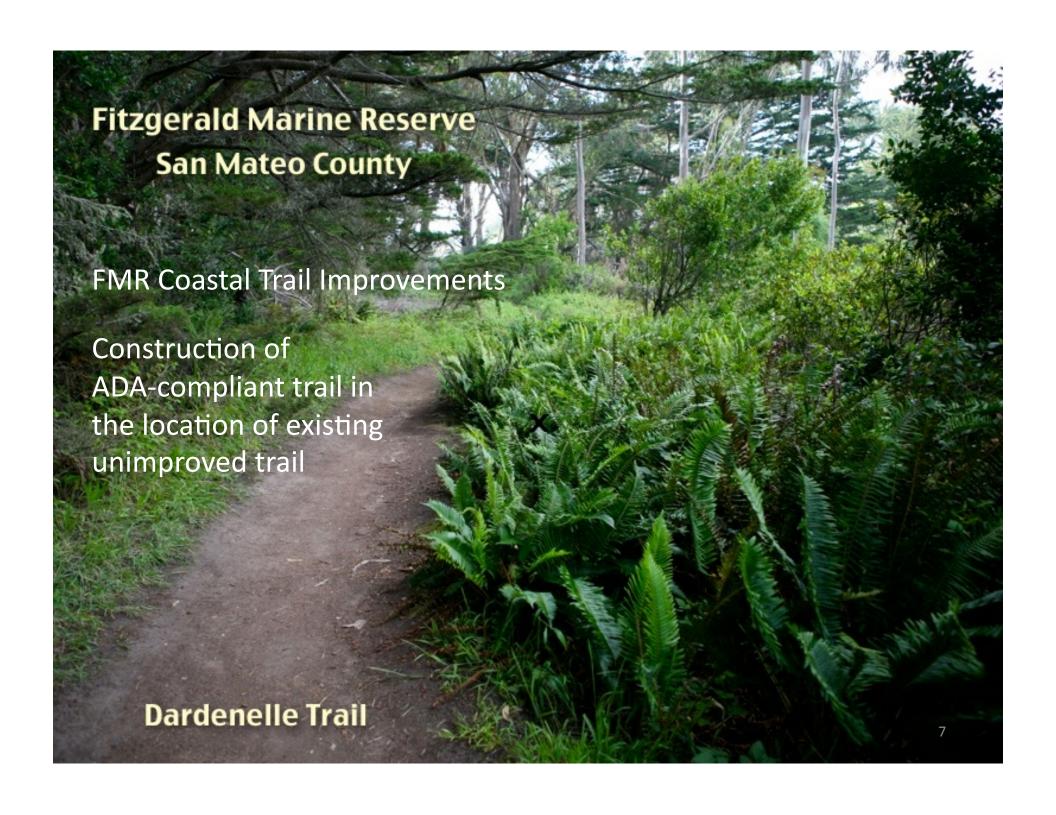
Public pressure reduced trail width from 12 ft to 8 ft, but destruction area limits were not reduced - construction site 10/14/12

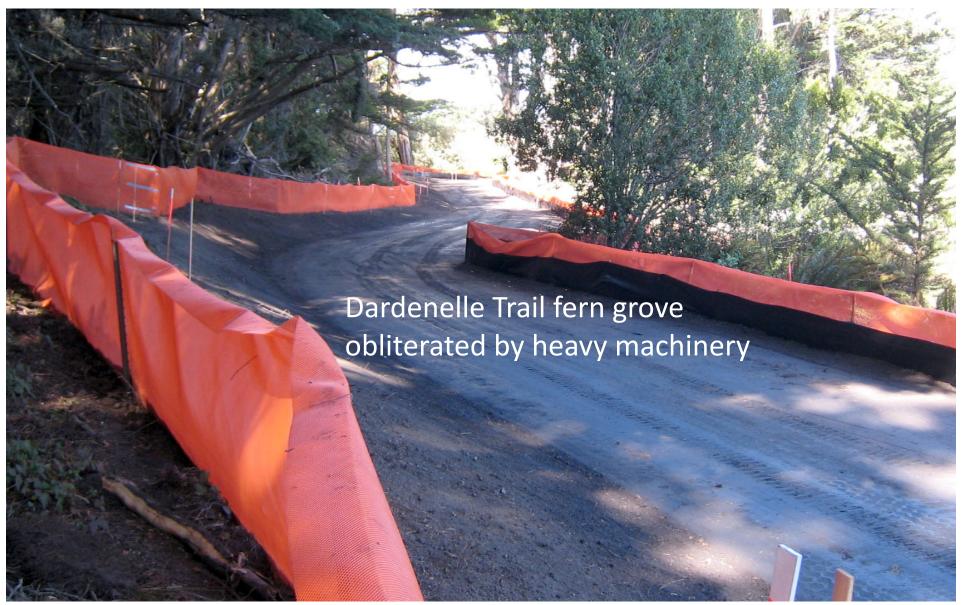
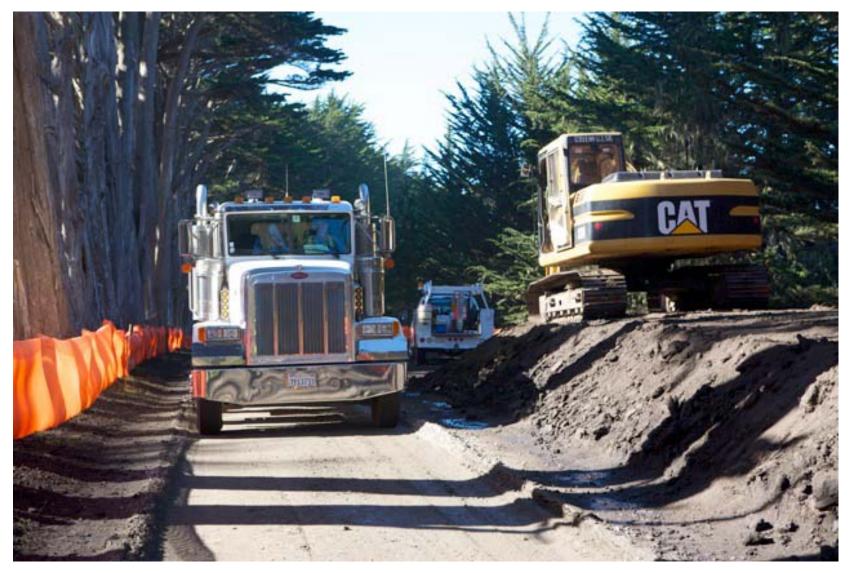
Road paving company was contracted to make the existing trail ADA-compliant. The unnecessarily wide swathe of destruction ensures that years of follow-up invasive weed control will be necessary to restore native habitat along the trail.

October was too late in the season to start construction, which led to lengthy weather delays and overwhelmed erosion protection measures discharging muddy stormwater runoff from the denuded construction site into San Vicente Creek and the protected waters of the Reserve.

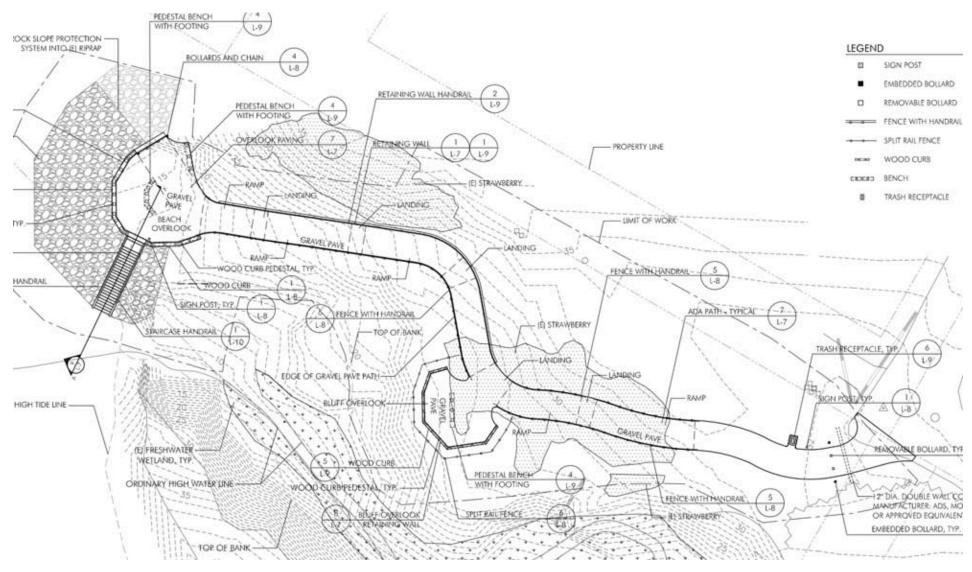
New coastal armoring structure to support lower overlook will cover about 3 times as much beach as the overlook itself. New switchback 10-ft-wide trail route, road cuts, and 6-ft tall retaining wall will completely alter the natural landscape and views.

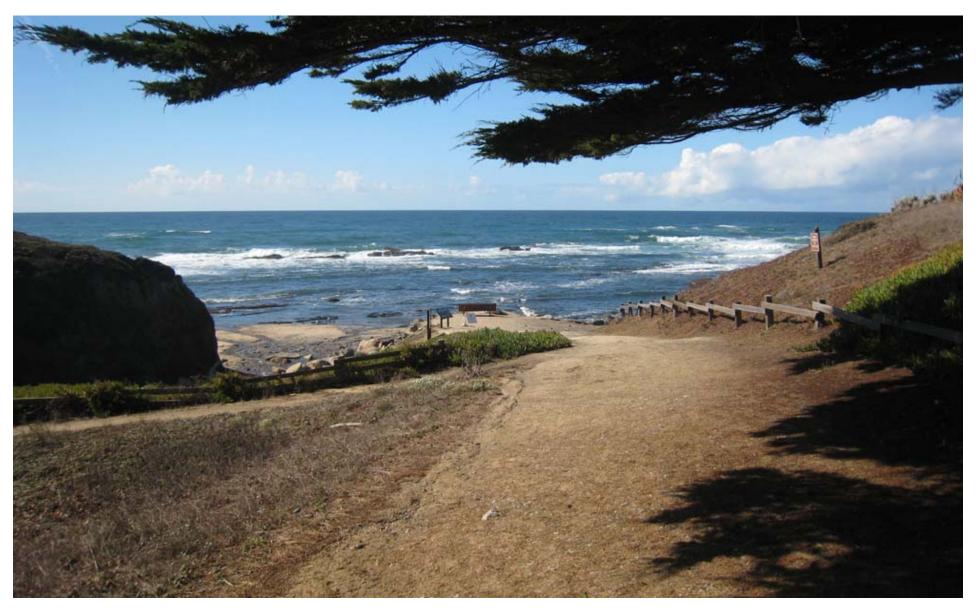
FMR beach access trail is currently ADA-accessible to this upper overlook. The lower overlook is above beach level on an old deteriorating structure of rock and concrete rubble piled onto the beach.

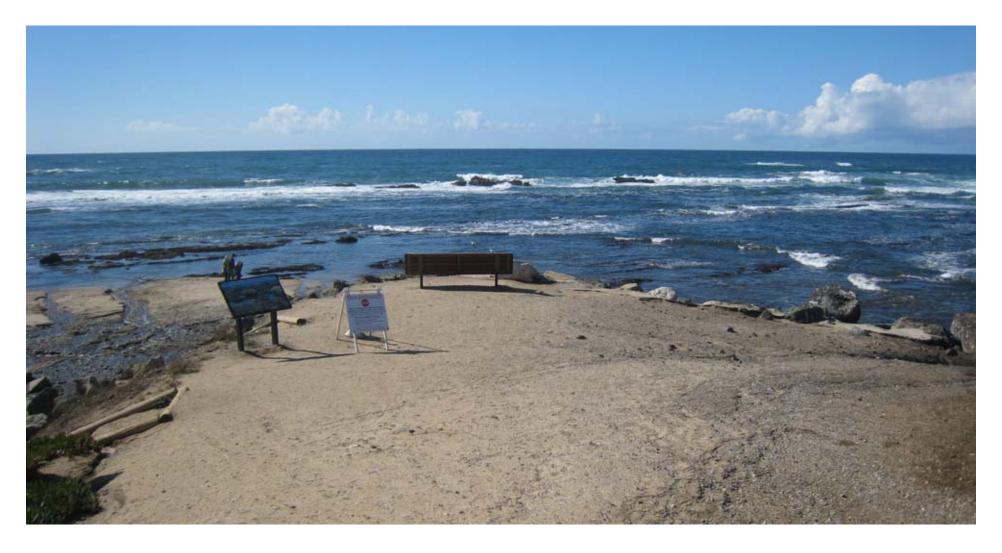
Lower overlook at Moss Beach reef: constructed of rock and concrete rubble before the Coastal Act and before the Marine Reserve.

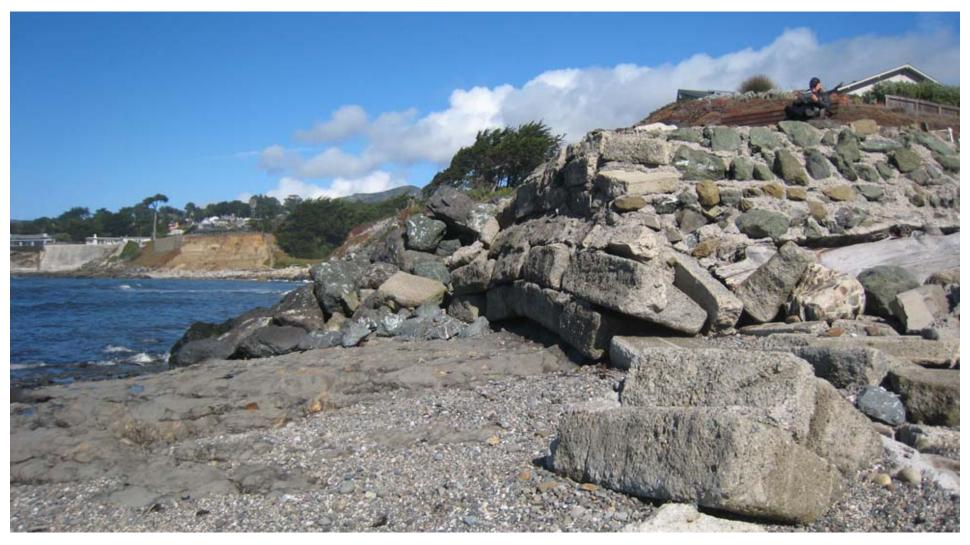
Lower overlook structure as viewed from the beach – project calls for complete rebuilding with massive 3-layer rock armoring extending out over the beach with a new stairway to the beach.

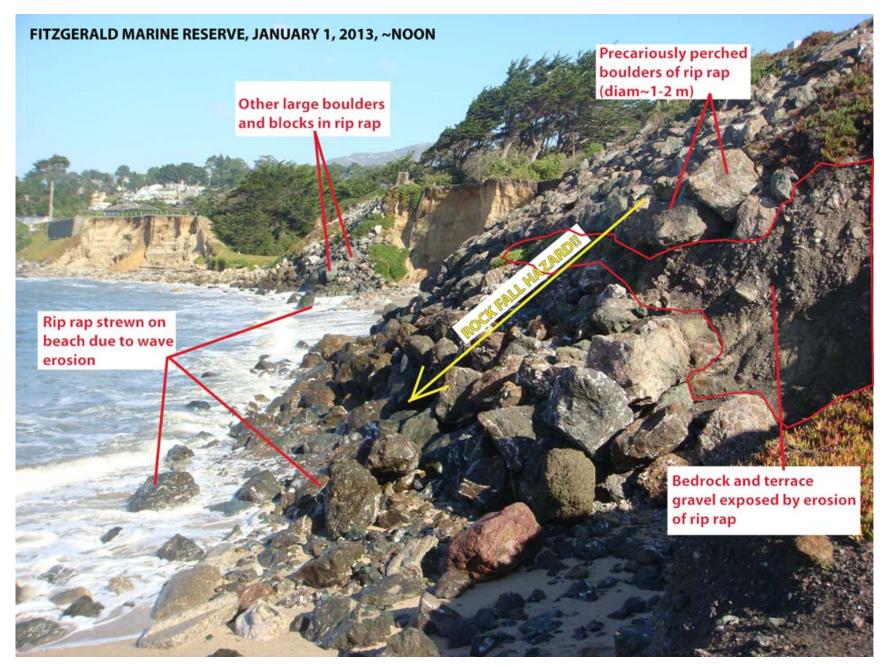
Dangerously eroding riprap to the north litters the public beach and the view.  $_{\it 24}$

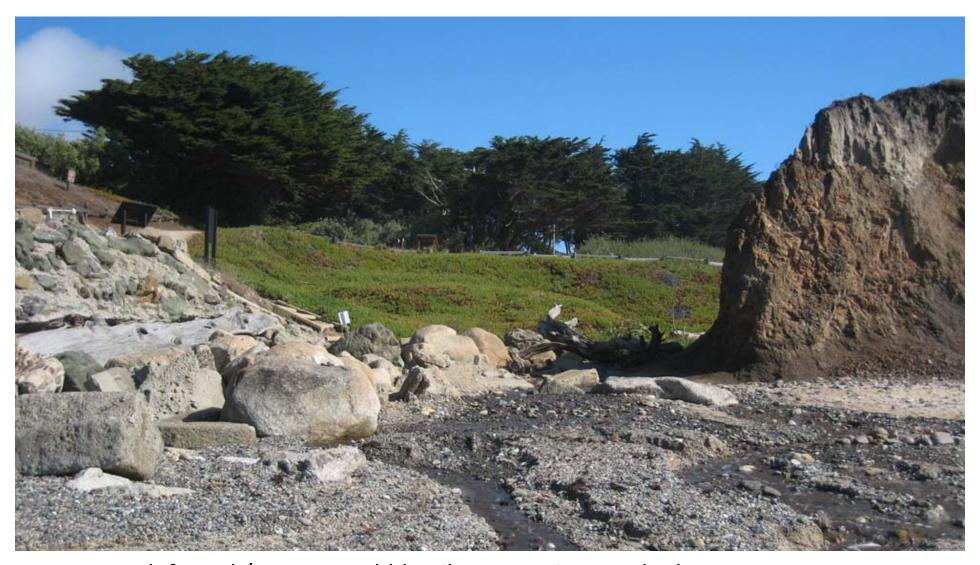
On left: rock/concrete rubble pile supporting overlook.
On right: natural seacliff. Center: San Vicente Creek outfall.
All green terrain behind is proposed for major grading, 10-ft-wide switch-back road, 6-ft high concrete retaining wall, for ¼ mile dead-end trail to an artificially constructed overlook piled on top of the beach.
