# Deteriorating Riprap at Montara State Beach – Hazards, Scenic Views, and Public Access

Midcoast Community Council  
April 12, 2017

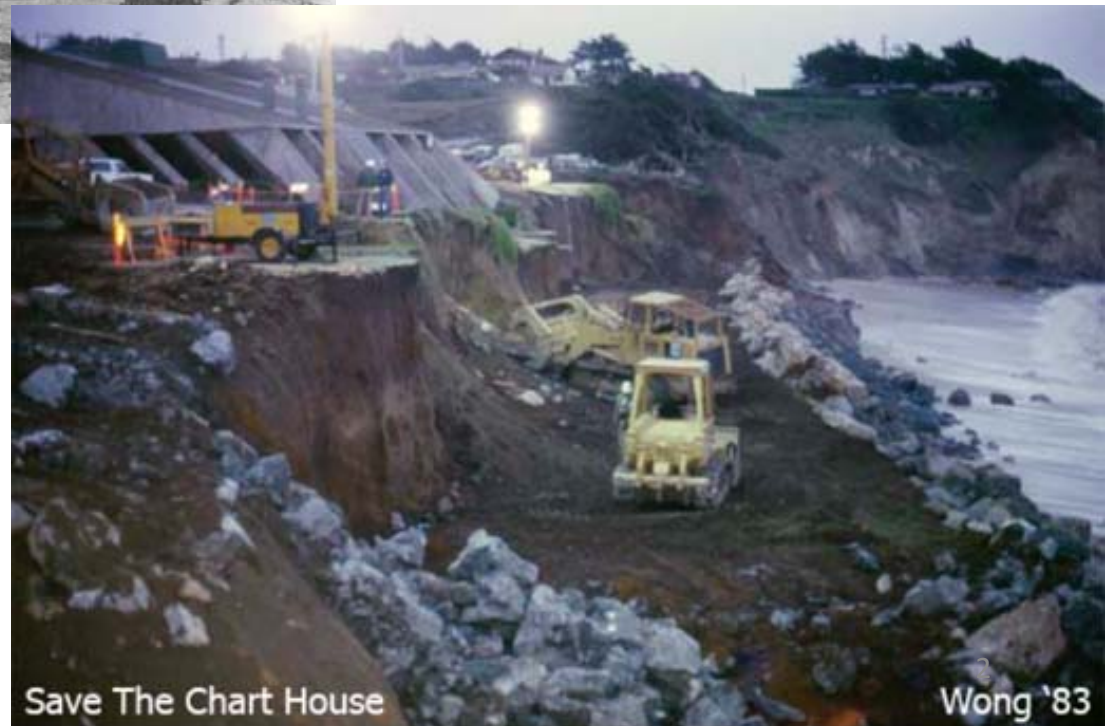
Emergency armoring installed on the public beach to protect the Chart House restaurant, only 4 years after construction.

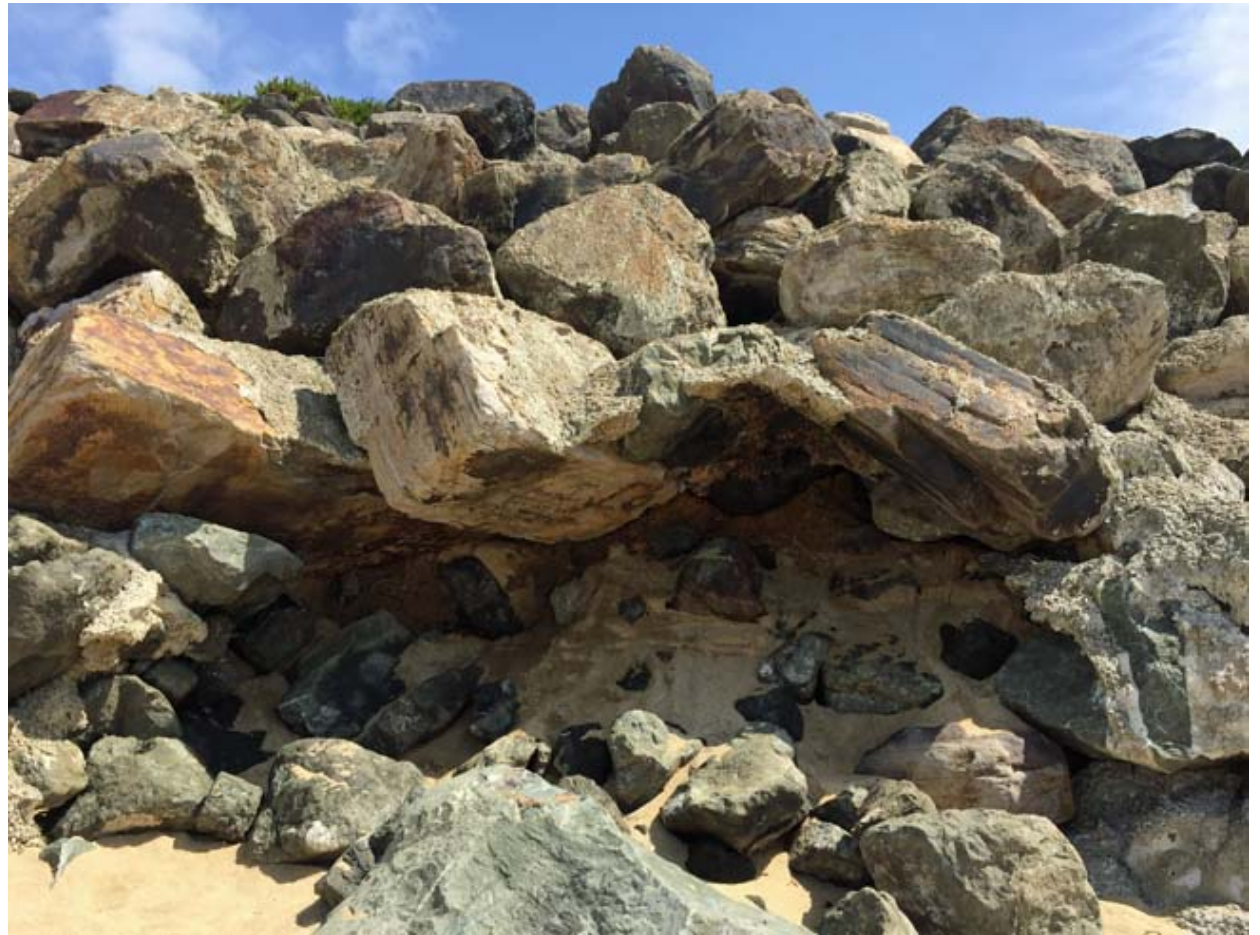
Over 30 years old, the steep wall of boulders protecting the restaurant is undermined and hazardous.

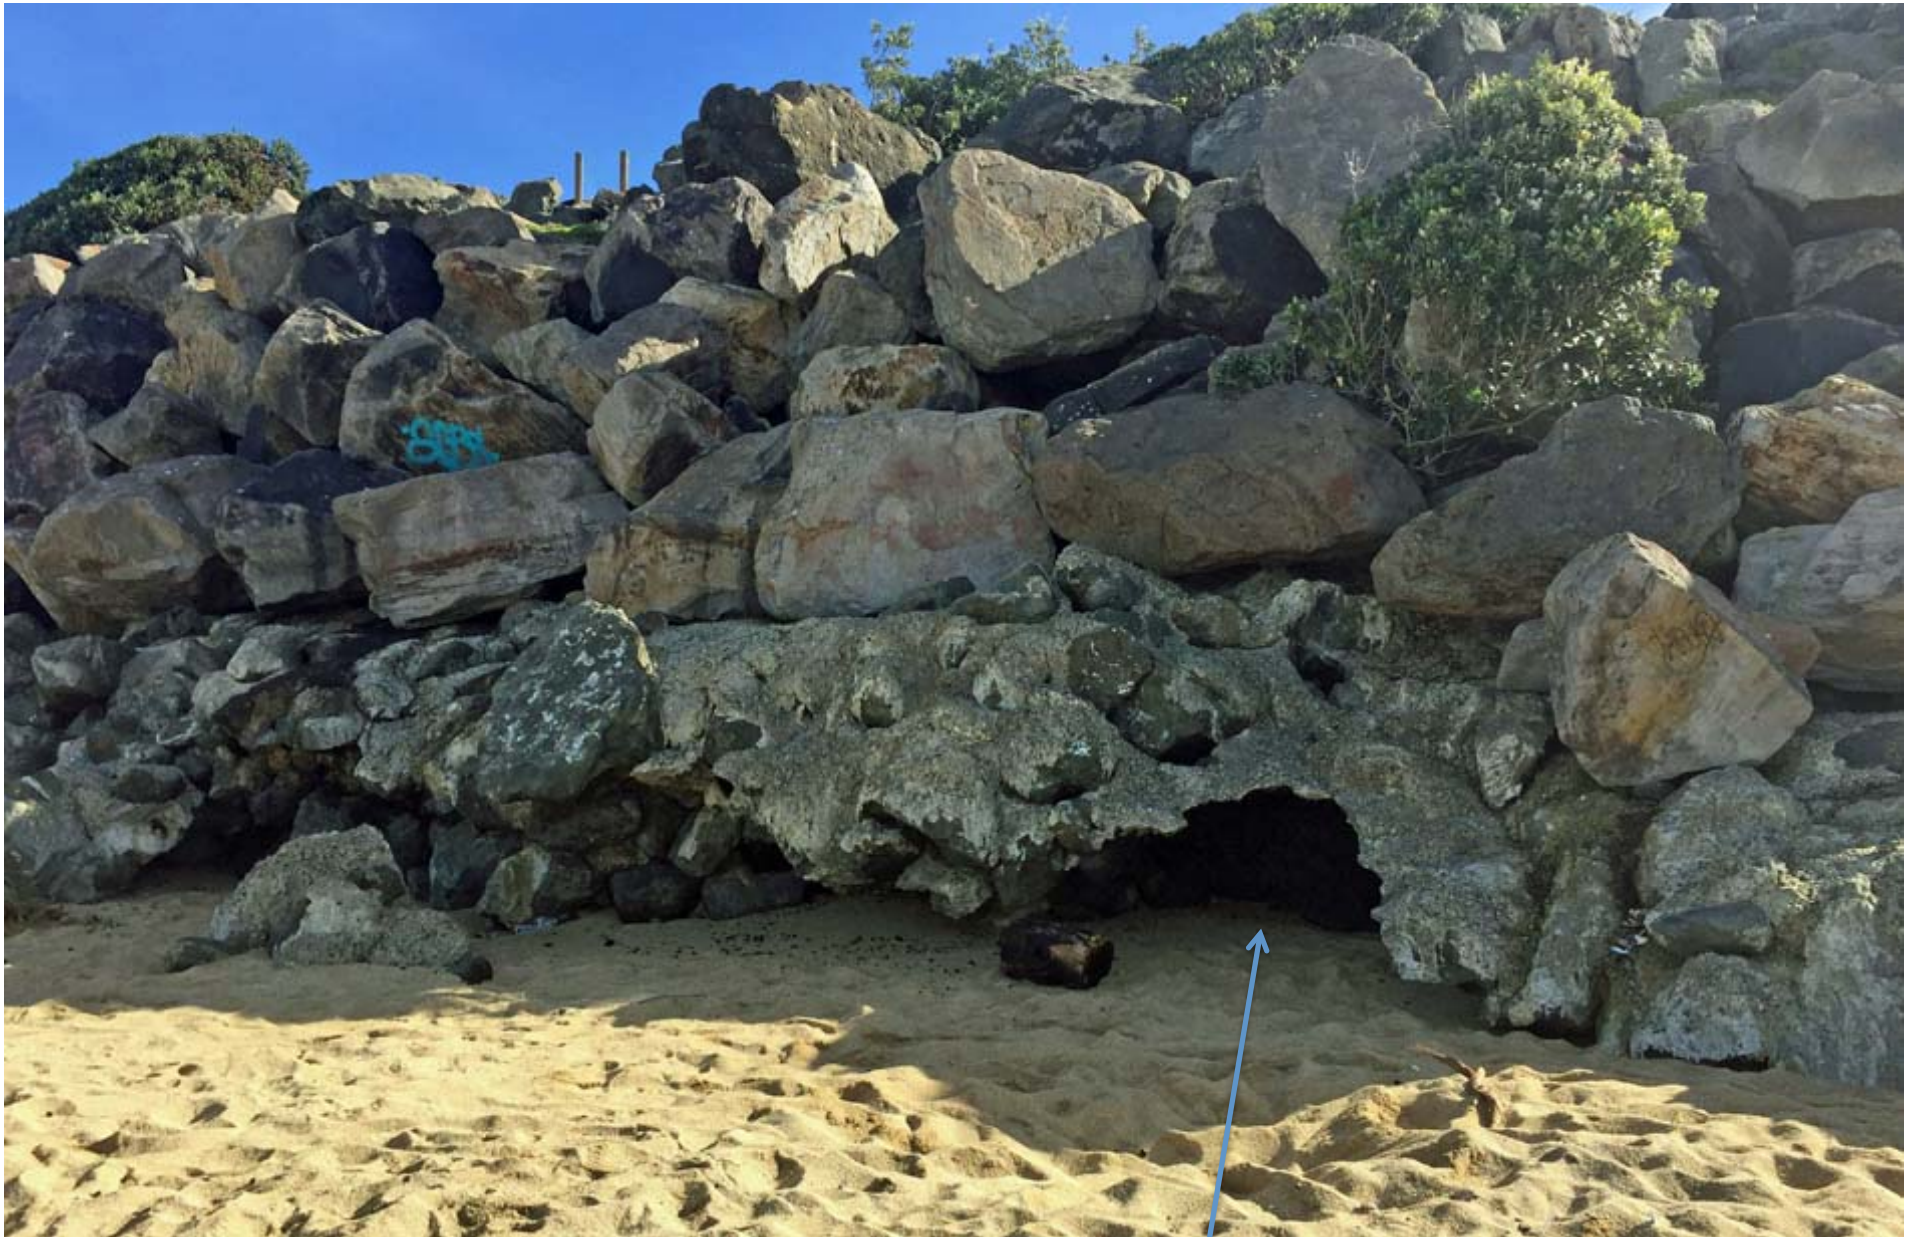
- The riprap was not keyed into the firm ground underlying the sand.
- The bottom 6 ft of the riprap has been grouted with cement.
- Both parking lots drain to outlet pipes that discharge behind the riprap, causing its undermining.
- The report includes recommendation for rerouting the drainage pipes and repairing the riprap sea wall.

Undermined riprap section just south of staircase --  
Overhanging rocks held together by concrete slurry --  
Large chunks and rocks have fallen onto the beach.

The cave on the right measures 7 ft deep,  
extending back under the large boulders.

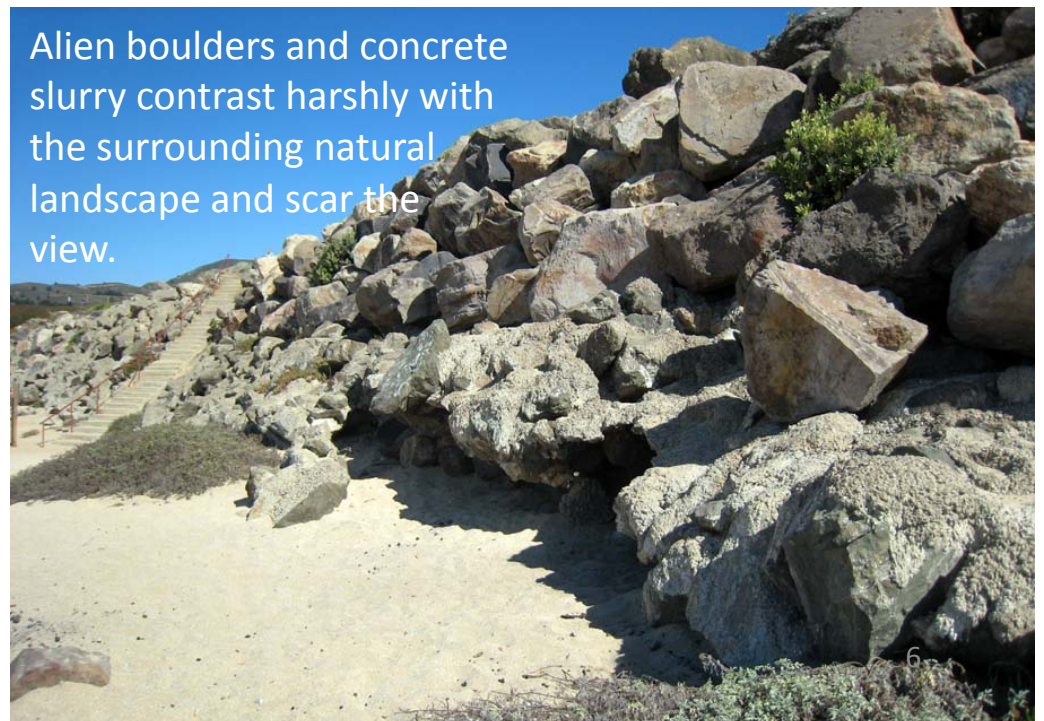
Alien boulders and concrete slurry contrast harshly with the surrounding natural landscape and scar the view.

Removal of excess boulders that cover the upper slope and top of bluff above the red line on either side of the restaurant would restore public access and views and reduce the area of alien rocks that mar the otherwise pristine viewshed.

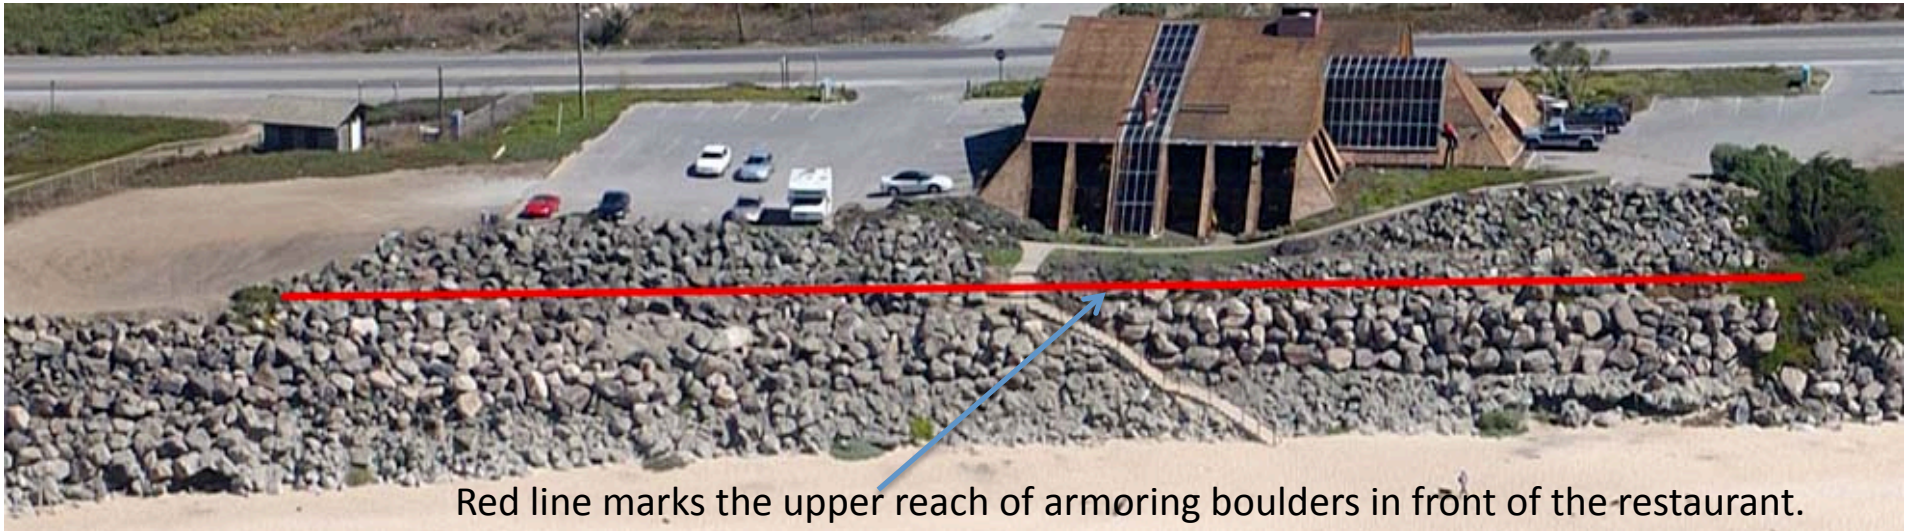
Red line marks the upper reach of armorng boulders in front of the restaurant.

Riprap extends onto top of bluff, far beyond where needed for erosion protection, blocking blufftop access and views.

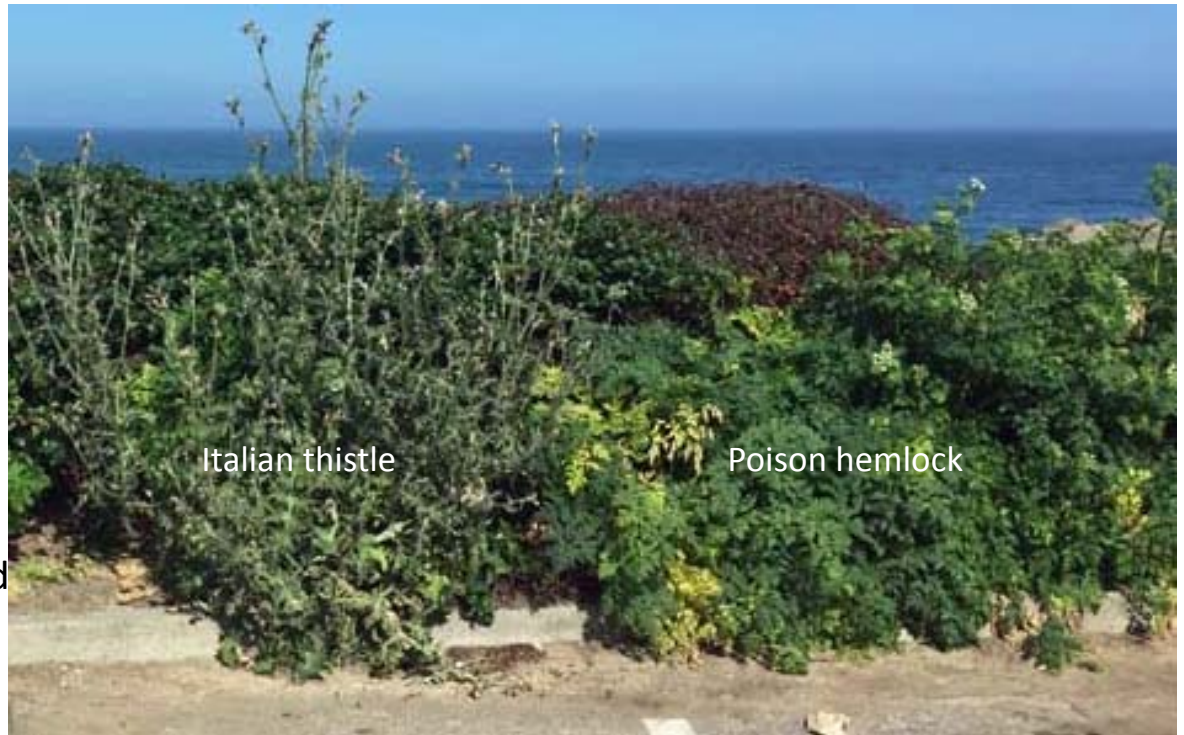
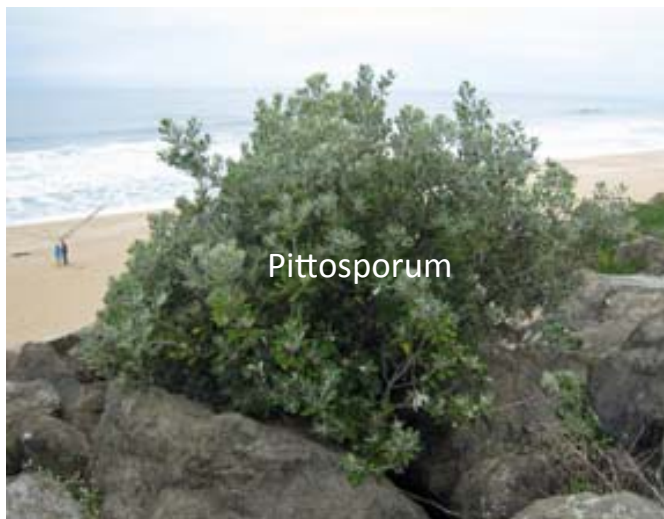
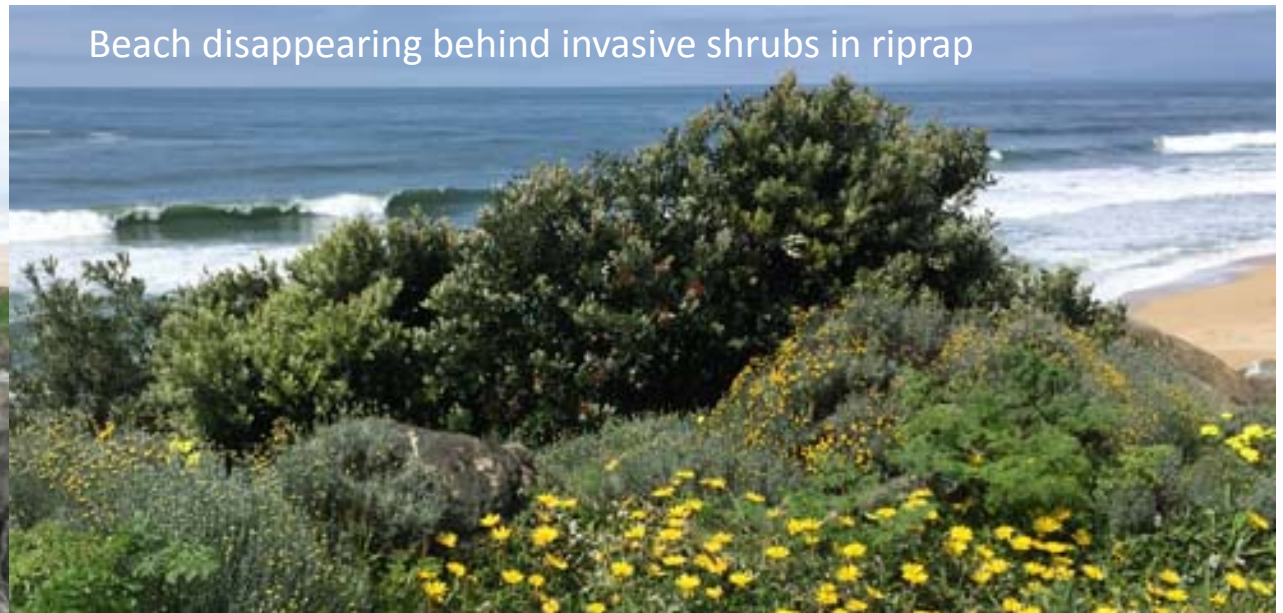
Upland riprap area has been invaded by non-native and view-blocking shrubs (pittosporum, etc) and noxious weeds (thistle, hemlock, etc).

All landscaping west of restaurant and parking lots should be locally native and low growing so as to allow beach views from parked cars in cold or inclement weather.
