**Northern Half Moon Bay
Shoreline Improvement Project
Pillar Point Harbor, CA**

**Section 216 Initial Appraisal
Review of Completed Projects**

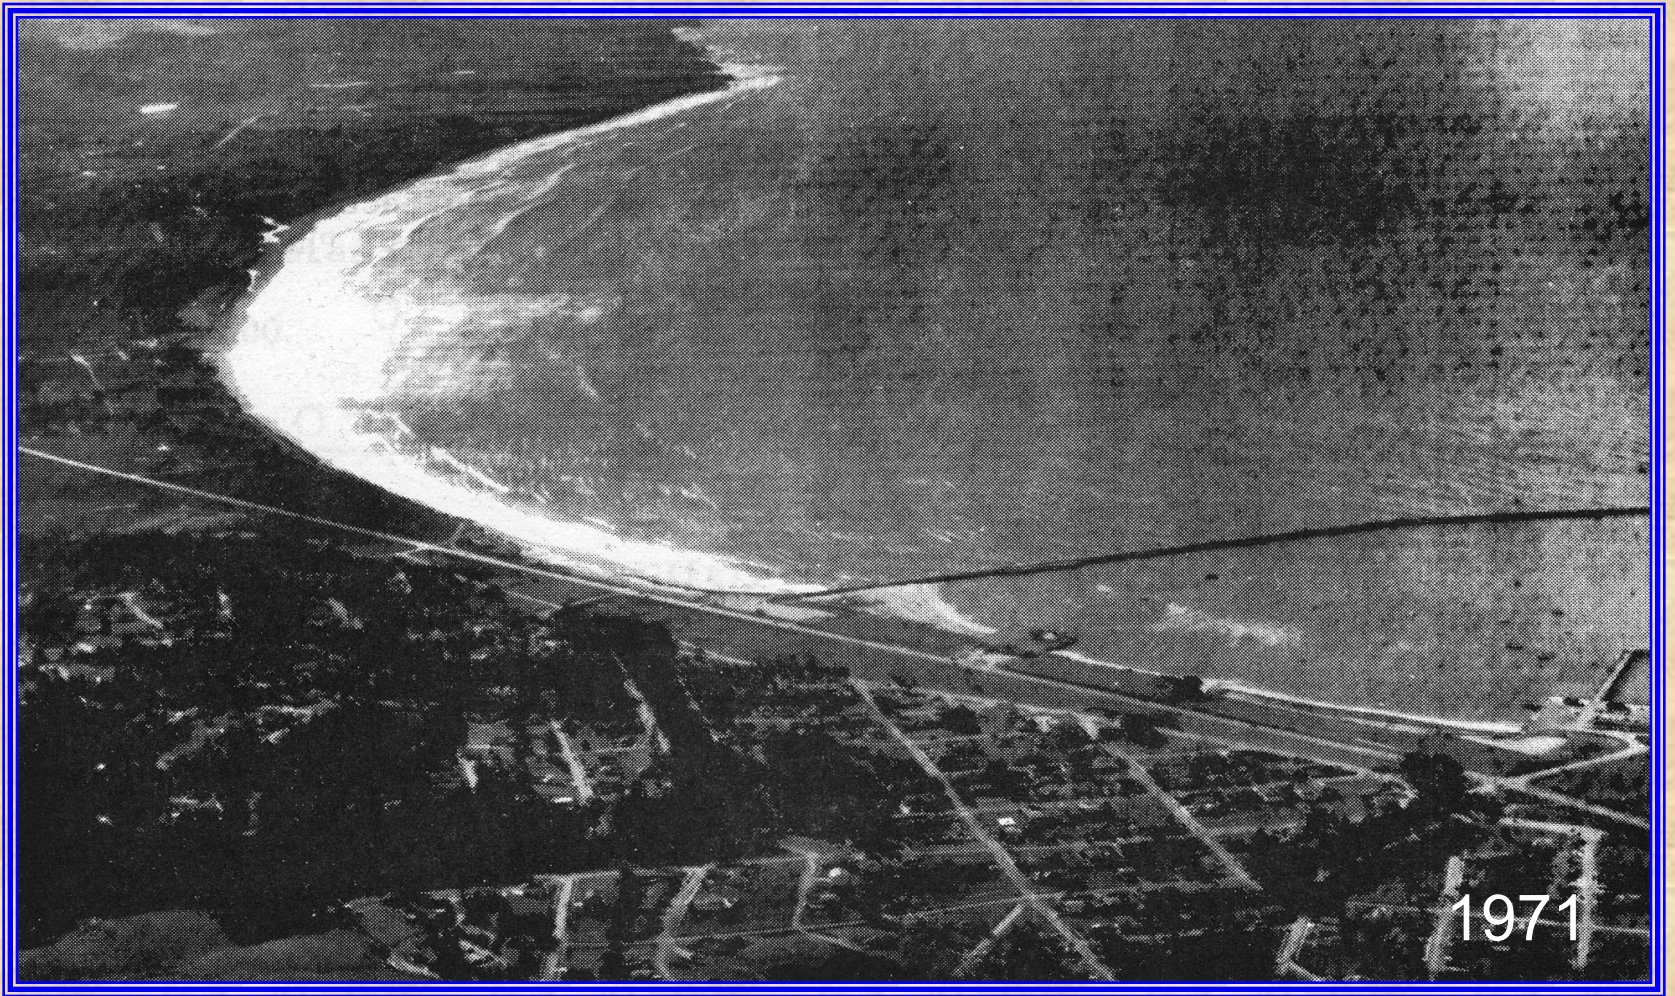
1971 aerial photograph of Half Moon Bay looking south with the East Breakwater in the foreground and Miramontes Point in the distance.

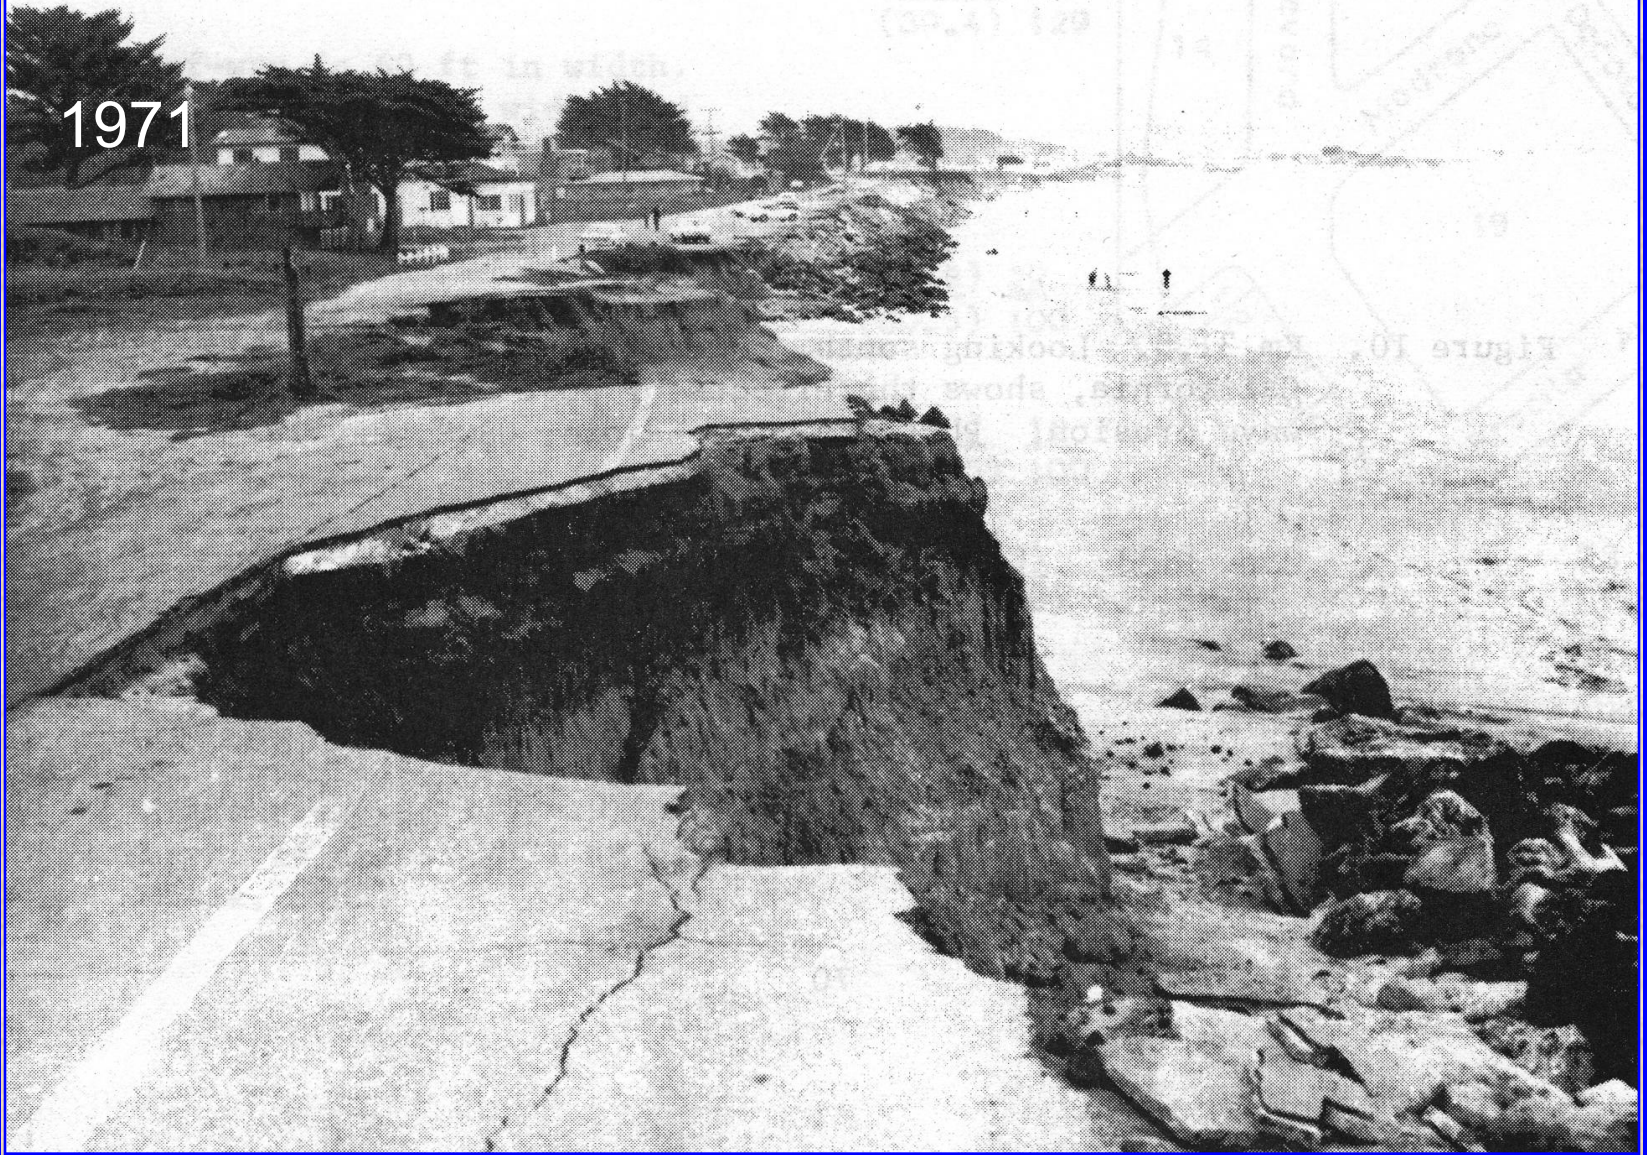
1971 photograph of Mirada Road looking south from near the root of the East Breakwater. Subsequently, the road was destroyed. Rip-rap can be seen along the sea cliff starting at about the white house and going south.
