**REMEDICATION OF PHYSICAL  
SAFETY HAZARDS**

**CARISSA GOLD MINE**

**SOUTH PASS CITY, WYOMING**

**SUBMITTED BY**

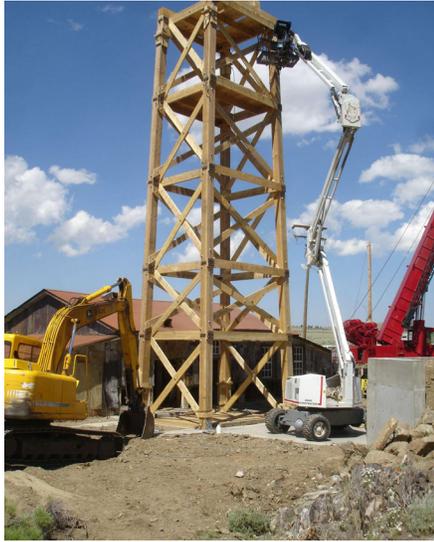
Figure 4: Construction and Placement of the Reconstructed Headframe Over the Operating Shaft.

The Operating Shaft was located within the Shaft House, and consisted of a 300-foot-vertical, double-compartment shaft sunk in the footwall of the Carissa Lode. It was the only accessible surface connection to the underground mine workings at the Carissa Gold Mine. The original headframe for the Shaft House was demolished in the 1980s. Initial mitigation work included the installation of a PUF plug, installation of 6-inch PVC perforated drain pipe into the PUF, and stabilization of the existing wood cribbing still present in the shaft. In later years, the WY AML and State Parks coordinated efforts to reconstruct a historically accurate headframe and Shaft House above the original Operating Shaft, as shown in Figure 2, and install a water pump through the PUF plug in the Operating Shaft to supply the Mill Building with water. Protective paneling and a floor system was installed in the Operating Shaft to protect SPC personnel from falling wood timbers and collapsing collar. The Ore Tram that connected the Shaft House to the Mill Building was also reconstructed. Figure 5 shows the completed Shaft House.

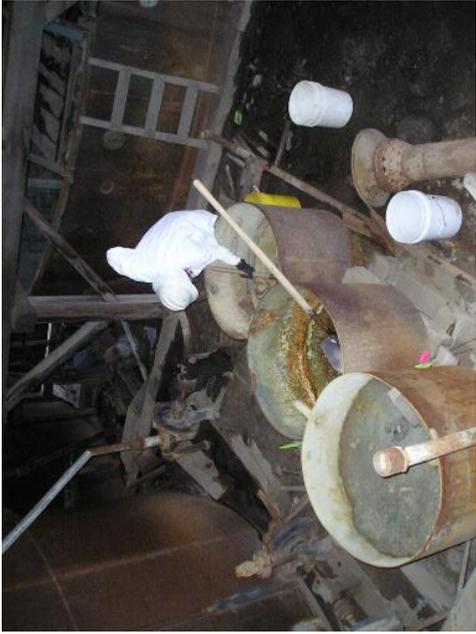
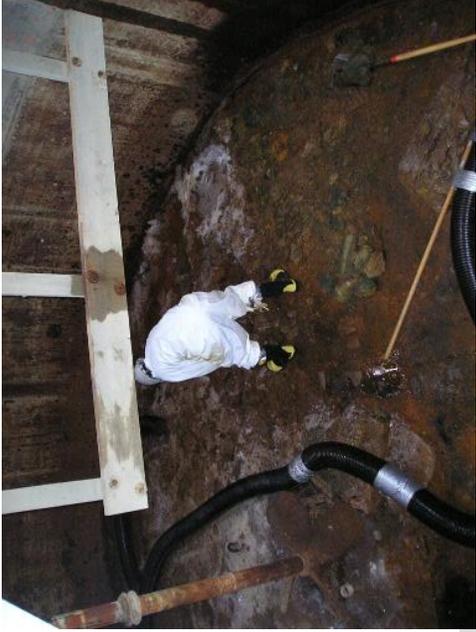
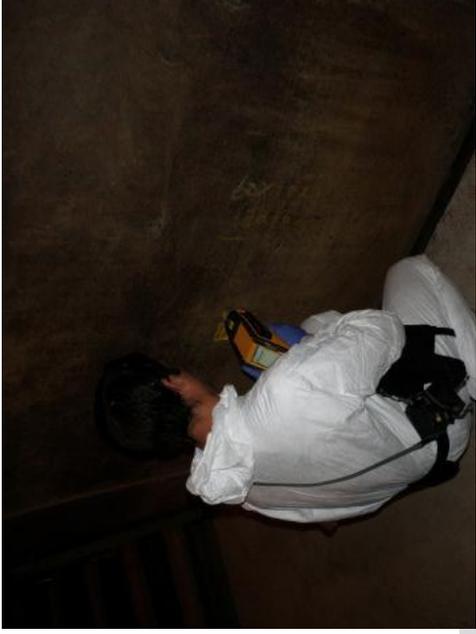
Cleanup of tanks within the Mill Building

- / Packaging and off-site disposal of inventoried wastes
- / Consolidation, packaging, and removal of all rock cores
- / Removal and exterior disposal of tailing and other bulk wastes from within tanks and limited areas outside of and adjacent to the tanks

- / Excavation and disposal of on-site bulk tailings from within and immediately exterior to the Mill Building into a designated open pit area adjacent to the site

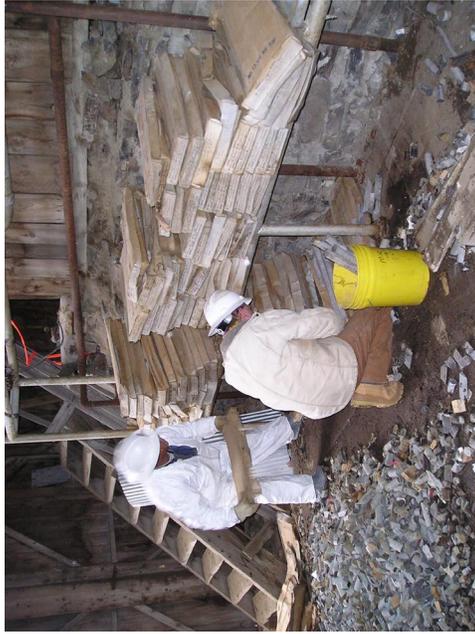
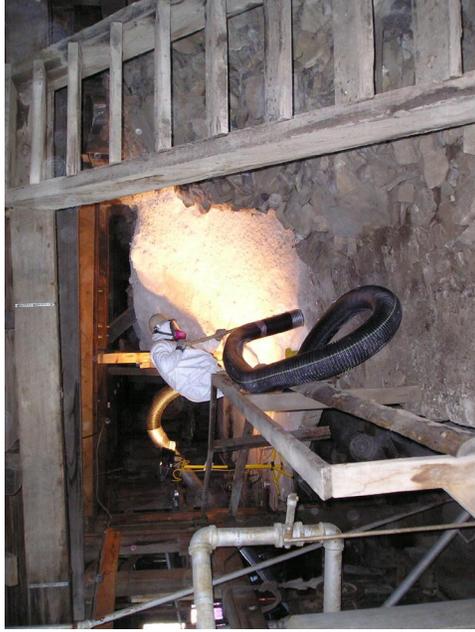
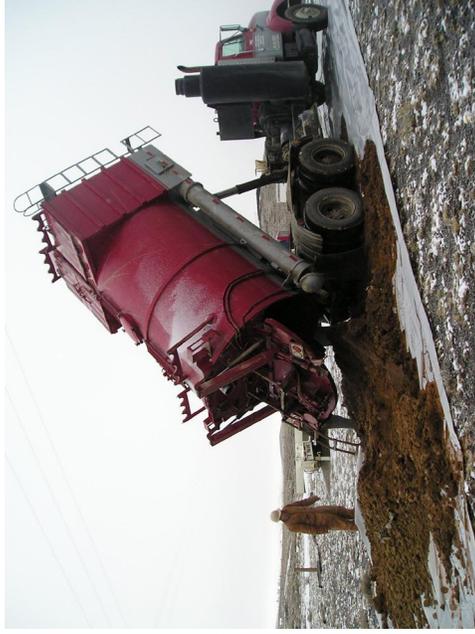
Cleanup of the interior of the Mill Building and the preparation of disposal of hazardous materials

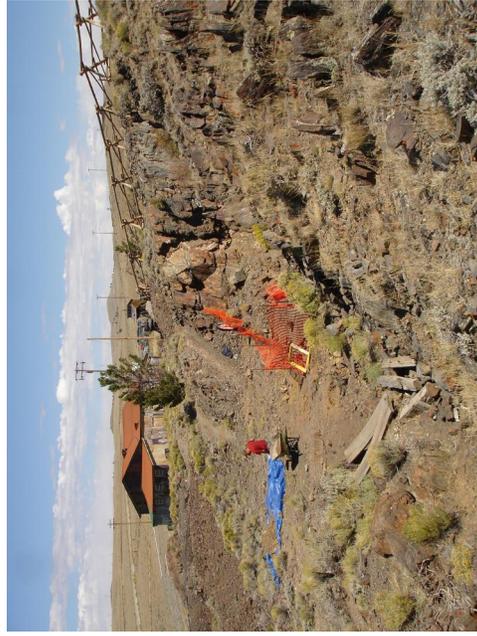
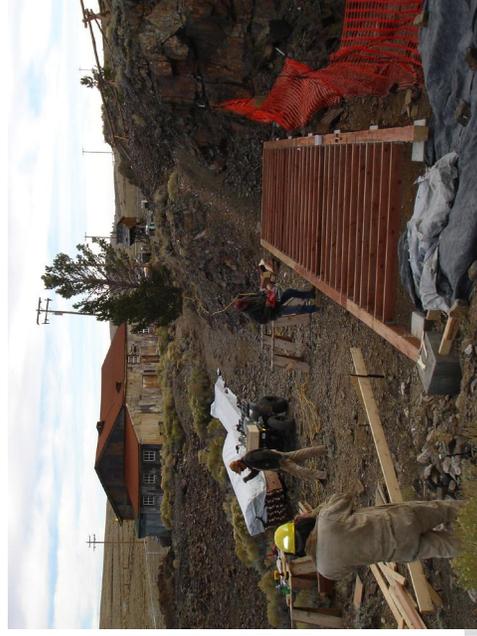
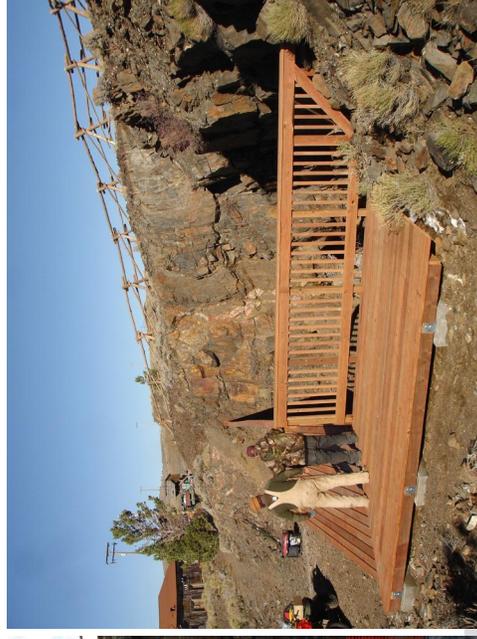
Viewing platform for the glory hole

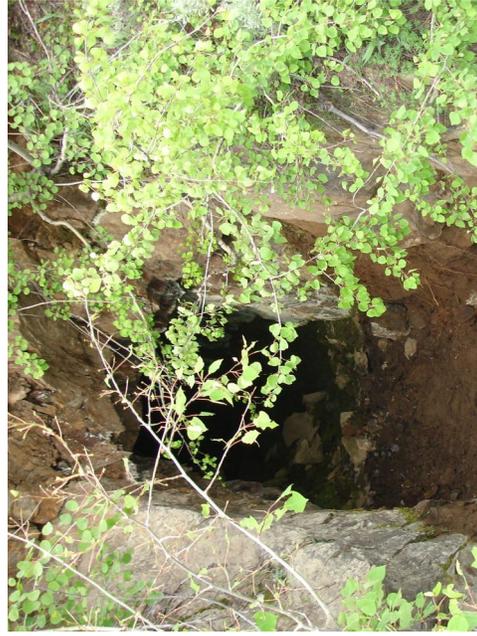
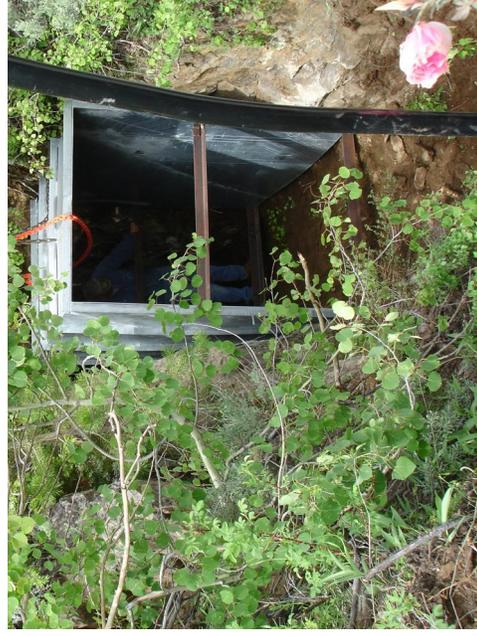
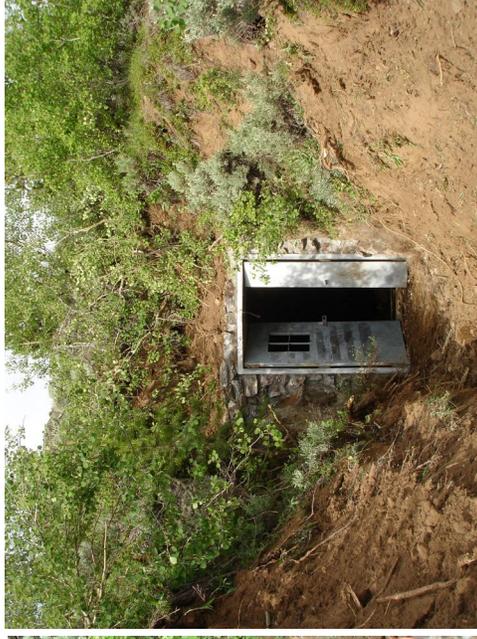
Mill Pond adit accessible closure

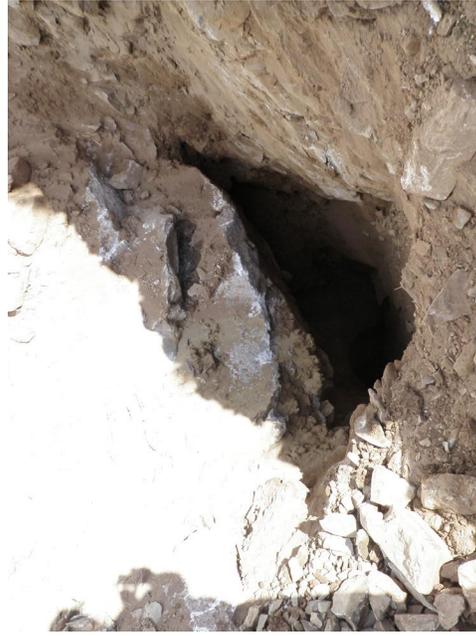
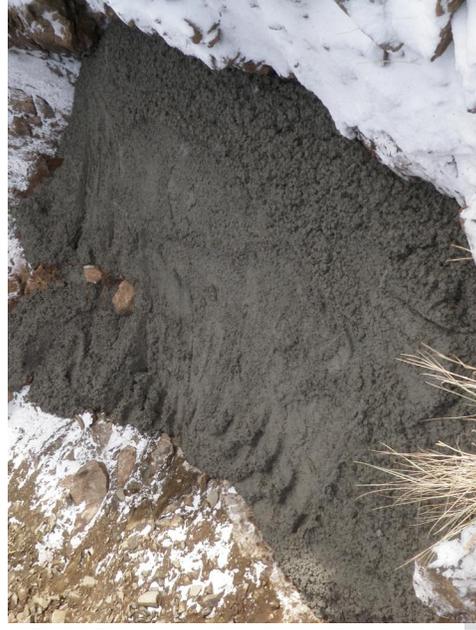
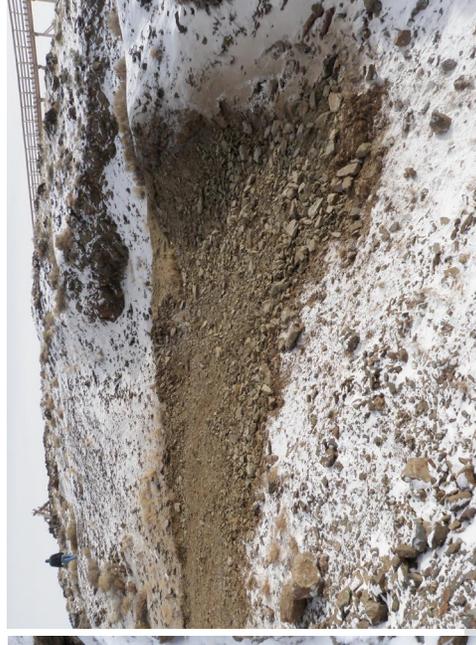
Concrete plug closure for Charlies Folly

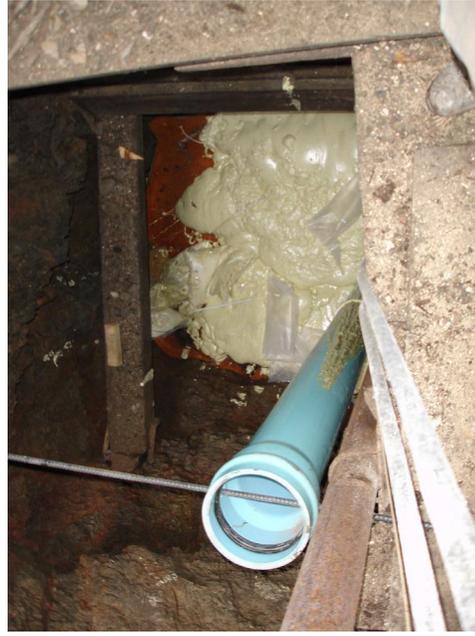
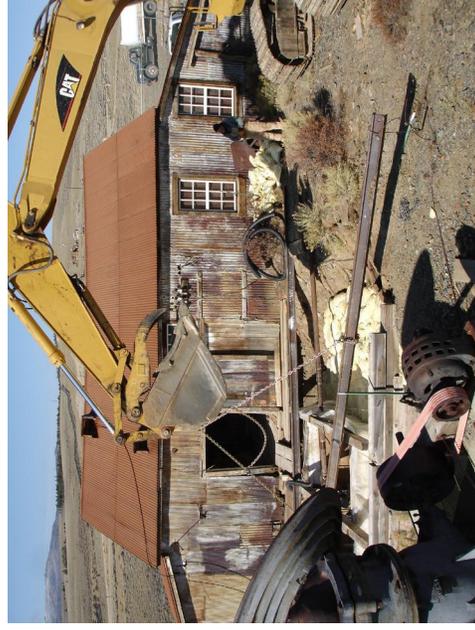
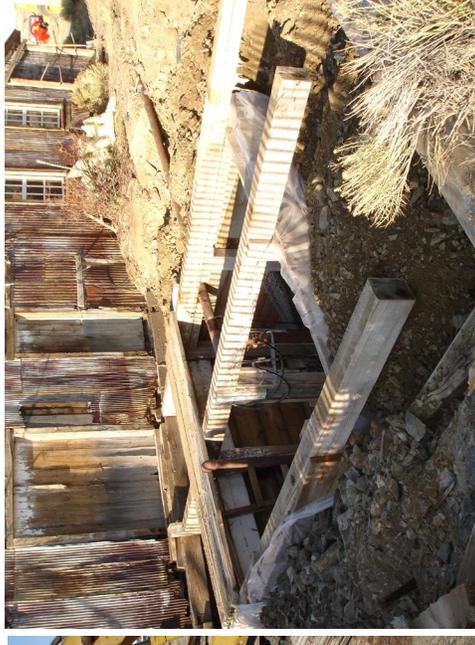
PUF plug closure for Willow Creek Shaft

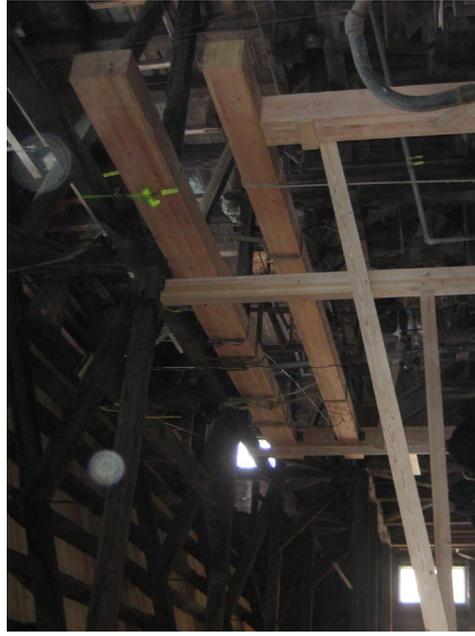
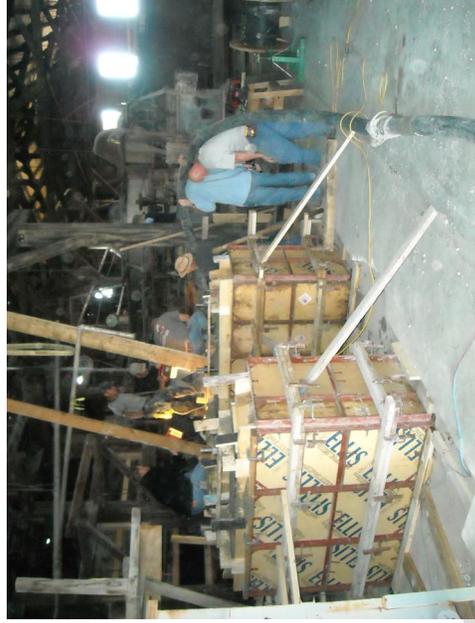
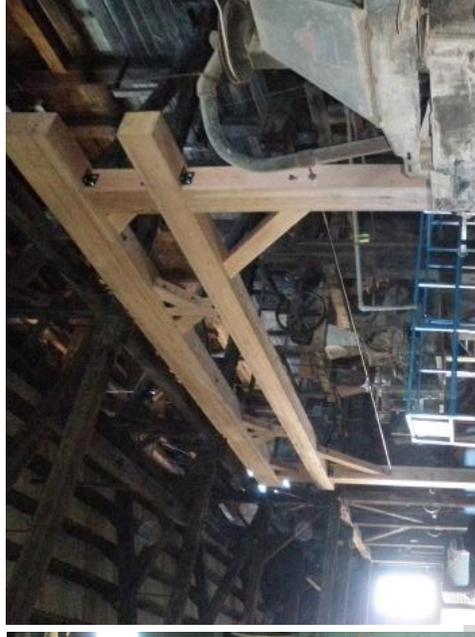
Construction of the structural glulam and ball mill foundation

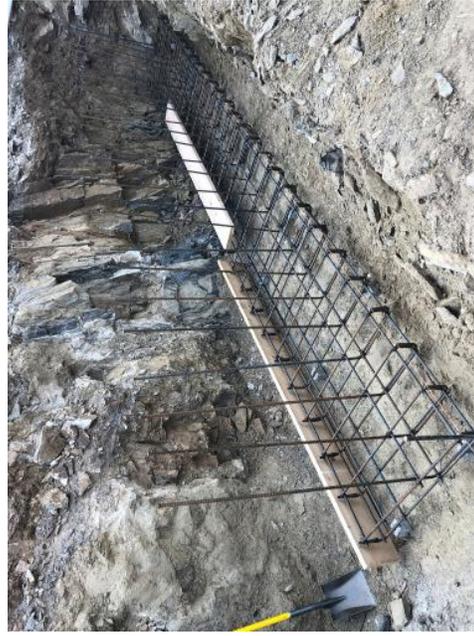
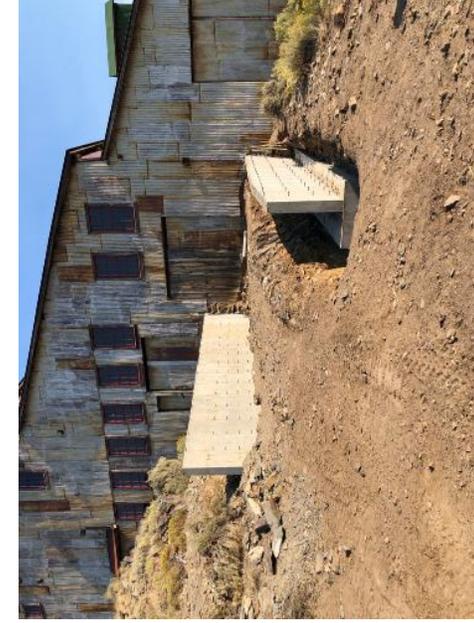
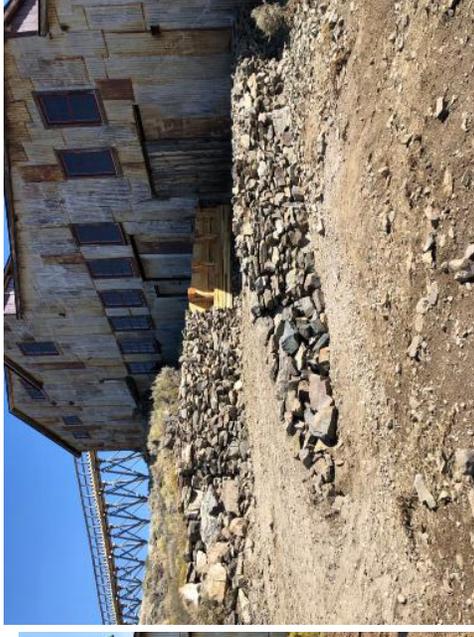
Retaining wall construction for the Mill Building approaches

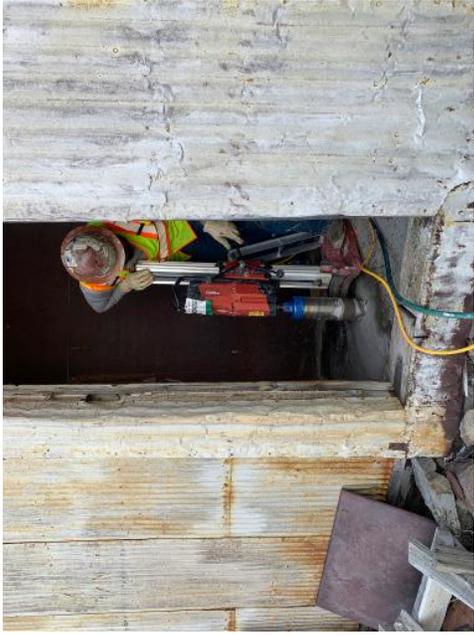
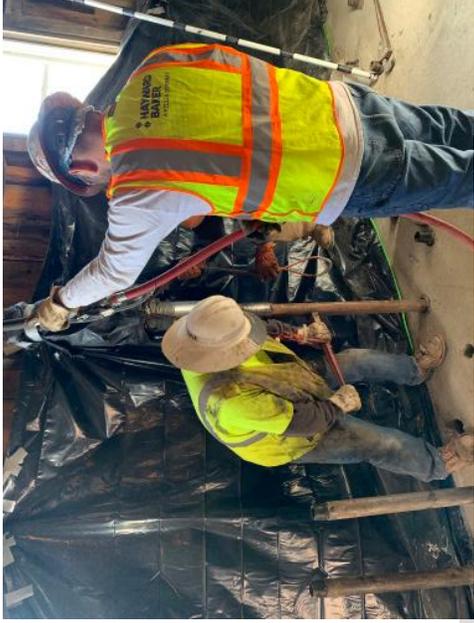
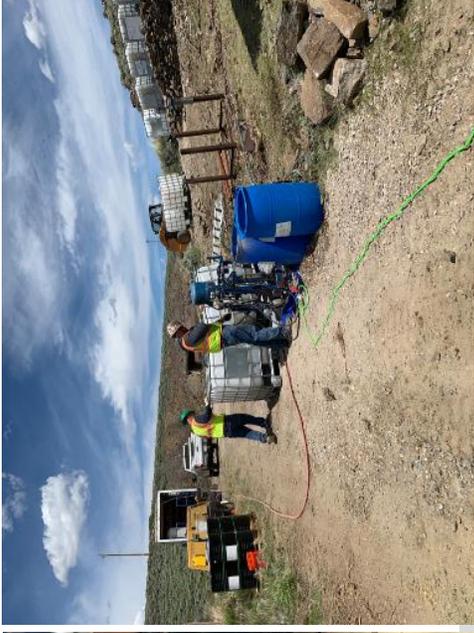
Permeation grouting of subfloor at Level 6 in the Mill Building

1. Coring out sections of previously placed concrete that covered original tailings on Level 6 of the Mill Building interior

2. Performing permeation grouting into the tailings to solidify the mass, which would allow it to support increased loads and resist collapse when the stacked rock wall would be removed

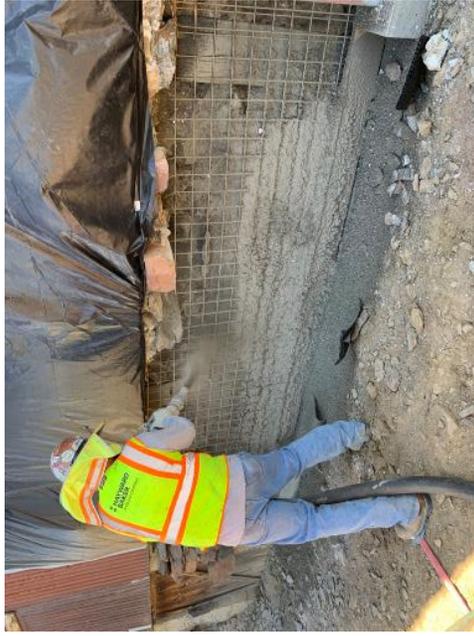
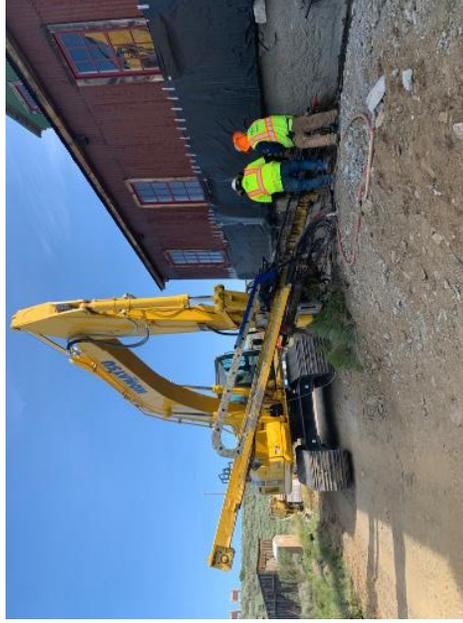
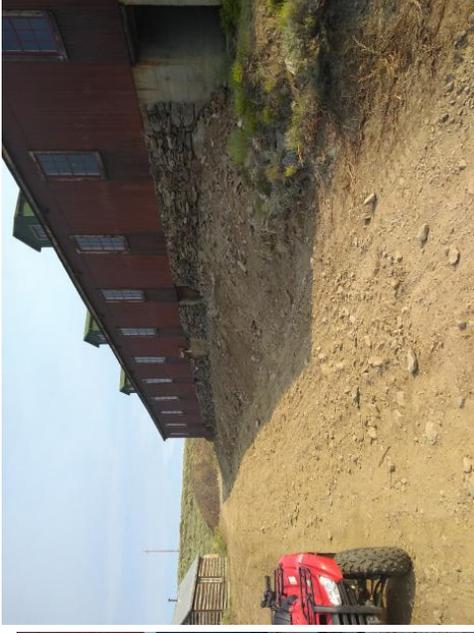
Construction of the shotcrete and soil nailed retaining wall on the south wall of the Mill Building; original stacked rock material used to recreate the original stacked rock foundation

After the permeation grouting process was completed, the stacked rock wall was temporarily stockpiled on site, and a shotcrete wall with soil nails was installed to stabilize the structure. The stacked rock wall was then reconstructed to reflect the historic accuracy of the structure. Also, agreements were made to share funding responsibilities on the project between the WY AML and State Parks—the WY AML was responsible for funding all hazard mitigation work and structural stabilization efforts, and State Parks was responsible for funding restoration or reconstruction portions of projects.

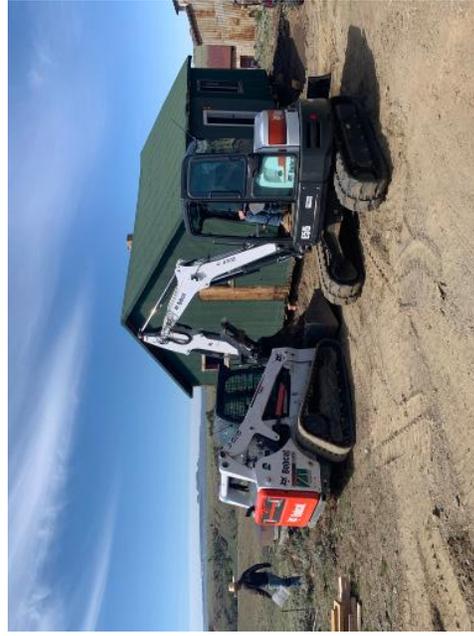
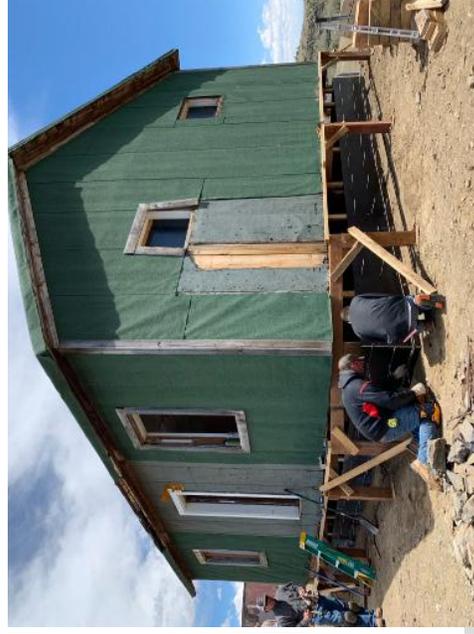
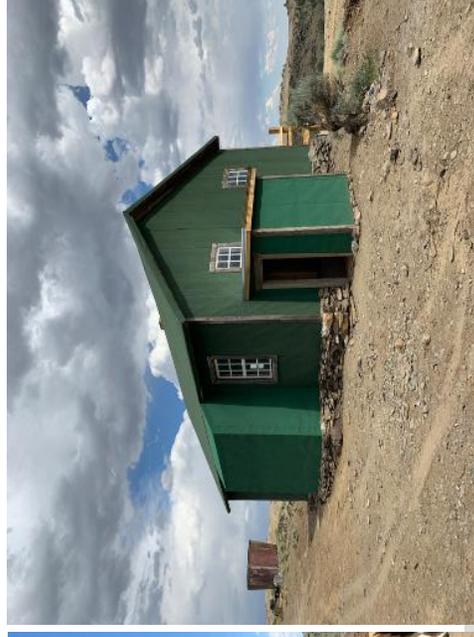
Structural stabilization of the Cookhouse with concrete stem wall foundation

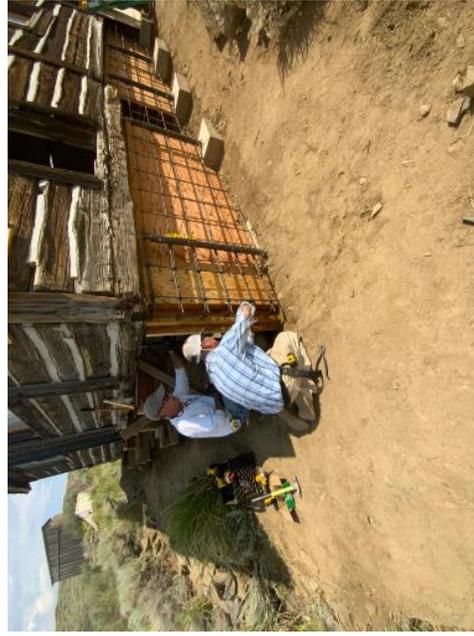
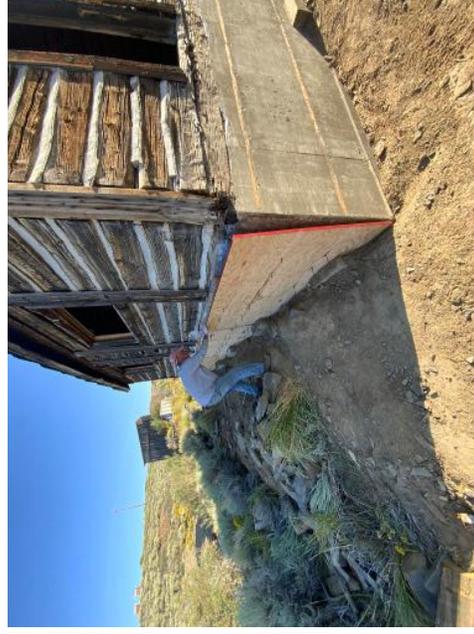
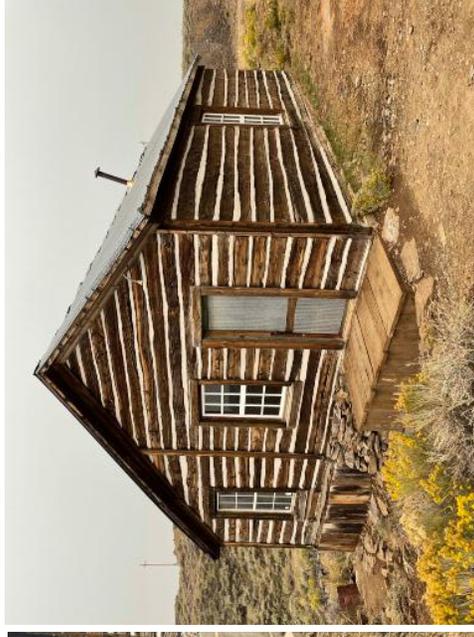
Structural stabilization of the Mill Office with concrete stem wall foundation
