Prepared For:

Prepared By:

**FINAL REPORT
FOR
N62470-14-D-3006
VALIDATE CORROSION INHIBITOR
AT
U.S. MILITARY INSTALLATIONS
OKINAWA, JAPAN**

(Corrpro Project No. – 340531156)

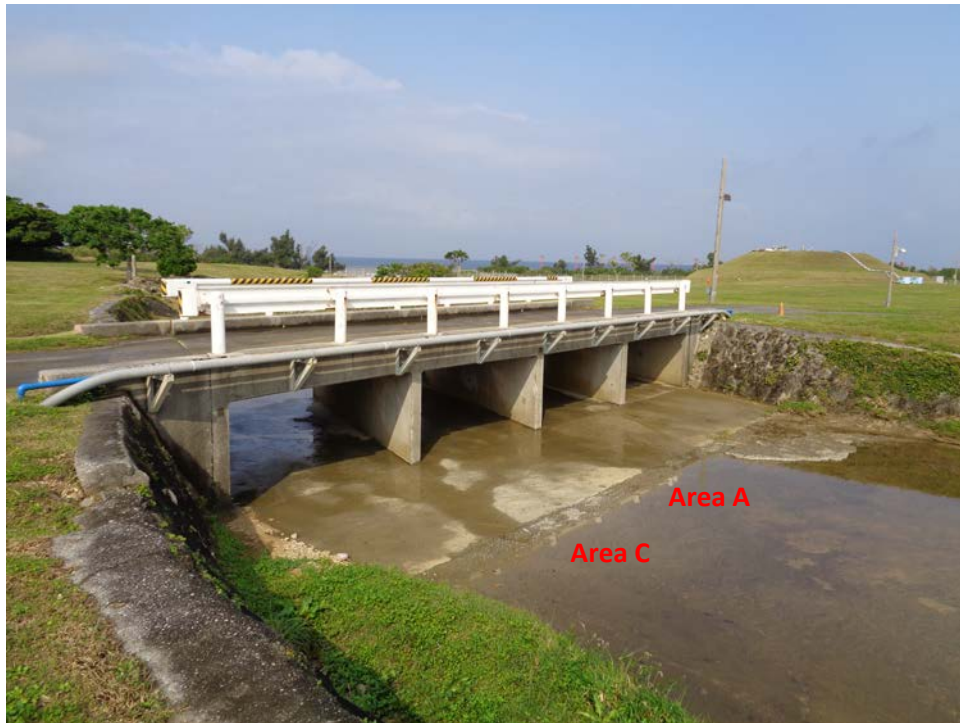
Bridge 2 that received the full Surtreat system was evaluated for effectiveness of the system. The same three specific areas chosen for the 2007 inspection were previously tested in 2010 as shown in Figure 2 were evaluated. These areas were designated as areas A, B, and C. All three areas were on vertical surfaces. No cracking or spalling of the treated area was visually apparent. A few small square patches were observed that were not originally present at the time of treatment, and the circumstances of their installation are unknown. Figures 3, and 4 show the condition of Bridge 2 as found in 2016.

Figure 3 – View from upstream of Bridge 2 at the Kuwae Tank Farm, Kadena AFB, 2016

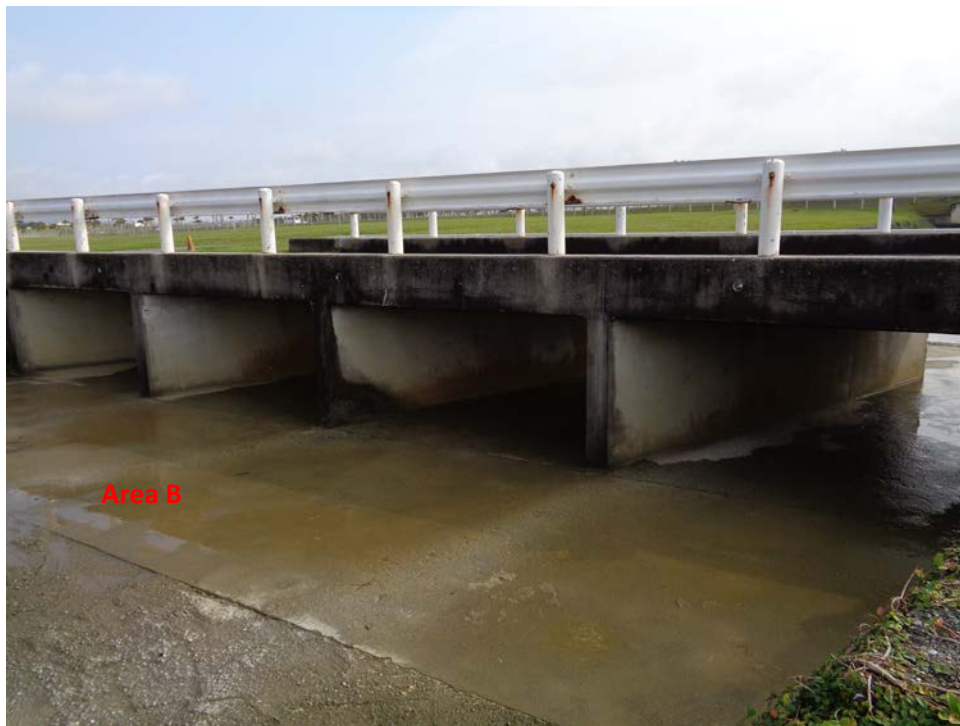
Figure 4 – View from downstream of Bridge 2 at the Kuwae Tank Farm, Kadena AFB, 2016

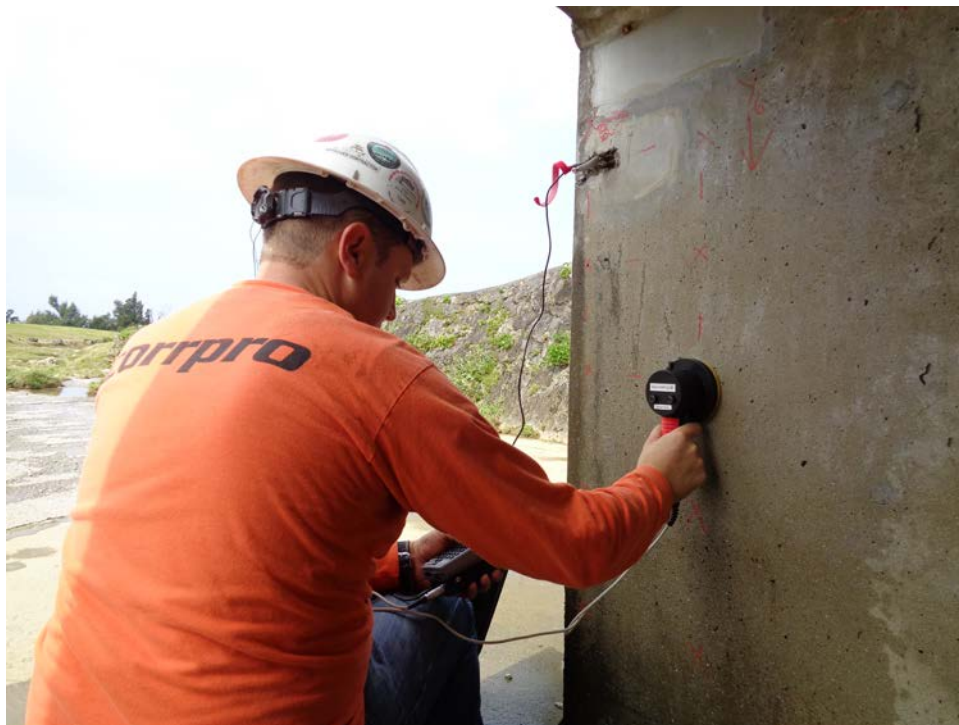
Table 1 compares the most recent corrosion rate values with the previously measured values before treatment, 6 months after treatment, and approximately 3 years after treatment. The data from sites A, B, and C are combined as resulting data was similar in nature. Galvapulse measurements, as shown in Figure 5, showed that corrosion rate remains significantly reduced from pre-treatment levels. Although the corrosion rates have increased since 2010 they are still below the first posttreatment evaluation in July 2007. Measurements ranged from 2.1 $\mu\text{m}/\text{yr}$ to 22.4 $\mu\text{m}/\text{yr}$ and were more consistent around lower sections of test areas which had lower resistance likely from the reduced effectiveness of the silicone treatment over time.

Figure 5 – Measuring corrosion rate

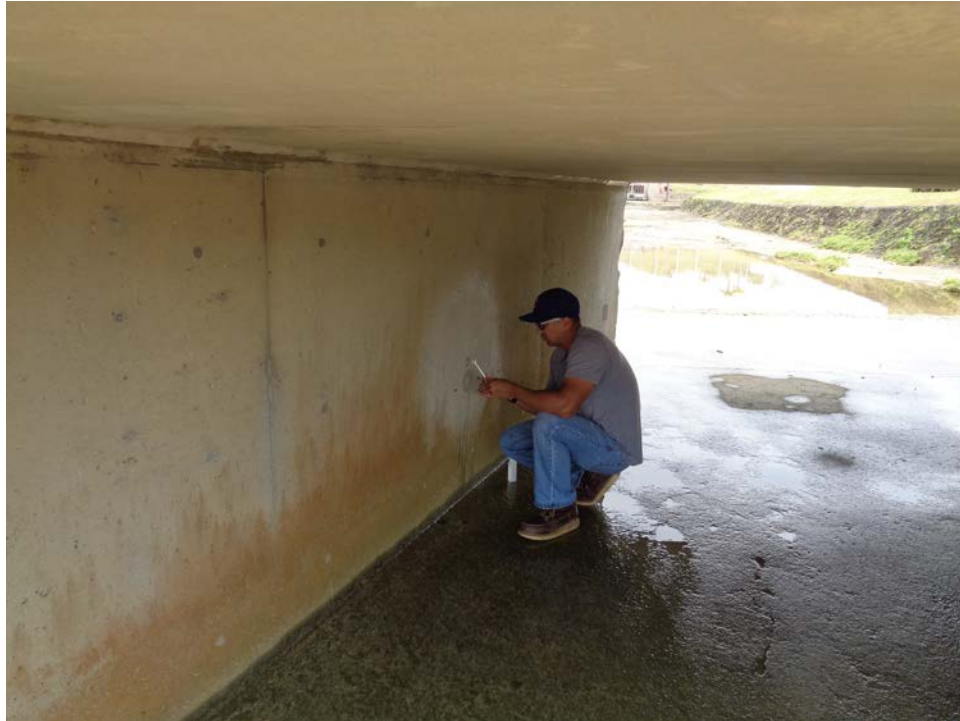
Water absorption was negligible and the silicone sealer is still effectively sealing the concrete from moisture. Rilem tube tests, as shown in Figure 6, performed in the same location as earlier testing showed virtually no measurable water absorption. Wetting out concrete on the test areas required a series of repeated wettings over a period of several hours to lower concrete resistance sufficiently for measurements to be made. Figure 7 shows an area of concrete where sealer was still inhibiting the absorption of water after several applications of water. Areas of application of the Surtreat system was still readily evident by a white coloration, or lack of discoloration, on the concrete where it was applied.

Figure 6 – Collecting rilem test tube, white area where Surtreat system applied

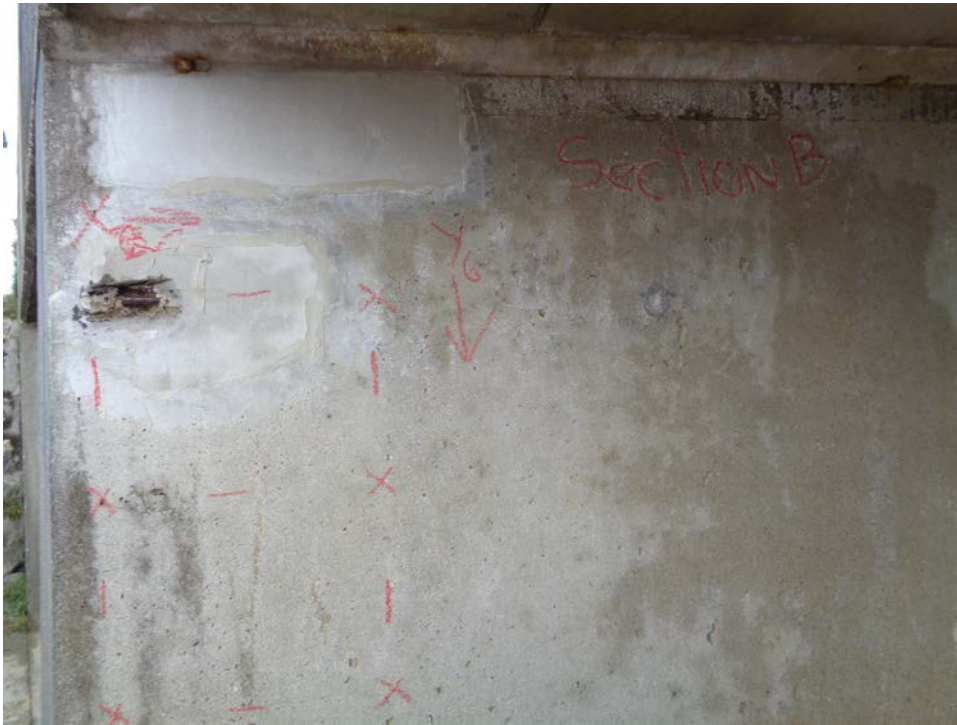
Figure 7 – Sealer still evident after several wettings of the concrete

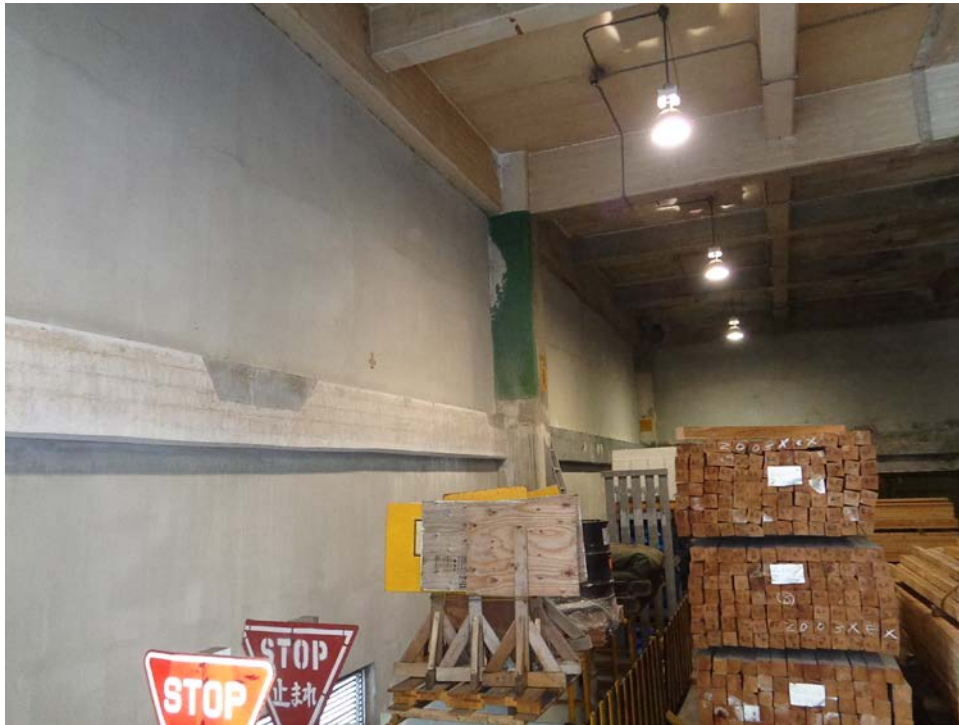
The Surtreat system was previously applied at the warehouse building no. 306 in Naha Military Port. Section 1 where the system was applied is a section of ring girder adjacent to the exit door in section A of the building. Visually, the ring girder identified as Section 1 with the Surtreat system had no apparent changes since the last testing performed in 2010 as shown in Figures 8 and 9. Section 1 appeared in good shape without signs of deterioration. However, the other ring girder identified as Section 2 with the NASA coating had a clear visual indication of the coating delaminating from the concrete surface. This deterioration can be seen in Figure 10 below.

Figure 9 - Section 1 of the ring girder at Building 306 in the Naha Military Port, 2016

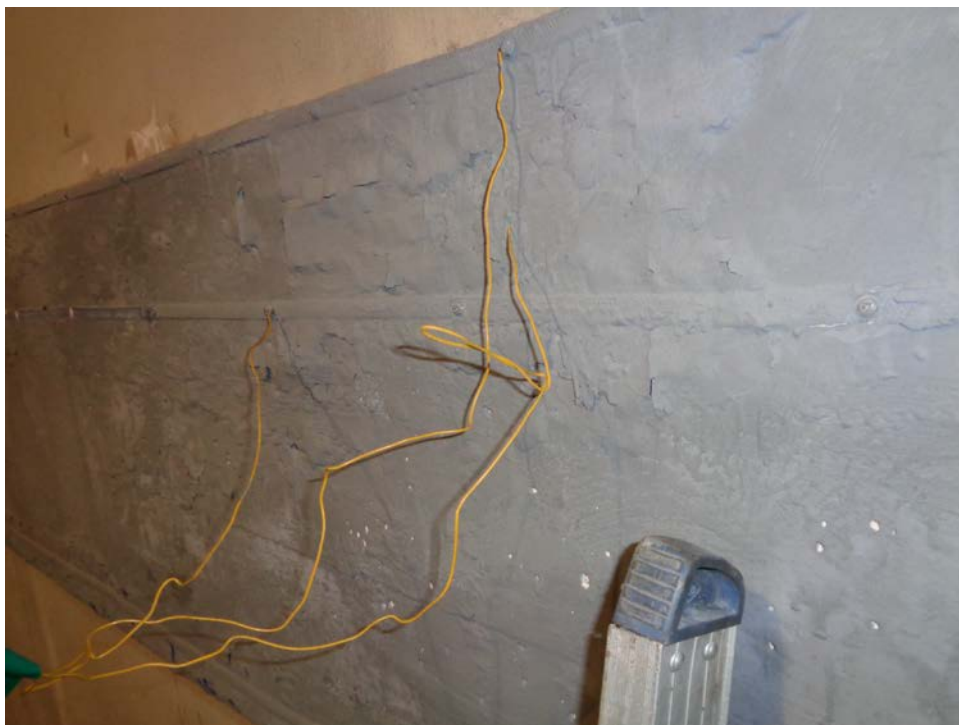
Figure 10 - Section 2 of the ring girder at Building 306 in the Naha Military Port, 2016

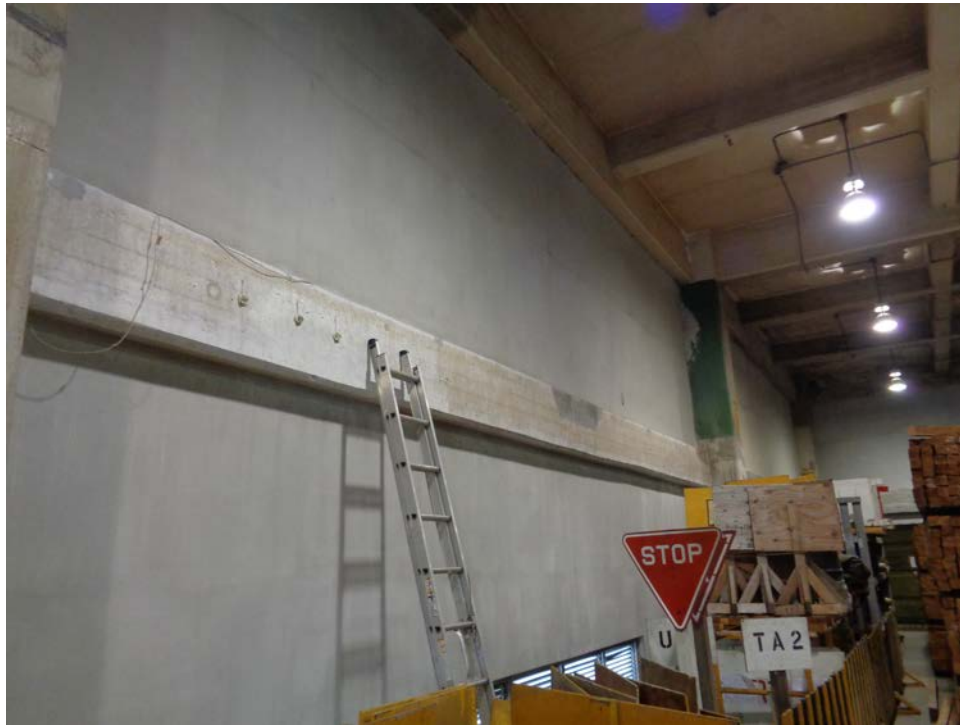
Rilem tube water penetration, as seen in Figure 11, yielded no noticeable absorption after several hours. Schmidt Hammer compressive strength of Section 1 averaged 5700psi which were close to the values previously obtained in 2010. As seen in Figure 12, pH testing provided a pH of approximately 9 to a depth of 1.5 inches where the pH subsequently increased.

Figure 11 – Rilem test tubes placed on section 1 ring girder.

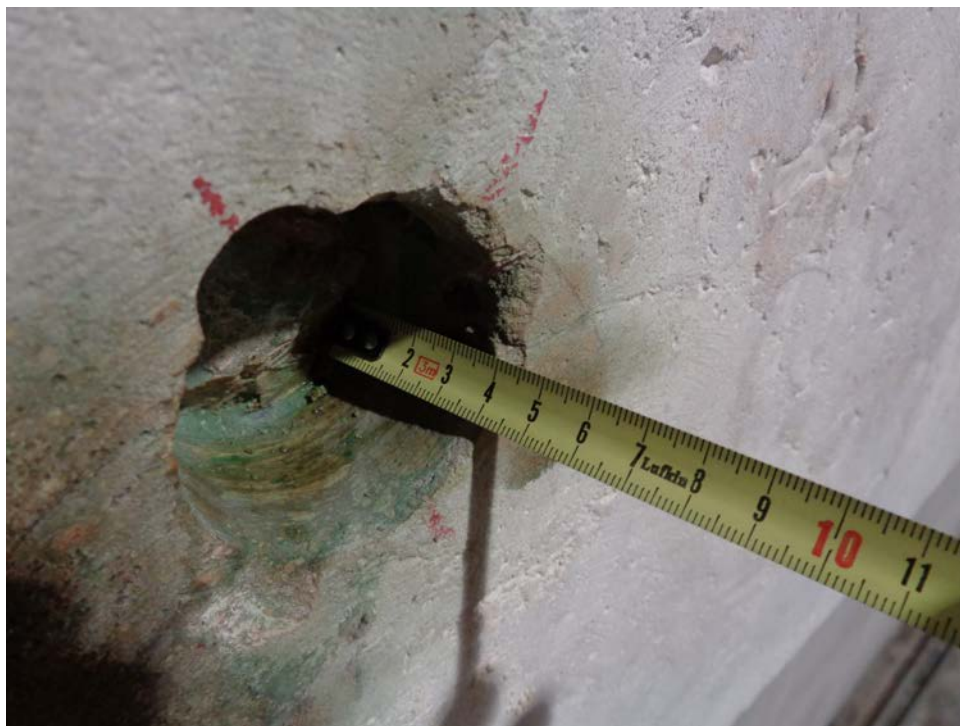
Figure 12 – Core removed over horizontal rebar, and pH indicator applied

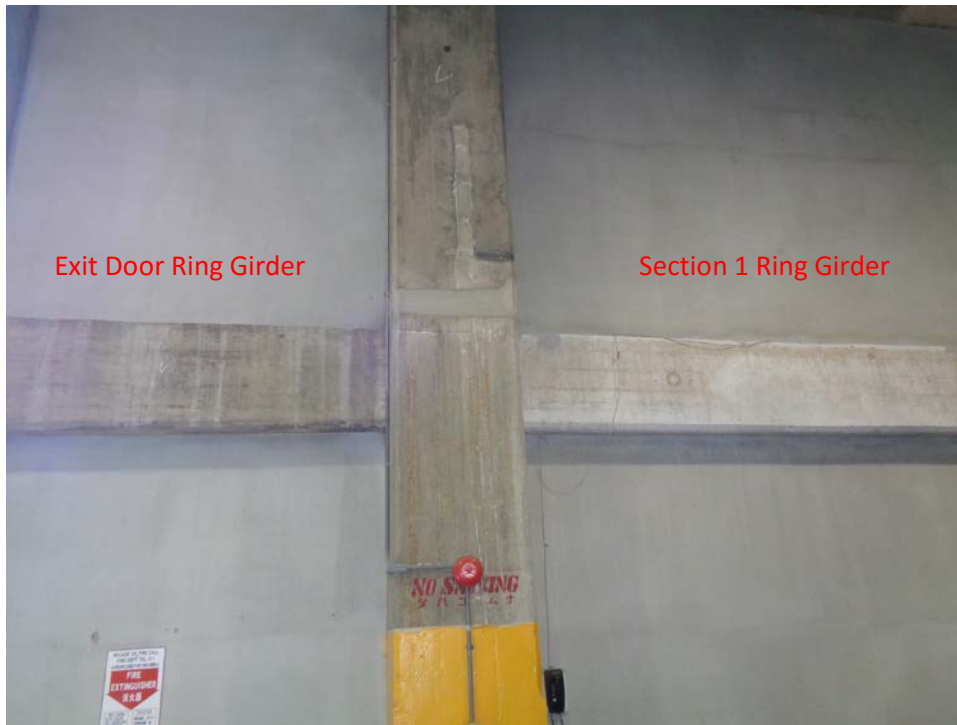
Figure 13 – Visual comparison of section 1 ring girder in to ring girder adjacent to exit door.
