**WAFCO MILLS  
CONDOMINIUM  
ASSOCIATION  
GREENSBORO, NC**

**DATE:  
JUNE 2, 2021**

**RESERVE STUDY  
UPDATE  
With  
Site Inspection**

**GILES & FLYTHE**  
ENGINEERS

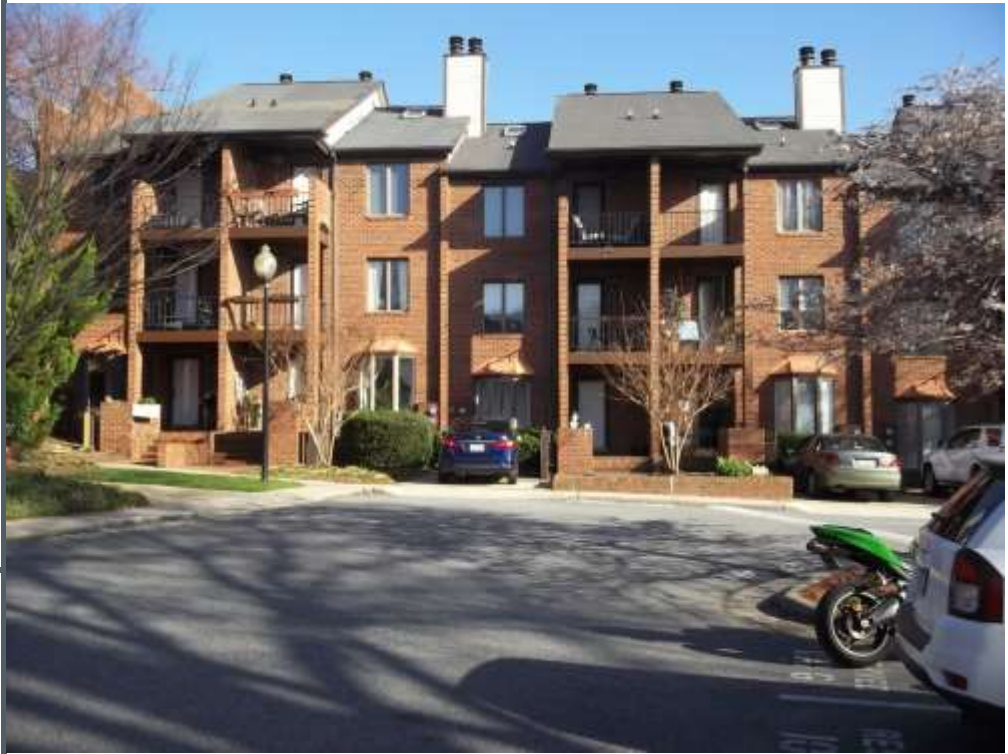
Photo No.  
1

General view of site,  
buildings.

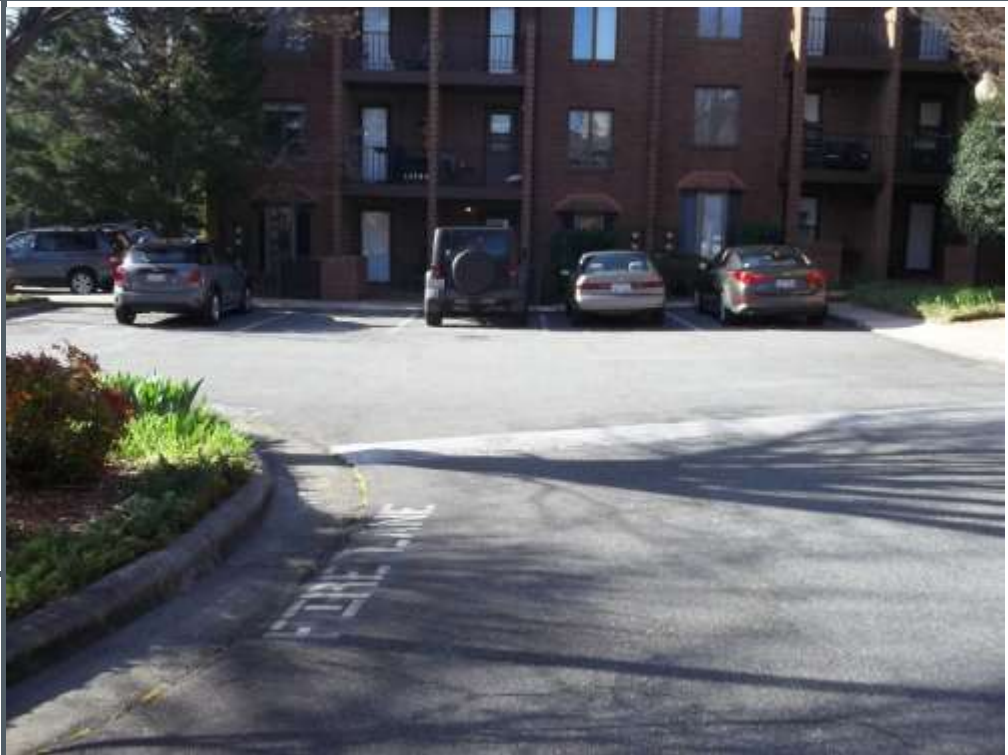
Photo No.  
2

The private drives of Wafco Lane and a small section at the end of Walker Avenue and parking areas throughout the community are asphalt paved and are maintained by the Association. The paving generally appeared to be in good to fair condition. We observed areas of longitudinal cracking developing and oxidation resulting in exposure of aggregate beginning to develop. Note that the streets/parking areas appear to have been resurfaced with an additional wearing layer of asphalt installed at some point since original construction.

General view of asphalt  
paving, concrete  
curbing.

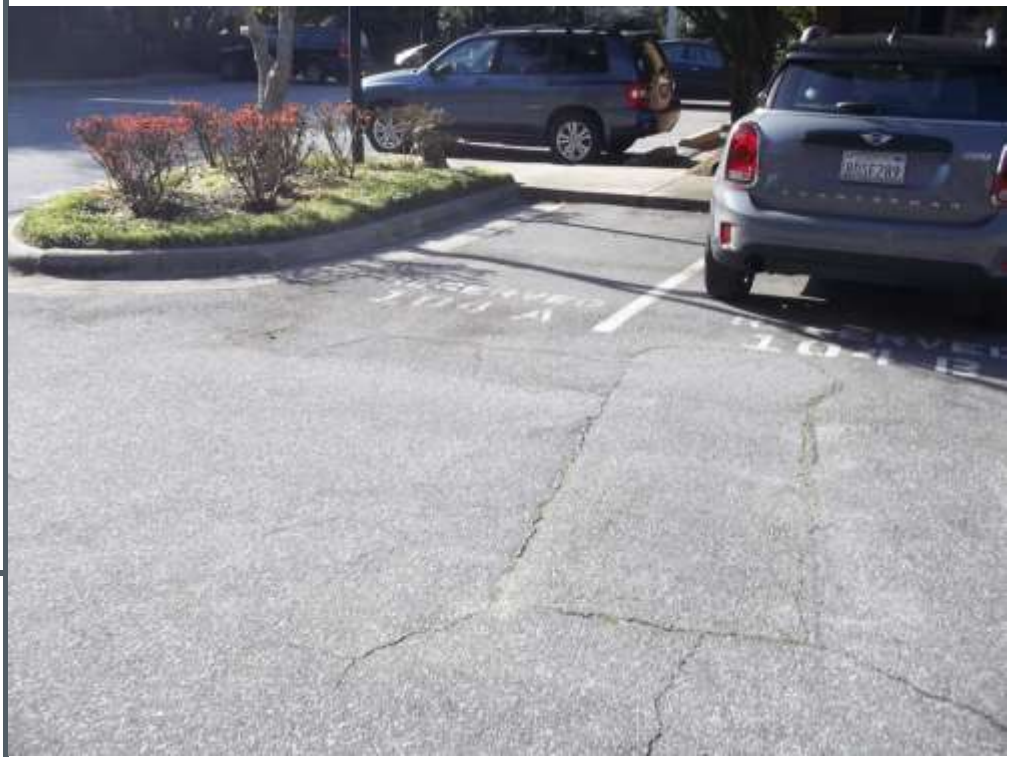
Photo No.  
3

View of cracking in sections of asphalt paving.

Typically, we recommend the application of an oil resistant sealant to all asphalt paved surfaces on an approximately 5 to 7-year cycle. At this same time, all cracks should be properly filled, patched, and sealed. We have allocated funds for crack repair, seal coating and re-striping the paved surfaces beginning in 2022 and on a 5-year cycle.

Assuming crack repairs and seal coating are completed in the interim, we anticipate the asphalt paving to have a remaining useful life of approximately 8 to 12 years. We have allocated funds to resurface the asphalt paving in 2032. Asphalt resurfacing would include milling to remove the top approximately 2” layer of asphalt paving, repairing sections of sub-grade/base course as needed, surface preparations and the installation and compaction of a new 1.5” to 2” layer of asphalt over all paved areas.

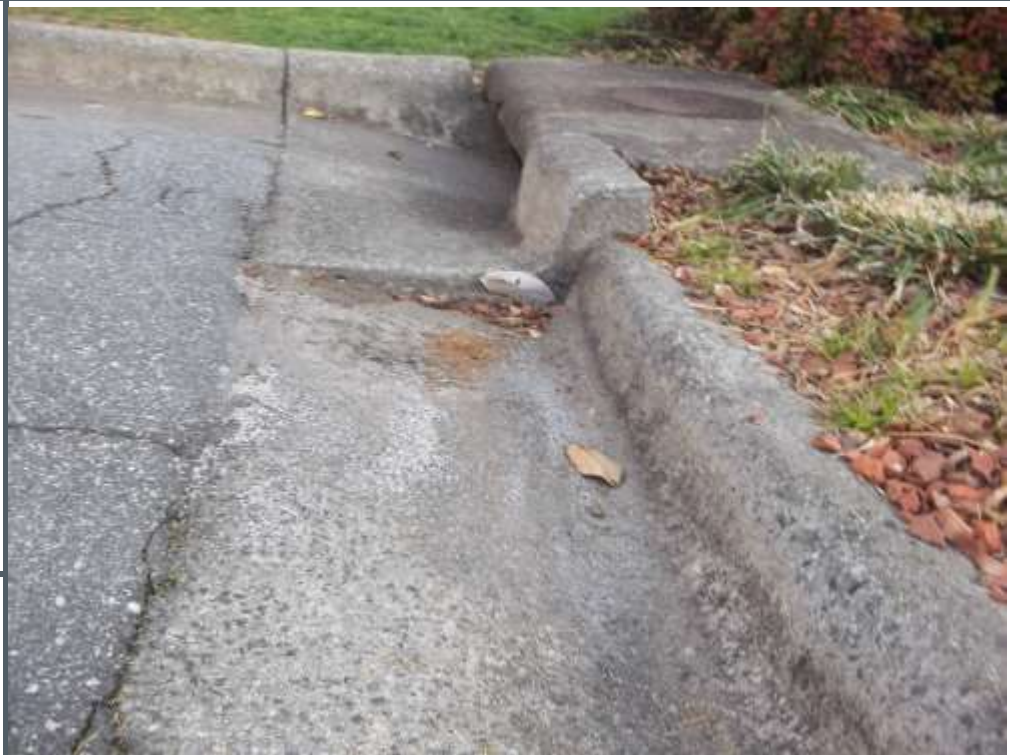
Photo No.  
4

Concrete curb and gutter are installed around sections of the paving in the community. The curb and gutter varied in condition. Sections of upheaval, depressions, cracking and spalling were observed in the concrete curb and gutter. We have allocated funds to replace approximately 5% of the concrete curbing on a 5-year cycle beginning in 2022. Replacement would include saw-cutting and removing damaged sections of curbing and pouring and finishing new concrete curbing.

View of concrete curb upheaval/depression.

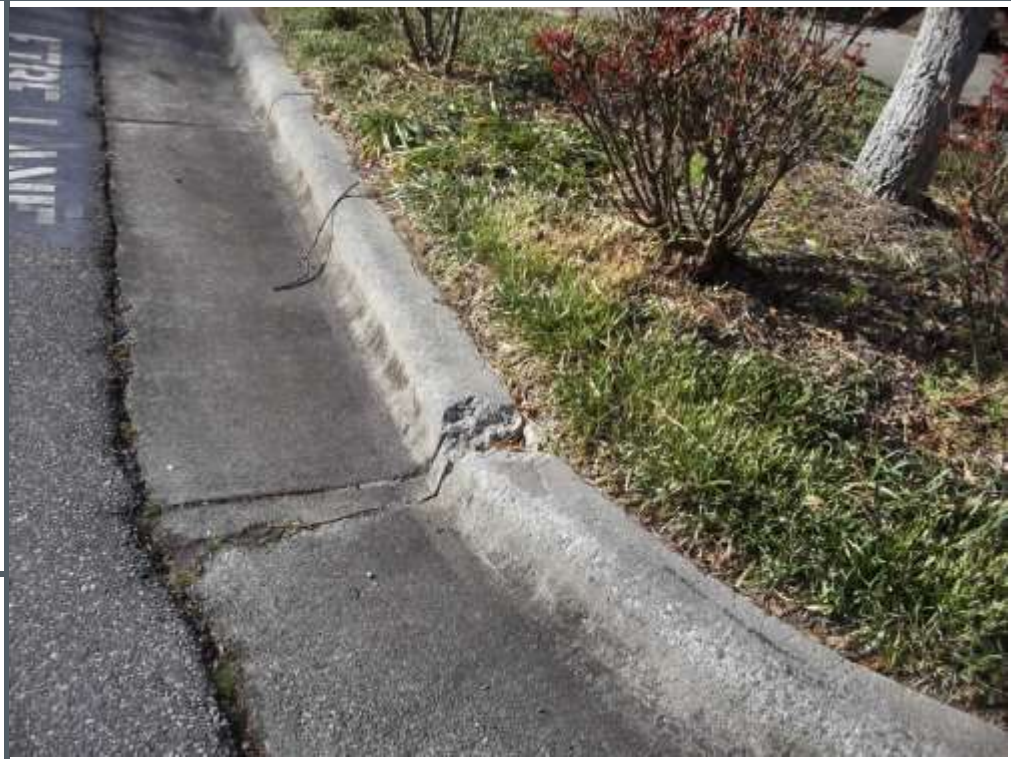
Photo No.  
5

View of  
spalling/cracking in  
concrete curbing.

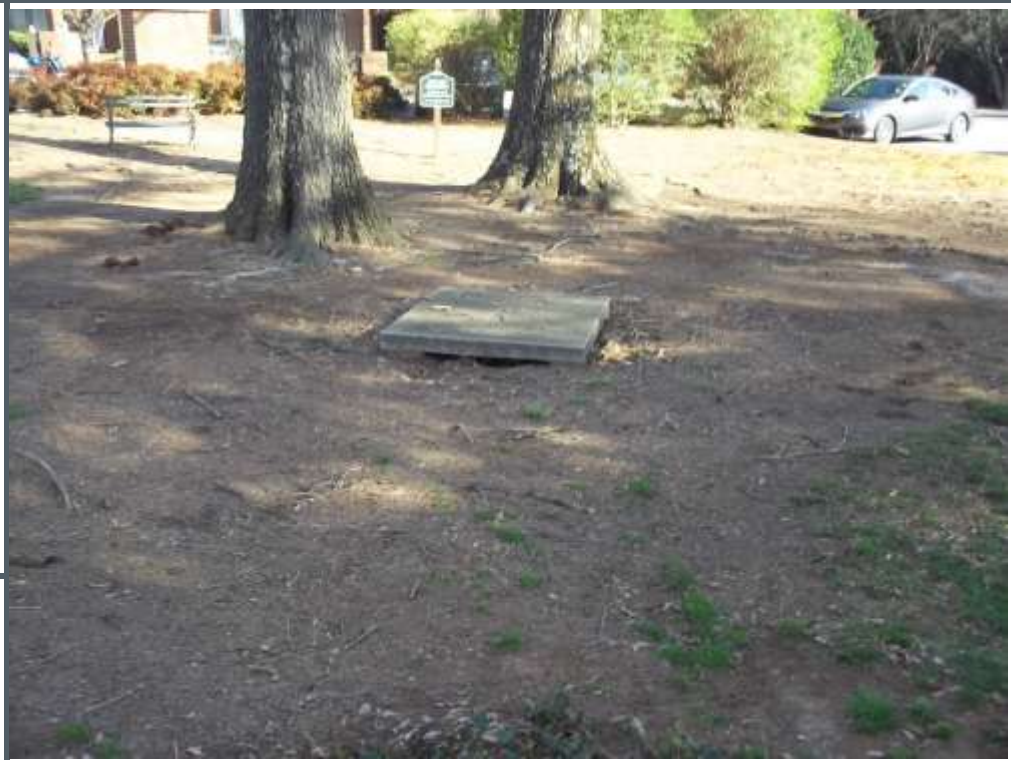
Photo No.  
6

We observed two inlet basins in the landscaped areas that are fully or partially blocked by sediment and debris. We recommend cleaning out areas around inlet basins to provide adequate drainage. We also recommend installing soil stabilizing ground cover or stone rip-rap armoring around the perimeter of the inlet basins to reduce erosion and help prevent sediment accumulation in buried piping/basins. We recommend maintaining areas around inlet basins clear of debris and sediment. We have allocated funds for drainage system improvements on a 5-year cycle beginning in 2022. Repairs will likely include addressing concerns with inlet basins noted above in the near term. Future repairs will likely include cleaning out/repairing window well drainage piping and waterproofing, cleaning out/replacing gutter downspout drain piping, cleaning out/repairing sections of buried stormwater piping, repairing erosion and possibly the installation of additional drainage infrastructure. As the buried piping systems age, the association should consider video borescope inspections of buried piping to better determine condition and repair needs.

View of drainage inlet  
basin blocked by debris  
and sediment.

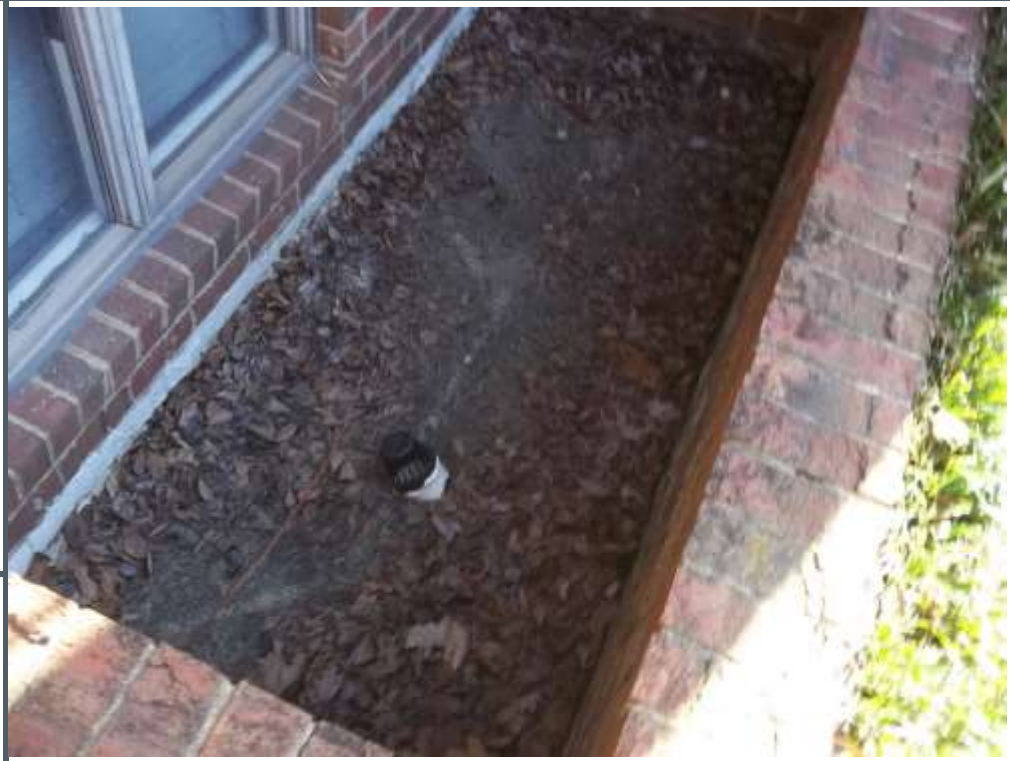
Photo No.  
7

Drainage systems include gutter downspouts that discharge to grade and buried piping. Many of the buildings include window/egress wells at the basement level. These areas include a drainage inlet pipe which presumably is connected to foundation drains leading to buried storm sewer piping. Storm water on the site also drains via surface flow toward inlet/catch basins in the curbing around paved areas and inlet basins in landscaped areas.

View of window well  
with pipe outlet.

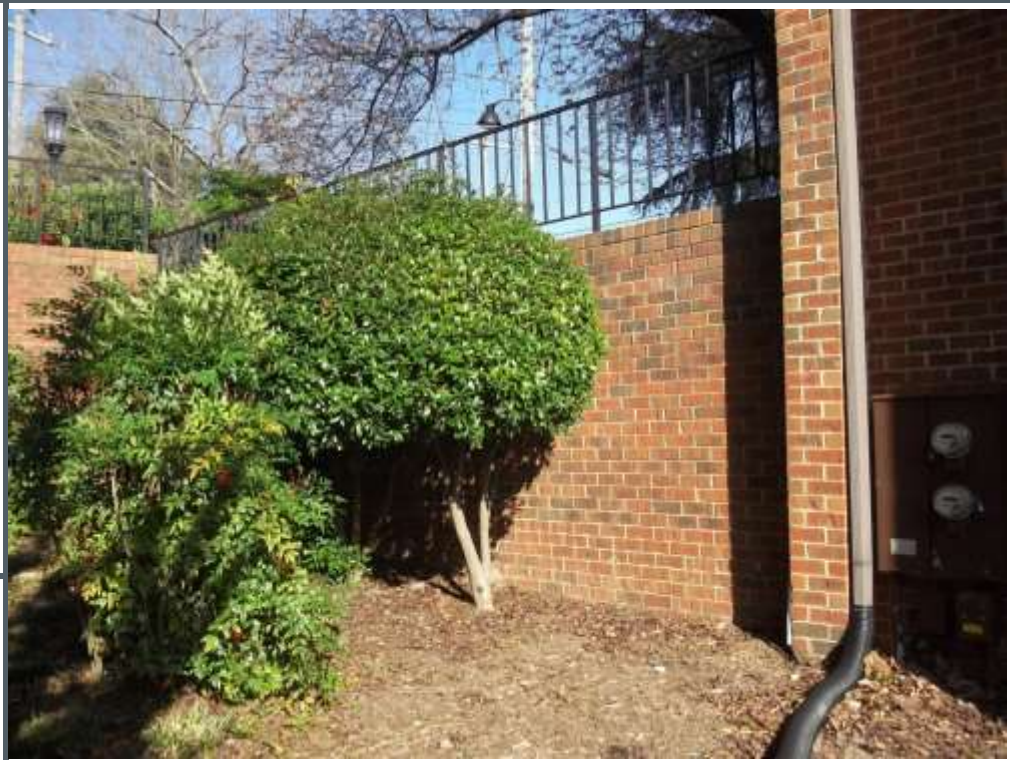
Photo No.  
8

View of masonry  
retaining wall.

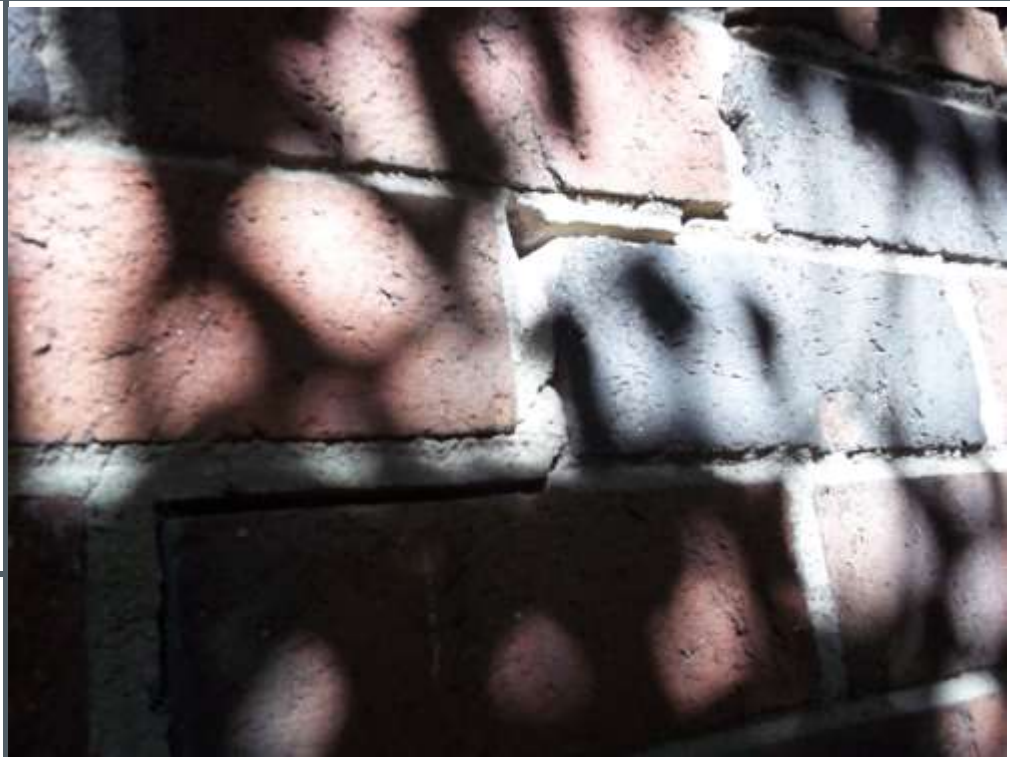
Photo No.  
9

Brick retaining walls are located in two areas between buildings in the community. We noted stair step cracking in the brick adjacent to unit 405 H. The cracking in the brick retaining wall should be closely monitored for additional movement. The cracking generally appears to be in similar condition as was noted in our previous reserve study inspection in 2015. A tree is located above the retaining wall in this area and root growth may be attributing to movement in the wall and cracking. Drainage systems behind retaining walls are also a crucial component to relieving hydrostatic pressure and prolonging the life of the retaining walls. We have allocated funds to repair the retaining walls in 2037.

Close up view of stair  
step cracking in  
retaining wall brick.

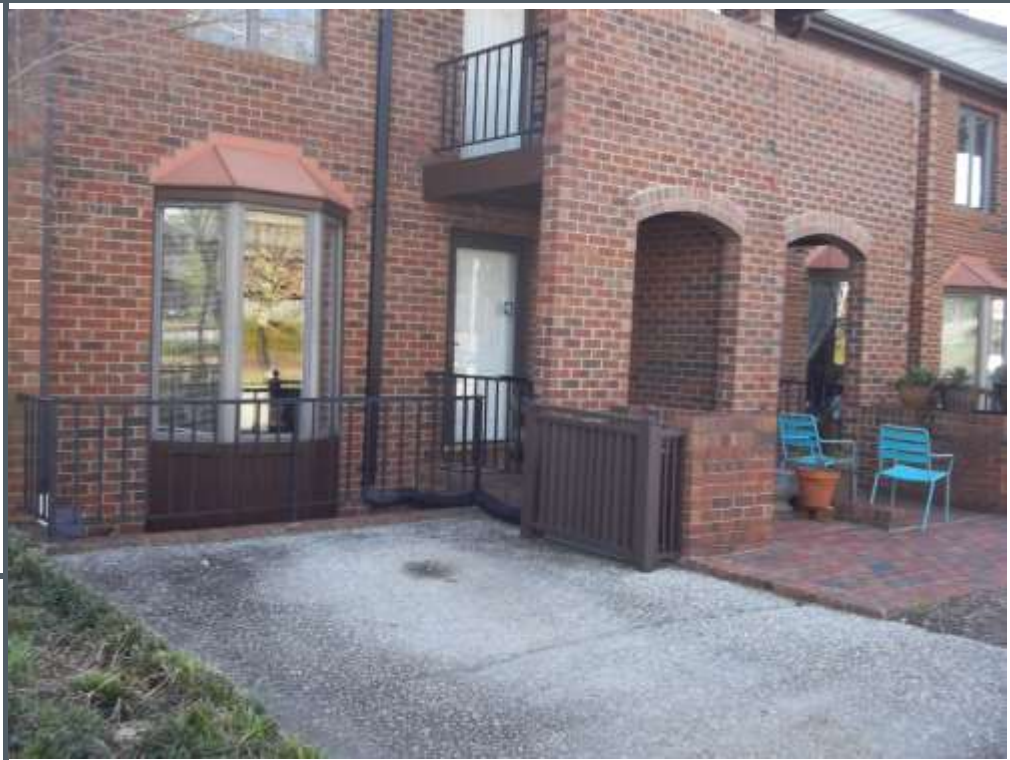
Photo No.  
10

Flatwork in the community is comprised of concrete sidewalks, concrete driveways (exposed aggregate) and brick paver walkways and steps. We noted limited cracking developing in sections of the flatwork. It is likely that due to ongoing cracking and settlement/upheaval, sections of the concrete and brick flatwork will require periodic replacement. We have allocated funds to repair approximately 5% of the total amount of flatwork on a 5-year cycle beginning in 2025. We have assumed any significant trip hazards that develop in the interim would be repaired by surface grinding and funded through an annual maintenance budget.

Typical concrete  
driveway, brick pavers.

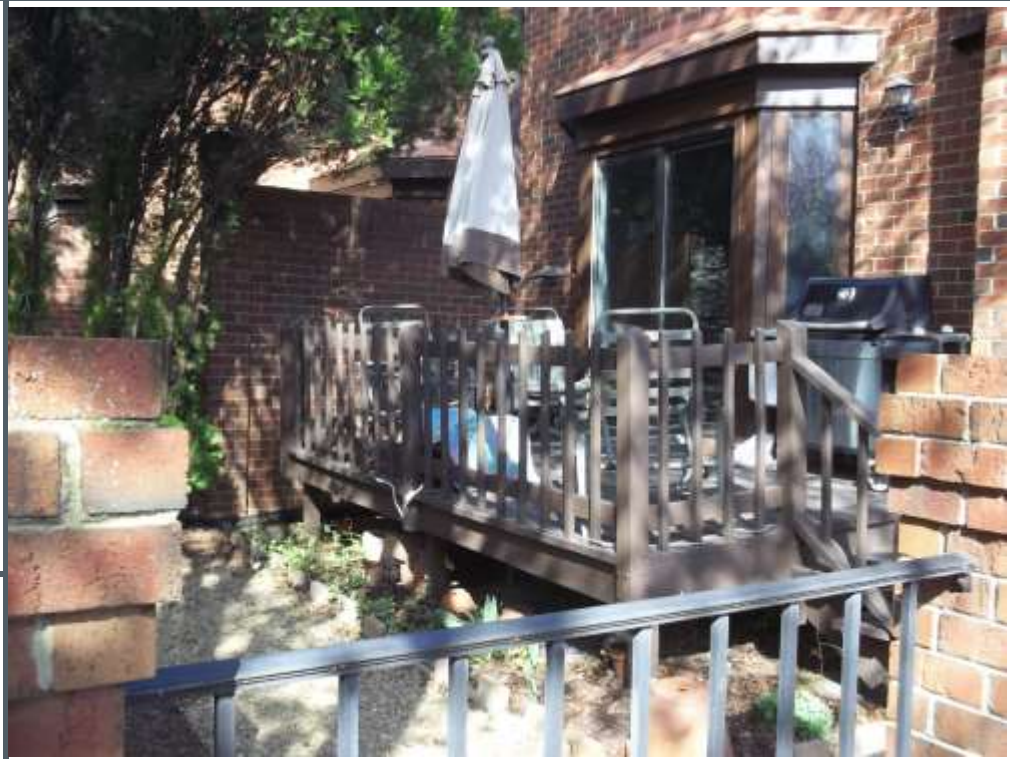
Photo No.  
11

General rear view of buildings, rear decks, bay windows, metal railings, brick accent walls.

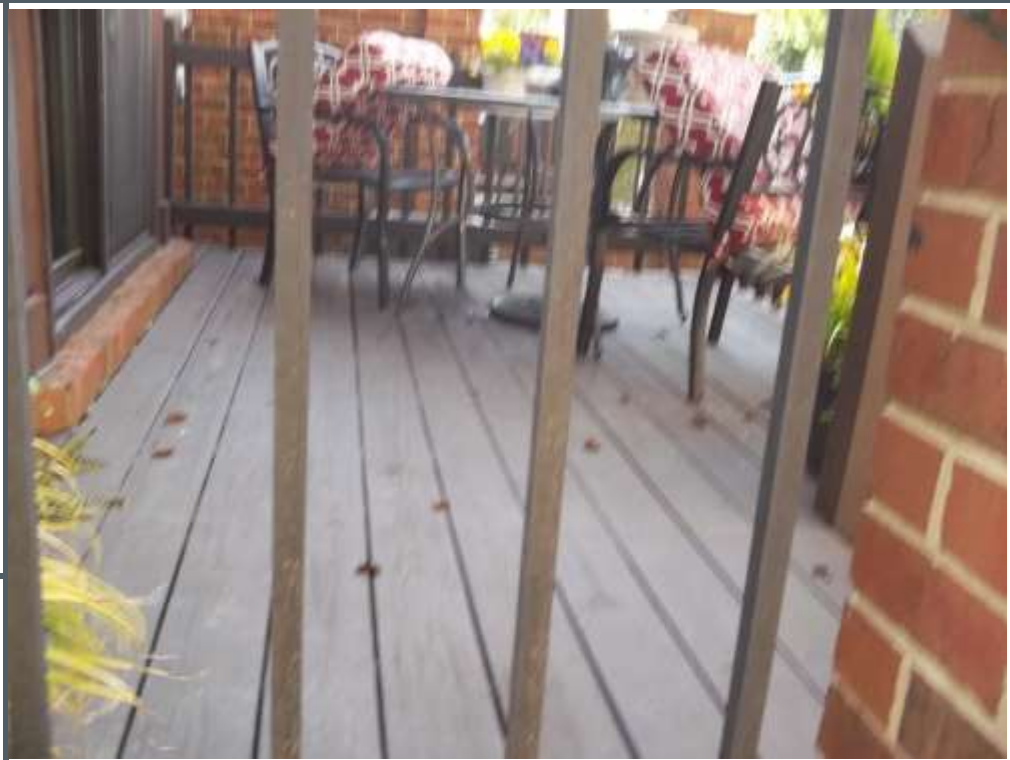
Photo No.  
12

The association is reportedly responsible for maintaining and repairing wood decks and balconies in the community. The wood decking appears to be routinely repaired and stained/painted. The wood decking and railings generally appeared to be in adequate condition. We estimate a remaining useful life of approximately 10 to 15 years prior to full replacement of decking. This assumes that replacement of damaged components and staining is completed in the interim as noted above. We have allocated funds for full replacement of wood decks and balconies in 2026.

View of wood decking.

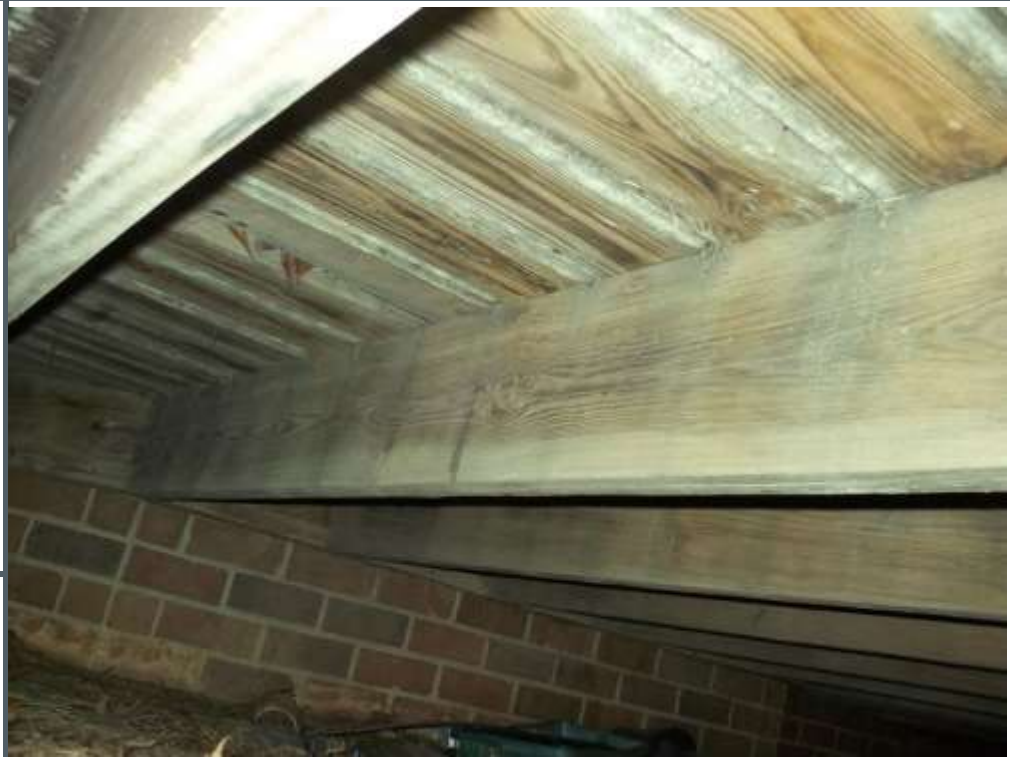
Photo No.  
13

View of framing under  
wood decks.

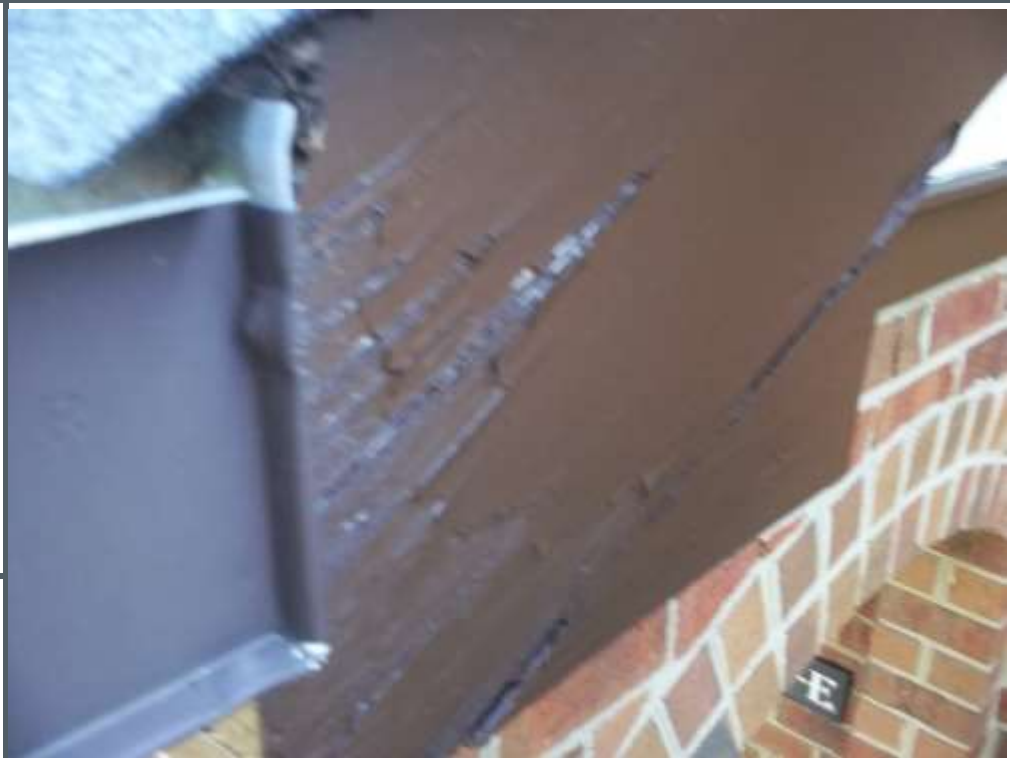
Photo No.  
14

The buildings in the community are of wood framed construction and are predominately clad brick veneer. Limited areas including upper gable ends and chimneys are clad in fiber cement lap siding. Painted wood trim is installed around chimneys, gable ends, soffit/fascia components, around doors and windows and around bay windows. Sections of painted wood screen fencing is installed around outdoor HVAC units throughout the community. The painted trim and siding components generally appeared to be in good to fair condition. Limited areas of flaking paint and splitting wood components were noted in sections of fascia trim on the buildings. Areas of deteriorated siding were observed on chimneys at the transition to shingled roofing. It appears the doors and trim work around doors and lower-level bay windows have recently been repaired and painted.

Close up view of  
deterioration in wood  
trim on fascia.

We have allocated funds to repair and paint all of the siding, painted wood trim, painted wood decking, painted wood fencing and metal railings on the buildings on a 7-year cycle beginning in 2025. The repair and paint project should include replacing any damaged sections of wood trim/decking or lap siding components with rot resistant fiber cement or PVC components. All sealant and caulking around windows, doors and other penetrations and transitions should be inspected and sealant/caulk replaced as needed. Note that the limited sections metal roofing over bay windows may also require periodic recoating during the painting project. We do not anticipate full replacement of metal roofing to be required over the term.

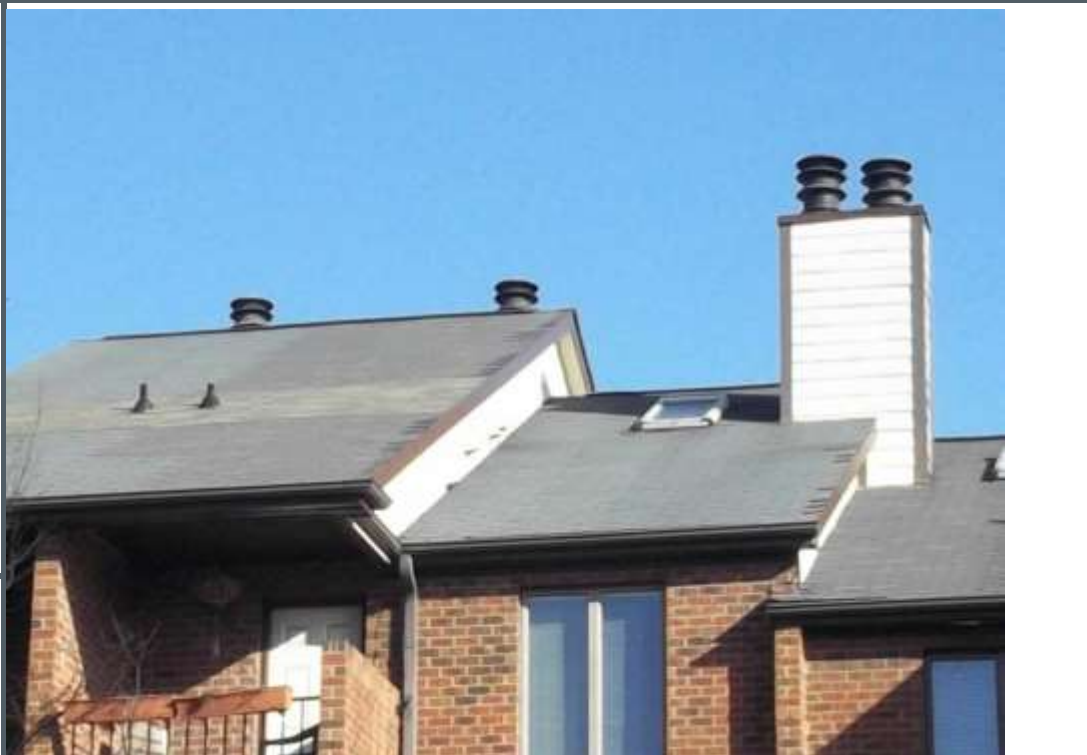
<p>Photo No. 16</p>

The pitched roof surfaces over the buildings are primarily covered in asphaltic fiberglass, 3-tab shingles. Roof surfacing is applied over roof sheathing and the shingles appeared to vary in condition. We noted significant amounts of patch work and repairs that have been completed on buildings 100/805 and 102/405. The shingled roofs on building 104/626 appeared to be in better condition with less patchwork evident. The shingles on the remaining buildings (620, 621, 622 and 624) generally appeared to be in better condition. We noted minor texture loss and limited areas of cracking developing in the shingles and isolated minor areas of individual shingle replacement. It appears that vent boots have been retrofitted with new gasket overlays at plumbing vent pipe penetrations.

<p>Description</p> <p>View of extensive patchwork and repairs on roofing of select buildings.</p>

Considering funding constraints and varying condition of roof shingles, we have allocated funds to replace the roofing in the community in phases. We have allocated funds to replace the roofs on buildings 100/805 and 102/405 in 2022. We have allocated funds to replace the roofs on the 104/626 building in 2023 and to replace the roofs on the remaining buildings (620-624) in 2024. Note that minor repairs will likely be required in the interim to these buildings including replacing individual shingles and repairing flashing.

We strongly recommend that any re-roofing project closely follow procedures outlined by the National Roofing Contractors Association's *Roofing and Waterproofing Manual*, Fifth Edition. A re-roofing sequence should include removal of the existing roofing material, replacement of any inadequate roof sheathing, replacement of any damaged flashing, and replacement of drip edge components. Many of the units include skylights. We have assumed the individual unit owners would be responsible for replacing skylights. We strongly recommend skylight replacement to be completed during roof replacement to ensure adequacy of flashing installation around these penetrations. The metal gutters and downspouts generally appeared to be in adequate condition. We have included funds in roof replacement allocations to replace sections of gutters and downspouts as needed.

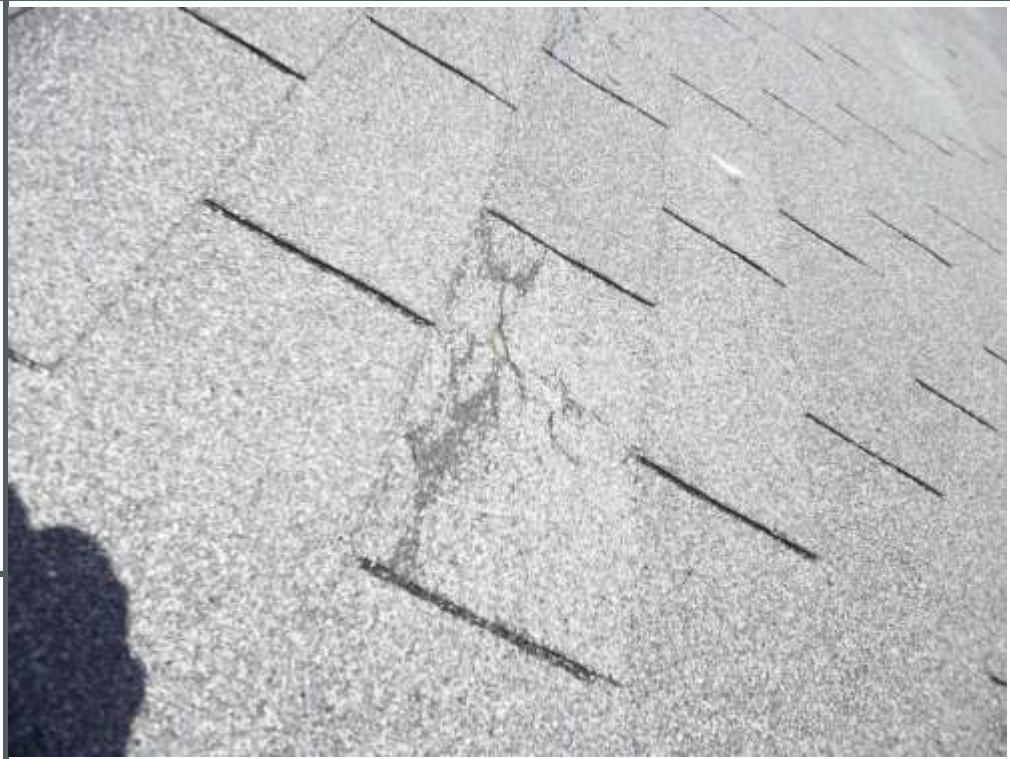
Photo No.  
17

View of minor texture loss and cracking developing in isolated areas of shingles.

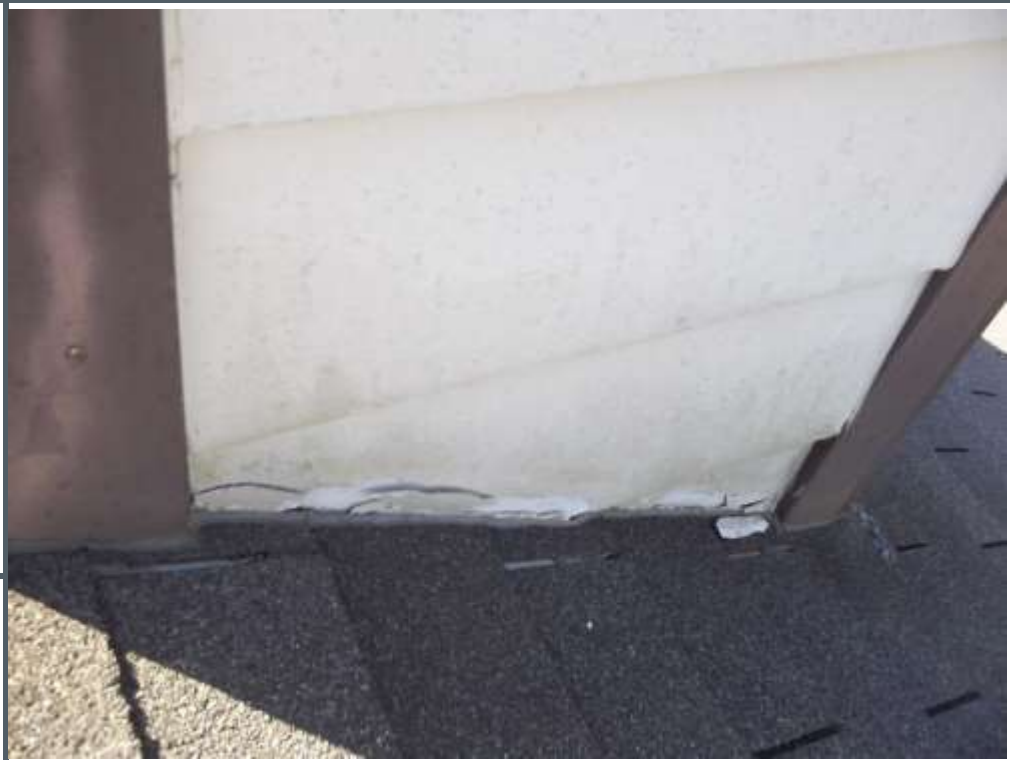
Photo No.  
18

Deterioration noted in siding at bottom of chimneys at roof transition.

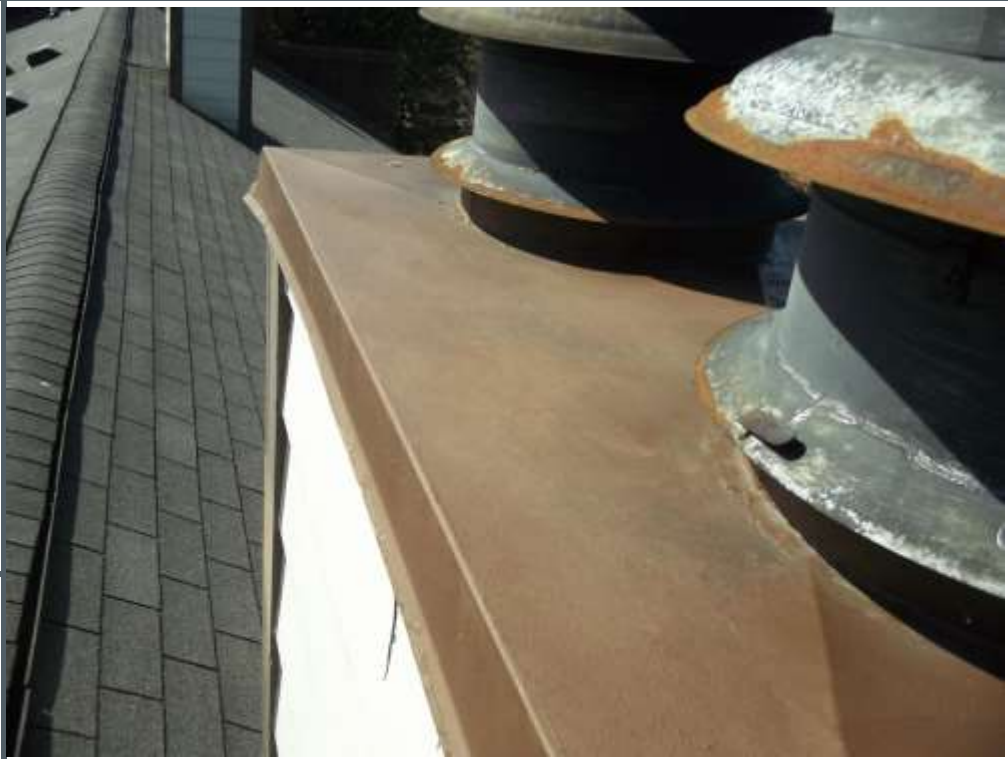
Photo No.  
19

The Association is also responsible for replacing the chimney caps throughout the community which appeared to be in fair condition. We have allocated funds to replace the chimney caps in 2028.

View of chimney cap generally in good condition.

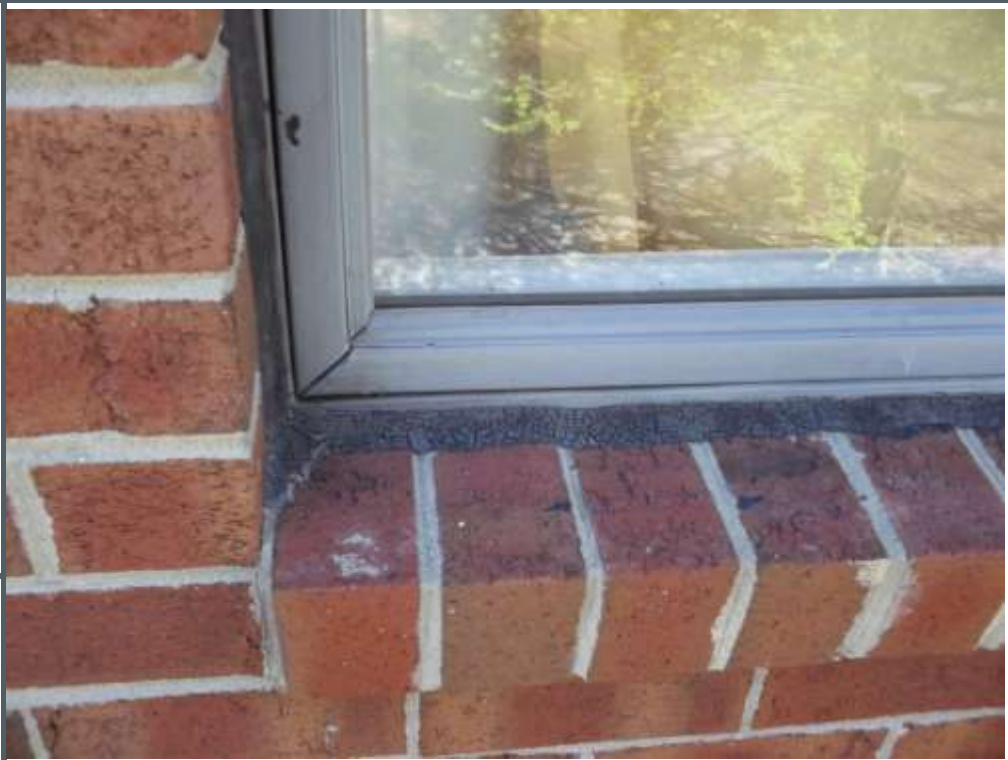
Photo No.  
20

Sealant installed between windows and brick veneer.
