# iCYCLONE CHASE REPORT

| storm | Hurricane BERYL | | |
| location | Quintana Roo, Mexico Texas, USA | | |
| date | 05-08 July 2024 | | |

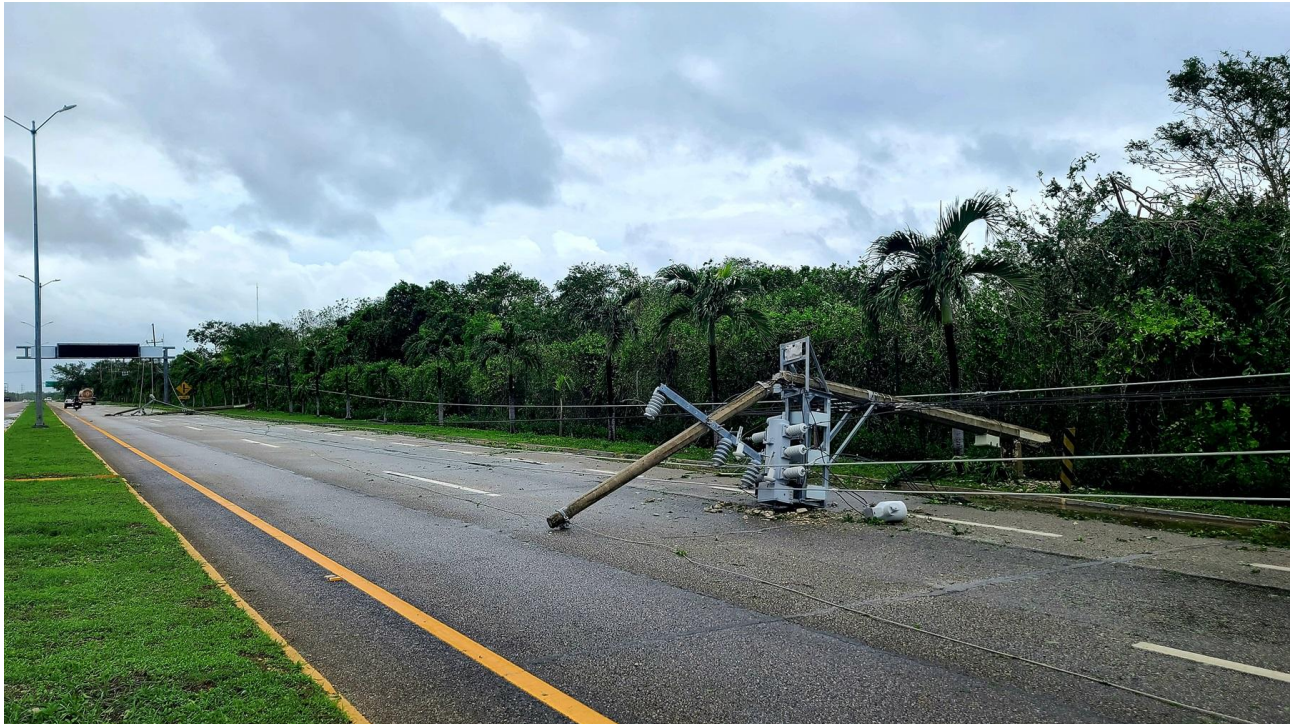
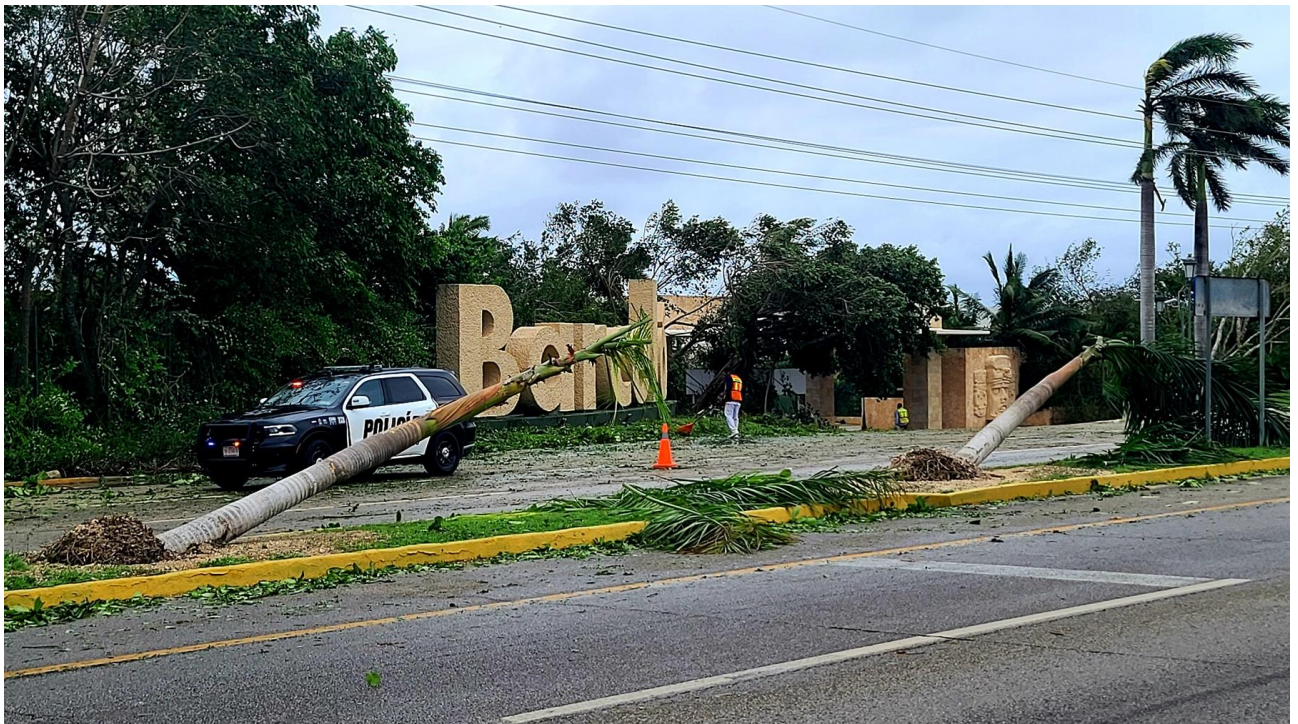
### Figures 16 & 17: Wind Damage Along Highway 307 Near Xpu Ha

There was little damage from Tulum up to Playa del Carmen, and what damage the author could find was spotty, suggesting damaging winds were highly localized. For example, on Highway 307 near Xpu Ha, the author found a 100-meter stretch with felled trees and power poles (see **Figures 16-17**). Since they fell in different directions, it’s assumed the damage was caused by a mesovortex or some other very localized disturbance. The author also saw at least one collapsed building façade (**Figure 18**).

*Wind damage on Mexico's Yucatan Peninsula was mostly very light. But there were some isolated pockets of heavier damage. A 100-meter stretch of Highway 307 near Xpu Ha had several downed palms and power poles. They fell in different directions, suggesting a localized disturbance or mesovortex struck the area.*

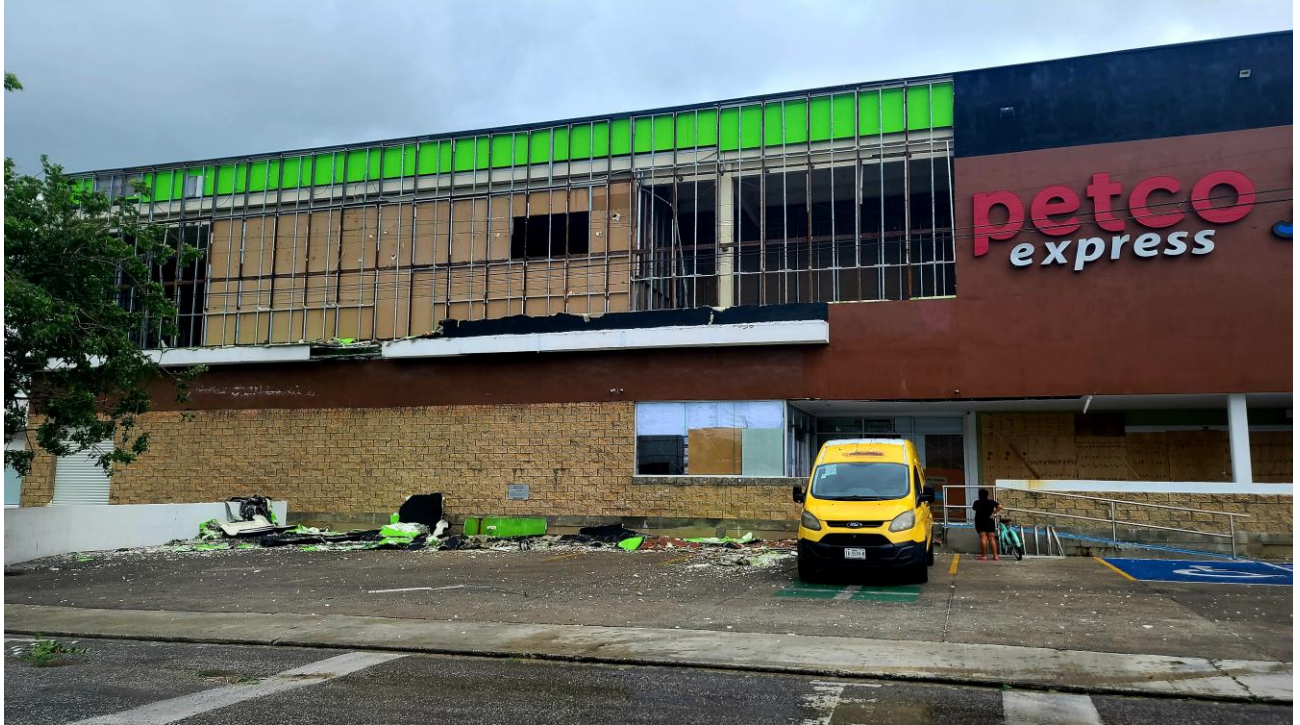
**Figure 18: Wind Damage in Playa del Carmen**

*Wind damage on the Yucatan Peninsula was mostly light. Instances of significant damage were spotty and isolated. This commercial building in Playa del Carmen lost much of its façade.*

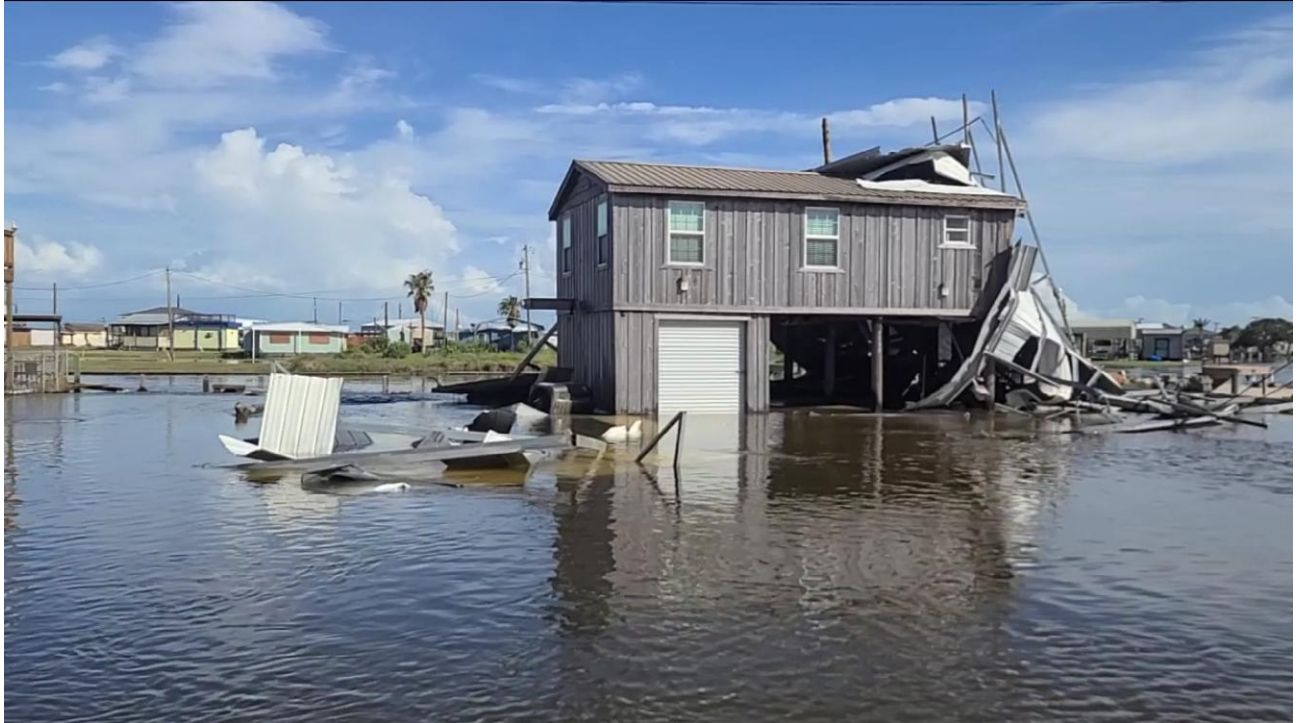
**Figure 20: Sargent—Wind & Storm Surge Damage**

Impacts in **Sargent** were heavier. Because this low-lying community was well E of the center, it had strong onshore flow, resulting in widespread light-to-moderate wind damage and a significant storm surge. Estimated by the author to be ~4-5 ft, this surge tore up the coast road, inundated many streets and homes, displaced some vehicles and structures, and left large piles of debris (see **Figures 20-36**).

*There was widespread, moderate wind and storm-surge damage across Sargent.*

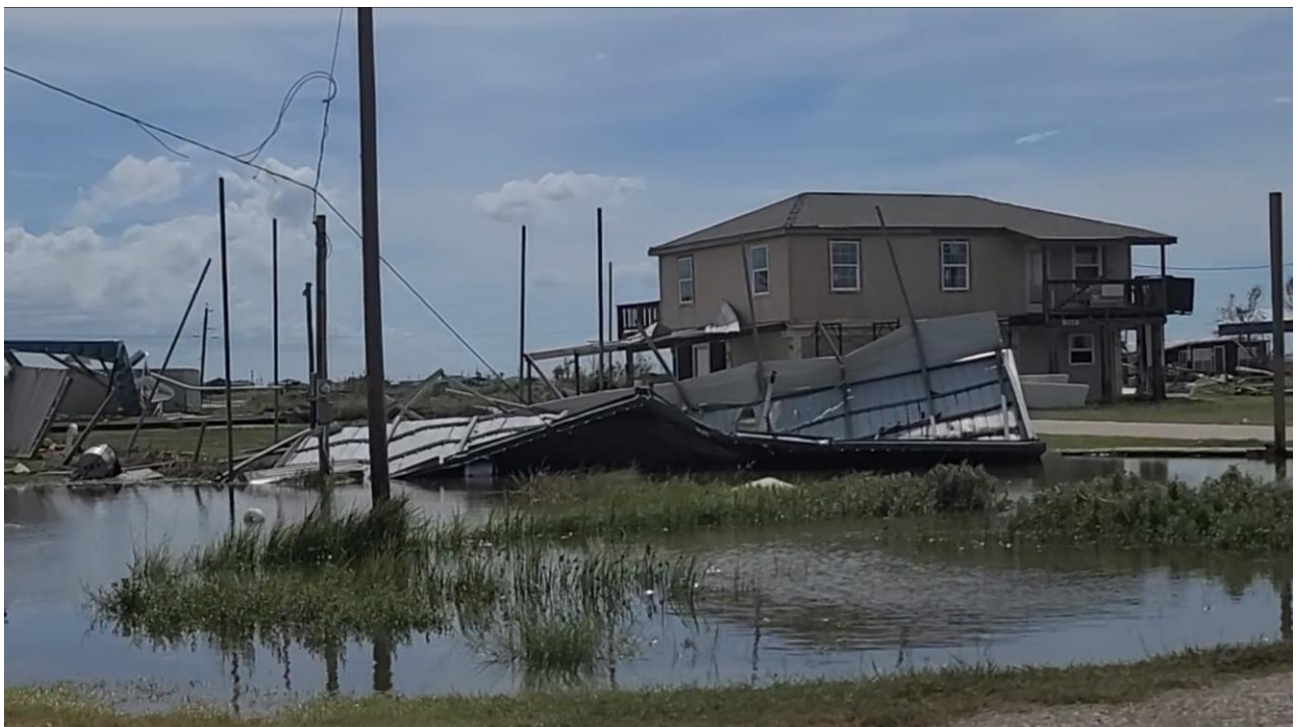
**Figure 21: Sargent—Wind & Storm Surge Damage**

*Poorly fastened roofs and lightweight carports were no match for BERYL's winds in Sargent.*

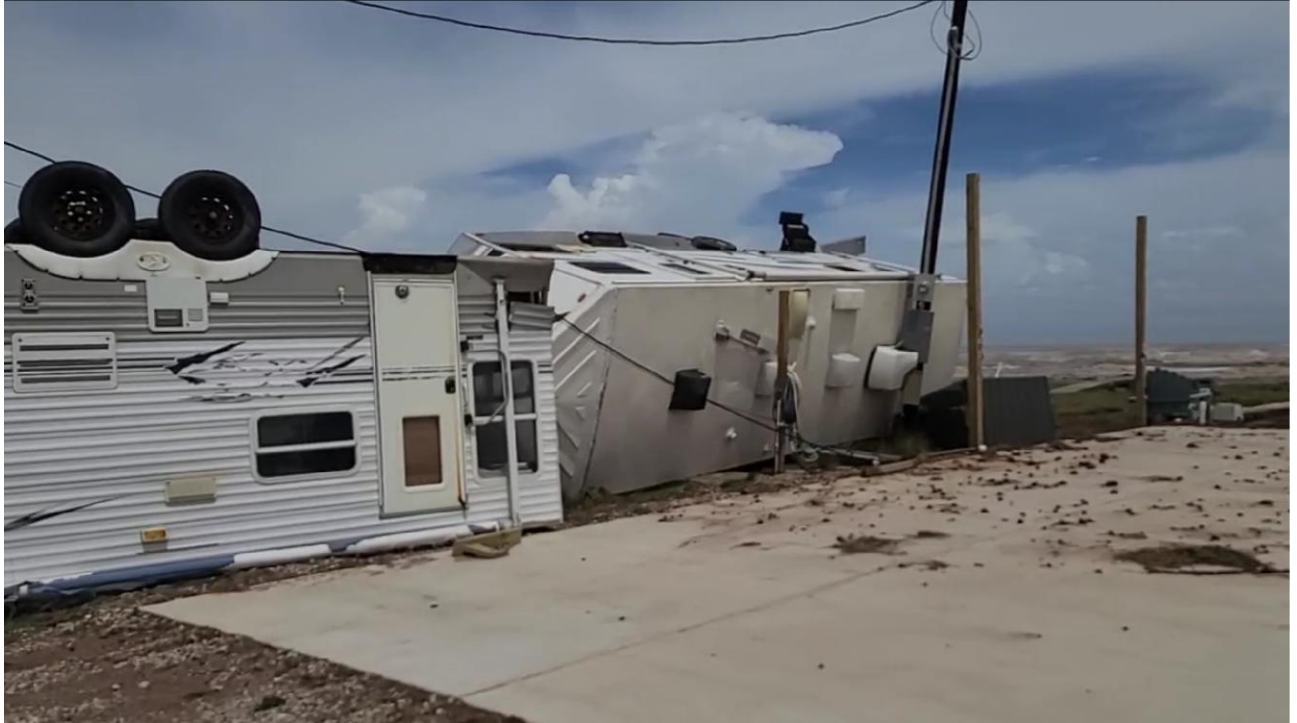
**Figure 22: Sargent—Wind & Storm Surge Damage**

*These vehicles near the beach in Sargent were probably flipped by storm surge, although wind may also have played a role.*

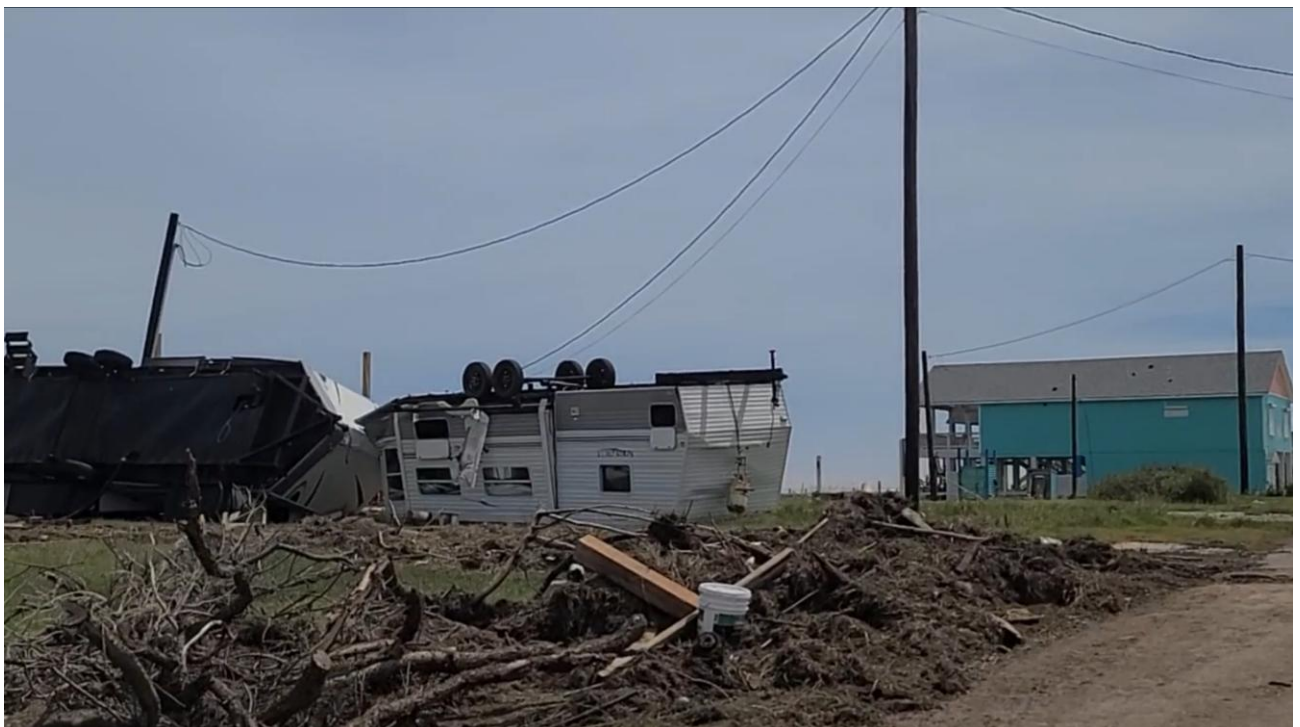
**Figure 23: Sargent—Wind & Storm Surge Damage**

*Another view of the flipped vehicles near the beach in Sargent.*

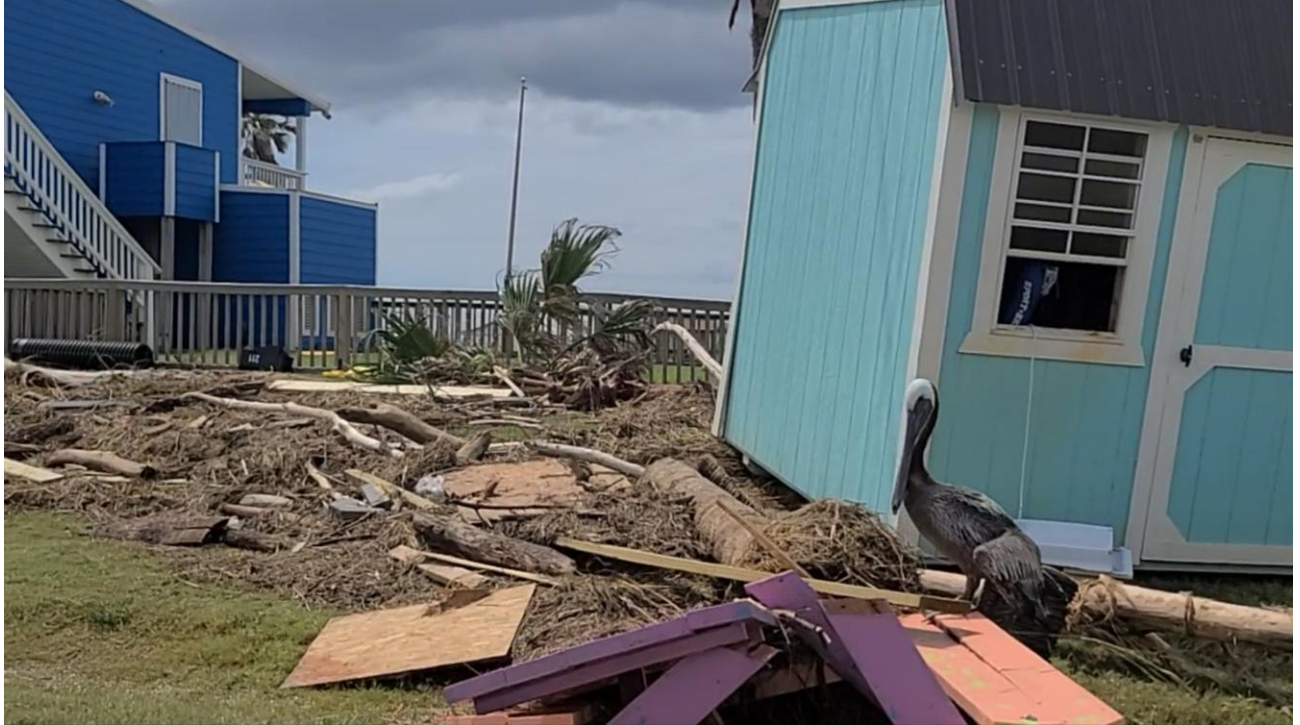
**Figure 24: Sargent—Storm Surge Damage**

*BERYL's storm surge wasn't especially high, but Sargent is so low-lying that even a few feet of water wreaked havoc, moving structures off their foundations and leaving large piles of debris.*

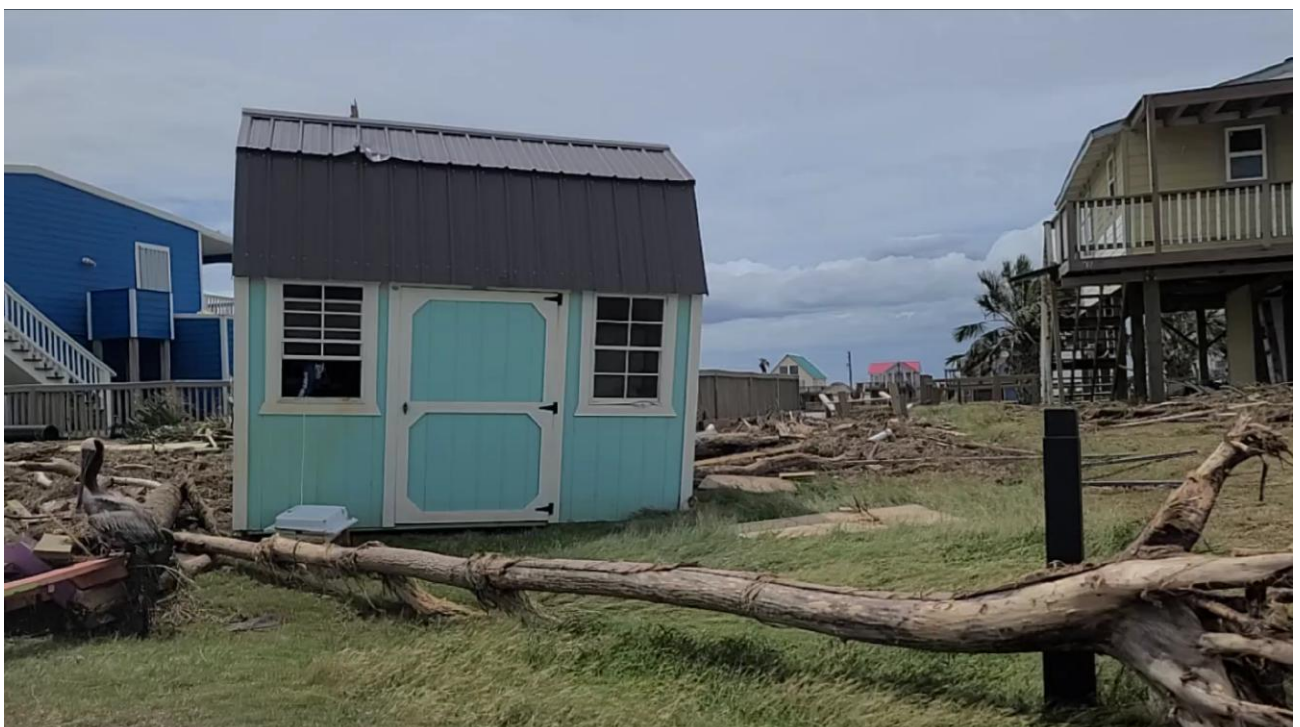
**Figure 25: Sargent—Storm Surge Damage**

*Another view of a shifted structure and other debris in Sargent.*

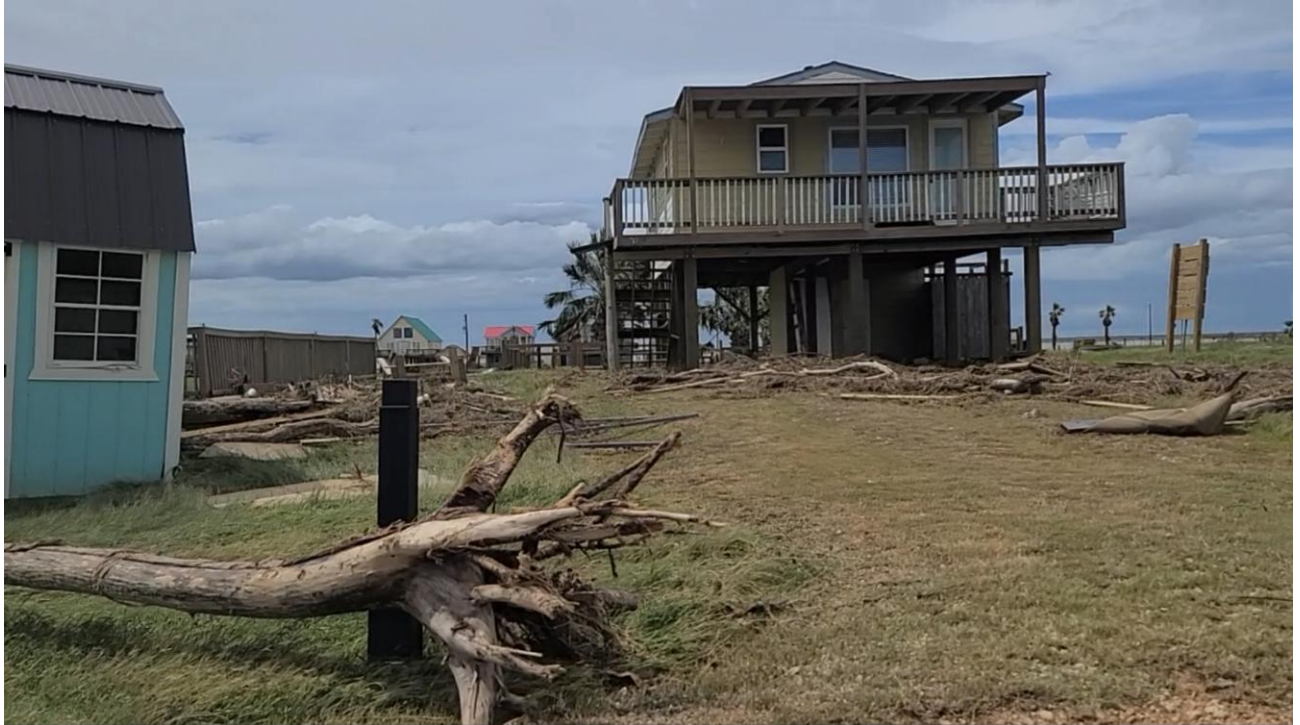
**Figure 26: Sargent—Storm Surge Damage**

*Another view of a shifted structure and other debris in Sargent.*

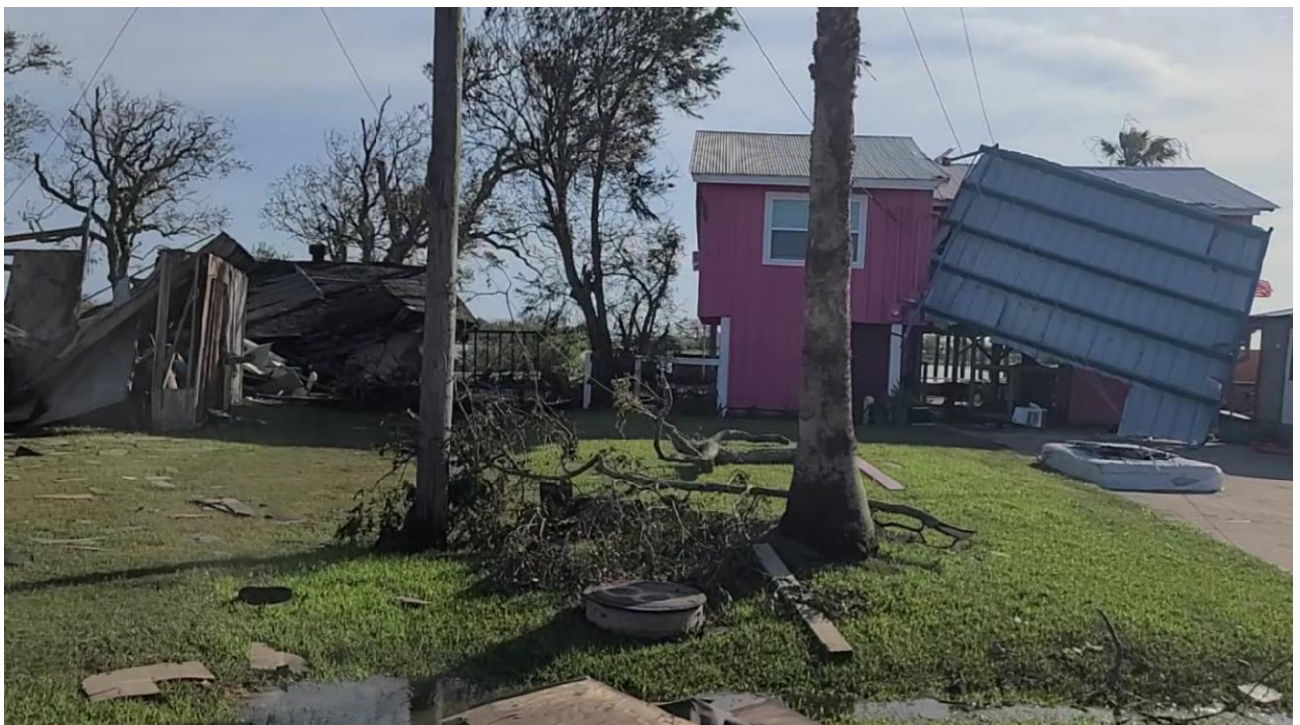
**Figure 27: Sargent—Wind & Storm Surge Damage**

*There was moderate but widespread wind and storm-surge damage across Sargent.*

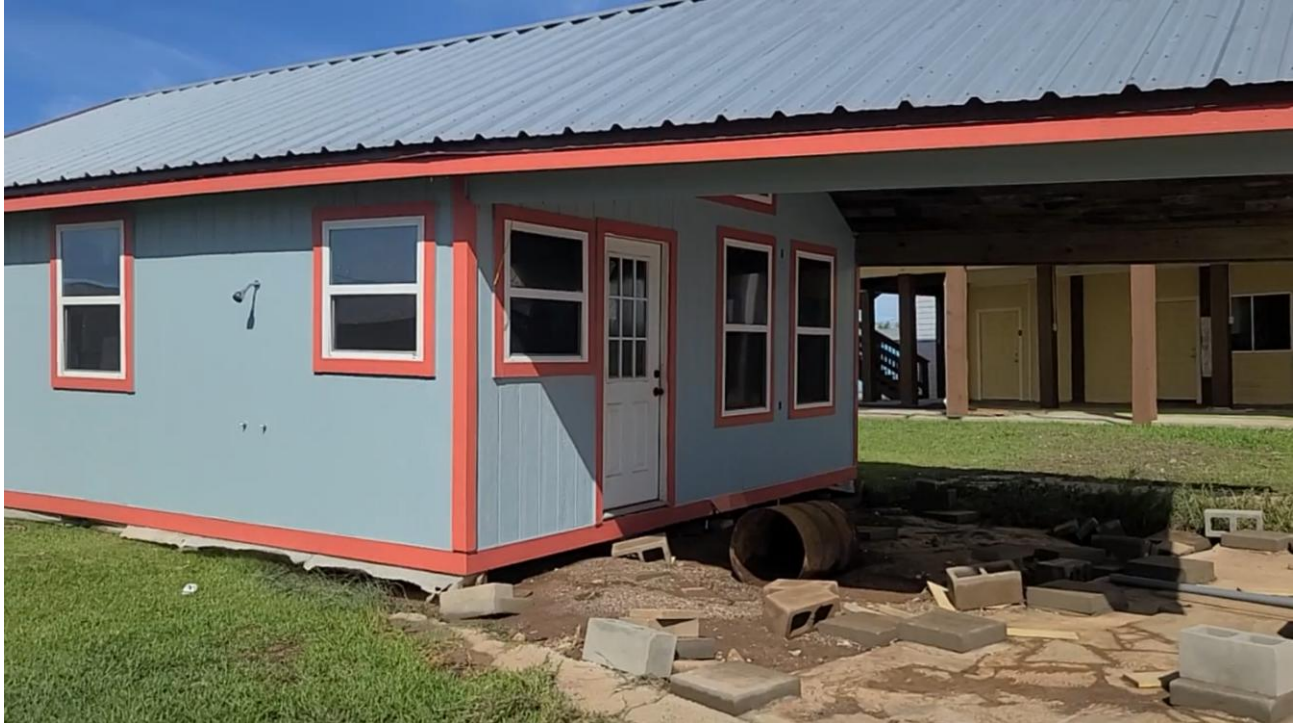
**Figure 28: Sargent—Storm Surge Damage**

*Storm surge knocked this beach house off its foundation and pushed it several feet back in Sargent.*

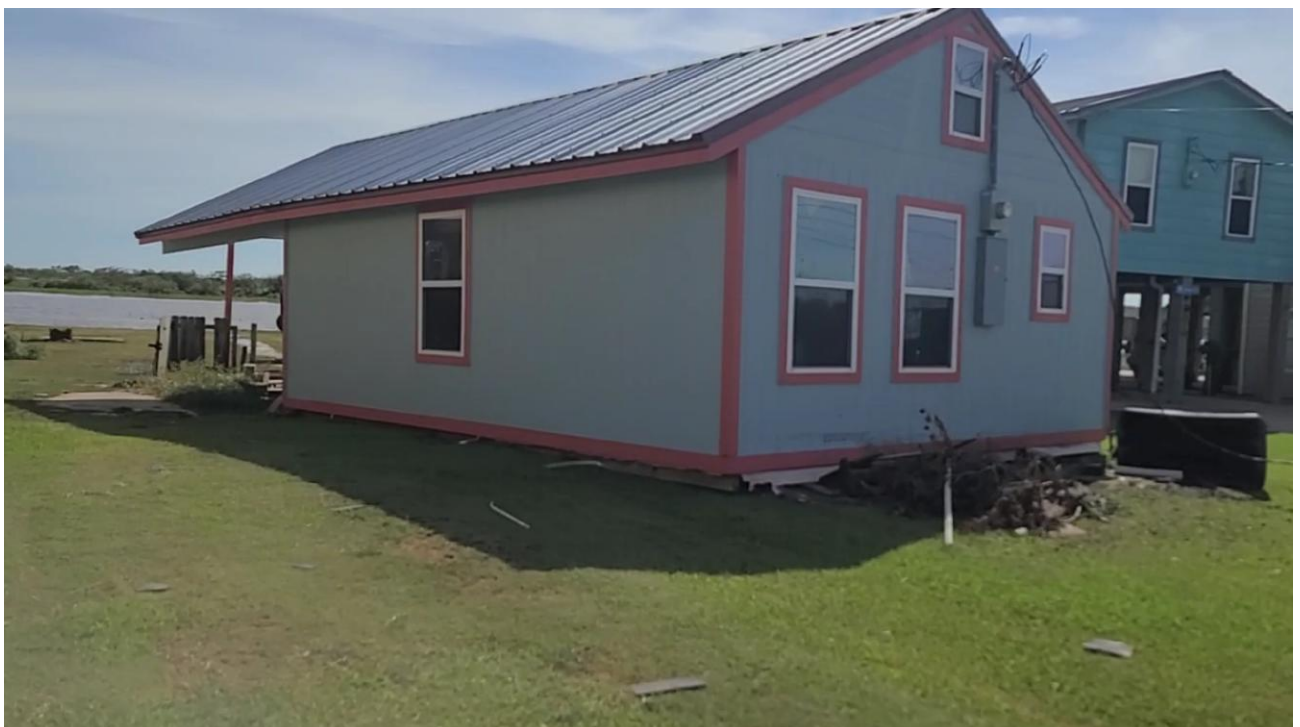
**Figure 29: Sargent—Storm Surge Damage**

*Another view of the beach house in Sargent that was pushed off its foundation by storm surge.*

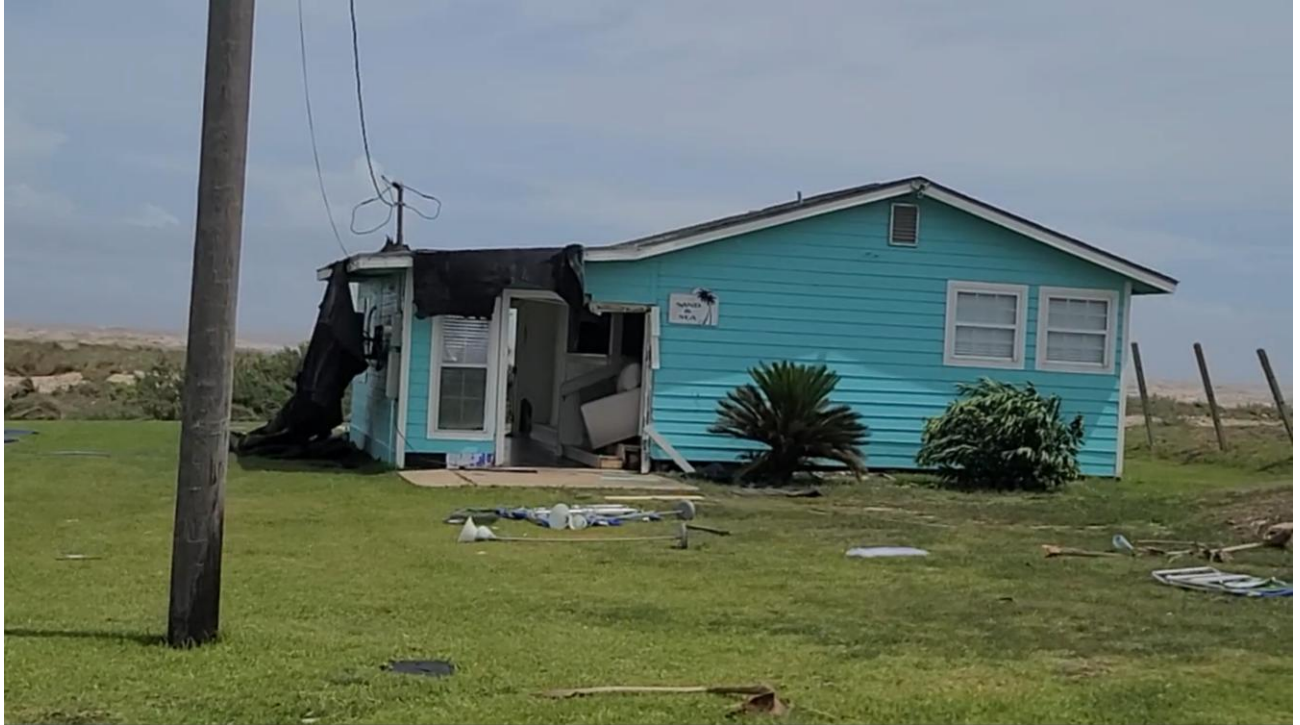
**Figure 30: Sargent—Wind & Storm Surge Damage**

*Most homes along the beach in Sargent survived BERYL's storm surge—but in many cases, the rushing waters bulldozed and gutted the first floor. This house also shows wind damage.*

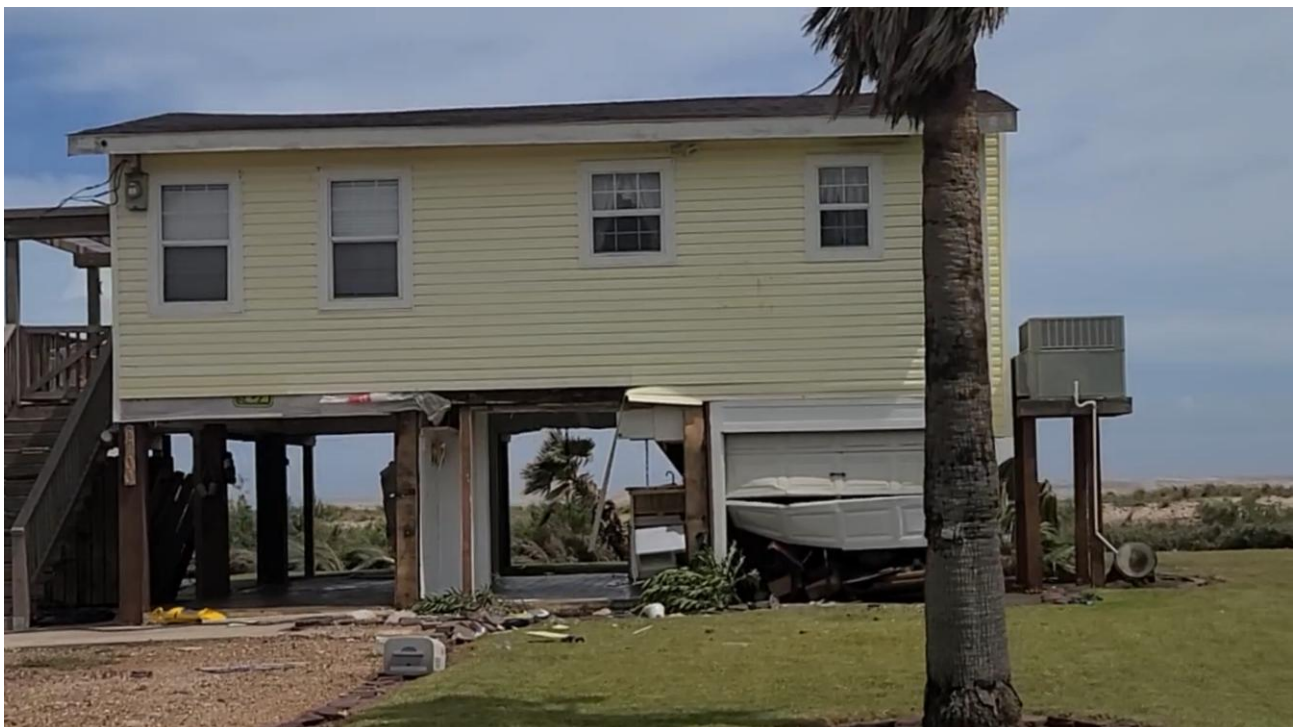
**Figure 31: Sargent—Storm Surge Damage**

*As with many homes along the beach in Sargent, BERYL's storm surge flowed through the first floor of this one, gutting it and badly damaging the garage.*

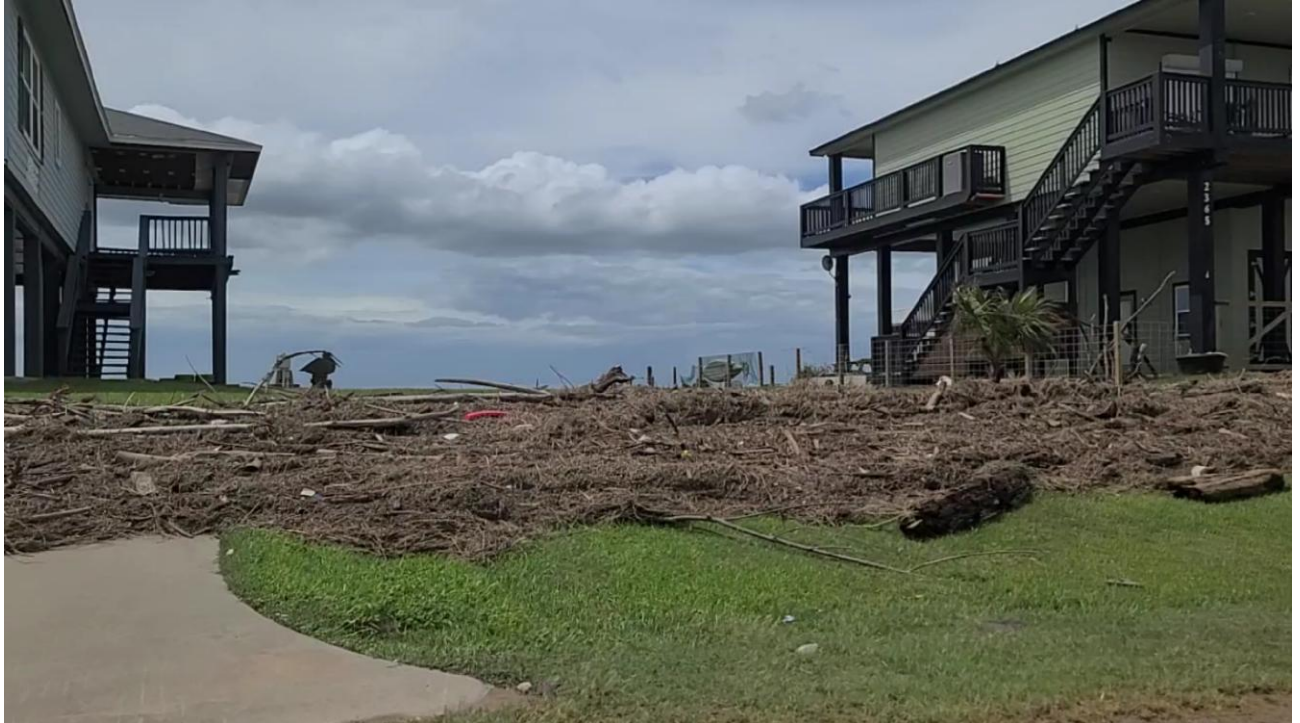
**Figure 32: Sargent—Storm Surge Damage**

*BERYL's storm surge left major debris lines and huge piles of wreckage all over the low-lying town of Sargent.*

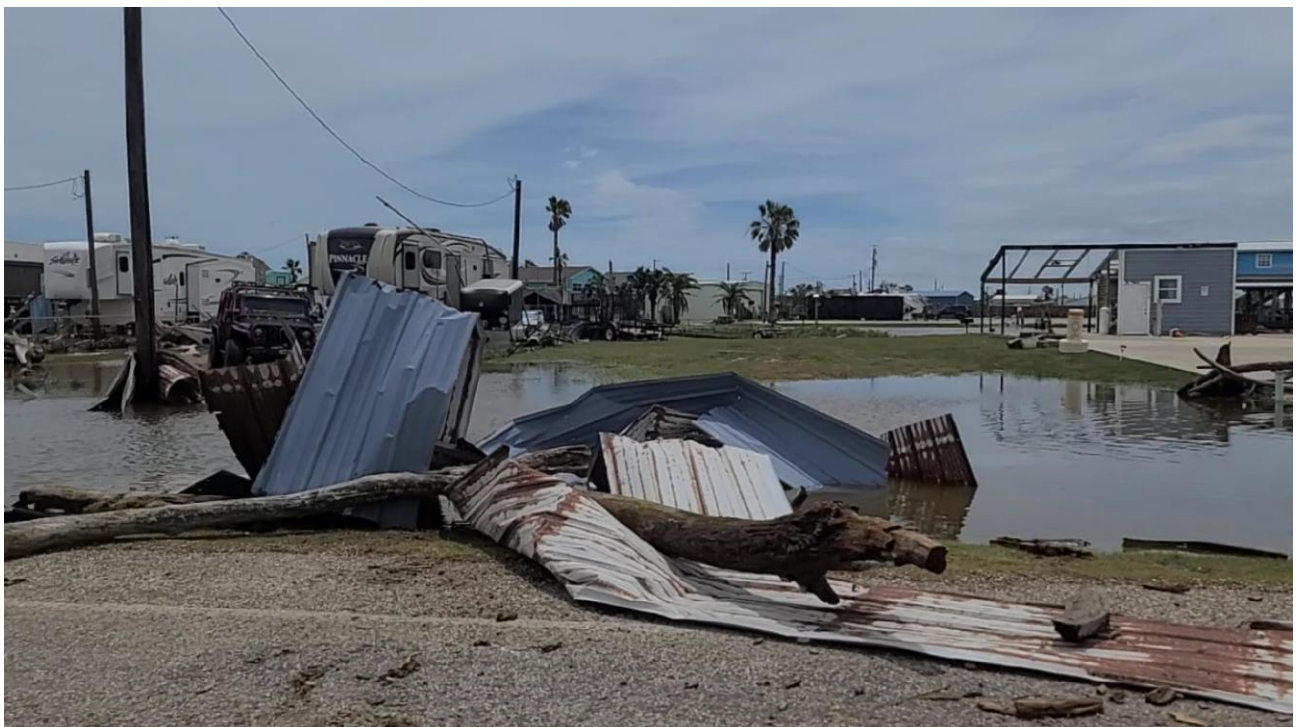
**Figure 33: Sargent—Wind & Storm Surge Damage**

*Hurricane BERYL's wind and storm surge left wreckage and debris all over Sargent.*

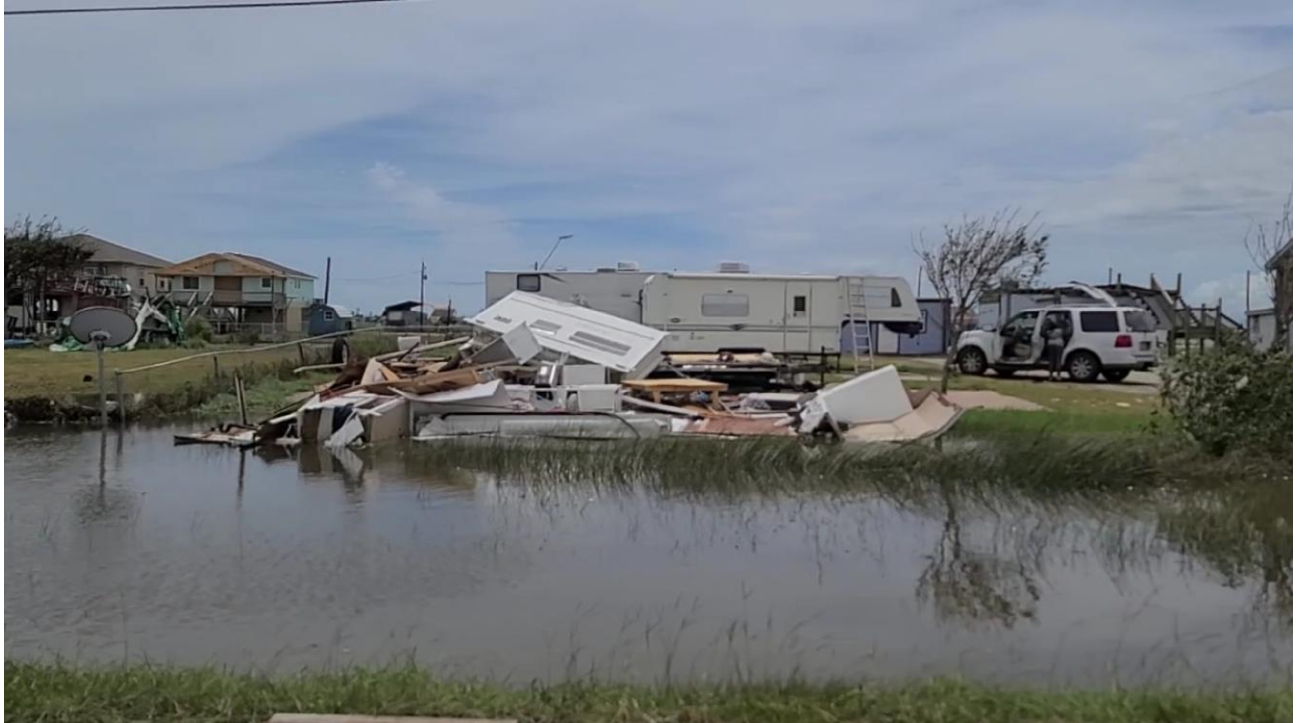
**Figure 34: Sargent—Wind & Storm Surge Damage**

*An apparent mobile home or RV in Sargent that was destroyed by Hurricane BERYL.*

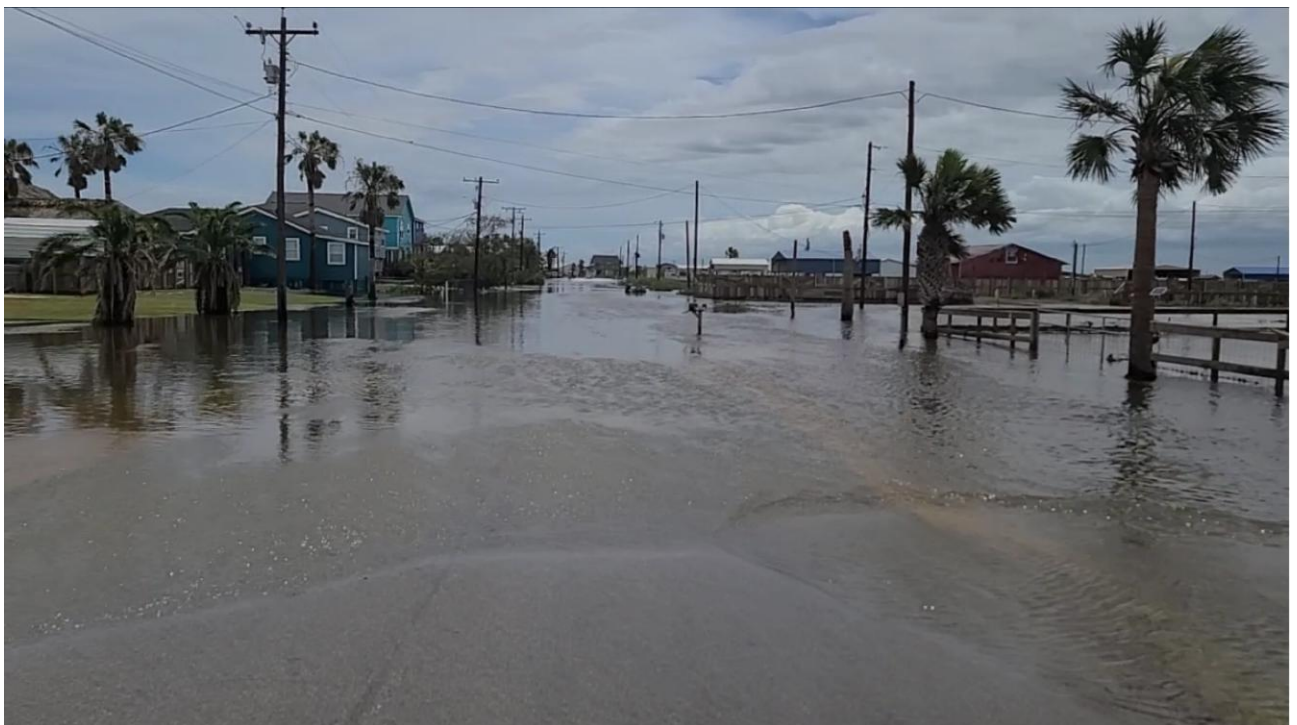
**Figure 35: Sargent—Storm Surge Inundation**

*The inundation caused by Hurricane BERYL receded only slowly. By late afternoon, many areas of Sargent—including major streets—were still flooded.*

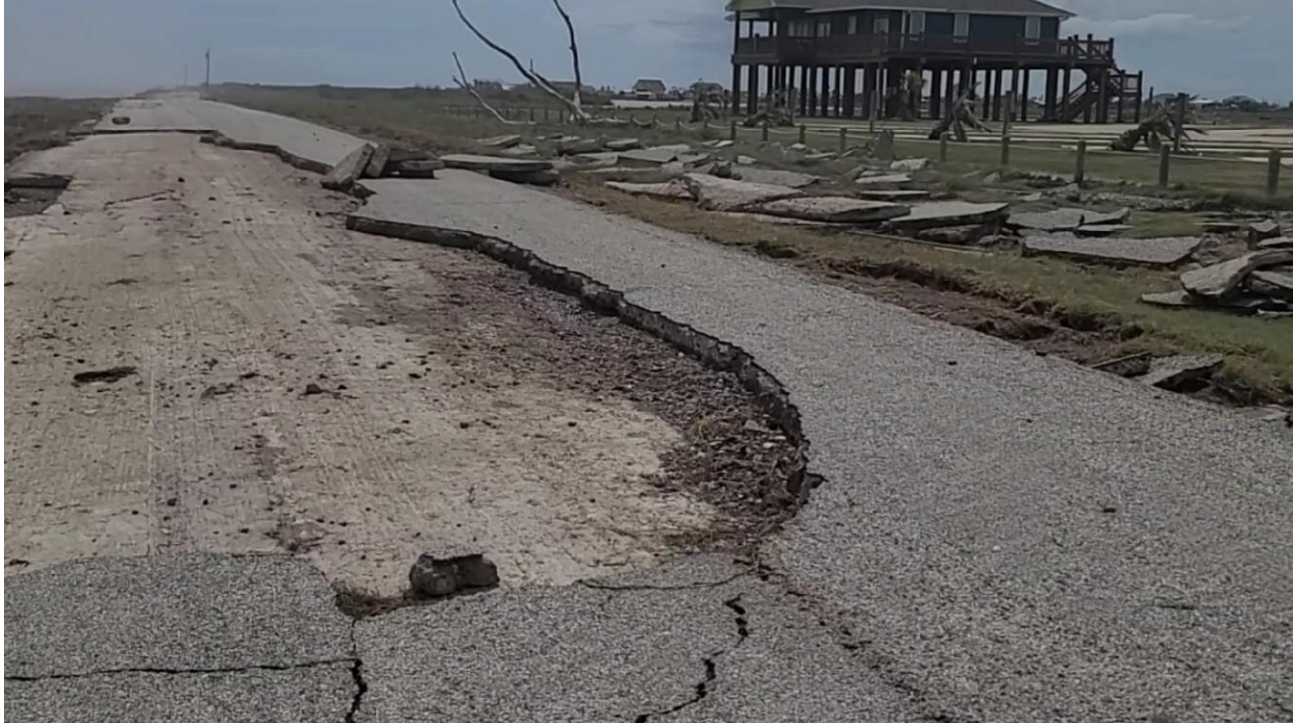
## Figure 36: Sargent—Storm Surge Damage

*Hurricane BERYL's storm surge defaced and destroyed this beachside road, scattering pieces of pavement far from the road.*
