Capitol Square Project History and Status

*Summary Report of the Oversight Group
on Capitol Rehabilitation and Restoration*

Prepared January 2016

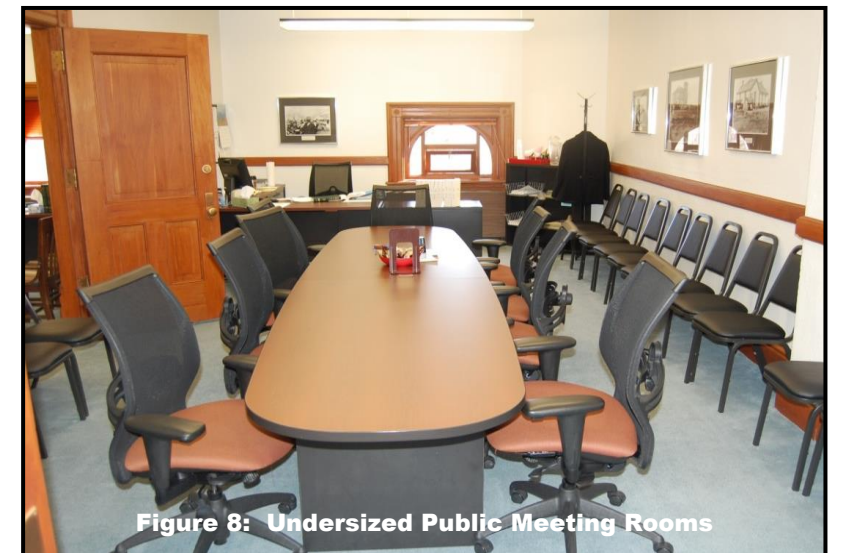
Figure 8: Undersized Public Meeting Rooms

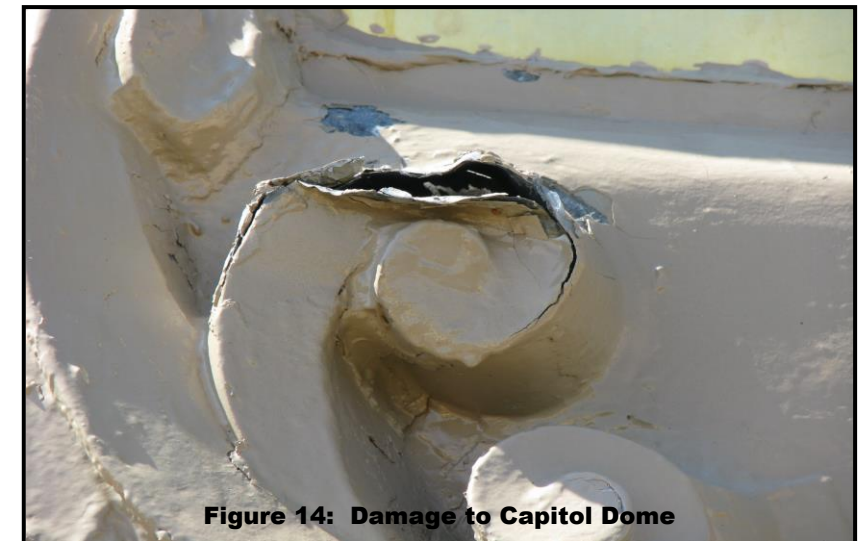
- The Dome appears to be generating cracks at the Rotunda, which allows water to enter and cause damage.
- There are coating failures over large portions of the exterior of the Dome.
- There are dents, tears, and punctures in virtually all of the metal surfaces across the exterior of the Dome and **water infiltration occurs in numerous locations**.
- There is moisture damage in the interior of the Dome, which is degrading the building fabric.

Figure 14: Damage to Capitol Dome

- The existing paint will be removed on the Dome, the metal will be repaired and replaced as necessary. Then, the surfaces will be re-primed and re-painted.
- The design team is currently engaged in an evaluation to prioritize masonry work for repair and replacement.

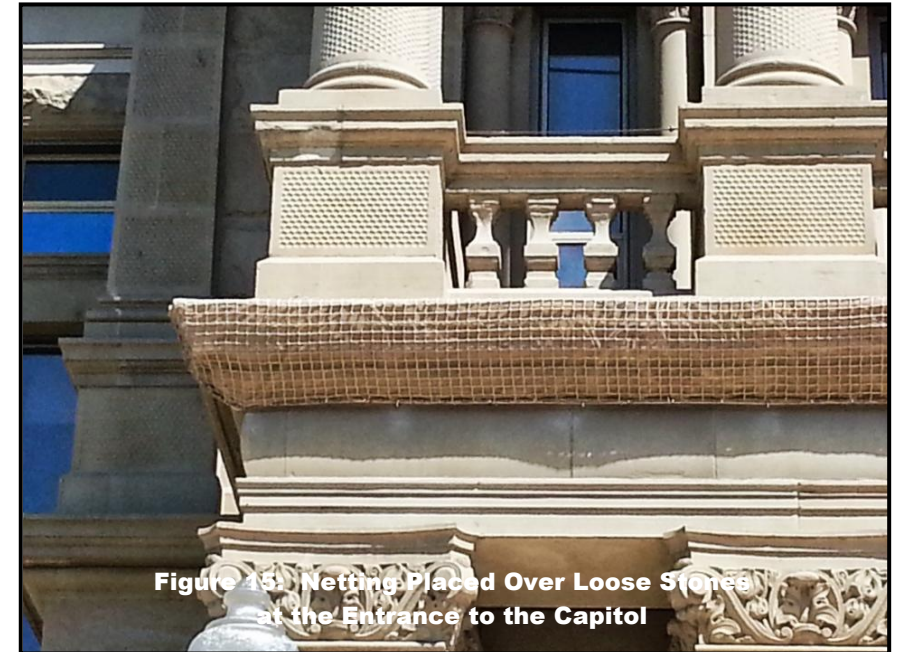
- **Many stones are damaged and loose.** In 2013, a loose stone was discovered over the front steps. The main entrance into the Capitol was closed for several weeks until the stone could be secured with netting.
- Cracks, spalls and voids, along with blistering, delamination, erosion, and discoloration have been identified.
- There are **open and deteriorated mortar joints** in the masonry.
- Most of the severe masonry damage exists in locations where there has been **continual water infiltration**.

Figure 15: Netting Placed Over Loose Stones at the Entrance to the Capitol

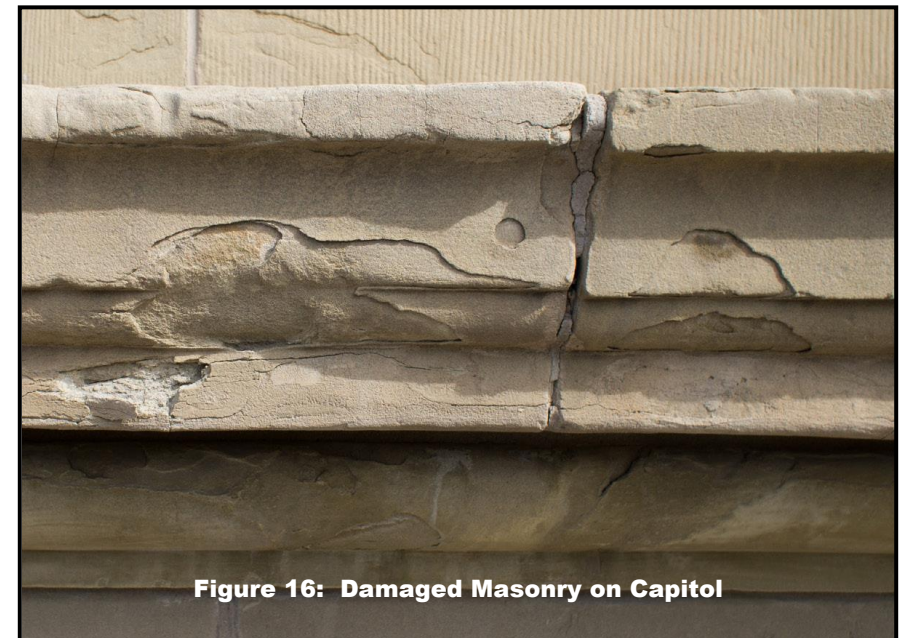
The stone on the Capitol exterior walls is generally sound, however significant localized issues exist. In some locations, the masonry is over 125 years old and periodic maintenance does not appear to have been performed. Repairs have been poorly executed or have failed.

Figure 16: Damaged Masonry on Capitol

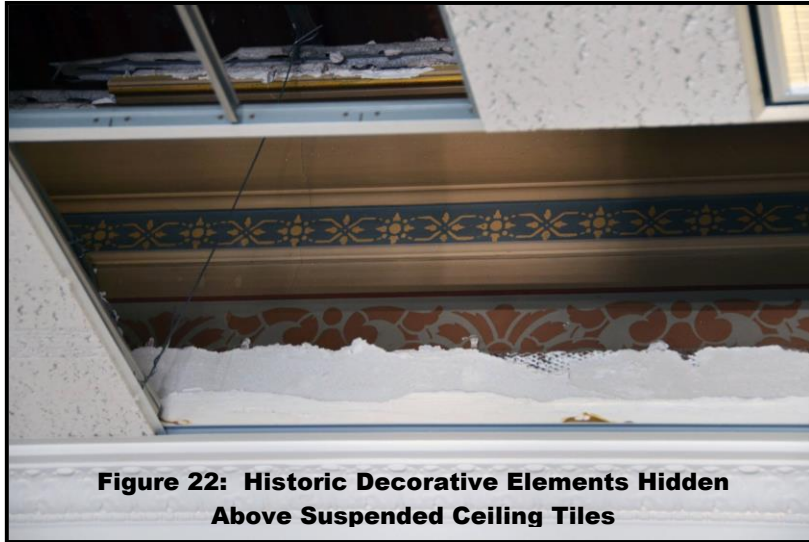
Suspended tile ceilings have been added throughout the building covering up historic details and significantly lowering ceiling heights. Restoring the original ceiling heights is **actually a cost savings**. By adopting a fan coil heating and cooling system, ceiling-mounted ductwork and stepped ceilings are avoided, lowering construction costs. Significant foundation underpinning reductions were also obtained by using this system.

Figure 22: Historic Decorative Elements Hidden Above Suspended Ceiling Tiles

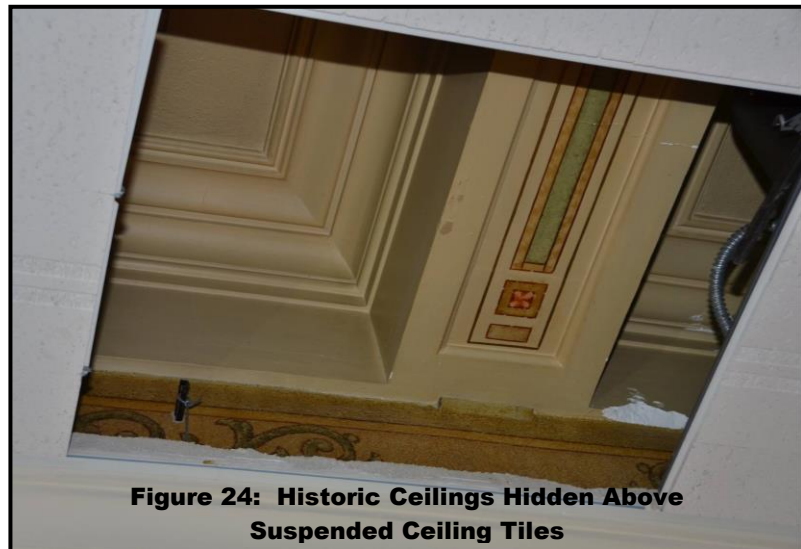
Figure 24: Historic Ceilings Hidden Above Suspended Ceiling Tiles

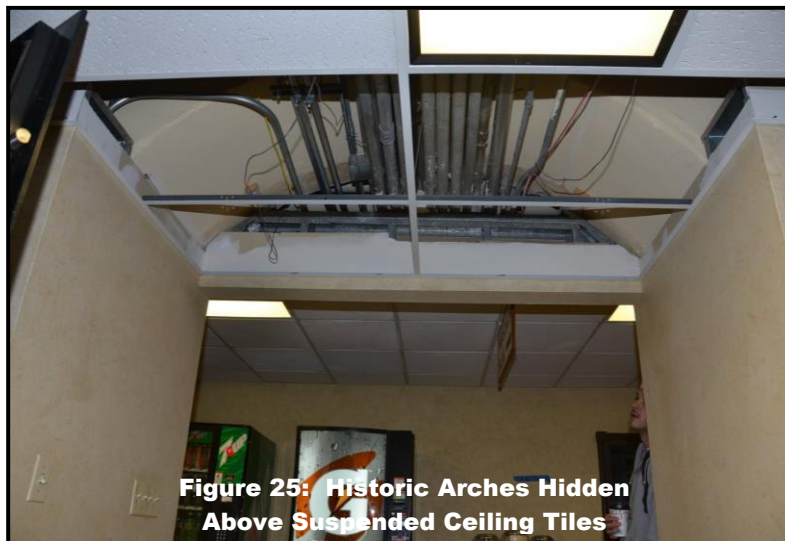
Figure 25: Historic Arches Hidden Above Suspended Ceiling Tiles

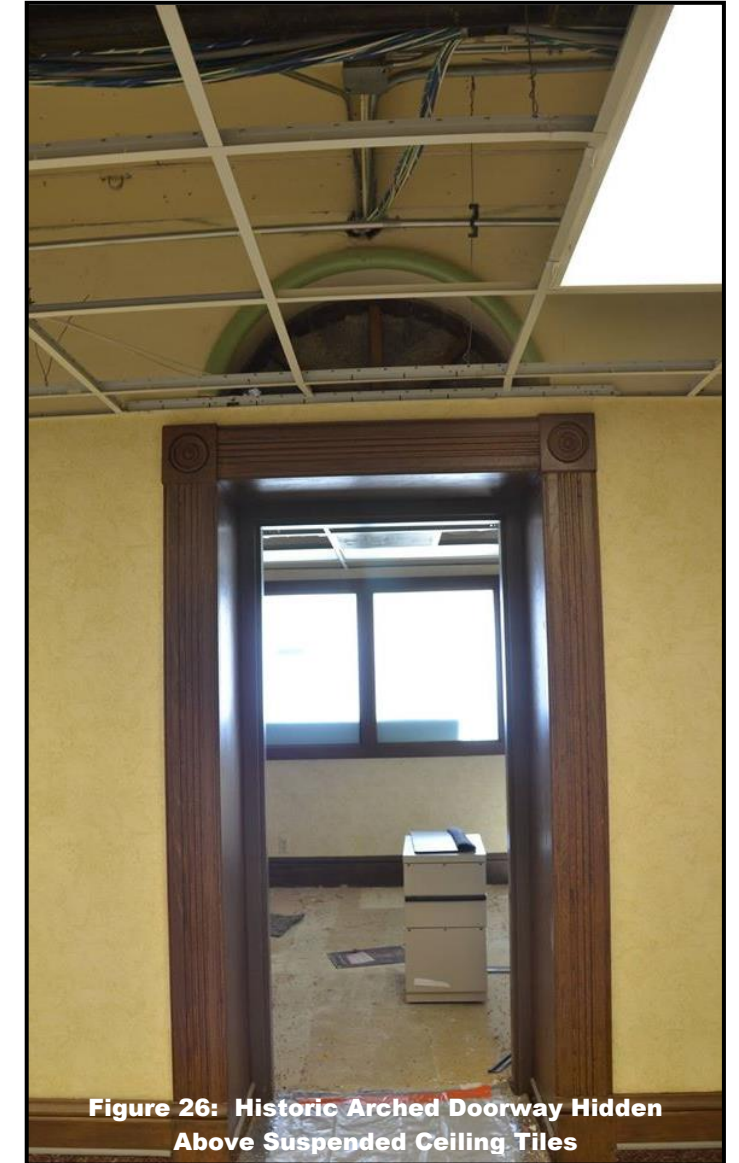
Figure 26: Historic Arched Doorway Hidden Above Suspended Ceiling Tiles

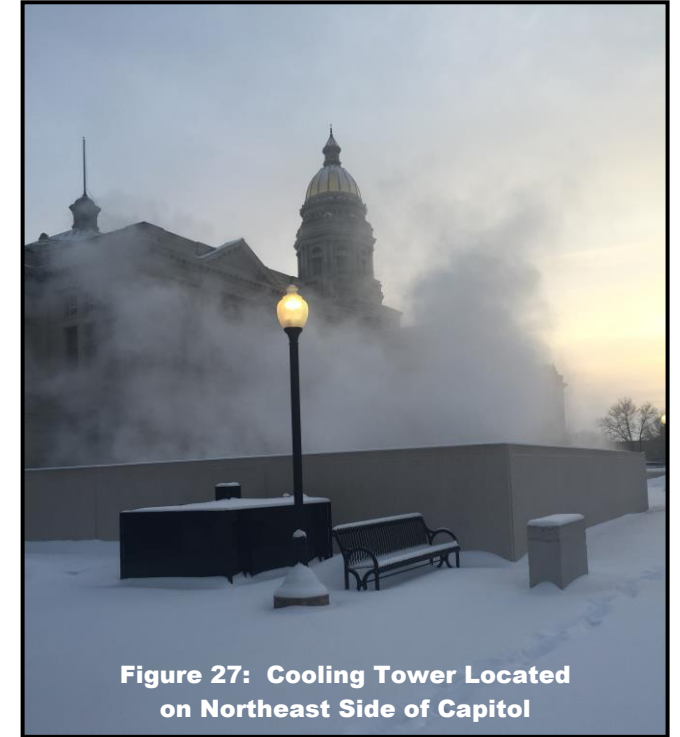
- The systems in the CUP have reached the **end of their life cycles** and require extraordinary maintenance to keep them operating. System failure is a real possibility.
- The existing CUP **lacks sufficient, serviceable space** for proposed systems. Expanding the footprint of the CUP allows installation of appropriate, modern systems. The CUP will be expanded from approximately 11,000 square feet to approximately 18,000 square feet.
- The above-ground cooling tower location on the northeast side of the Capitol creates noise and mist on the Capitol grounds. Moisture from the tower has **degraded the nearby stone** on the Capitol. The cooling tower requirements will increase with the combined capacity of the new CUP.
- The above-ground generator, transformer, and associated switchgear **pose a security risk** and detract from the appearance of the Capitol grounds.

Figure 27: Cooling Tower Located on Northeast Side of Capitol

- The CUP will be relocated to the southeast side of the Herschler Building. The existing systems will continue to provide services to the Capitol Complex until the new system is completed.
- The cooling tower will be **relocated to the fourth floor of the east side of the Herschler Building**.
- The generator, transformer, and electrical switchgear will be **relocated to the CUP and Herschler Building**.

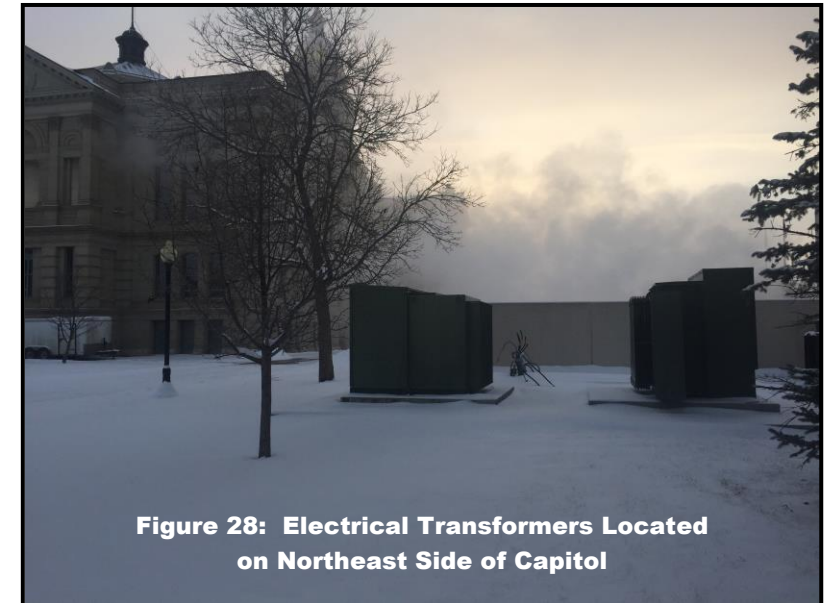
Figure 28: Electrical Transformers Located on Northeast Side of Capitol

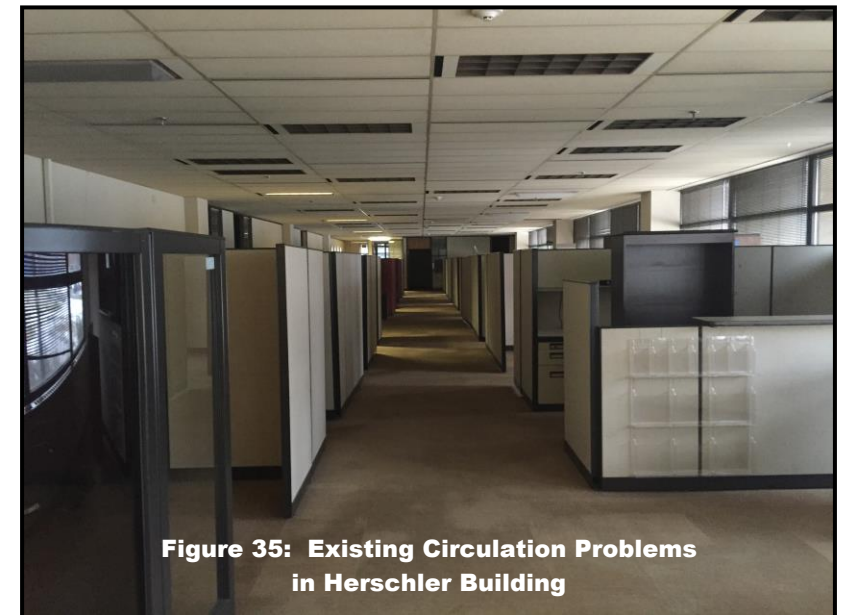
- **Wayfinding is difficult** within the building, because there is a greater distance from building entry points to elevators and stairs than typical.
- Elevators and stairs cannot be seen from the building entries, **making navigation difficult** to upper floors.
- The building's **open floorplan lacks security** and individuals can wander throughout the building.
- The atrium is underutilized and there are **heating and cooling costs** associated with maintaining it. Sound carries throughout the building when there are activities in the atrium, because each floor opens to the atrium.

Figure 35: Existing Circulation Problems in Herschler Building

- The new entries will provide more efficient access into the building, minimizing travel distance to elevators and restrooms, and **improving wayfinding** through the building.
- The new configuration will allow agencies to have clearly defined suites, allowing for improved security.
- The new configuration will reduce pedestrian traffic through unrelated agency space and increase the amount of square footage that can be used to house employees.
- Elevators will be added adjacent to the new lobby of the building to improve building circulation and to provide convenient access to the elected officials' staff located on the south side of the building.

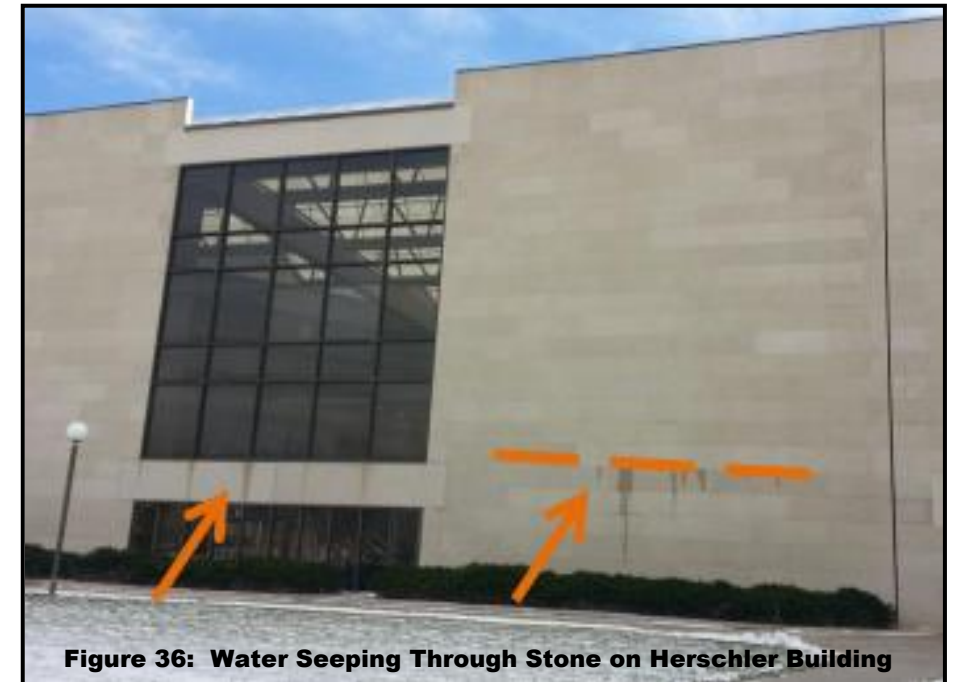
Figure 36: Water Seeping Through Stone on Herschler Building
