Sept-Îles fatal train derailment: Locomotive engineer couldn't have prevented crash, says TSB

Federal transportation safety board says QNS&L railway didn't regularly inspect rock face for danger of slides

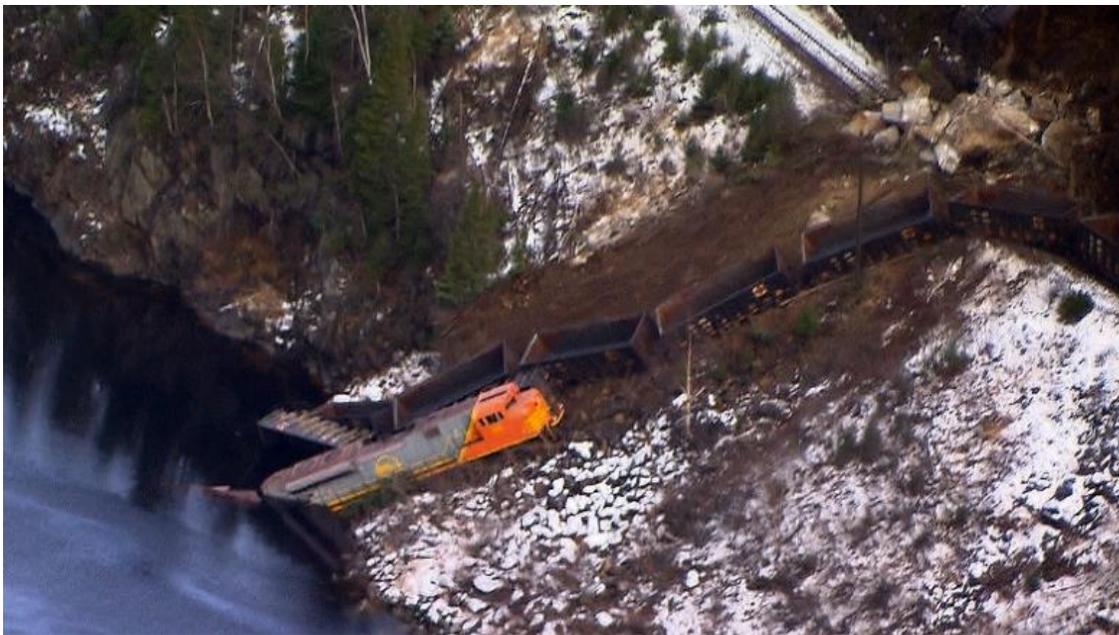
The train derailed and slid into the Moisie River. (Radio-Canada)

In a report released Wednesday morning, the TSB said the November 2014 collision caused the two lead locomotives and the first nine cars of the 240-wagon train to derail, sending them down the slope and into the Moisie River.
