Volume 3, Issue 5
October 2009

Commercial Façade Restoration Hurricane Ike Damages Restored

American National Insurance Office Building is located at #1 Moody Plaza Galveston Texas.

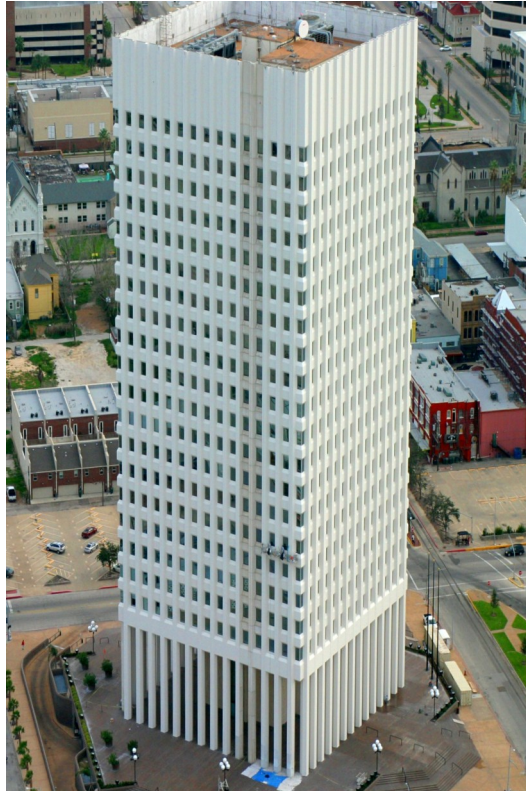
In Progress Photo Of Project

A specification was agreed on to repair all cracks, new sealants, clean, prime and apply 2 coats of Neogard Neoflex. There was a total of over 5,000 gallons of Neogard products applied .

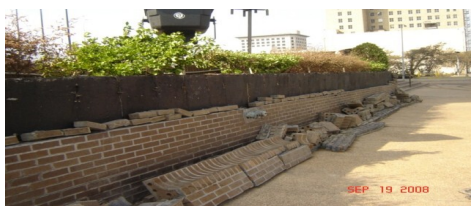
Typical damaged brickwork that was restored

All damaged brick of the retaining walls and penthouse were removed and reset with matching brick which were manufactured locally

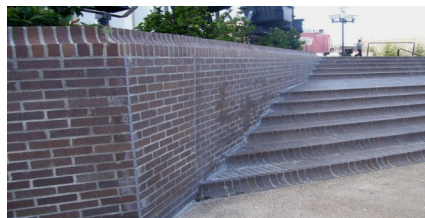
Completed brickwork after being restored
