## Banding the outboard end on a V-Ring comm

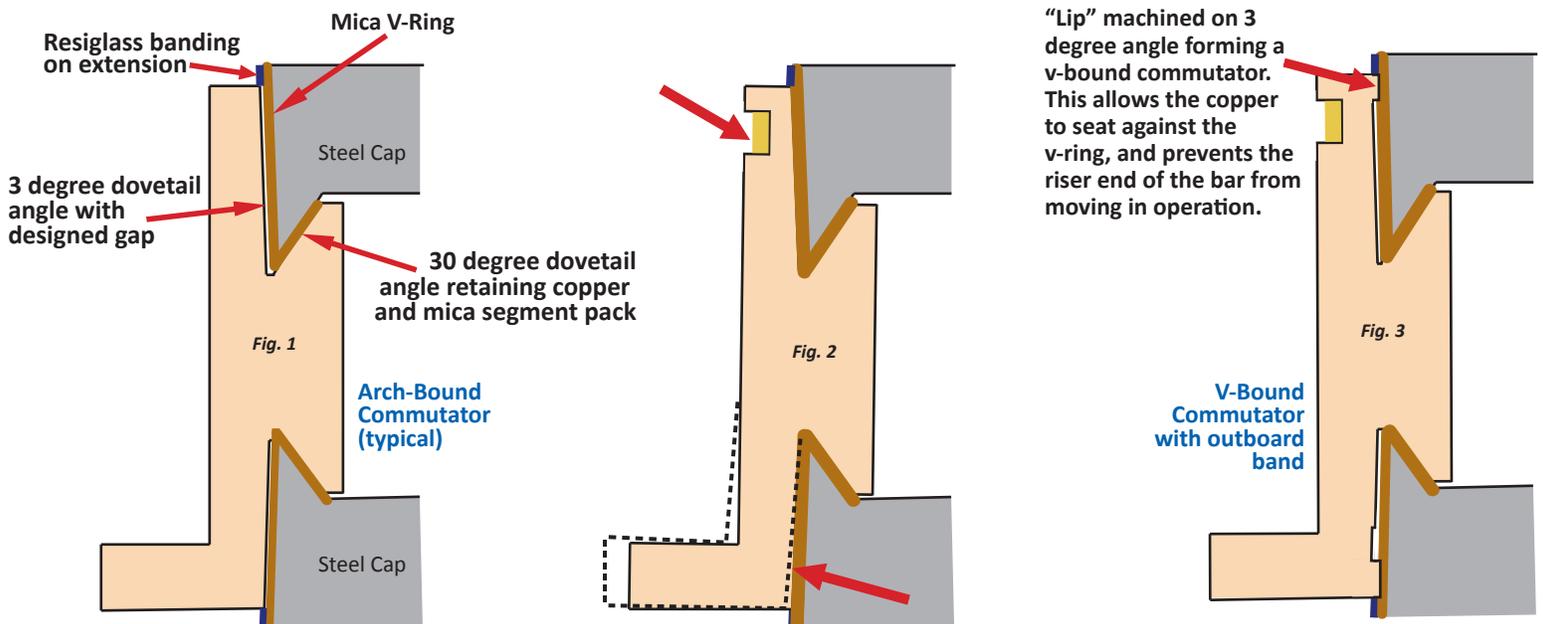
In v-ring commutators there is a designed gap between the steel cap and the copper bar on the 3° angle of the dovetail (see fig 1). This is included to allow differential expansion of the copper and steel in operation, and is a necessary design component.

By banding the outboard end, the gap is forced closed, effectively shifting the entire length of the bar and causing the riser end and center to lift in operation (see fig 2). In addition, at the outbound end, the angles begin fighting for seating position, and the result is even more bar instability at this end.

Some commutators are designed with a band on the outboard end (see fig.3). This design incorporates a machined lip on the inside of the dovetail which rests against the steel cap. This maintains the gap, but prevents any bar movement in operation.

Repairs for these situations are as varied as the causes, but banding the outboard end is not a solution.
