When should you dip a commutator in varnish?

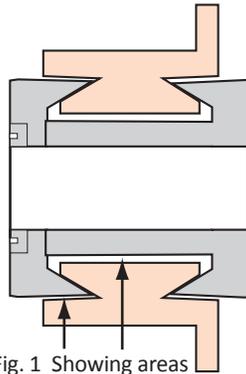
Commutators are designed with gaps throughout (see Fig. 1). This allows for differential expansion and contraction of the various materials in operation, and results in successful operation over many years. If varnish is introduced into these gaps, the commutator can no longer perform as designed and the varnish can cause three distinct problems:

Overheating: When dipped with varnish, these gaps are filled, which inhibits cooling and can often result in overheating in specific areas of the commutator.

Imbalance: Uneven distribution of the varnish may result in imbalance of the armature. For example, if the unit is dried horizontally, the varnish will pool to one side, and within the confines of the commutator, it may never entirely cure. This material can then result in the overheating noted above, but also in imbalance in operation.

Shorting: In addition to the problems noted above, exposing the commutator to any impurities in the varnish can also result in failure due to shorting bars. Though most repair facilities keep their varnish as clean as possible, minimal impurities which would not affect coils, will potentially bridge the small spaces between commutator bars.

Fig. 1 Showing areas where varnish can infiltrate

Depending on the severity, the comm may indeed need to be refilled. However, if after having banded the unit and taking it apart, you discover that the varnish deposits are minimal and contained mainly to the dovetail area, you may be able to simply clean the dovetails and replace the v-rings. Sanding or taking a very light skim cut should do this effectively. For tips on v-ring replacement, see Motor Fax Issue 2, or call us for information.
