Supporting paper potential traffic management proposals

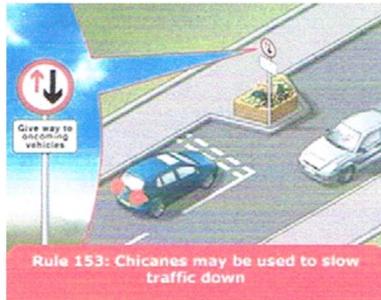
(where Rectory Lane joins Leicester Road). The location of the central reservation bollards and permanent inconsiderate parking makes very difficult the right turn from Leicester Road into Anstey Lane when travelling south; particularly for buses and other large vehicles.

Introduction of more effective traffic calming measures such as chicanes (see above) which are proven to be effective in slowing traffic down and creating safer crossing areas for pedestrians.
